National Transportation Safety Board Aviation Accident Final Report

Location:	Moose Pass, AK	Accident Number:	ANC19FA029
Date & Time:	06/28/2019, 1608 AKD	Registration:	N56512
Aircraft:	Maule M6	Aircraft Damage:	Substantial
Defining Event:	Abrupt maneuver	Injuries:	3 Fatal, 1 Serious
Flight Conducted Under:	Part 91: General Aviation - Personal

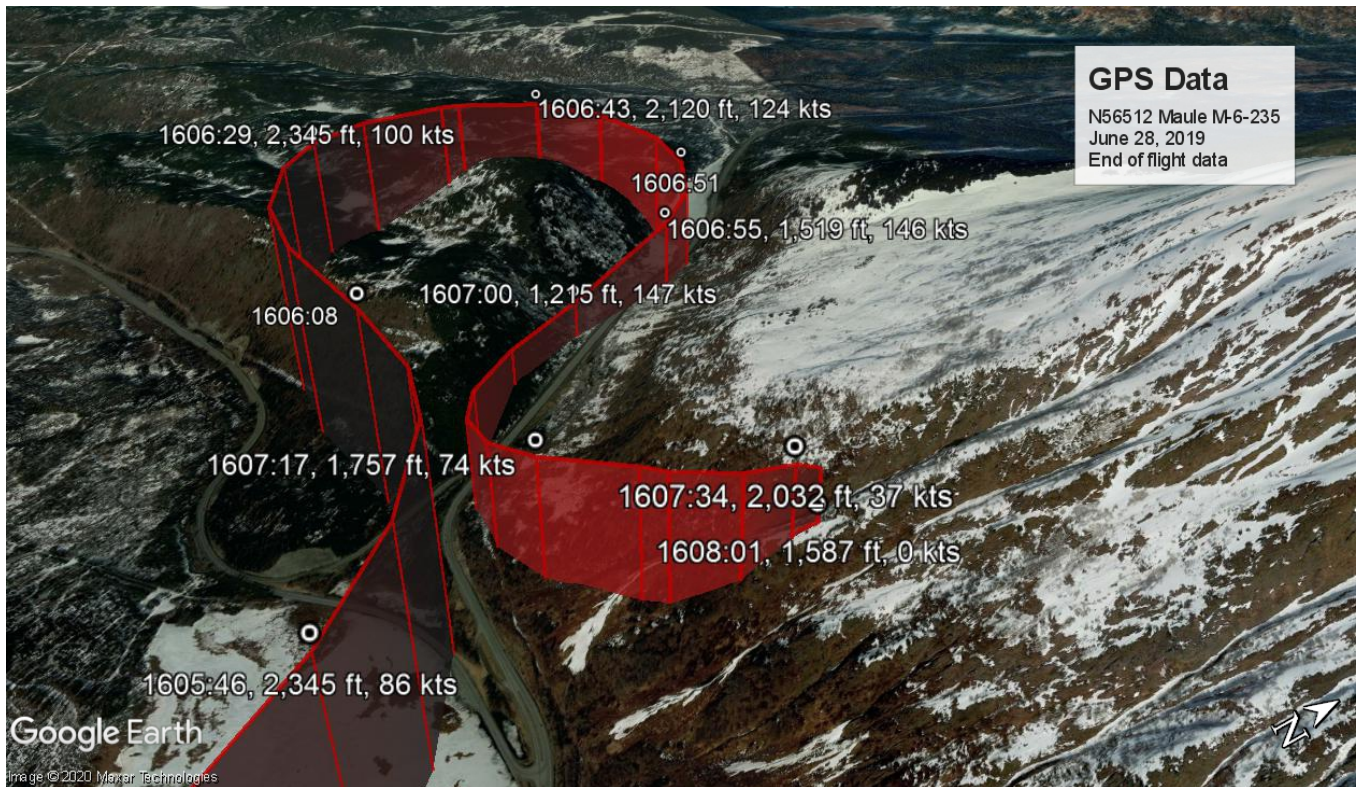
GPS data from the accident flight revealed that, about 2 minutes before the accident, the airplane made about a 180° right turn and began a descent to a GPS altitude of 1,235 ft, followed by a left turn to a northerly heading and a climb to a GPS altitude of 2,032 ft and a groundspeed of 37 knots. The last recorded in-flight data point showed that the airplane was at a GPS altitude of 1,587 ft and at a 0- knot groundspeed.

The GPS data logs for the day of the accident revealed that, about 1602, the airplane crossed Moose Pass at a GPS altitude of about 2,000 ft. The airplane continued northwest along Sterling Highway at GPS altitudes that varied between 1,700 and 2,400 ft. About 1606, after passing the intersection of Sterling and Seward Highways, the airplane began a right 180° turn to the southeast; shortly thereafter, the airplane began a descent to a GPS altitude of 1,215 ft. At 1607:00, the airplane began a left turn toward a northerly heading and initiated a climb. At 1607:34, the airplane was on a track of 354° at a GPS altitude of 2,032 ft, and at a groundspeed of 37 knots. The last fully recorded in-flight data point was at 1608:01, when the airplane was at a GPS altitude of 1,587 ft and a 0-knot groundspeed and on a track of 282°. (See figure 1.)

Figure 1. Last minutes of flight ground track.

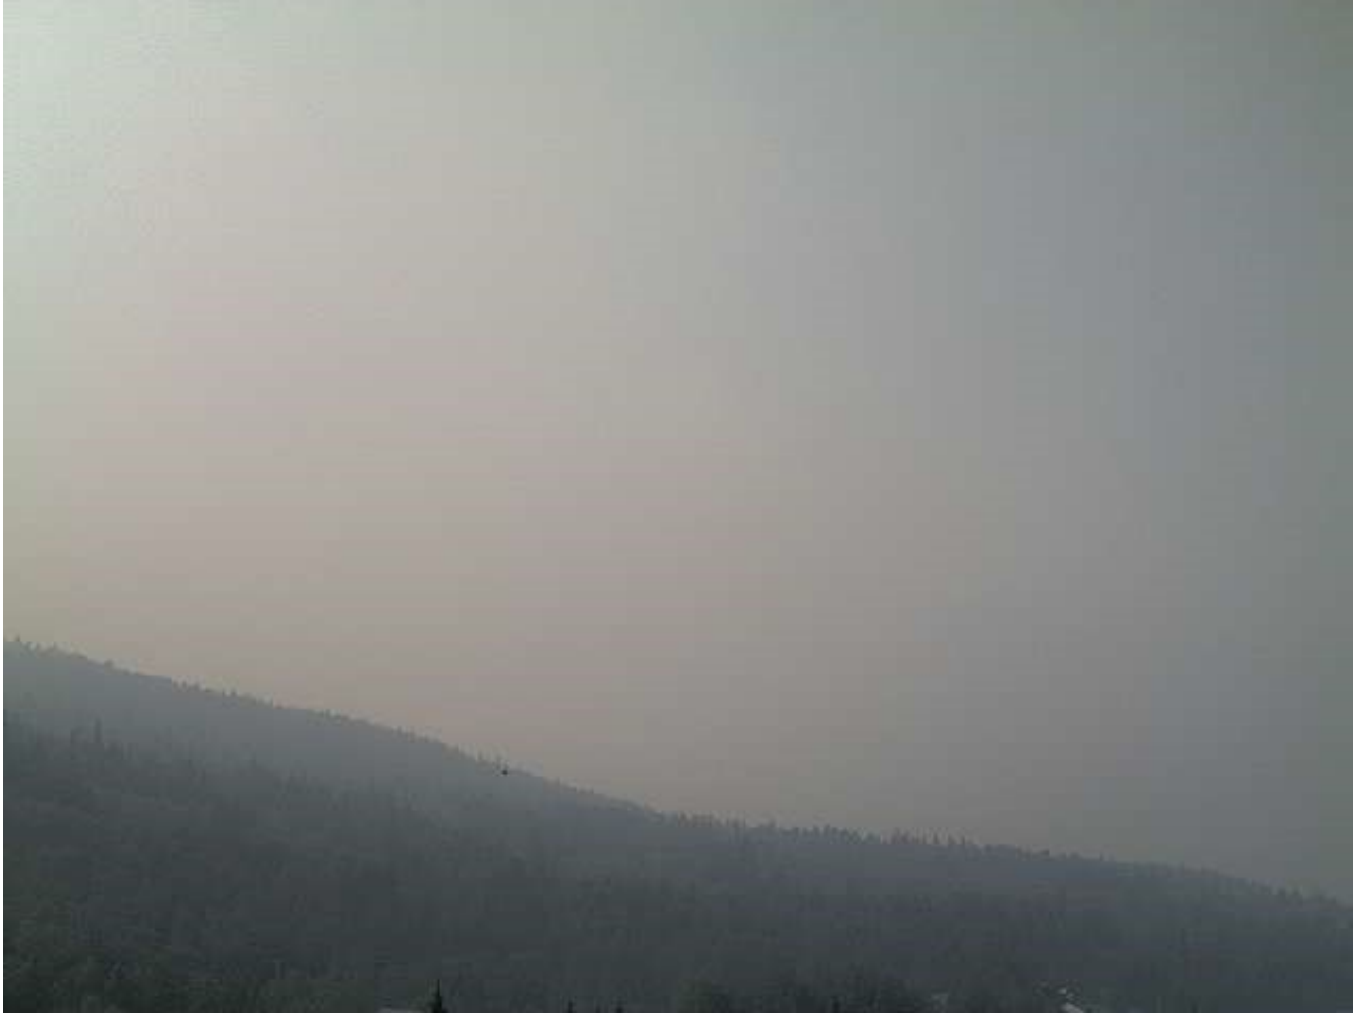
A review of Federal Aviation Administration (FAA) weather camera images recorded from Moose Pass (52Z), about 7 miles southeast of the accident site, revealed reduced visibilities in all directions about the time of the accident as a result of smoke and/or haze in the area. Figure 2 shows the visibility in the direction of the accident site about the time of the crash; Figure 3 shows the visibility on a clear day.

Figure 2. Reduced visibility conditions in the direction of the accident location at 1610 on the day of the accident.

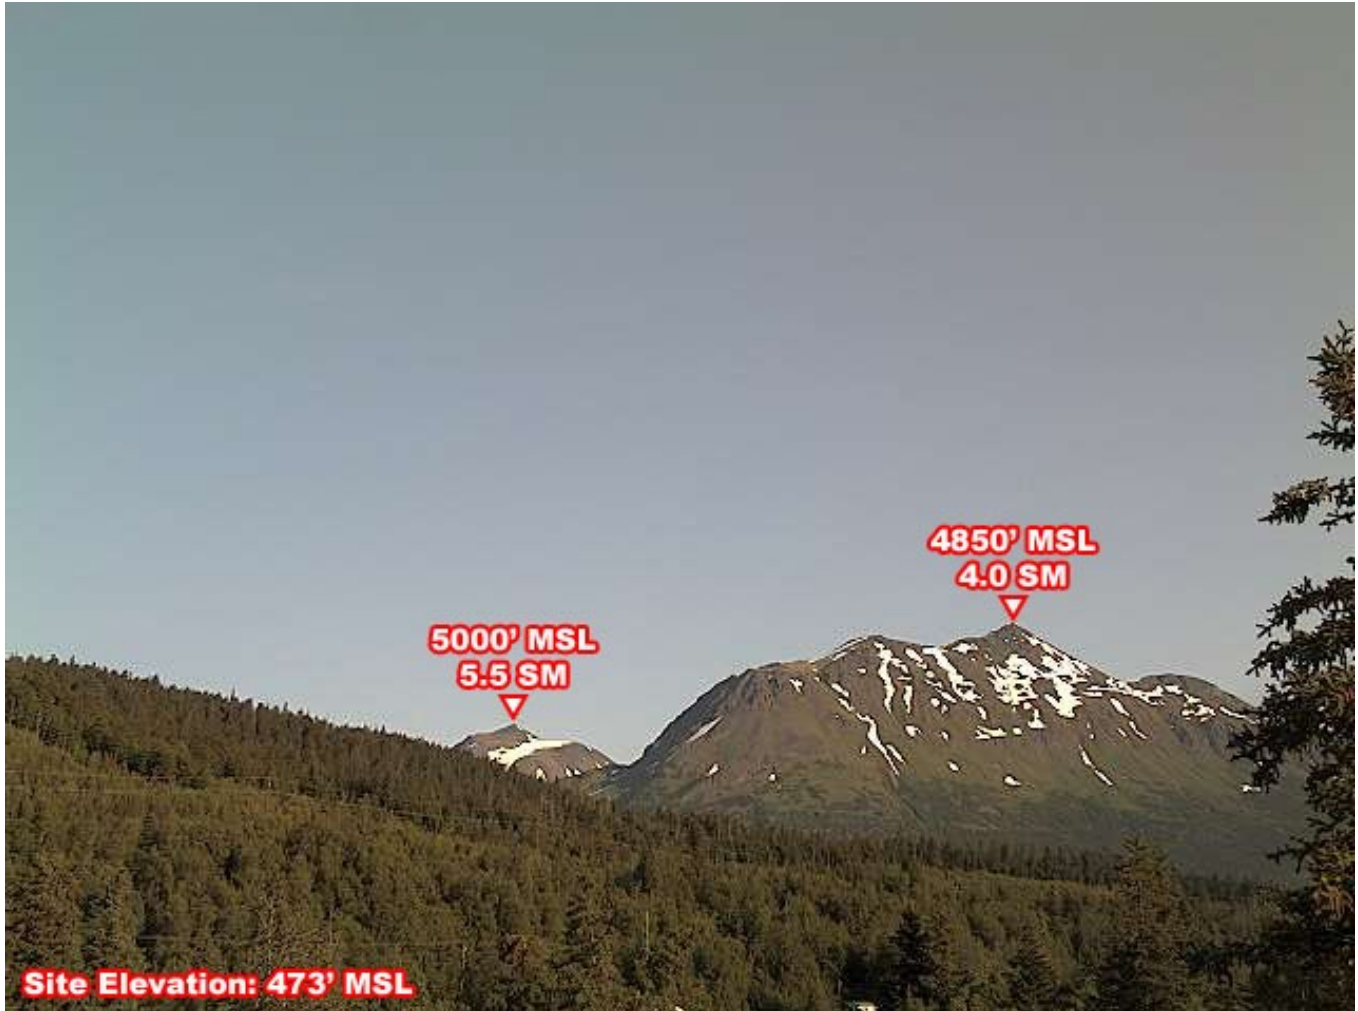
Figure 3. Visibilities in the direction of the accident location on a clear day.
