First Flight Home Inspections, Inc.

HOME INSPECTION REPORT

Inspected Property Address:
1234 Sample Report Drive
Any Town, NC 27000

Field Inspection Performed on Tuesday, January 1, 2019 Scheduled Time: 10:00
Type of Inspection: Pre-Purchase Report # 10119-1

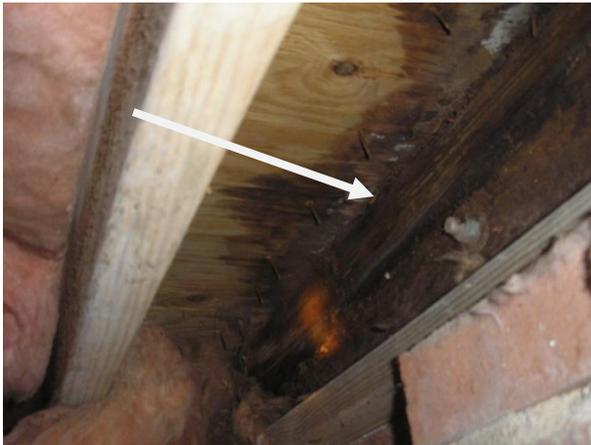
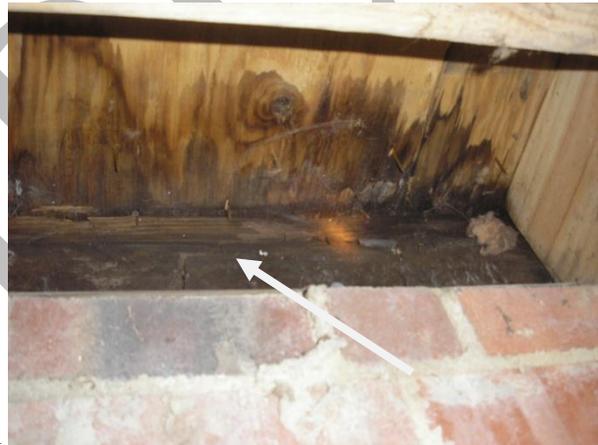
1. The wood sub floor and wood band joist located in the crawlspace and along the area of the rear entryway door and rear deck are water stained and decayed. See exterior section. Water infiltration into the building envelope poses to result in decay and undesirable environmental conditions.

Consult a qualified professional general contractor experienced in residential structures for further investigation and repair.

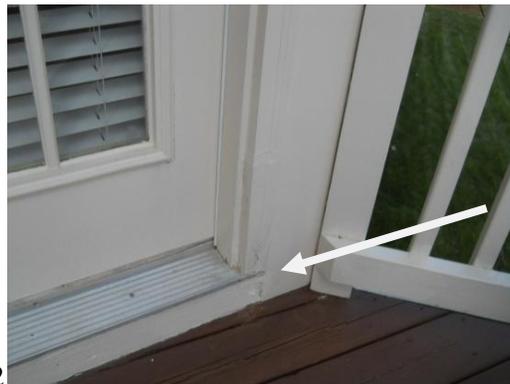
2. The exterior wood trim located at the bottom of the rear entryway door is water damaged. Water infiltration into the building envelope poses to result in water damage and other undesirable environmental conditions. See structural components section.

Consult a qualified professional general contractor experienced in residential exteriors for repair.

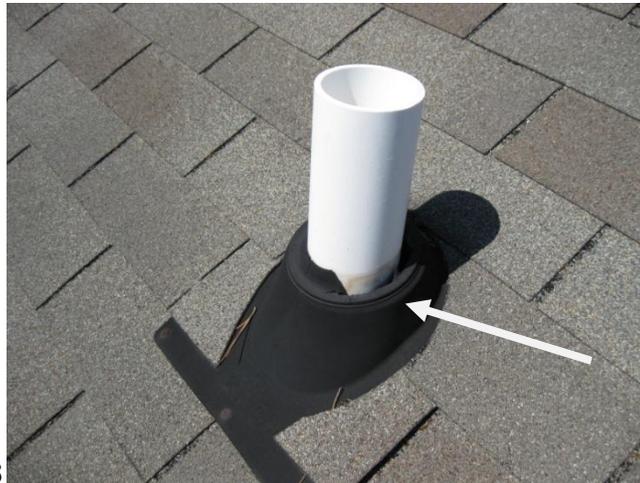
3

3. The plastic DWV plumbing vent pipe collar flashing located on the rear roof is deteriorated and has an approximately two square inch opening. Water infiltration into the building envelope poses to result in water damage and other undesirable environmental conditions. This is above the area of the second floor master bathroom ceiling that is water stained. See Interior Section.

Consult a qualified professional contractor experienced in residential roofing for repair.

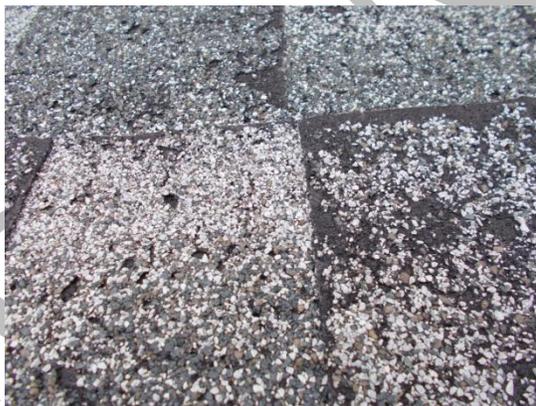
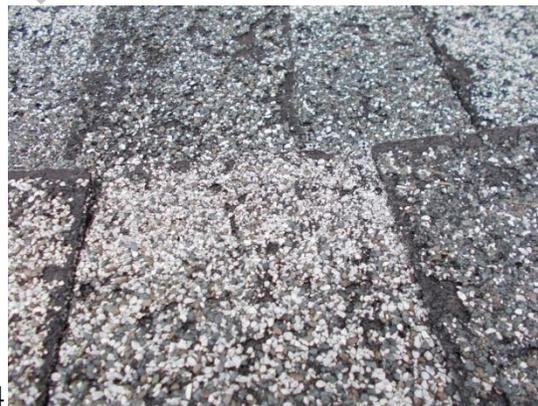
4

4. The composition asphalt roofing shingles located on the right front roof are deteriorated. The deterioration is consistent with ruptured shingle blisters resulting in excessive mineral granule loss and exposure of the mat substrate. While not conclusive, the possible causes of asphalt shingle blisters maybe from the expansion of gas from either moisture or gases from the volatile organics or resins trapped in the shingle substrate and or inadequate attic ventilation. Deteriorated roof coverings pose to allow water to infiltrate into the building envelope and result in water damage and other undesirable environmental conditions.

Consult a qualified professional contractor experienced in residential roofing for further investigation.

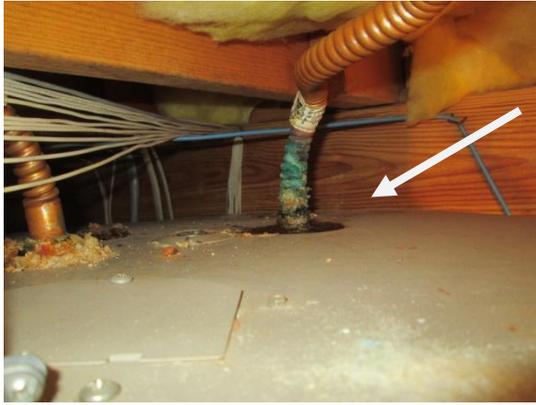
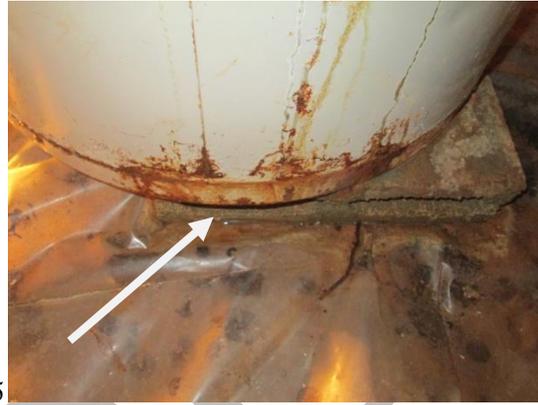
5. The cold water supply pipe connection located above/on the water heater located in the center of the crawl space is corroded and is leaking water. The outer cover of the water heater, starting at the cold water supply pipe and continuing all the way to the bottom of the water heater is wet and rust stained from leaking water. Water infiltration into the building envelope poses to result in water damage and other undesirable environmental conditions.

Consult a qualified professional NC licensed plumbing contractor for repair.

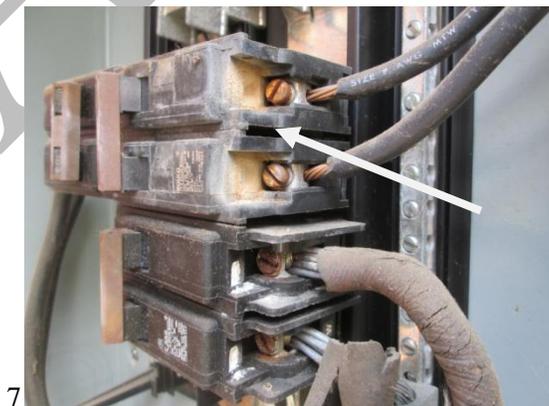
7. The lugs for the circuit breakers in the main electrical distribution panel located on the right exterior are corroded. Corroded lugs pose to increase the resistance, which can lead to overheating and an electrical fire.

Consult a qualified professional NC licensed electrical contractor for further investigation and or repair.

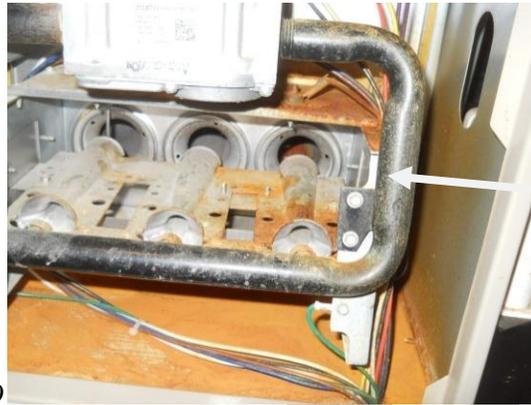
9. The right most burner section of the heat exchanger in/for the second floor HVAC furnace located in the attic is corroded or rusted. Faulty heat exchangers pose to allow carbon monoxide (CO) gas to enter the forced air distribution system. High levels of carbon monoxide (CO) gas, which is virtually undetectable without using detection technology, poses to result in carbon monoxide poisoning.

Consult a qualified professional NC licensed heating contractor for further investigation

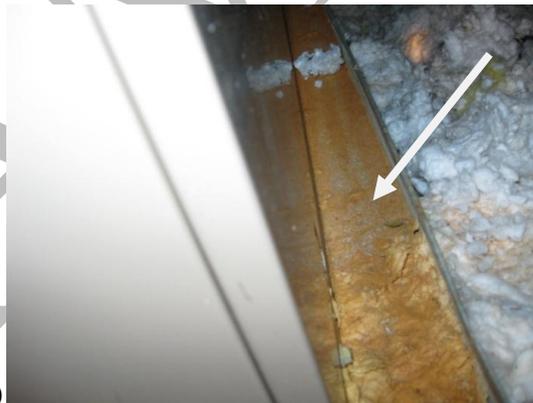
10. The drip pan under the second floor HVAC unit located in the attic is corroded or rusted and has a watermark from past standing water. This is an indication of past improper draining of condensate (water) from the AC evaporator. Improper proper draining of condensate (water) poses to damage the equipment and other undesirable environmental conditions.

Consult a qualified professional NC licensed heating contractor experienced in residential air conditioners for further investigation and repair.

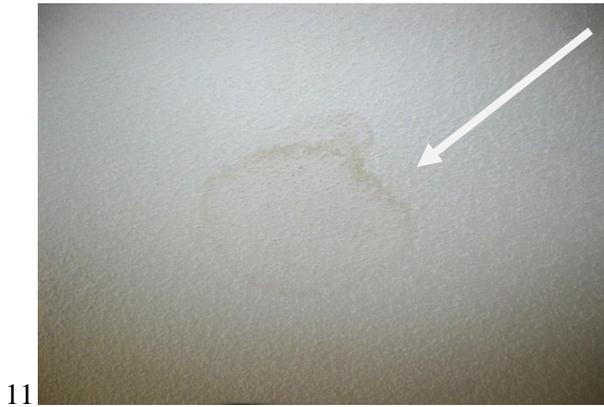
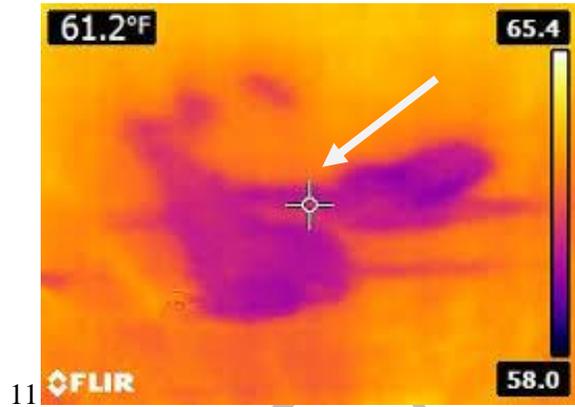
11

11. The ceiling located in the second floor master bathroom is water stained. The ceiling has a thermal anomaly that appears to be consistent with possible water/moisture infiltration. This is below the area of the DWV vent pipe roof penetration located on the rear roof. See roofing section. Water infiltration into the building envelope poses to result in water damage and other undesirable environmental conditions.

Consult a qualified professional contractor experienced in residential interiors for further investigation and repair.

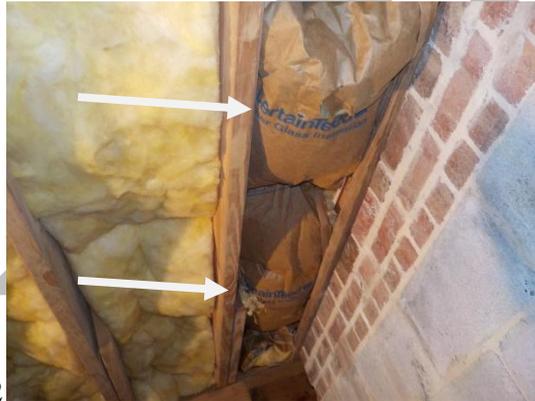
12

12. The under floor insulation located in the crawl space and along the area of the front entryway door is improperly installed with the kraft paper moisture barrier facing away from the conditioned surface. This poses to allow moisture to be trapped between the moisture barrier and the conditioned surface. Consult a qualified professional contractor experienced in insulation for repair.
