First Flight Home Inspections, Inc.

HOME INSPECTION REPORT

Inspected Property Address:
1234 Sample Report Drive
Any Town, NC 27000

Type of Inspection: Pre-Purchase Report # 10123-1

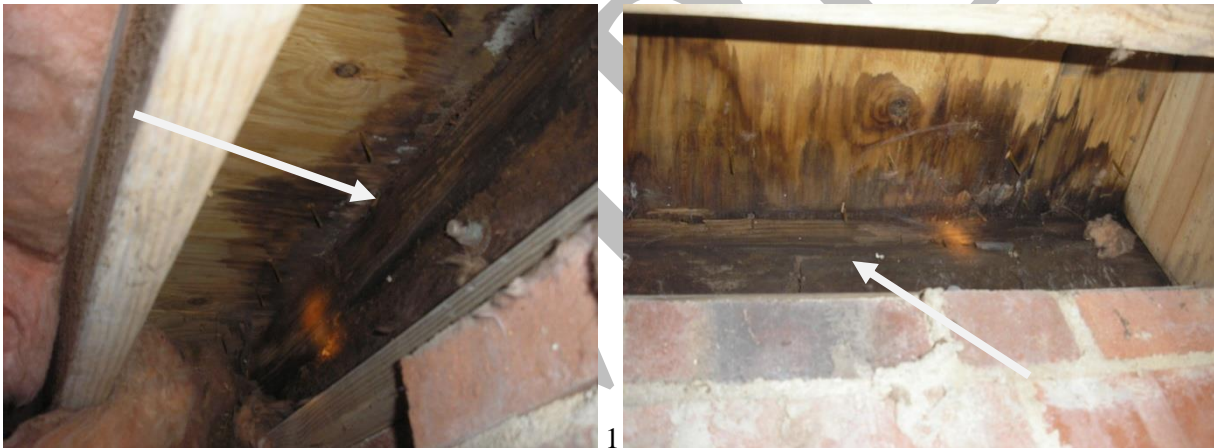
1. The wood sub floor and wood band joist located in the crawlspace and along the area of the rear entryway door and rear deck are water stained and decayed. See exterior section. Water infiltration into the building envelope poses to result in wood decay and other undesirable environmental conditions. Decayed wood pose to reduce the strength of the structural members.

Consult a qualified professional general contractor experienced in residential structures for further investigation and repair.

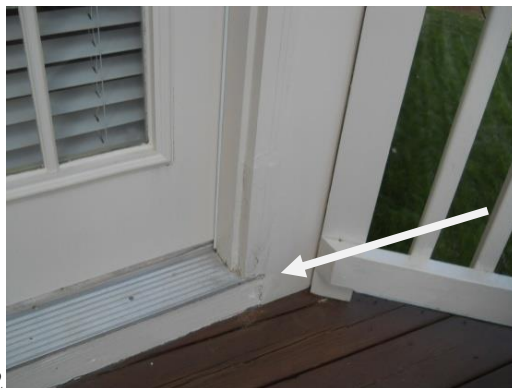
2. The exterior wood trim located at the bottom of the rear entryway door is decayed. See structural section. Decayed exterior trim poses to allow water infiltration into the building envelope and result in water damage and other undesirable environmental conditions. See structural components section.

Consult a qualified professional general contractor experienced in residential exteriors for repair.

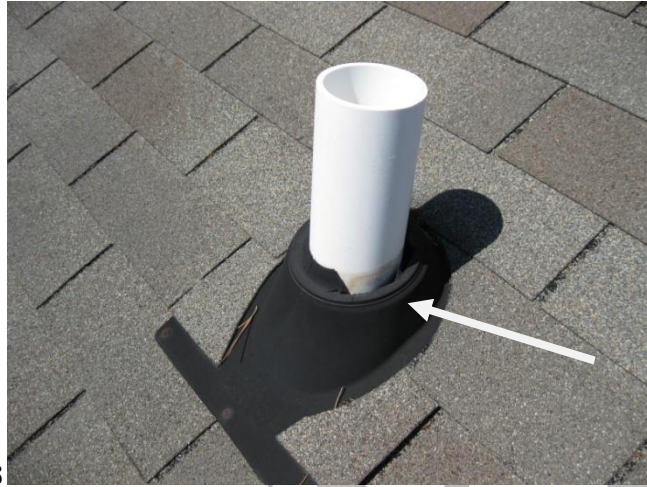
3

- 3. The plastic DWV plumbing vent pipe collar flashing located on the rear roof is deteriorated and has an approximately two square inch opening. Water infiltration into the building envelope poses to result in water damage and other undesirable environmental conditions. This is above the area of the second floor master bathroom ceiling that is water stained. See Interior Section.

Consult a qualified professional contractor experienced in residential roofing for repair.

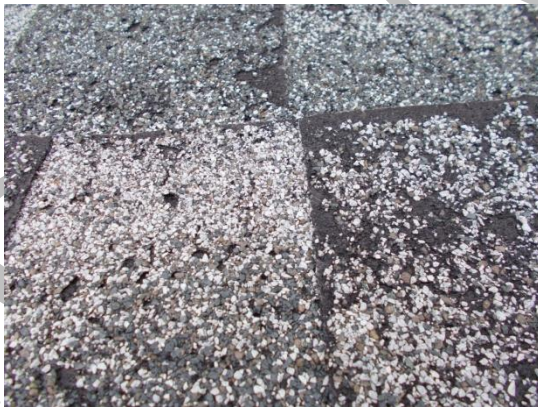
4

- 4. The composition asphalt roofing shingles located on the right front roof are deteriorated. The deterioration is consistent with ruptured shingle blisters resulting in excessive mineral granule loss and exposure of the mat substrate. While not conclusive, the possible causes of asphalt shingle blisters maybe from the expansion of gas from either moisture or gases from the volatile organics or resins trapped in the shingle substrate and or inadequate attic ventilation. Deteriorated roof coverings pose to allow water to infiltrate into the building envelope and result in water damage and other undesirable environmental conditions.

Consult a qualified professional contractor experienced in residential roofing for further investigation and repair.

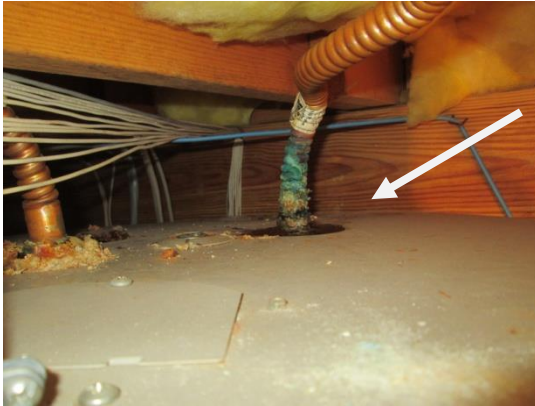
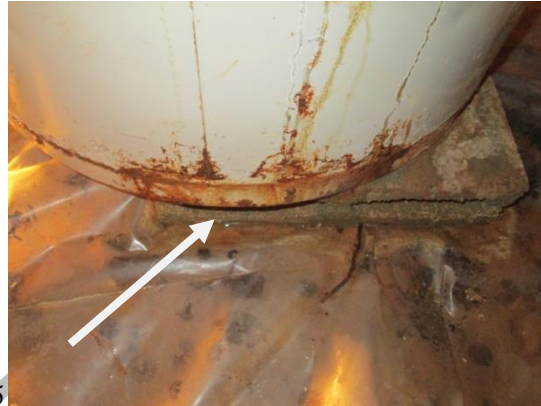
5. The cold water supply pipe connection located above/on the water heater located in the center of the crawl space is corroded and is leaking water. The outer cover of the water heater, starting at the cold water supply pipe and continuing all the way to the bottom of the water heater is wet and rust stained from leaking water. Water infiltration into the building envelope poses to result in water damage and other undesirable environmental conditions.

Consult a qualified professional NC licensed plumbing contractor for repair.

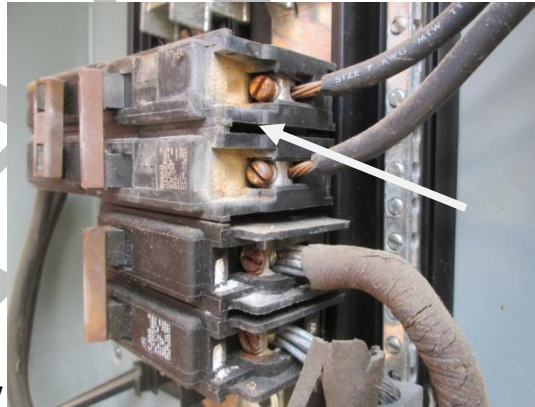
6. The light bulbs in the ceiling light fixture located in the second floor hall and above the stairs are not functioning. Bunt out or missing light bulbs make it impossible to ascertain if the light fixtures and the associated wiring and switches are functioning. Check or replace the bulbs first.
 7. The lugs for the circuit breakers in the main electrical distribution panel located on the right exterior are corroded. Corroded lugs pose to increase the resistance, which can lead to overheating and an electrical fire.
- Consult a qualified professional NC licensed electrical contractor for further investigation and or repair.

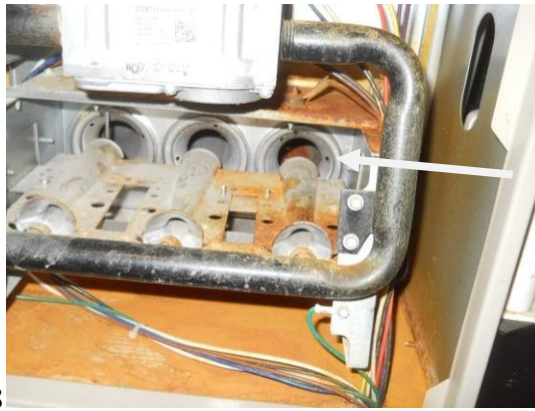
8. The right most burner section of the heat exchanger in/for the second floor HVAC furnace located in the attic is corroded or rusted. Faulty heat exchangers pose to allow carbon monoxide (CO) gas to enter the forced air distribution system. High levels of carbon monoxide (CO) gas, which is virtually undetectable without using detection technology, poses to result in carbon monoxide poisoning.
- Consult a qualified professional NC licensed heating contractor for further investigation

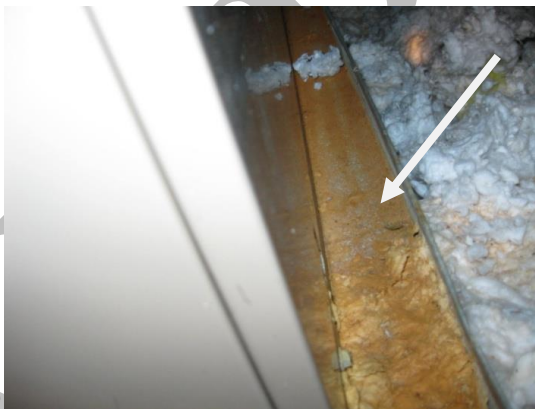
9. The drip pan under the second floor HVAC unit located in the attic is corroded or rusted and has a watermark from past standing water. This is an indication of past improper draining of condensate (water) from the AC evaporator. Improper proper draining of condensate (water) poses to damage the equipment and other undesirable environmental conditions.

Consult a qualified professional NC licensed heating contractor experienced in residential air conditioners for further investigation and repair.

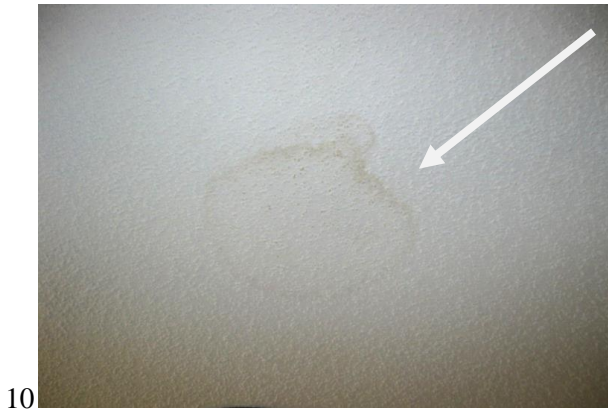
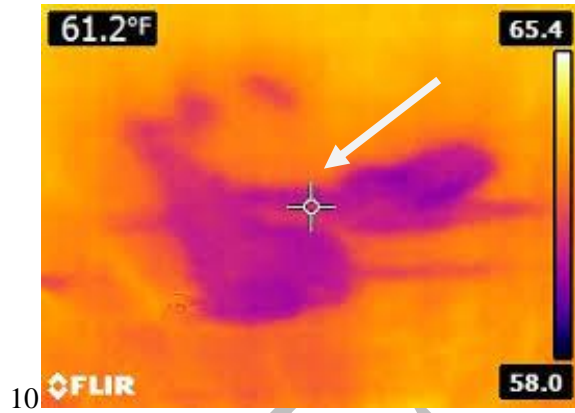
10. The ceiling located in the second floor master bathroom is water stained. The ceiling has a thermal anomaly that appears to be consistent with possible water/moisture infiltration. This is below the area of the DWV vent pipe roof penetration located on the rear roof. See roofing section. Water infiltration into the building envelope poses to result in water damage and other undesirable environmental conditions.

Consult a qualified professional contractor experienced in residential interiors for further investigation and repair.

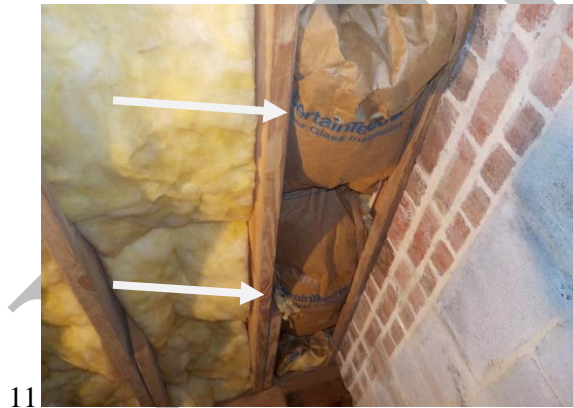
11. The under floor insulation located in the crawl space and along the area of the front entryway door is improperly installed with the kraft paper moisture barrier facing away from the conditioned surface. This poses to allow moisture to be trapped between the moisture barrier and the conditioned surface. Consult a qualified professional contractor experienced in insulation for repair.
