Feb 17th, 2026

123 SAMPLE STREET, SAMPLE, AL 00000

Home Inspection Report

Garrett Gamble / Gamble Home Inspections LLC

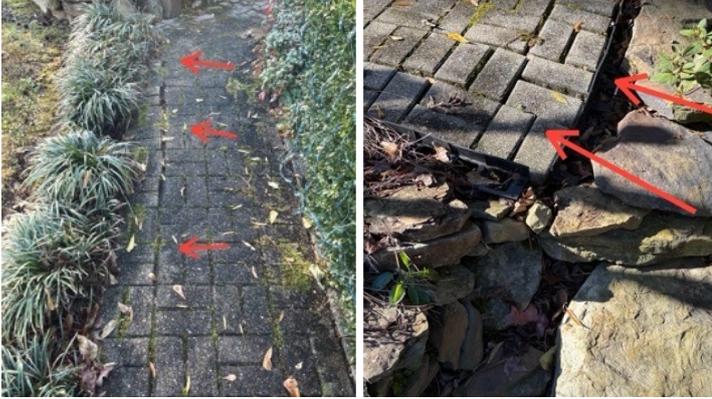
The walkways are observed to be slippery, uneven, and/or unlevel. It is recommended to address these issues to prevent potential tripping hazards. Consider resurfacing or leveling the walkways and applying a non-slip coating for improved safety.

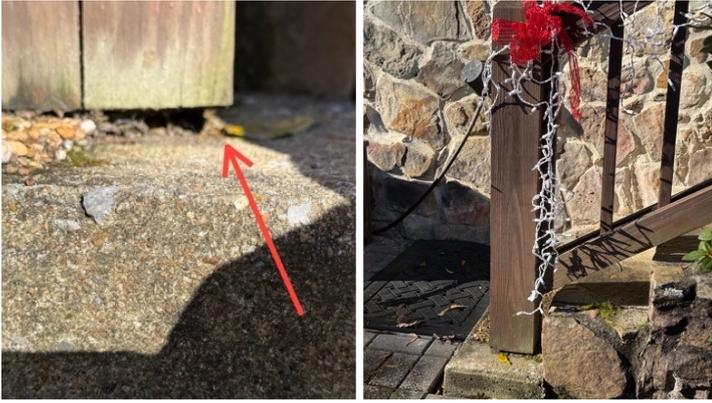
Handrail loose

The handrail on the steps/stoop is loose and may pose a safety hazard. Recommend securing or replacing the handrail promptly to ensure stability and prevent potential injuries. Please consult a qualified contractor for repairs.

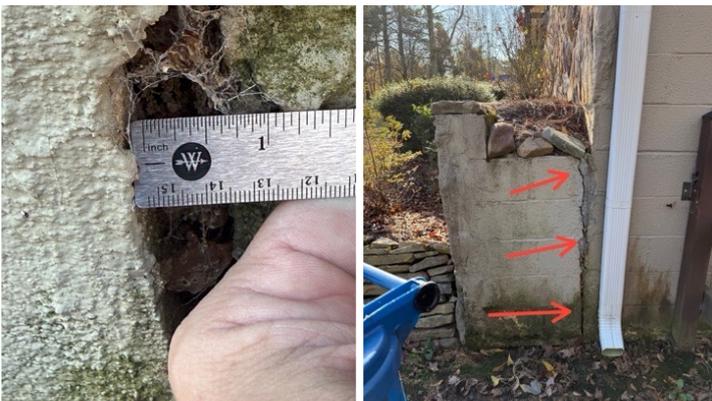
The retaining wall is observed to be separating from the home. This may compromise both the wall's structural integrity and the surrounding soil stability. It is recommended to consult with a structural engineer or qualified contractor to assess the situation and perform necessary repairs.

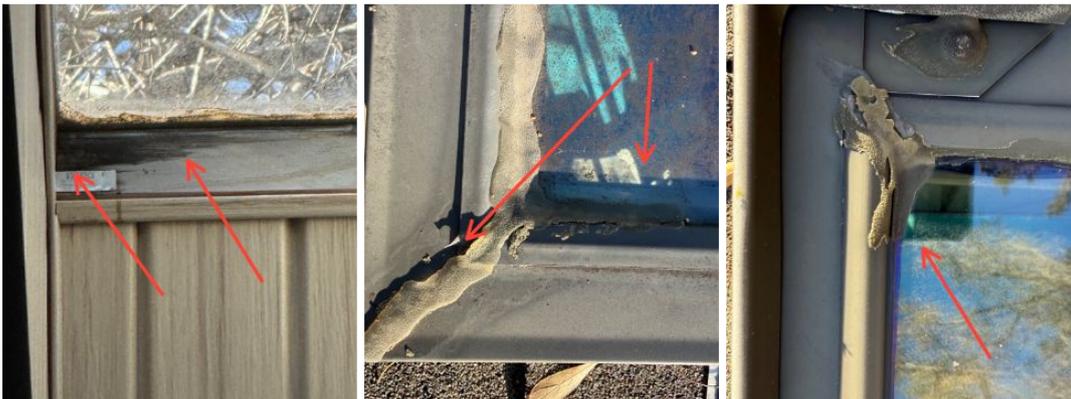
Skylight water intrusion/deteriorating caulk

One or more sky lights have deteriorating caulking around the seals and water intrusion on the interior frame.

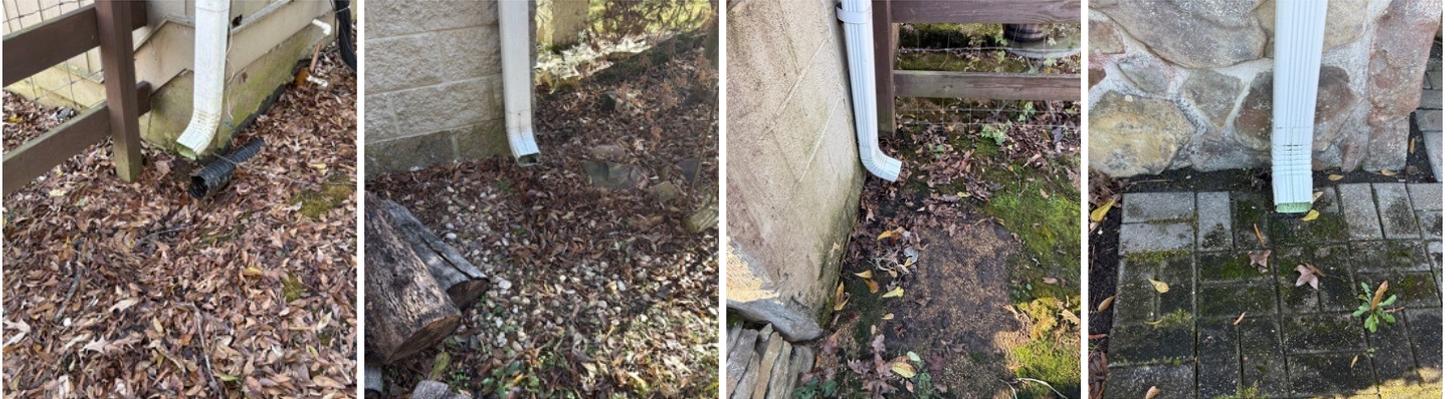
Missing splashblock/extension

Observed missing splashblock/extension at the downspout. Recommend installing a splashblock or extension to ensure proper water diversion away from the foundation and prevent potential water damage.

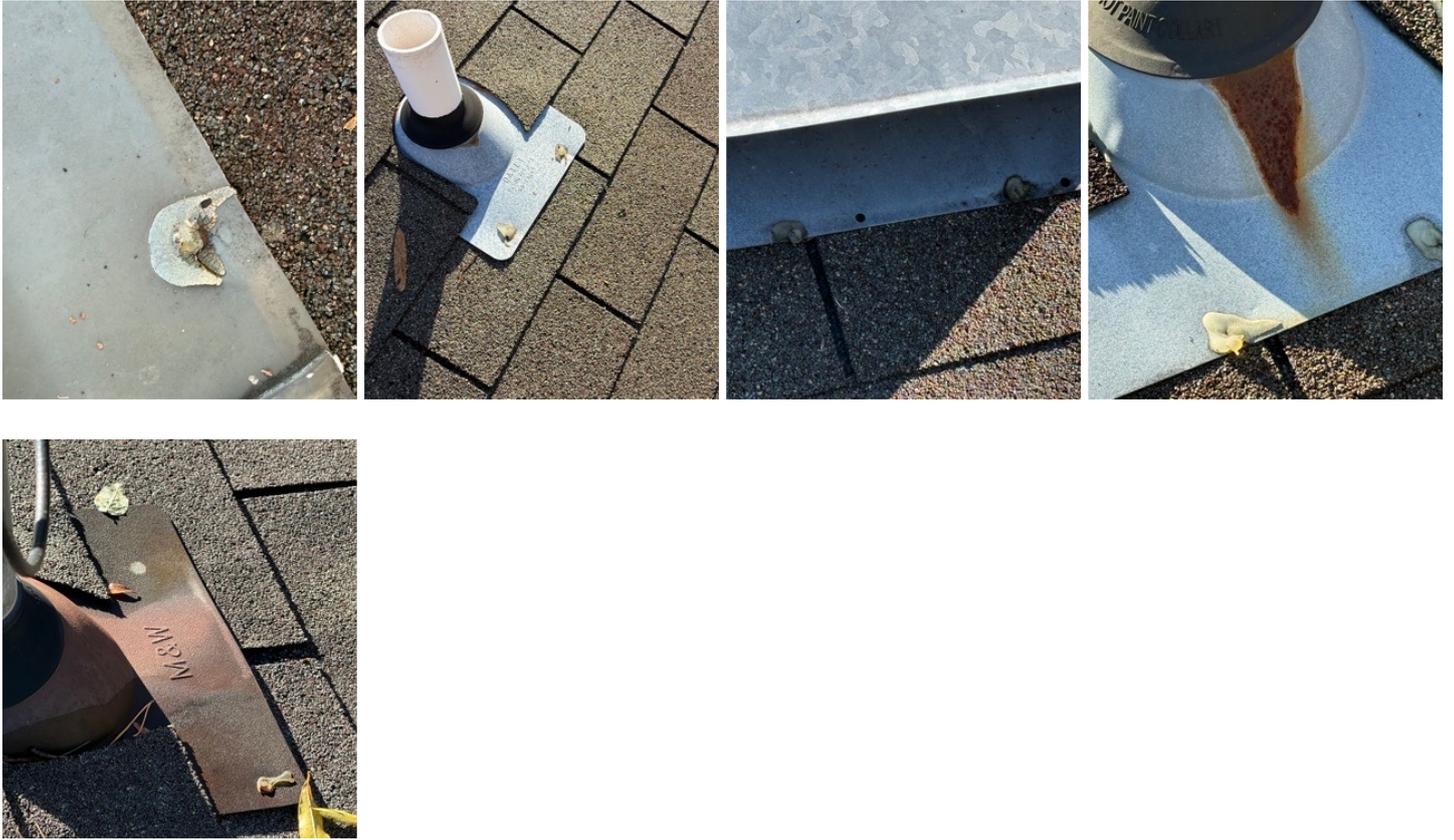
Fasteners have missing/deteriorating caulk

The roof plumbing vent fasteners have missing or deteriorating caulk, which could lead to potential water intrusion. Recommend resealing these areas with appropriate caulk to ensure proper weatherproofing and prevent leaks. Consult a qualified roofing professional for repairs.

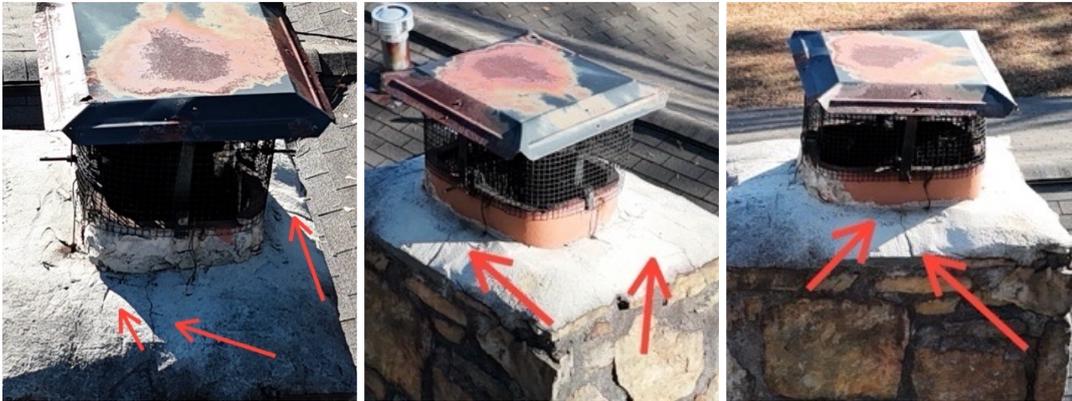
Chimney crown has crack/s

Observed cracks in the chimney crown, which can lead to water intrusion and further damage. Recommend having a qualified mason assess the situation and perform necessary repairs to prevent potential deterioration.

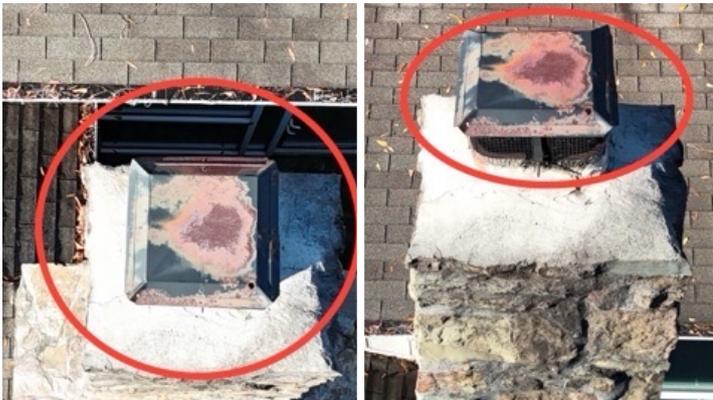
Rusted chimney cap

The chimney cap is rusted, which may lead to impaired functionality and potential water infiltration. Recommend contacting a qualified chimney specialist to assess the condition and replace the cap as necessary to prevent further deterioration and ensure proper operation.

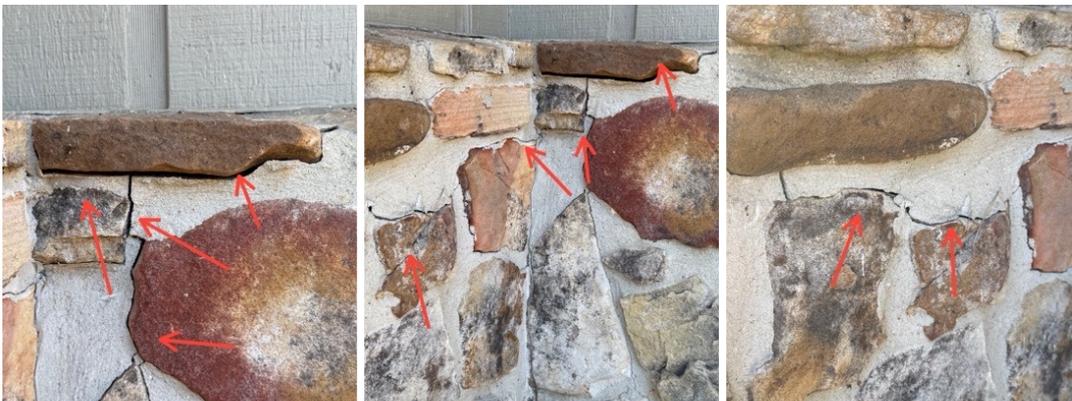
Mortar missing/deteriorating/stone separation

I observed areas where the mortar is missing or deteriorating, leading to stone separation. This condition can allow moisture intrusion and structural issues over time. I recommend consulting a professional mason to assess the damage and perform the necessary repairs to prevent further deterioration.

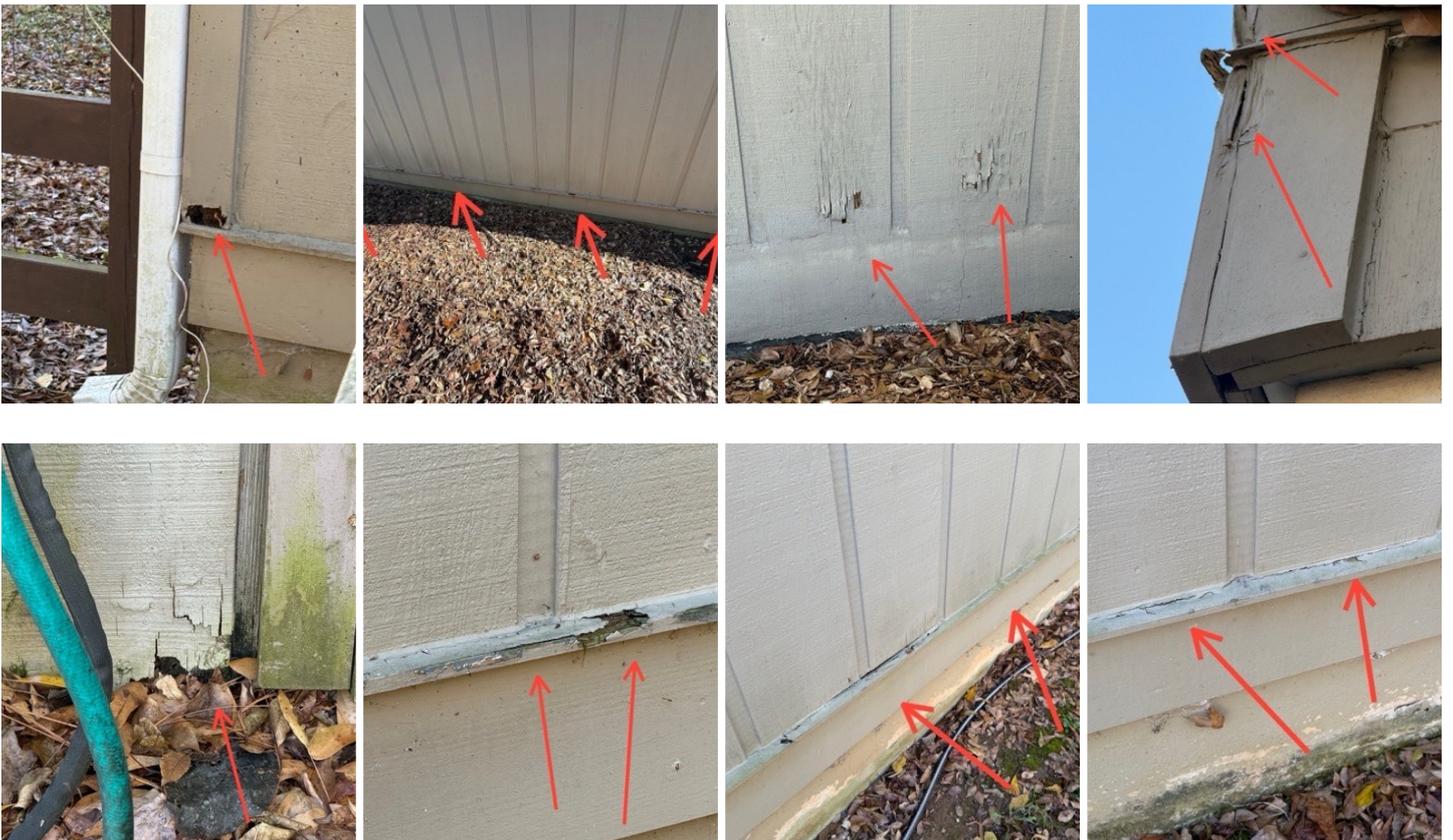
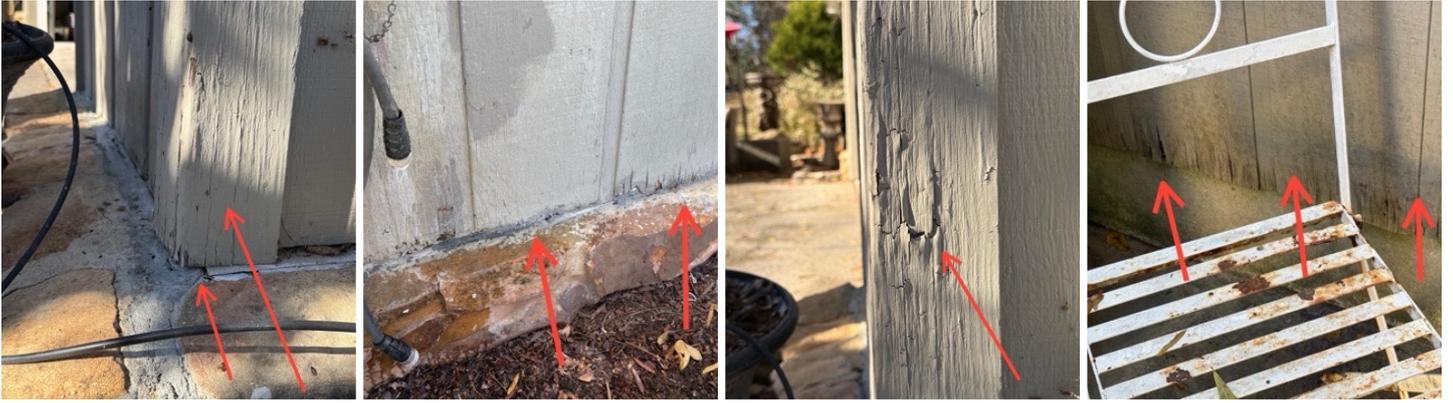
Rot noticed

Rot was observed on the exterior, which may compromise structural integrity and aesthetics. Recommend further evaluation by a licensed contractor to assess the extent of the damage and proceed with necessary repairs to prevent further deterioration.

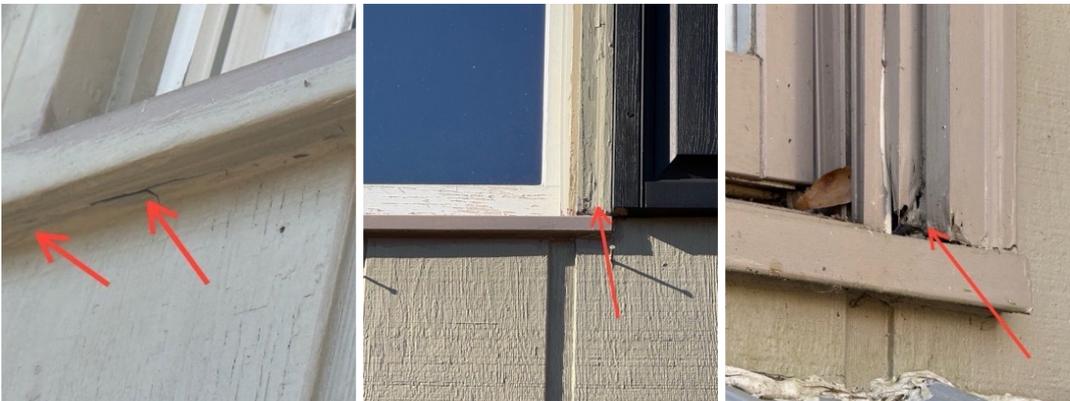
Some rot around windows

Noticed rot around some exterior windows. Recommend a professional evaluation to assess the extent of the damage. Repair or replacement may be necessary to prevent further deterioration and maintain energy efficiency. Regular maintenance is advised to avoid recurrence.

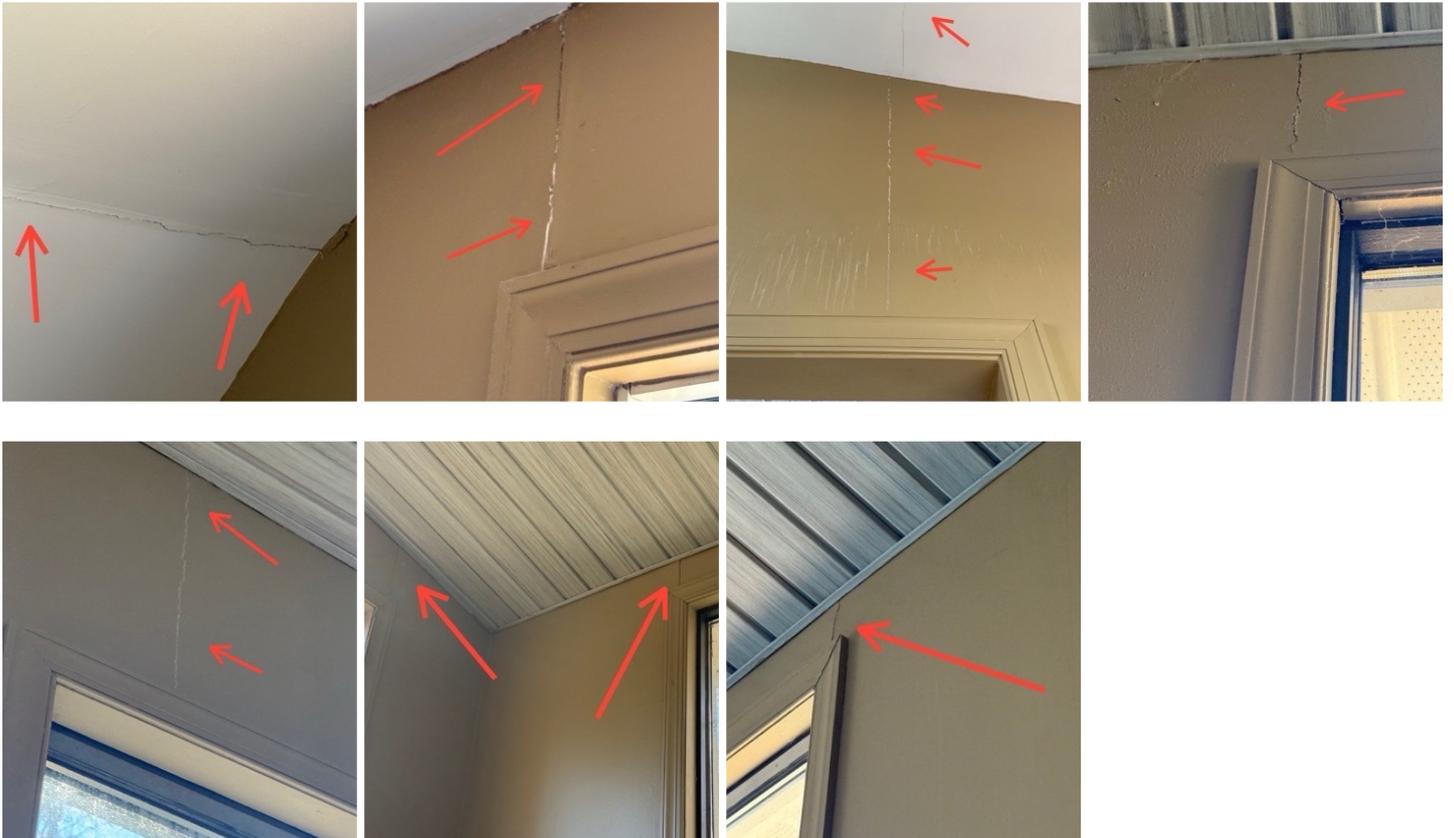
Cracks on walls, around windows, supports

Cracks observed on interior walls and around windows/supports may indicate settling or structural issues. Recommend consulting a structural engineer for further evaluation and necessary repairs to ensure structural integrity.

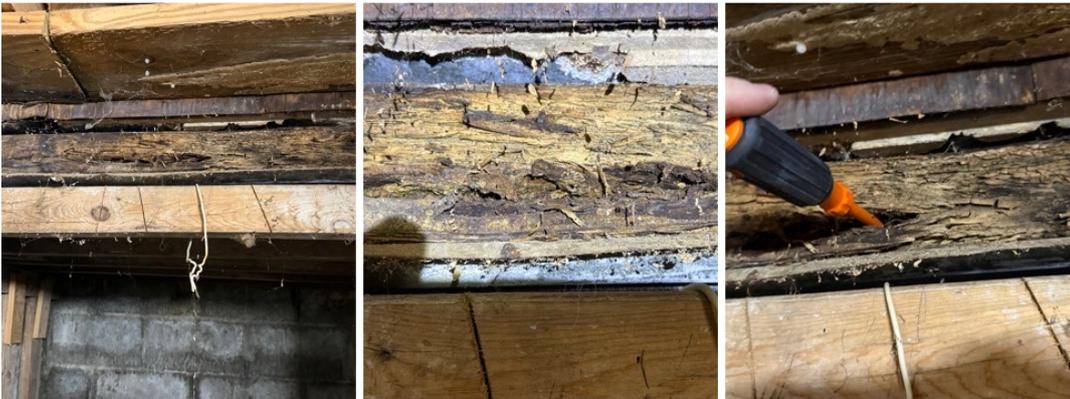
Rot/Damage

During inspection, rot/damage was observed in the structure. It is recommended to engage a licensed contractor to assess the extent of the damage and make necessary repairs to prevent further deterioration and ensure structural integrity.

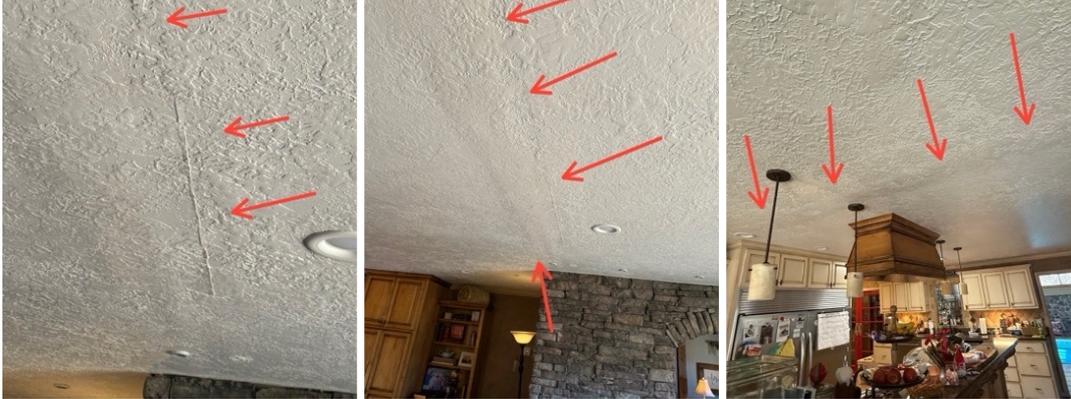
***SEVERAL STRUCTURAL CONCERNS NEED TO BE EVALUATED BY A LICENSED PROFESSIONAL STRUCTURAL ENGINEER. THE CORNER IN THE POOL WALL, THE SUPPORT BEAM IN THE CRAWLSPACE, AND THE SUPPORT BEAM IN THE LIVING ROOM CEILING. MANY AREAS HAD STEP CRACKING, MOVEMENT, AND VERTICAL CRACKS AS NOTED IN THE REPORT.

A linear crack was observed in the ceiling finish. The cracking appears consistent with movement along a structural support line. Notably, alterations and notching were observed at a support beam in the crawlspace below this area. While the exact cause cannot be confirmed without further evaluation, the observed conditions may indicate structural movement. Evaluation by a qualified structural professional is recommended prior to repairs.

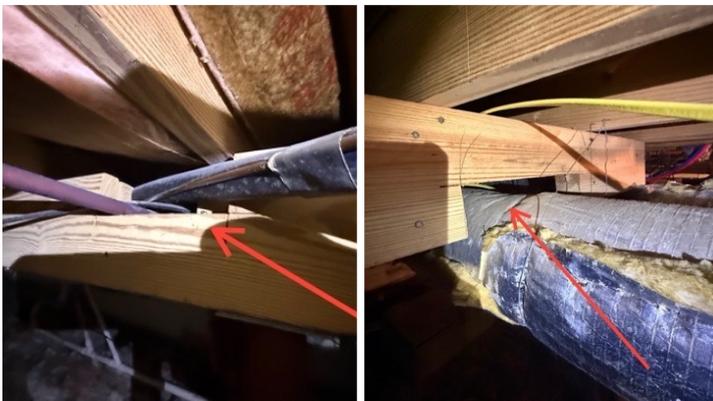
The beam exhibits notches and cuts along its edge, which could compromise its structural integrity. Recommend evaluation by a structural engineer to assess necessary repairs or reinforcements to ensure safety and compliance with building codes.

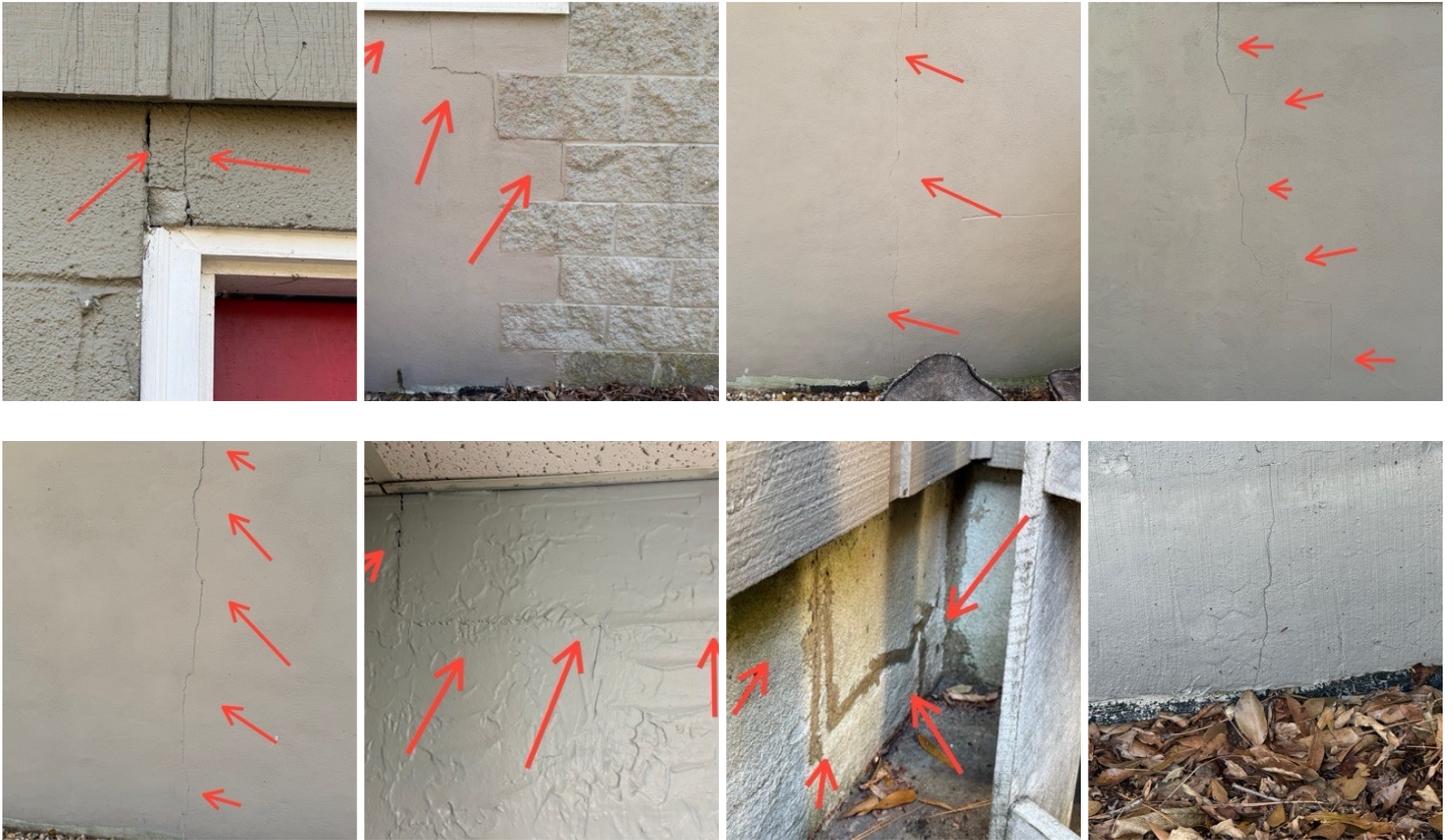
Movement/cracking/step cracking in block bearing wall

Observed movement and step cracking in the block bearing wall, indicating potential structural issues. Recommend consulting a structural engineer for a detailed assessment and to determine necessary repairs to ensure structural integrity.

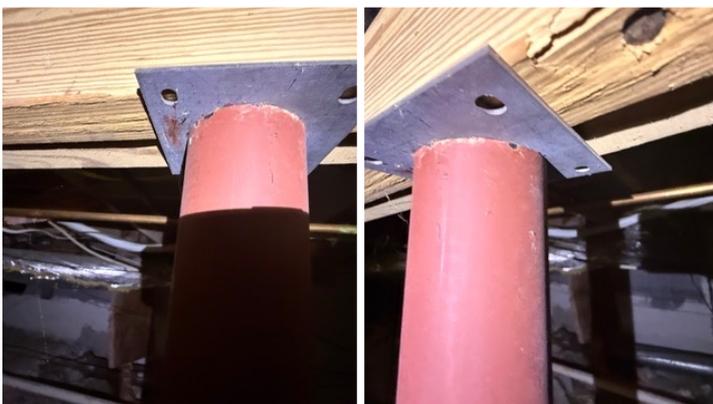
The structure piers/posts are not fastened to the beam. This may lead to shifting or instability. Recommend securing them promptly to ensure structural integrity and safety. Consult a licensed contractor for proper fastening methods.

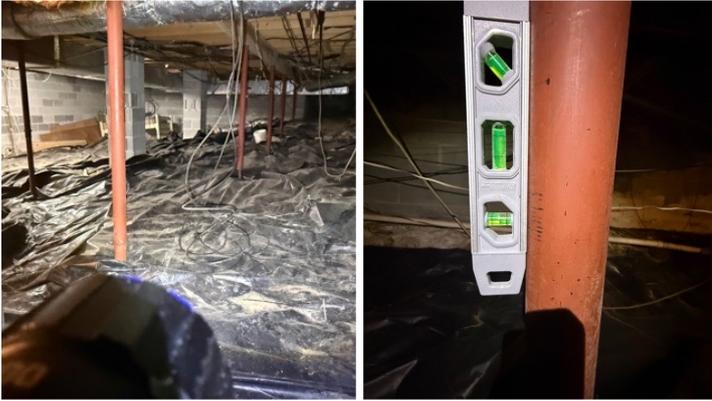
One or more steel support posts were observed to be not plumb and not adequately secured. It's recommended to engage a qualified contractor to evaluate and correct the alignment and secure the supports to ensure structural stability and safety.

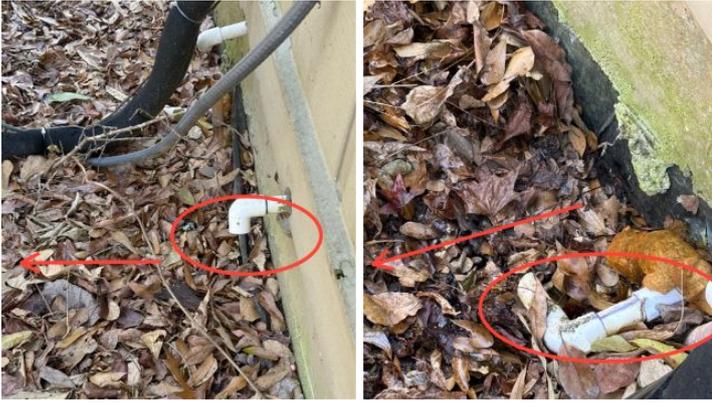
Extend condensate pipe away from unit/foundation

The condensate pipe currently discharges too close to the unit/foundation. It is recommended to extend the pipe to redirect the flow away from these areas to prevent potential water damage or foundation issues. Consider consulting a professional for proper modification.

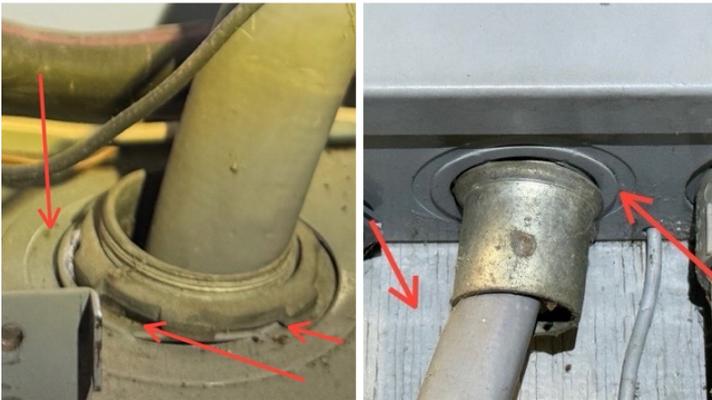
Service line into panel has no strain relief and loose hub

The service line into the main panel lacks strain relief, and the hub is loose. This could lead to wire damage or connectivity issues. Recommend engaging a licensed electrician to secure the hub and install appropriate strain relief to ensure safety and compliance.

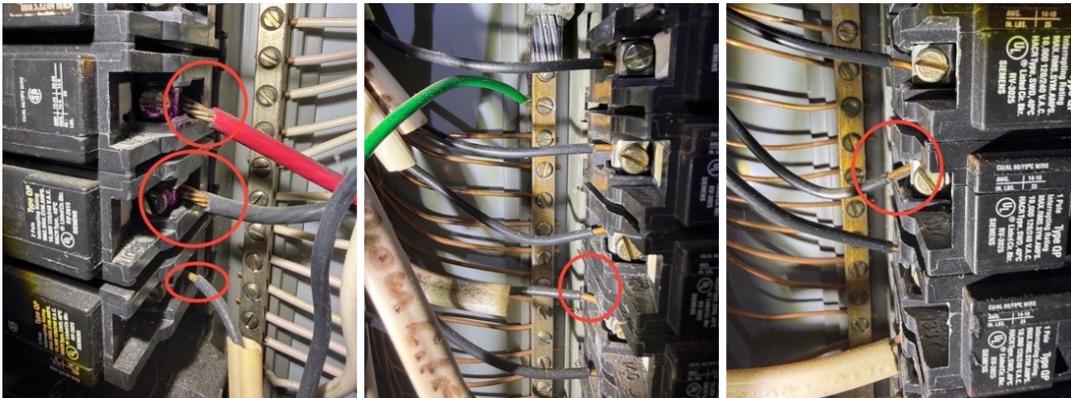
The electrical sub panel has excessive sheathing removed from the wiring, which may expose conductors and present a safety hazard. Recommend evaluation and correction by a licensed electrician to ensure all wiring complies with safety standards.

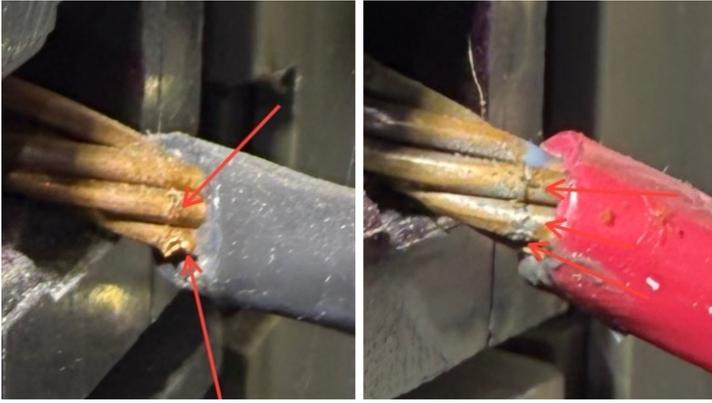
During the inspection of the electrical sub-panel, damaged wires were observed. This poses a potential safety hazard and may lead to electrical malfunctions. It is recommended to have a licensed electrician assess and repair the damaged wiring to ensure safety and compliance with local electrical codes.

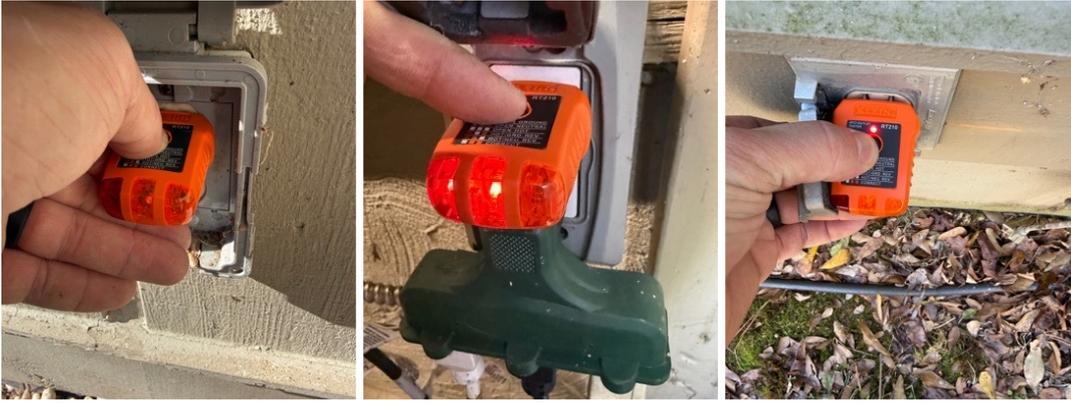
It was observed that one or more outlets are not GFCI protected, which is essential for safety, particularly in areas exposed to moisture. It is recommended to upgrade these outlets to GFCI to enhance safety and comply with current electrical standards. Consult a licensed electrician for assessment and installation.

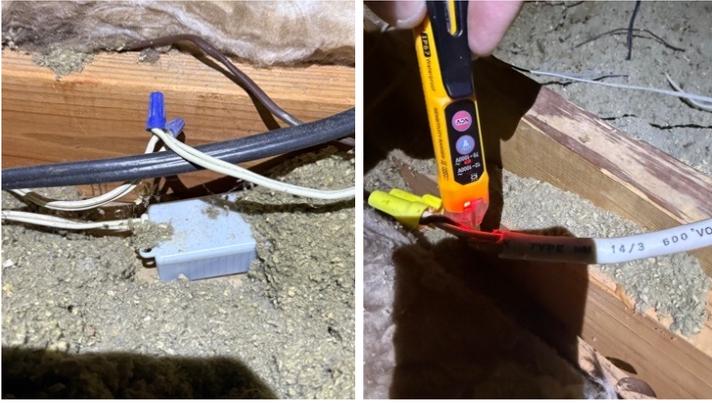
Exposed wiring was observed during the inspection, posing a safety hazard. It is recommended to have a licensed electrician assess and properly secure the wiring to prevent potential electrical shock or fire risks.

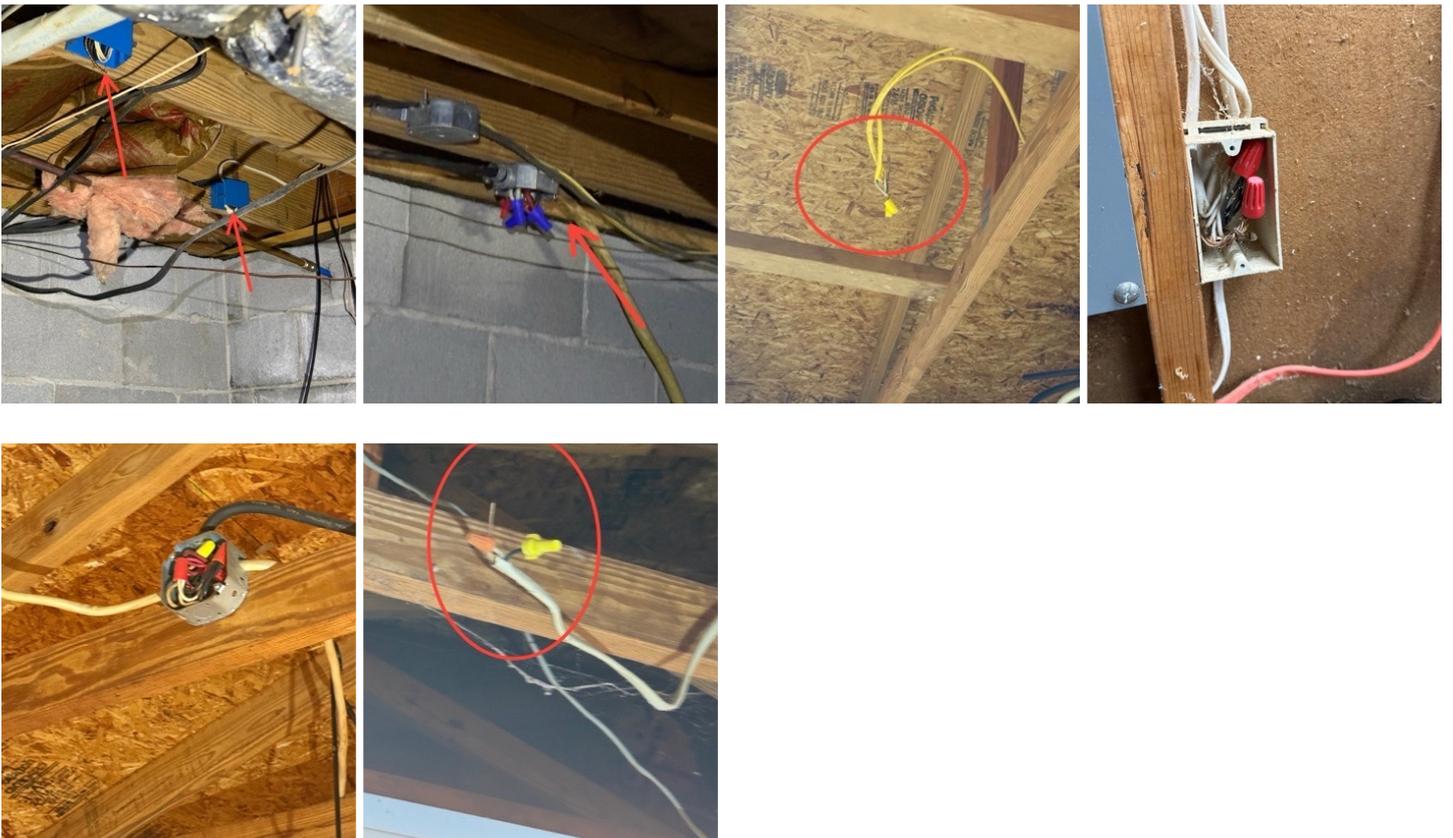
Exposed wiring was observed, which poses a safety hazard. It is recommended to have a licensed electrician evaluate and properly secure or enclose the wiring to ensure compliance with safety standards.

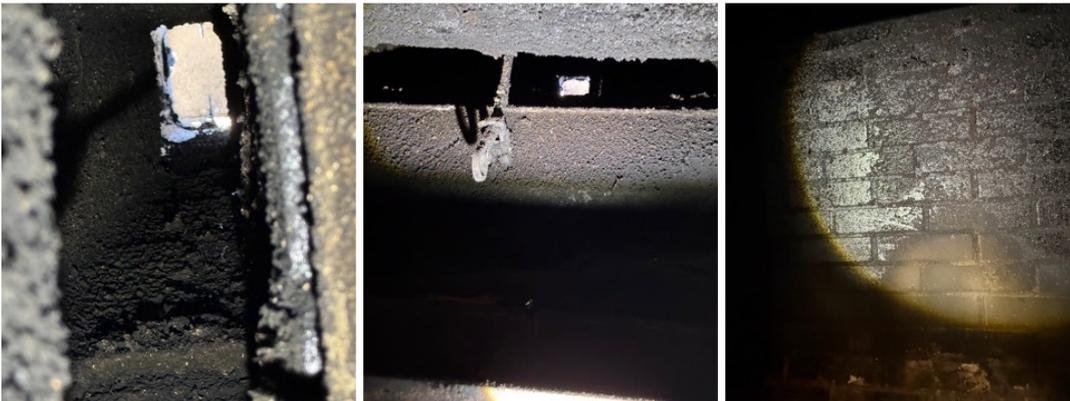
***THE FIREPLACE HAD HEAVY CREOSOTE BUILDUP, WHICH IS A FIRE HAZARD. I RECOMMEND HAVING A PROFESSIONAL CHIMNEY SWEEP CLEAN AND INSPECTED BEFORE USING.

Recommend cleaning and inspection prior to use

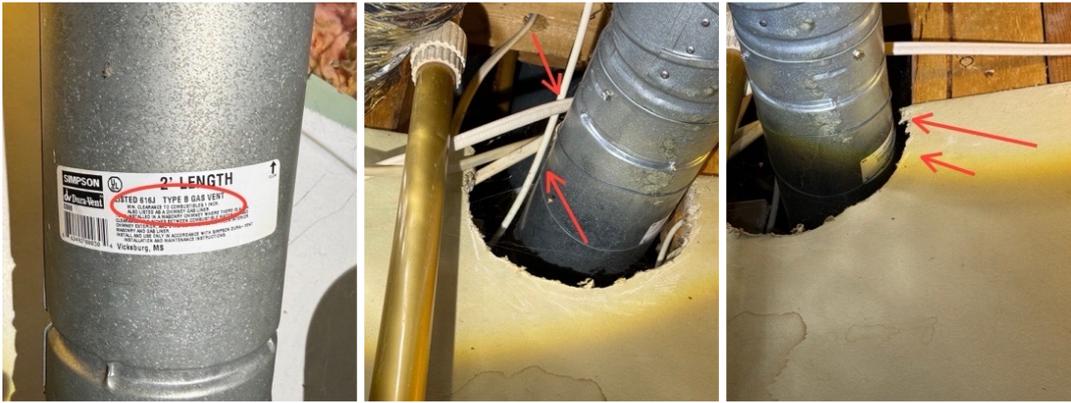
The flu vent pipe is too close to combustible materials, posing a fire hazard. It is recommended to have a qualified technician relocate or shield the vent to ensure safety and compliance with local building codes.

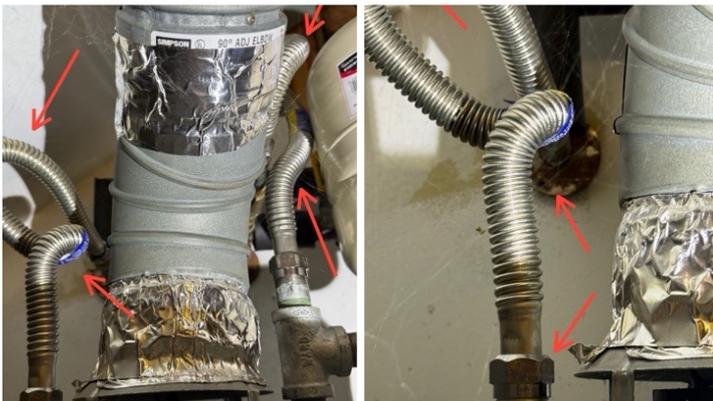
The water heater's flex connectors show excessive bending, which can lead to premature wear or leaks. Recommend having a licensed plumber evaluate and reposition the connectors to ensure proper alignment and reduce stress.

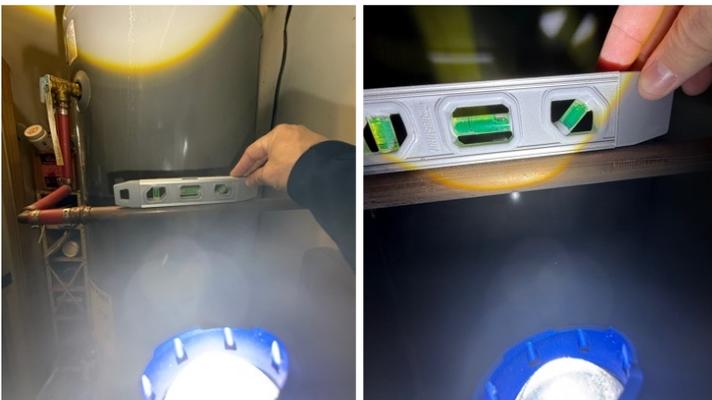
The TPR valve extension on the water heater is improperly sloped, which may hinder proper drainage and safety function. Recommend adjusting the extension to have a downward slope to ensure effective pressure relief. Consult a qualified plumber for correction.

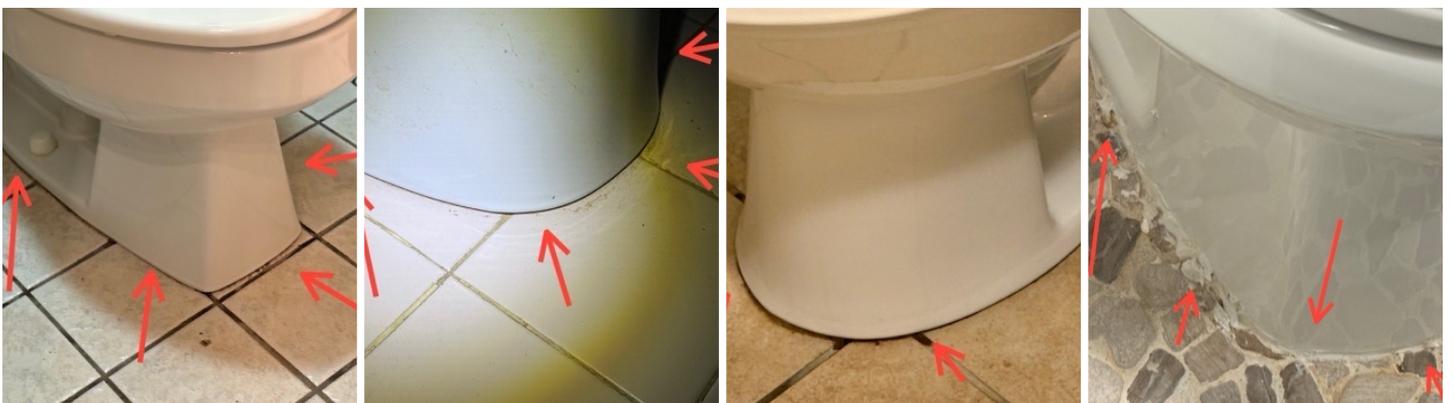
Caulking around the toilet base is missing or deteriorating, which can lead to moisture issues and potential damage to flooring. Recommend re-caulking to ensure a proper seal and prevent water intrusion.

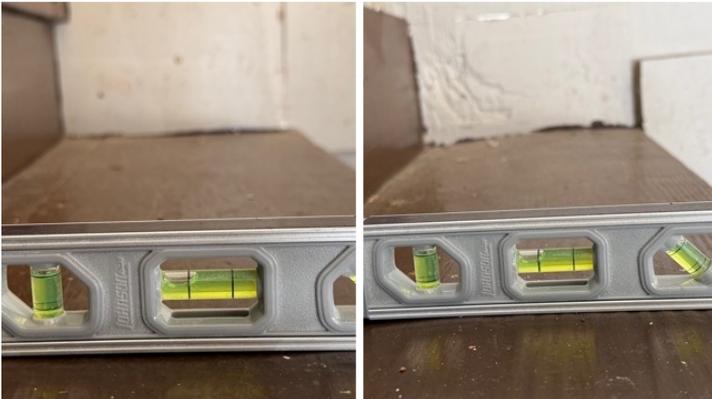
The steps leading from the garage to the interior are not level, which may pose a safety hazard. I recommend having a qualified contractor assess and correct the steps to ensure they are even and secure.

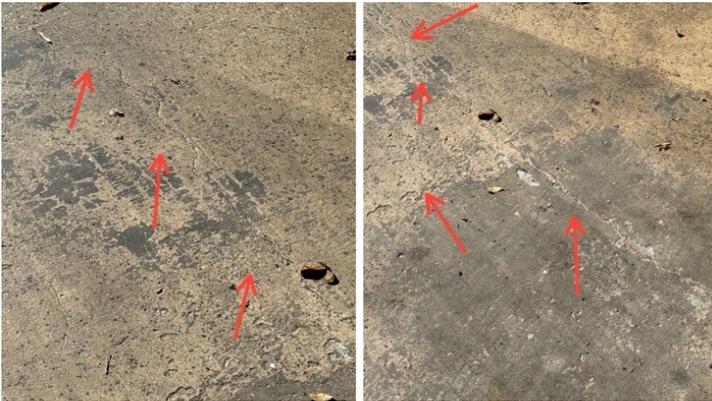
Minor floor crack(s)

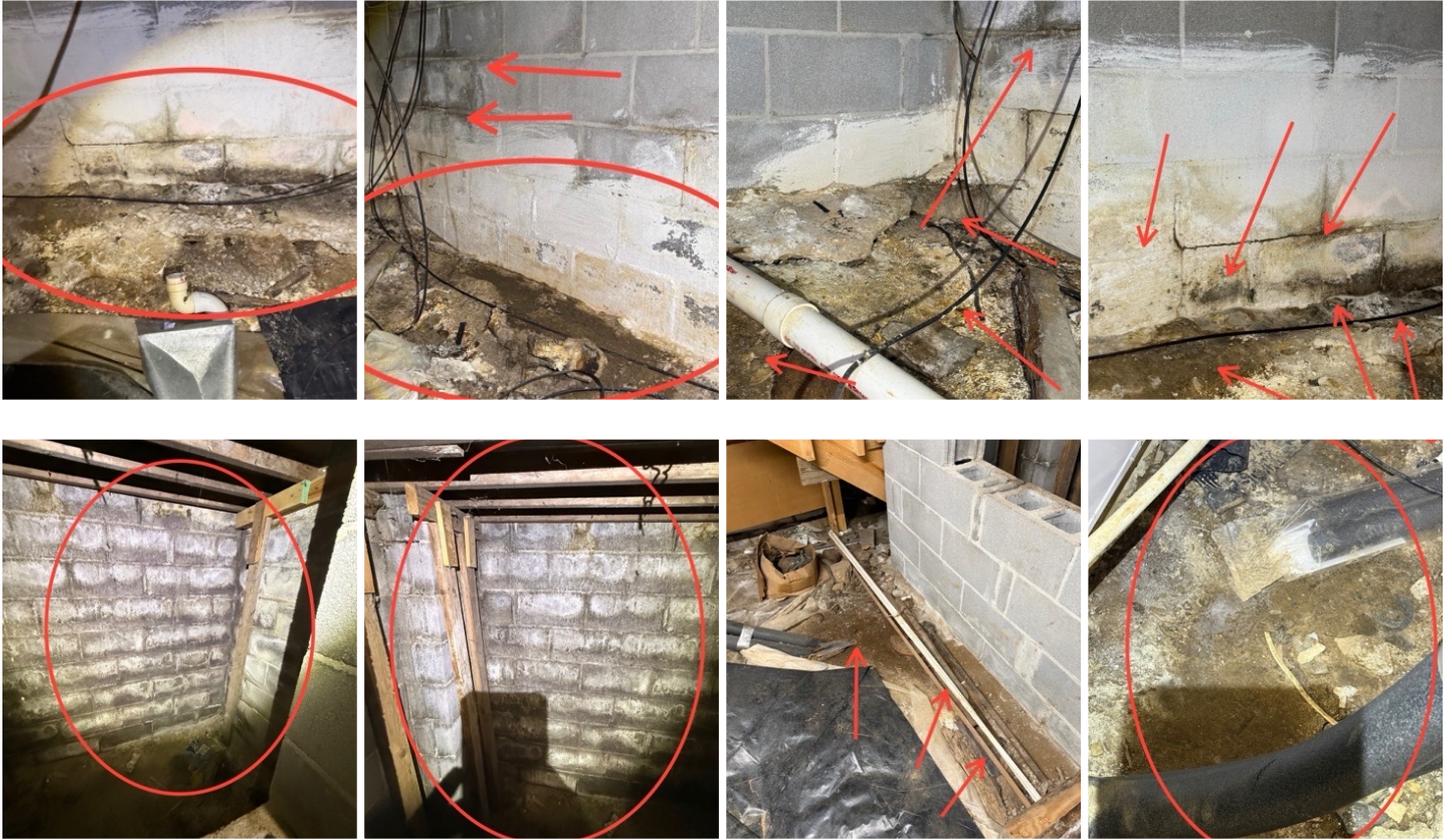
Water intrusion was observed on the walls and ground in the crawl space, indicating potential drainage or plumbing issues. Recommend further evaluation by a licensed contractor to identify the source and implement corrective measures to prevent damage and ensure structural integrity.

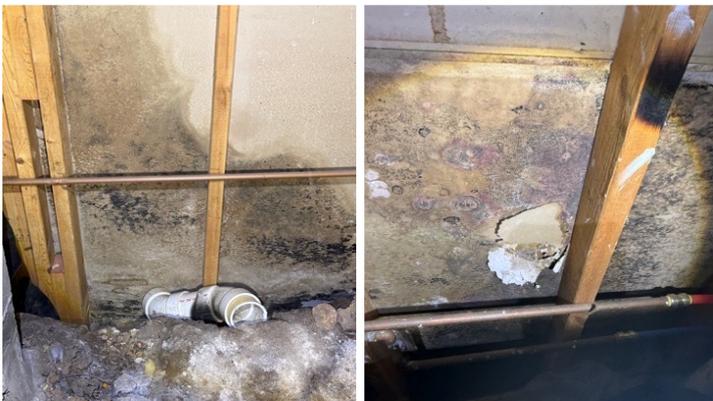
***POSSIBLE MOLD WAS FOUND IN THE CRAWLSPACE. I RECOMMEND HAVING MOLD SAMPLING AND TESTING PERFORMED BY A PROFESSIONAL. (I OFFER MOLD SAMPLING/TESTING AS A SERVICE, AND I HAVE A MOLD REMEDIATION PROFESSIONAL IF NEEDED)

Evidence of possible mold was observed in the crawl space. Recommend further evaluation and remediation by a qualified mold remediation specialist to address the issue and prevent potential health concerns and structural damage. Ensure proper ventilation and moisture control going forward.
