COLLISION ANALYSIS AND RECONSTRUCTION REPORT

Incident No.: 2010-R87-NE
Incident Date: April 20, 2010

Location: USH-41 / Memorial Dr.
Village of Howard
Brown County, Wisconsin

Trooper Jeremy VerGowe
Wisconsin State Patrol Academy – Technical Reconstruction Unit

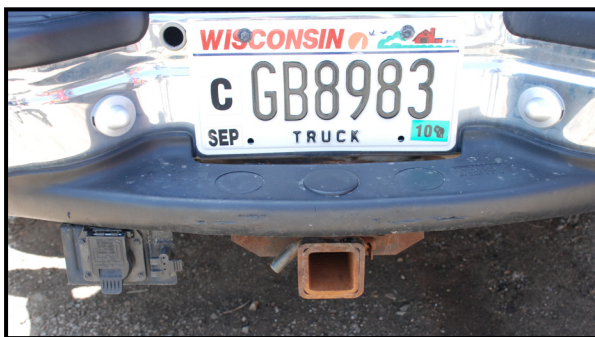
FIGURE 1

This photo shows the 2 inch hitch receiver and electrical socket mounted at the rear of the Ford F-250. The socket was wired for trailer lighting and electronically controlled trailer braking.

The hitch receiver was securely mounted to the rear frame of the truck and did not exhibit any significant damage or deterioration. The unit did have some surface rust and contained some light scratch marks in the area where safety chains are generally attached. In addition, the step bumper displayed some small cuts in the area directly above the receiver. An electrical link up was also mounted at the rear of the vehicle (See Figure 1). There was a common 4-way flat connector and a socket for a round 7-pole RV connector. A 7-pole connector, allowing for trailer lighting functions and electronic trailer brakes, was being used at the time of the collision. The driver had an electronic trailer brake controller hooked up inside the cab of the truck. However, the trailer brakes would have stopped functioning once the trailer completely separated from the truck and the electronic connection was severed.

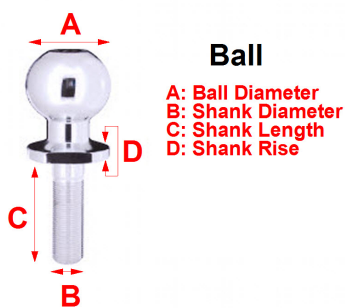
A 11.5 inch drawbar, with a 3 inch ball drop, was secured in the receiver with a 5/8 inch receiver pin and an accompanying cotter pin. The drawbar contained a pintle hook that did not appear to be in use at the time of the collision, as it was pinned in the upward position. A 2-5/16 inch diameter ball was bolted tightly to the end of the drawbar. The ball's shank had a 1 inch diameter and was 2-1/4 inches in length. The shank rise was 1/4 inch.

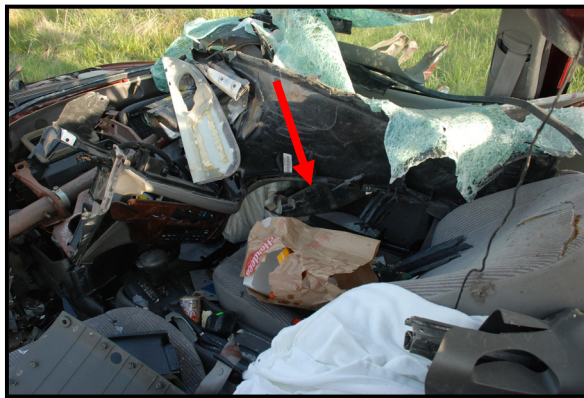
FIGURE 3

Figure 3 shows the passenger compartment of the Mercury Mystique. The red arrow points to the trailer coupler that was found wedged alongside the front passenger door. Figure 4 is a photo of the coupler after it was removed from the vehicle. The arrow points to the weld attaching the coupler to the portion of the steel tongue that was torn from the trailer.

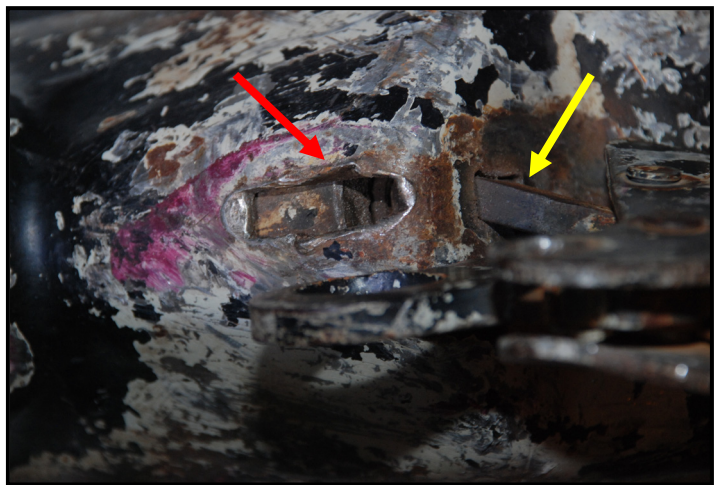
FIGURE 6

This is a close up view of the top of the coupler in the area of the actuator assembly. The red arrow points to the deformed metal surrounding the small cutout in which the barb on the actuator inserts to lock the plunger down. The yellow arrow points to the bent metal arm which connects the actuator to the plunger.

The coupler was transported to the University of Wisconsin-Milwaukee so that it could be examined by Mr. Benjamin Church. Mr. Church is an assistant professor who specializes in materials within the University's College of Engineering and Applied Science. Mr. Church indicated that the metal forming the cutout for the barb appeared to be pulled upward. He also noted that based on the appearance of the safety pin holes, the "ovaling" likely did not occur from something such as the repeated jostling of a safety pin, but rather a single jarring force. His observations seem to suggest that the coupler may have been latched and pinned when the trailer came unhitched. The barb from the actuator assembly may have been forced out of the cutout at an angle due to collision forces encountered when the tongue of the trailer struck the passenger car. This could potentially explain the manner in which the metal cutout was deformed. It would also seem possible that a safety pin was jarred and snapped as a result of the impact. The jarring of a safety pin could have created the "ovaling" deformation of the safety pin holes.

- Particular areas of metal deformation found on the coupler may have resulted from the coupler being latched and pinned when the trailer collided with the passenger car.

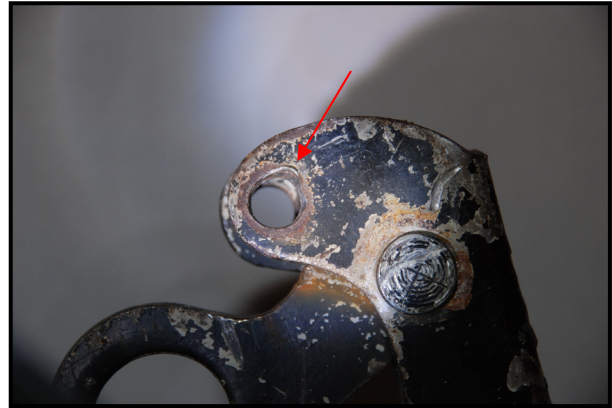
FIGURE 7

This photo illustrates the "ovaling" of the safety pin hole on one side of the actuator assembly. The "ovaling" on the opposite side is near the bottom of the hole.

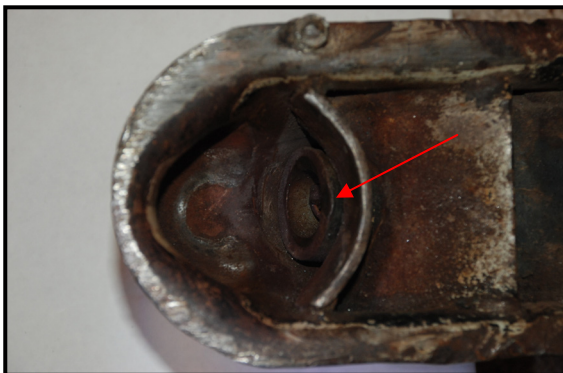
FIGURE 8

The appearance of the coupler suggested that it had been in service for some time as it did exhibit wear from usage. In particular, the end of the plunger appeared to be somewhat worn and did not have much of a curved shape to it. Based on the visual appearance of the plunger, it would seem possible that it did not "cup" the bottom of the ball sufficiently enough to prevent the ball from "popping" out of the coupler under the right circumstances (such as a jolt experienced as the vehicle combination traveled over a rough portion of roadway) even if the actuator assembly was latched. Since the manufacturer of this particular coupler is unknown, no comparisons can be made to determine the actual extent of the wear to the latching system's components. In addition, the coupling capability cannot be checked due to collision damage.

This photo shows the portion of the coupler that receives the ball. It can be seen that the end of the plunger appears to be relatively flat. In the area that the arrow is pointing, the bottom lip of the plunger seems to be worn flatter than the surrounding areas.

- The coupler from the trailer exhibited wear from usage. Based on the probable collision damage sustained by the coupler and the exhibited wear, it would appear possible that the ball could have released from a latched coupler if the hitch was jolted by rough spots in the roadway.

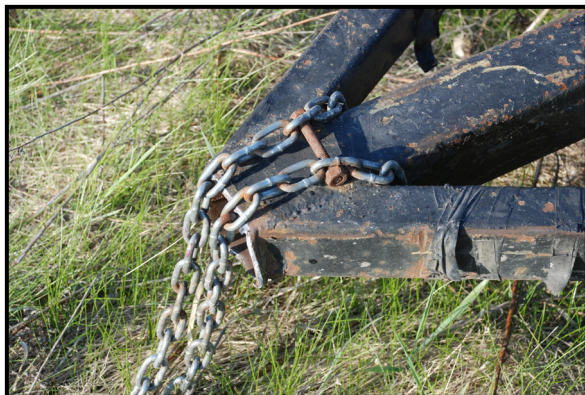
FIGURE 10

The truck/trailer combination was using a single safety chain at the time of the collision. The safety chain was wrapped around the tongue of the trailer in a manner which allowed both ends of the chain to be attached to the towing vehicle (**See Figure 10**). The 1/4 inch chain had 79 links and was approximately 97 inches long. Each end of the chain had a 7/16" x 4-3/4" carabiner clip attached via a double clevis mid link. The chain links appeared to be in relatively good condition. There was some relatively minor surface rust in various areas, but the links did not exhibit any signs of failure. The mid links also appeared to be in good condition. The carabiner clips both exhibited significant bending which allowed them to release from the towing vehicle (**See Figure 11**).

The single safety chain was wrapped around the tongue just behind the area where two steel support channels were welded to the tongue. A nut and bolt were used to create two ends of equal length that could be attached to the towing vehicle.

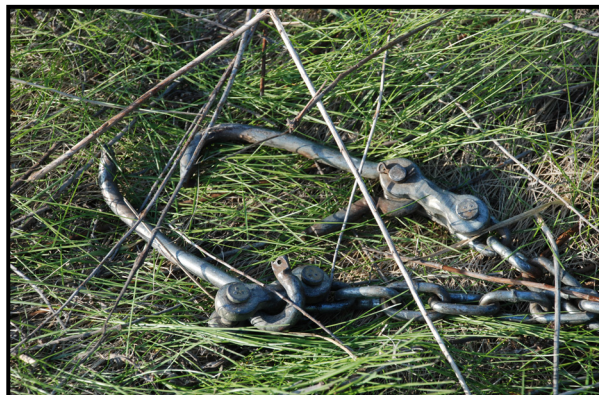
FIGURE 11

Figure 11 shows the bent carabiner clips that were used to attach the safety chain to the truck. It can be seen that they were the weak link in the secondary safety linkage.

An Inadequate type of C-clamp in use, from the chain to the towing vehicle.<347.47(3)> Under the MCSAP regulations, this type of C-clamp is unsuitable for all applications.

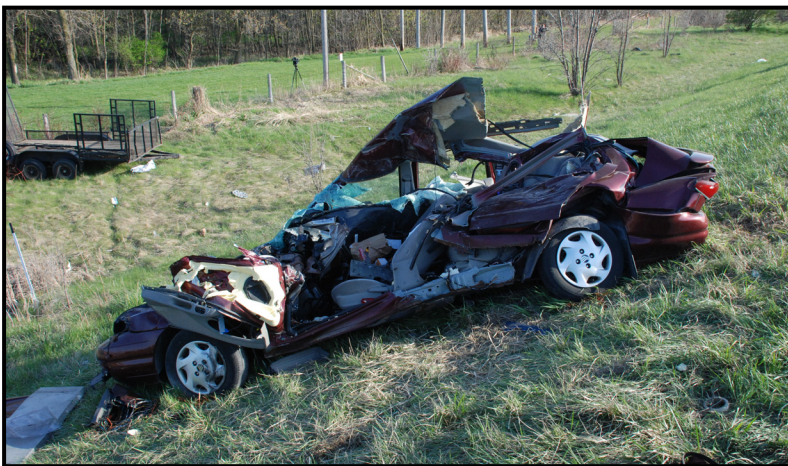
FIGURE 12

The Mercury Mystique was a 4-door sedan powered by a 2.0 Liter, 4-cylinder engine. The power was provided at the front wheels through an automatic transmission. The vehicle sustained very severe damage as a result of the collision with the trailer. The damage indicates that the front of the trailer overrode the driver side rocker panel and intruded well into the passenger compartment of the vehicle. This is evident by the displacement of the vehicle's roof and left side support pillars. The contact damage began at the front left fender in front of the axle and extended back along nearly the entire left side of the car (**See Figure 12**).

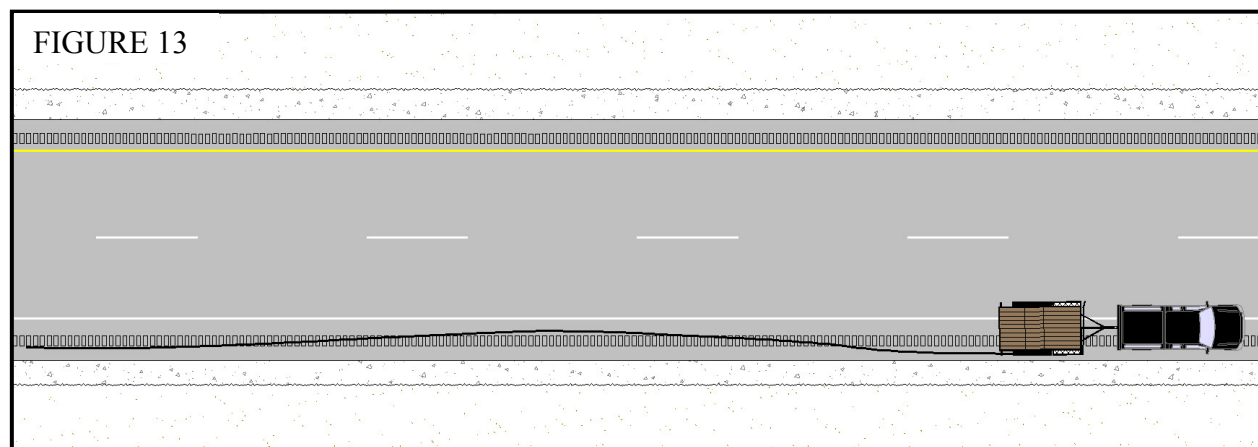
A 1999 Ford F-250 pickup truck, pulling a flat bed utility trailer, was approaching the Memorial Drive overpass on southbound USH-41 using the outside traffic lane. In the general area of the overpass, the trailer's coupler released from the coupler ball mounted on the truck. Following the unhitching, the trailer remained attached to the truck by means of a safety chain for a relatively short period of time. A wavy tire mark located on the outside paved shoulder of southbound USH-41 suggests that the driver began to move onto the outside shoulder as the trailer began swaying back and forth (**See Figure 13**). The driver of the truck, James McDermid, made statements that were consistent with this evidence. He indicated that he felt a "jolt" as he traveled over Memorial Drive. He also noted that the trailer began to sway soon after.

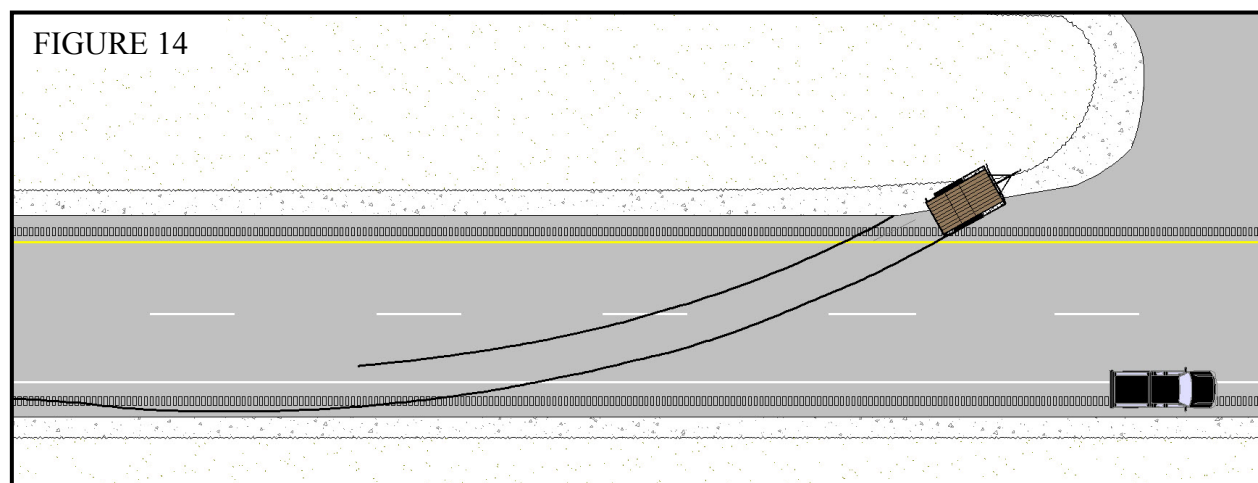
After traveling approximately 300 feet south of the Memorial Drive overpass, the safety chain separated from the truck. This allowed the trailer to begin to swerve across the southbound traffic lanes from the outside shoulder. This is evident by the fact that the previously mentioned tire mark ceased its wavy pattern and veered across both southbound traffic lanes. The start of a second mark was also located in this area. The second mark also veered across the southbound traffic lanes and ran parallel with the previously mentioned mark (**See Figure 14**). The distance between the two marks was consistent with the track width of the trailer.

- A wavy tire mark located on the outside shoulder of southbound USH-41 suggests that the trailer began to sway, as it remained attached to the towing unit by a safety chain, for a relatively short distance following the uncoupling of the hitch.

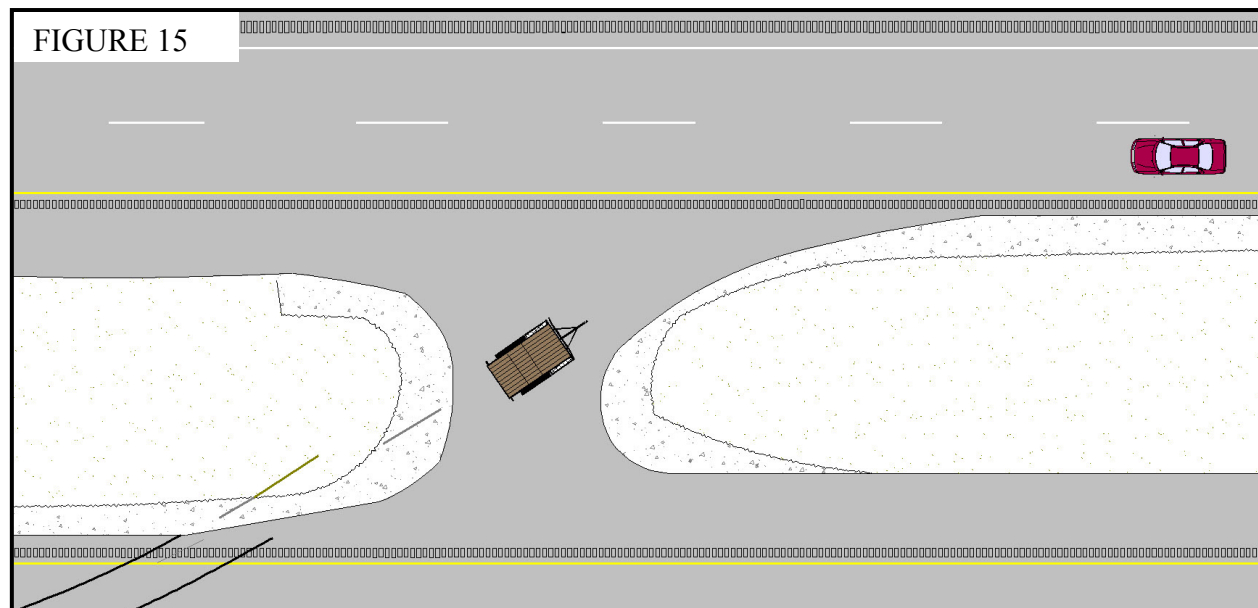
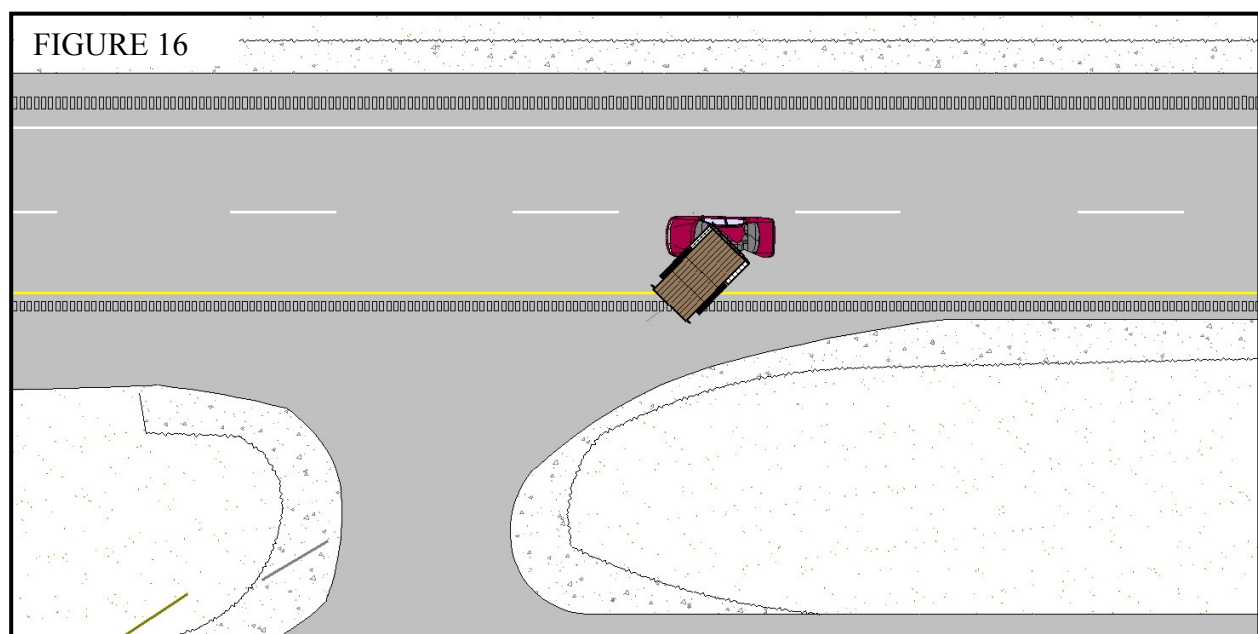
The trailer initially entered the median approximately 30 feet to the north of a paved cross-over designed for use by highway maintenance and emergency vehicles. As the trailer began crossing the median, the left side wheels of the trailer dropped down into the grassy median which was slightly lower in elevation than the gravel shoulder that the right side wheels passed over. As a result, the front of the trailer's tongue gouged the extension of the gravel shoulder which passed between the grassy median and the paved cross-over. As the left side of the trailer exited from the lower elevation, the tongue of the trailer likely gained some lift as the left side wheels rode up the relatively small, sharp embankment between the grassy median and the cross-over (See **Figure 15**). Shortly after, the trailer finished crossing the median by traveling through the cross-over. The front of the trailer then entered into the northbound lanes of USH-41 and impacted the driver's side of a 1999 Mercury Mystique which was approaching from the south in the median traffic lane (See **Figure 16**).

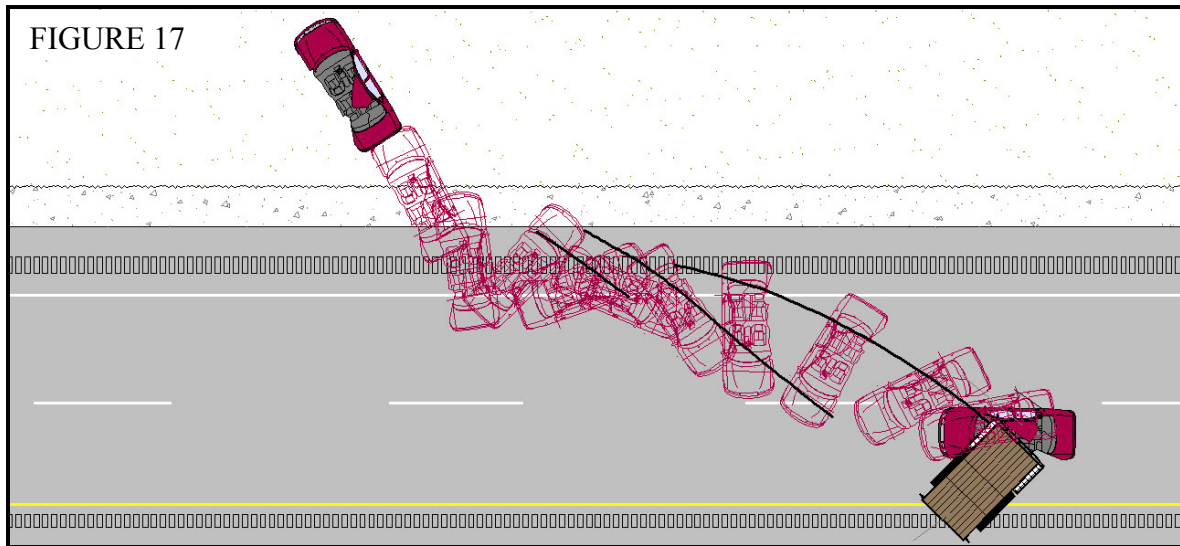
Following the collision, the Mystique began to rotate counterclockwise and departed northeast towards the outside shoulder of the northbound traffic lanes. The car traveled approximately 85 feet from impact before coming to rest on the grassy slope adjacent to the outside shoulder. The vehicle was facing primarily towards the east and was approximately 10 feet from the outside pavement edge (**See Figure 17**).

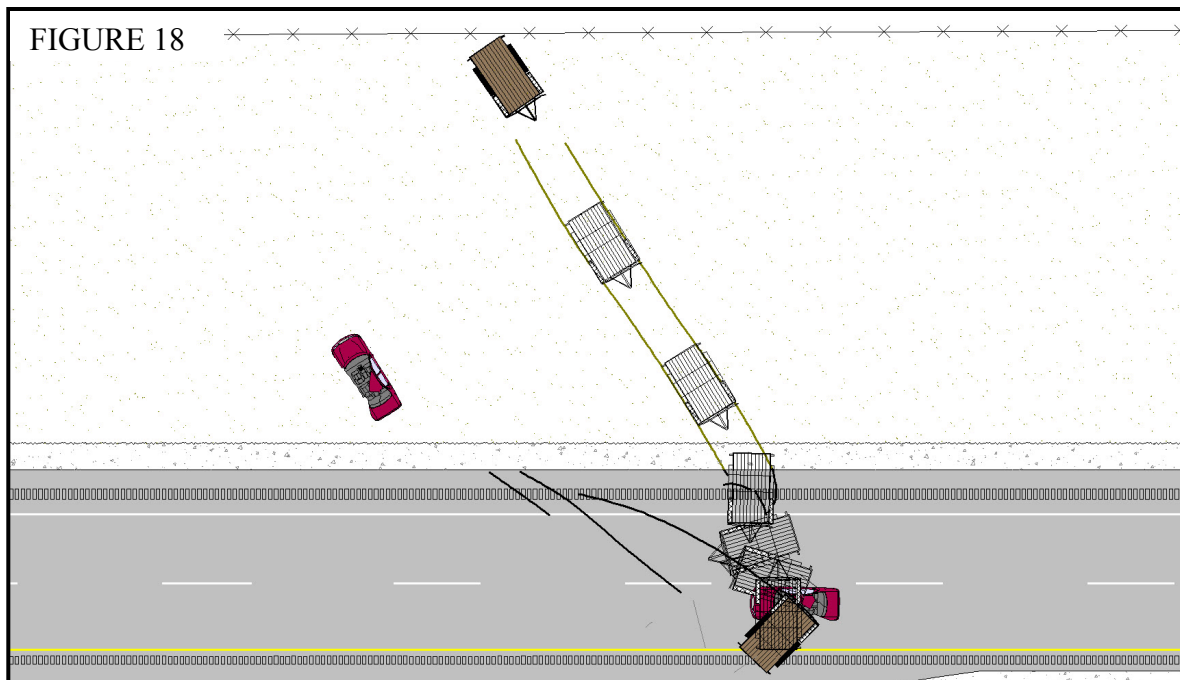
The trailer also rotated counterclockwise following the collision, but departed relatively straight towards the outside shoulder of northbound USH-41. The trailer left the paved portion of the roadway facing primarily towards the west and rolled backwards down the grassy slope. The trailer eventually came to a stop at the wire fence located at the bottom of the sloped terrain. The trailer traveled approximately 105 feet from impact to final rest (**See Figure 18**).
