COLLISION RECONSTRUCTION UNIT

Case # 07L004697

LOCATION: Route 50/301 Westbound Span of the Bay Bridge at Mile-marker 34.2

CASE TYPE: Seven vehicle collision with three fatalities and multiple injuries (Involving two commercial motor vehicles)

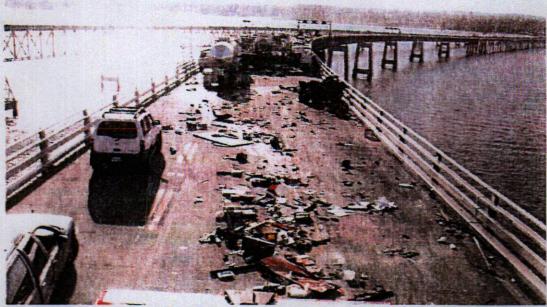
The above photograph shows the debris field left on the roadway mainly from the cargo carried by Vehicle #2. The photograph was taken facing westbound from the roof of a Fire Department engine unit.

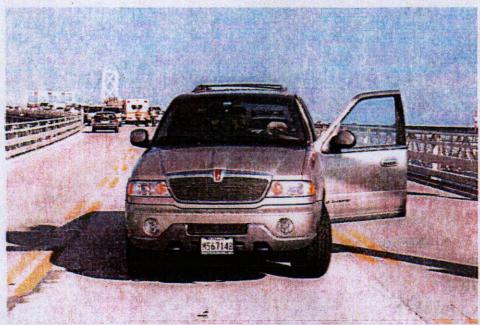
The above photograph shows the final rest of Vehicle #1. There was no damage sustained to Vehicle #1.

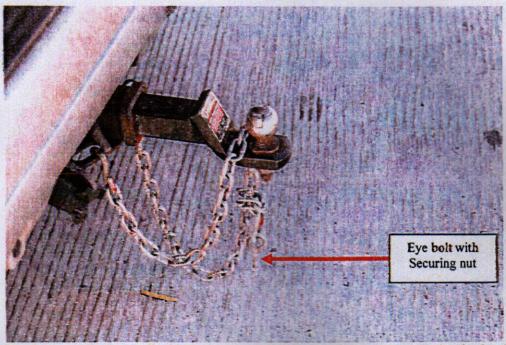
The above photograph shows the hitch, receiver, ball, and chains that were attached to Vehicle #1. The photograph also shows that the eye bolt with the securing nut that attached the chains to the trailer is still attached to the chains.

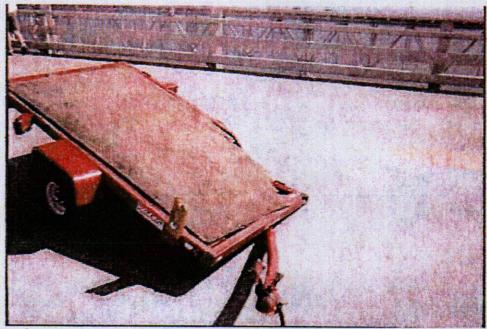
The above photographs show the final rest and the damage sustained to the Homemade trailer which Vehicle #1 was towing.

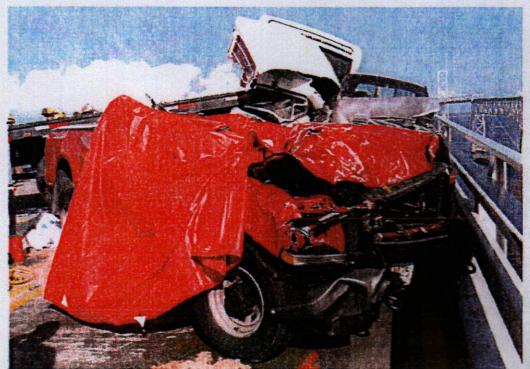
The above photographs show the final rest and the damage sustained to Vehicle #2.

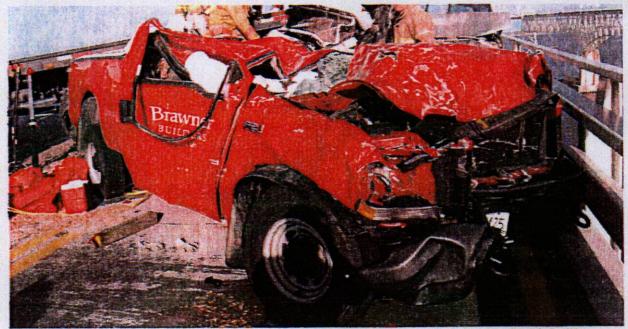
The above photographs show the final rest and the damage sustained to Vehicle #2.

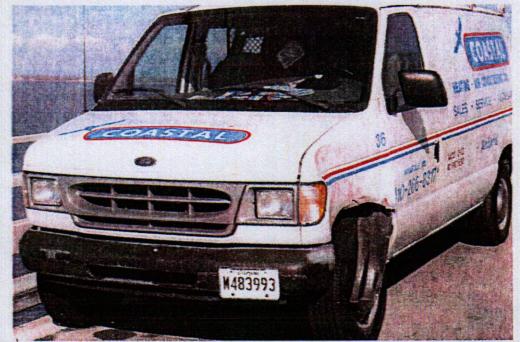
The above photograph shows the final rest and the damage sustained to Vehicle #3

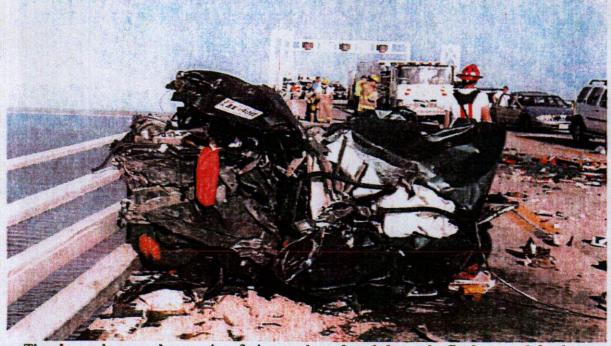
The above photograph was taken facing eastbound, and shows the final rest and the damage sustained to Vehicle #4.

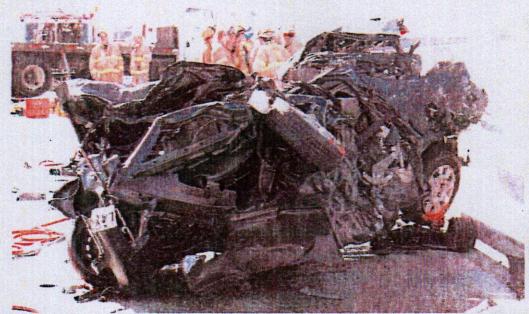
The above photograph was taken facing westbound, and shows the final rest and the damage sustained to Vehicle #4.

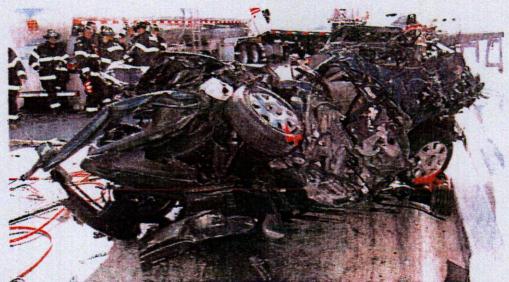
The above photograph was taken facing westbound, and shows the final rest and the damage sustained to Vehicle #4.
