# Parasailing Safety

## Special Investigation Report

NTSB/SIR-14/02  
PB2014-106341

**Abstract:** This special investigation report examines issues involving parasailing safety and oversight. It discusses a number of recent accidents and the subsequent testing of parasailing equipment involved in these mishaps.

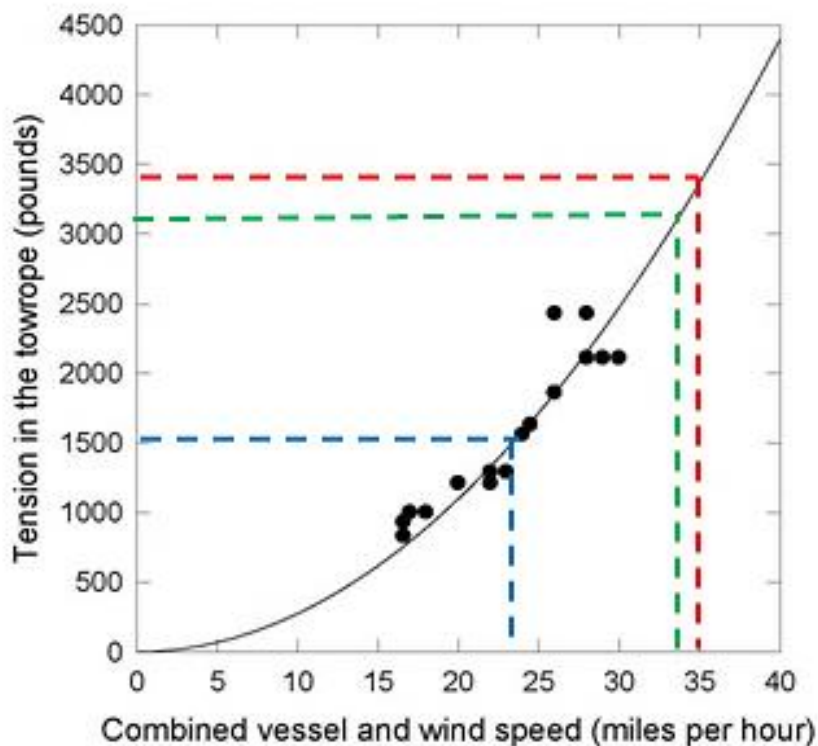
**Figure 4.** Towline tension force at combined vessel and wind speeds.

As illustrated in the above figure 4, the data points and the curve axes start at zero and extend beyond the data points. The horizontal red dashed line represents the accident towline average failure load of 3,415 pounds (from the laboratory testing of the towline from the *Tied High*), and crosses the curve in the vicinity of a combined vessel and wind speed of 35 mph, as indicated by the vertical red dashed line. Similarly, the horizontal blue dashed line represents the working load of 1,520 pounds specified in the manufacturer's literature for that towline, and indicates that a combined vessel and wind speed of about 23 mph could exceed that working load. (See section "3.2 Winch Testing and Examination; Vessel: *Tied High*" for details on the green dashed line).

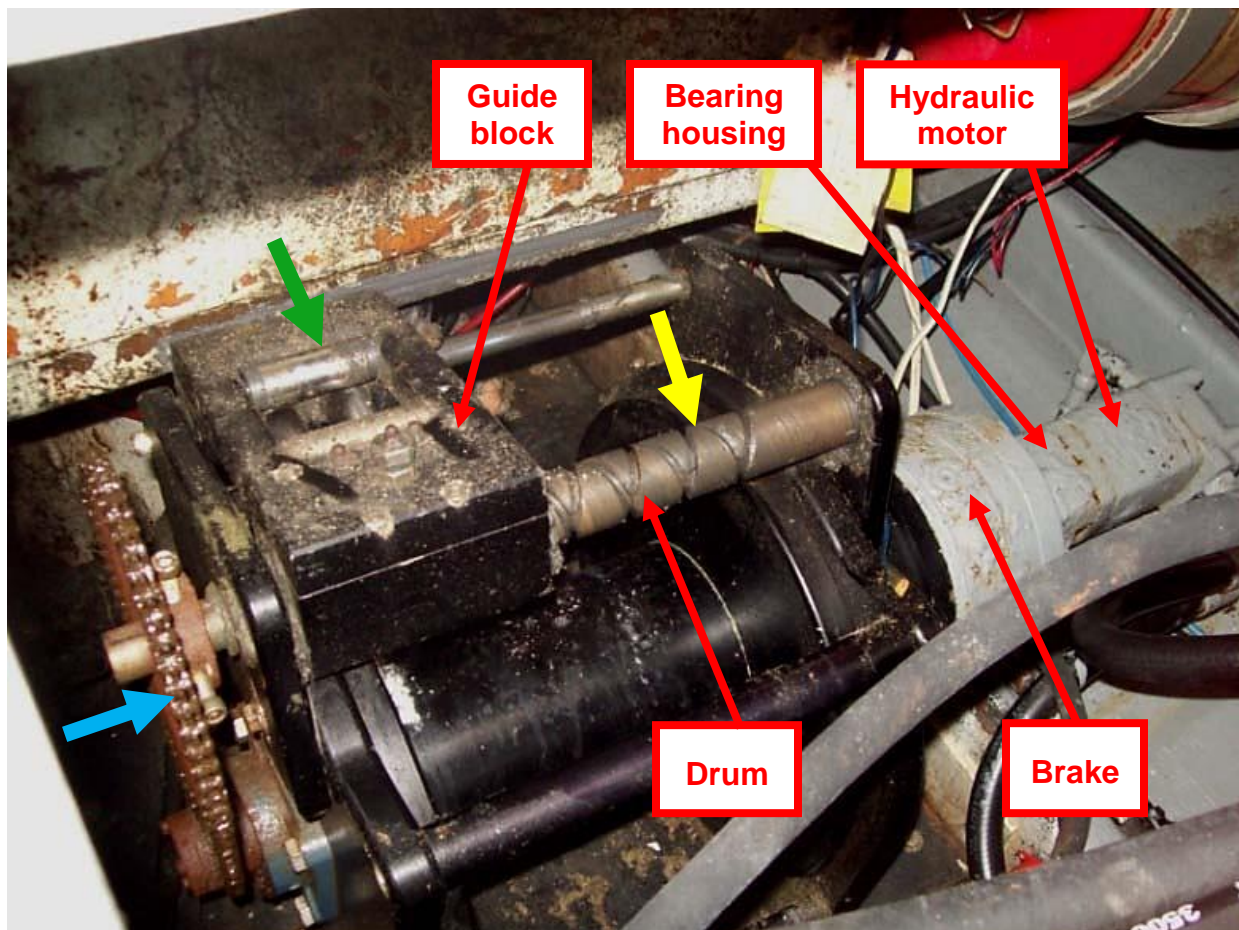
**Figure 5.** The winch used on board the *Sky Screamer*.

The Coast Guard reported that the two *Sky Screamer* passengers were being reeled in and were about 100 feet from the vessel when the towline suddenly reeled out uncontrollably, despite attempted use of the winch (which prevented the brake from activating), until the drum was empty and only the end of the towline was attached to the drum. At that moment, the vessel reportedly heeled over on its starboard side and the towline parted at the bowline knot where it attached to the parasail's yoke. A subsequent Coast Guard examination and disassembly revealed that the splined drive connecting the hydraulic motor to its bearing housing had failed. The two major pieces of the splined drive are illustrated in figure 6 below, along with the bearing housing, the output shaft, and the recovered spline pieces.

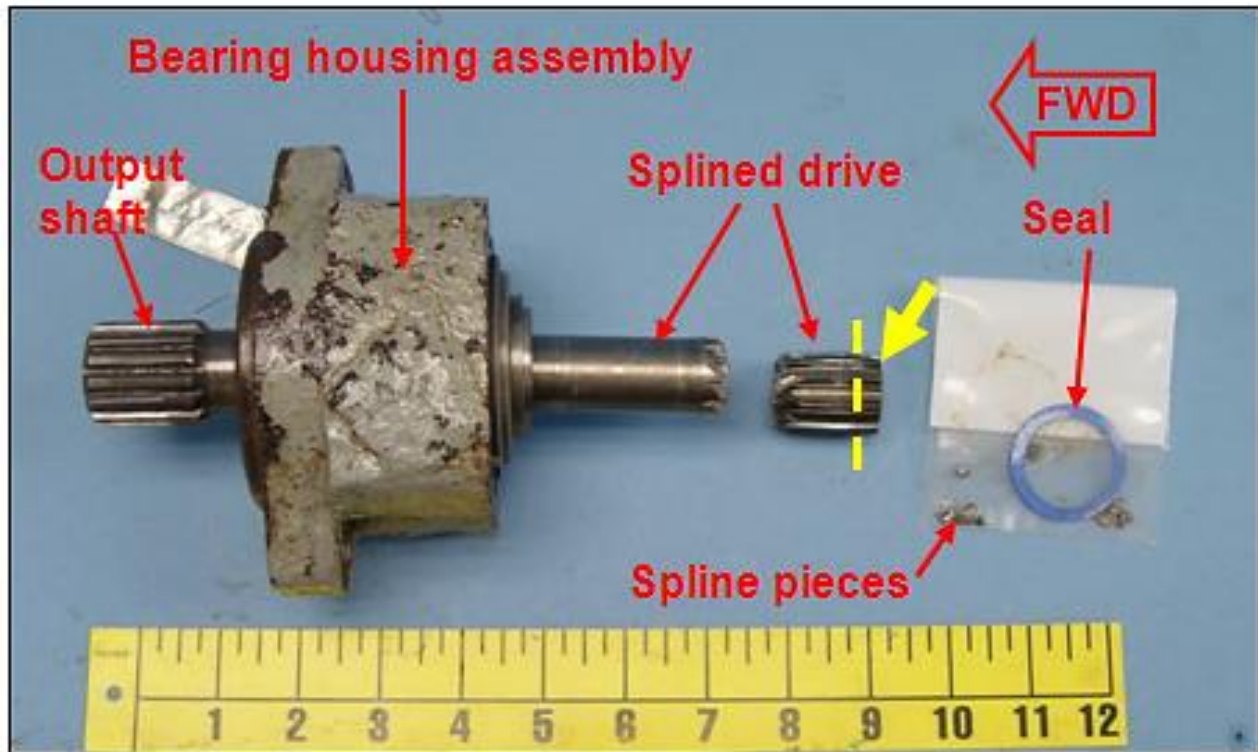
**Figure 6.** The splined drive pieces with the bearing housing assembly.

Because a torsional fracture is a type of shearing action, investigators made calculations to relate the shear capacity of the splined shaft to the shear applied to it by parasailing operations. The calculations indicate that the shaft will fail when a shear stress in the vicinity of 78,000 lb/in<sup>2</sup> is applied to it, and that a parasail in high winds can develop a shaft shear stress in the vicinity of 326,000 lb/in<sup>2</sup>. The results, although approximate, indicate that parasailing in high winds can produce shear stress on the shaft that far exceeds its capacity.

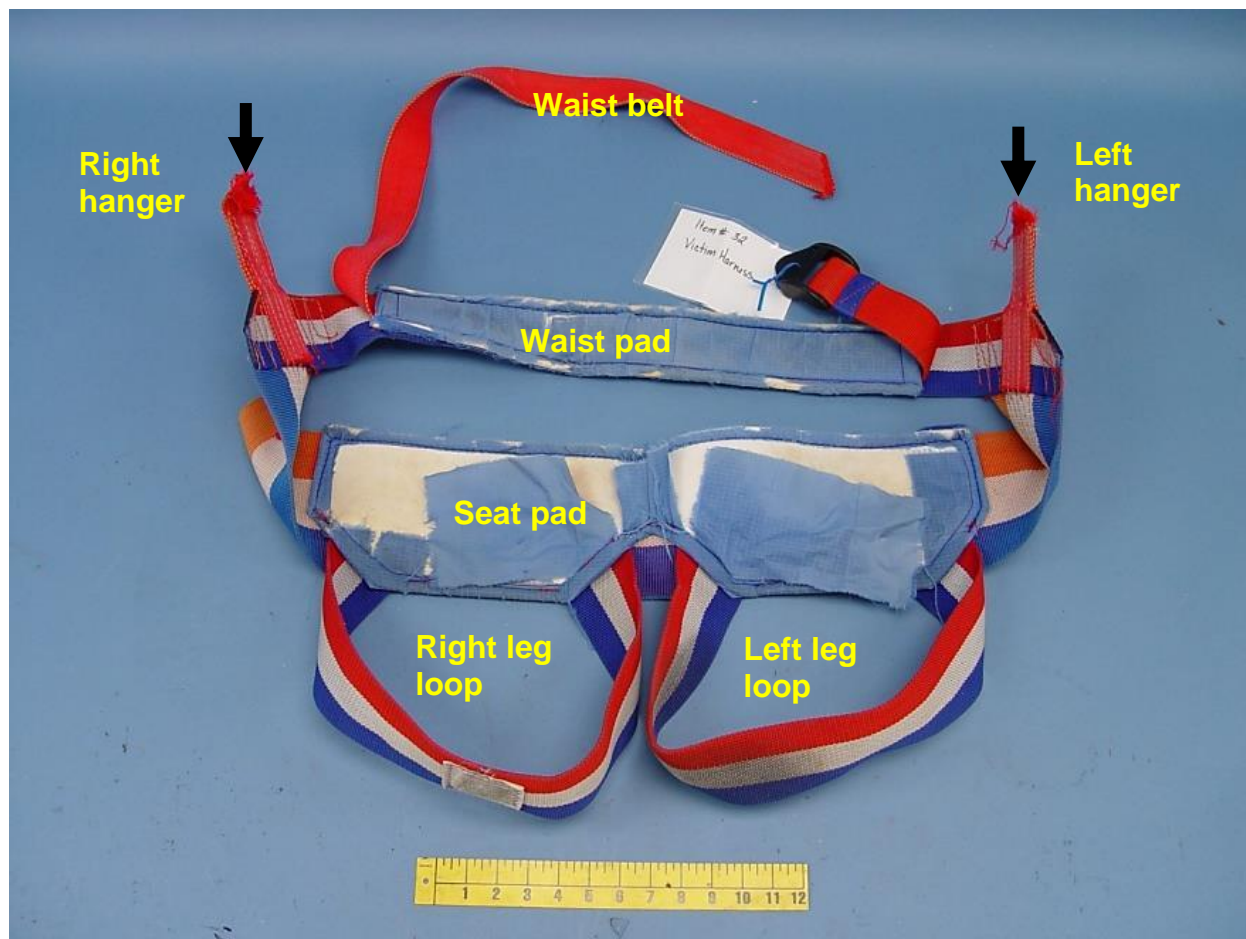
examined the fractured harness that she had been wearing (figure 7). The fractured ends of the red hangers displayed raveled filaments adjacent to the fractures. The tips of the filaments were relatively flat and oriented on a slant plane, or were split and showing white discoloration, all features consistent with overload separation. In addition, much of the blue covering on the seat pad was worn out from extended use and revealed the underlying white padding. Worn areas on the waist pad also exposed white padding. Investigators removed the red waist belt for tensile testing (see section “3.4 Tensile Testing of Harness Waist Belts”).

**Figure 7.** Fractured harness, worn by the victim. The black arrows illustrate the fractured ends of the hangers.

Investigators learned that the parasailing operator had purchased a bag of harnesses from another operator who was going out of business. The history of the harnesses (frequency of use, extent of exposure to saltwater and sun, etc.) was unknown. Investigators could not determine the precise age of the accident harness, but by researching and analyzing images of the hanger webbing and stitching, they concluded that the harness had likely been made in England in the late 1990s or early 2000s.

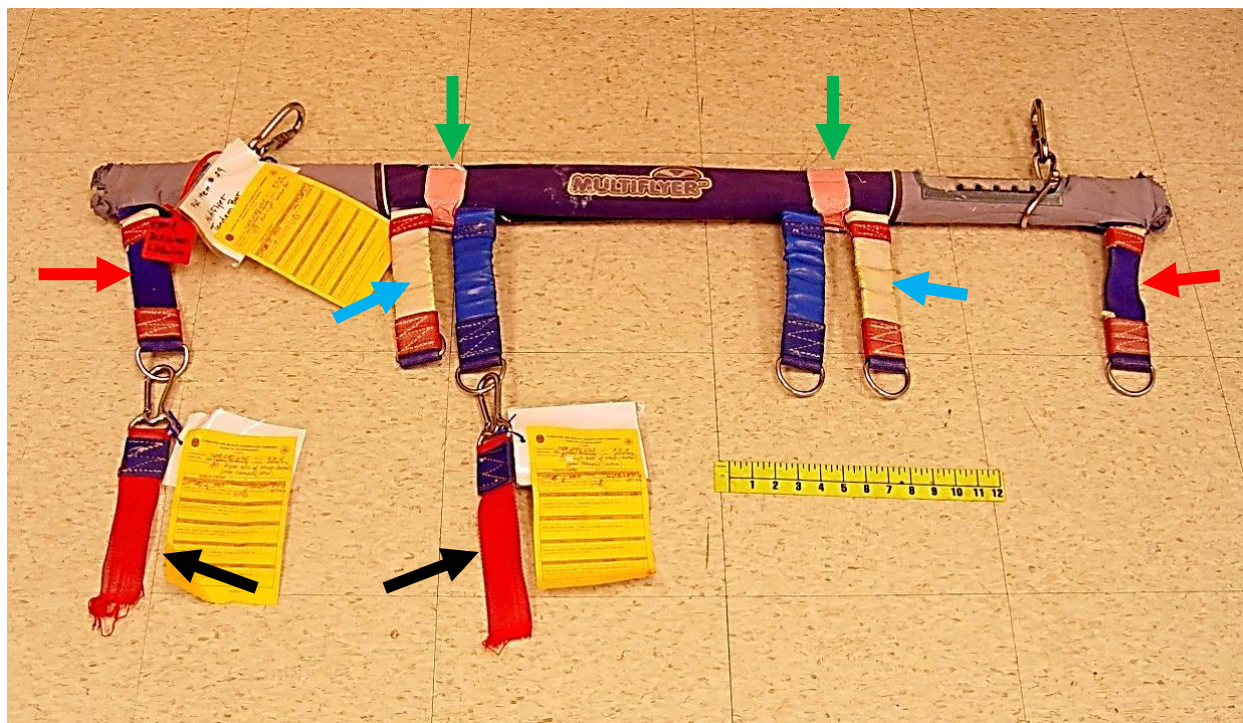
Investigators also examined the flight bar from which the harness detached (figure 8). Torn portions of the harness’s left and right hangers were still attached to the flight bar.

**Figure 8.** Accident flight bar.

Examination of the flight bar revealed torn and missing padding at the outer ends, and most of a protective cover missing from the outer straps (indicated by red arrows). What remained on the outer straps was the same cream color as the cover on the next inboard strap, indicated by the blue arrows. When investigators turned the edges of these covers, it was revealed that the inboard straps were originally red but had faded due to extended use and sun exposure. The green arrows indicate a portion of pink-colored duct tape that had originally obscured most of a warning label on the opposite side of the flight bar, but now only the adhesive remained.<sup>18</sup> On the warning label's lower edge, "www.customchutes.com" was displayed.

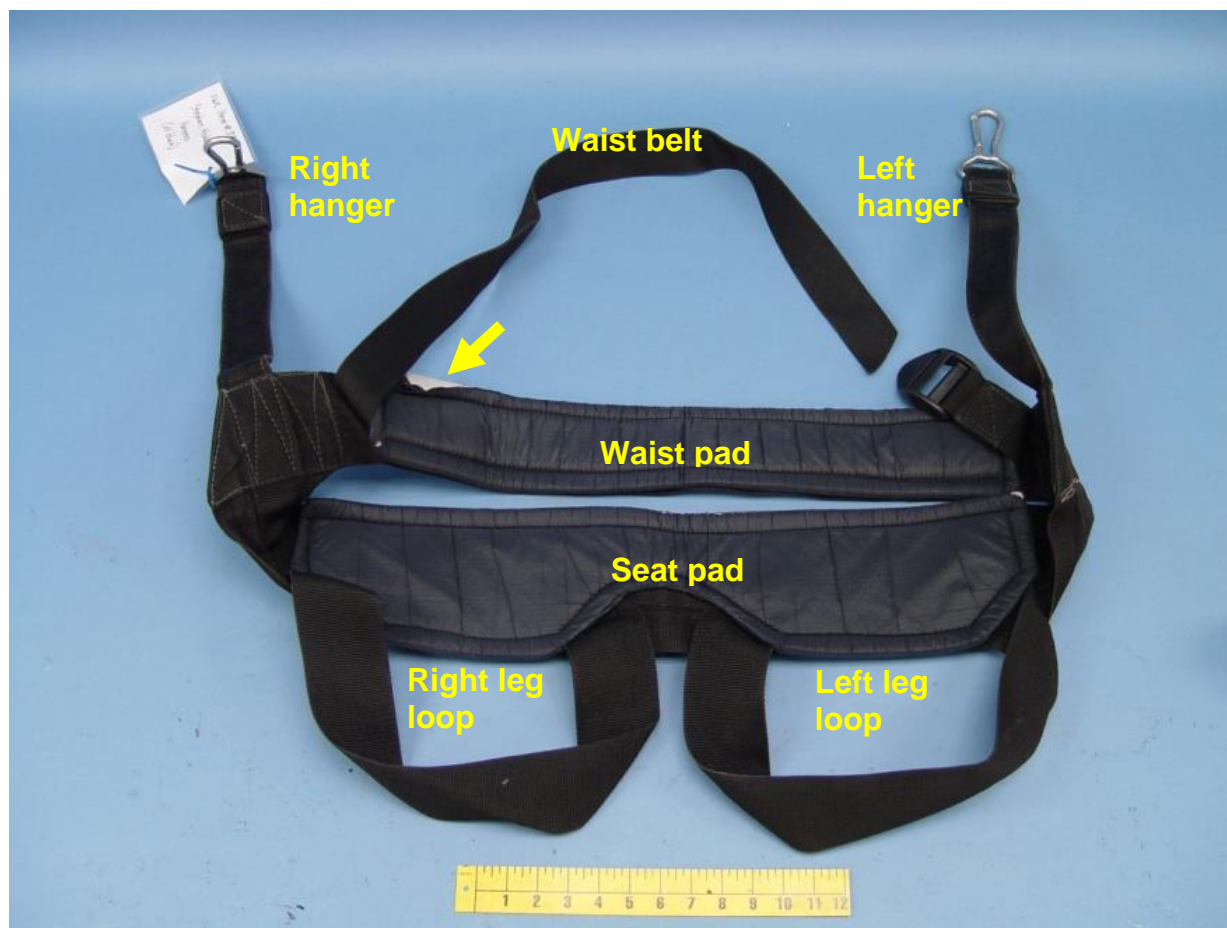
**Figure 9.** Intact harness, worn by the victim's husband.

The husband's harness, like the flight bar, was manufactured by Custom Chutes. This harness had only a small worn area where the white padding was exposed, indicated by the yellow arrow in the image. The waist belt from this harness was also removed for tensile testing (see section "3.4 Tensile Testing of Harness Waist Belts").

Comparison of the two harnesses revealed that the hangers on the fractured harness consisted of a single piece of webbing that extended from the flight bar attachment to the seat/waist webbing junction. The hangers on the intact harness consisted of two pieces of webbing that were sewn together and extended from the flight bar attachment through the seat/waist webbing junction, under the seat, through the other seat/waist webbing junction and to the other flight bar attachment. The intact harness that the victim's husband had been wearing had a more robust original design and was also less degraded from extended use.

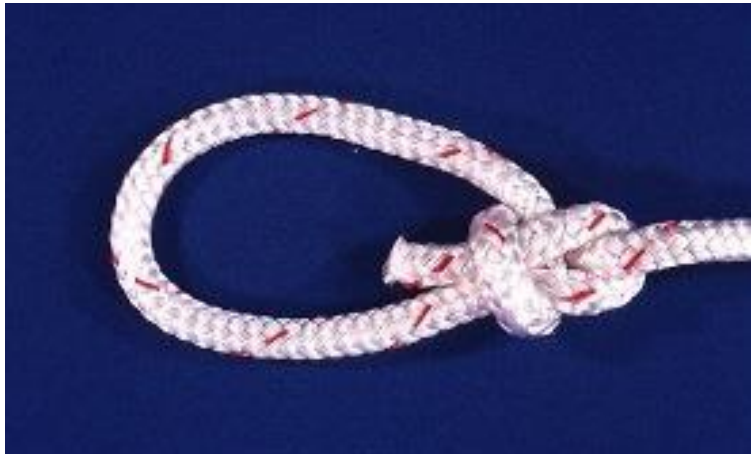
Towline failure is the leading cause of injury and death in parasailing accidents.<sup>1</sup> The NTSB recently studied several parasailing accidents and verified that the knot most commonly used by parasailing operators to fasten their towlines is a bowline knot. In subsequent laboratory testing, the NTSB confirmed that this knot (and any knot in general) can reduce towline strength by as much as 70 percent, even on brand-new, otherwise-strong ropes.<sup>2</sup>

**A bowline knot, the knot most commonly used by parasailing operators in their towlines. This type of knot can weaken a brand-new rope by as much as 70 percent.**

- Frequently and carefully inspect your ropes to ensure that they are in good overall condition with no sign of external abrasion or other damage, and that they are suitable for the intended operation.

- Store your ropes in a clean and dry location out of direct sunlight.
- Trim back the working ends of the ropes as needed, and replace your ropes frequently. For more specifics, consult a recognized source of information such as the Cordage Institute on the selection, care, and disposition of ropes. In addition, refer to the standards for parasailing equipment, currently being developed by ASTM International.
