## Property Inspection Report #20240269

**Date of Inspection: 2/5/2024**

**For the Property located at:**  
2572 Virginia Street unit #5, Berkeley, CA 94709

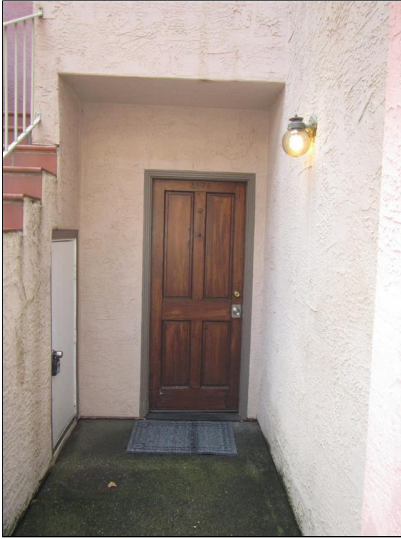
1

The overall condition of the entranceway was noted to be serviceable (Picture 1). The concrete walkway was examined and found to be in serviceable condition with light to moderate staining. The entry door was in serviceable condition, was securely fitted, and swung easily on its hinges (Picture 2). The latch, dead bolt and door hardware were fully functional and were smooth to operate. The exterior lighting fixture was working.

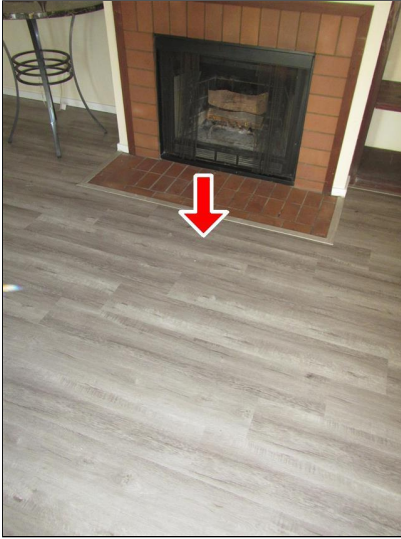
1

(1) The overall condition of the floor coverings was noted to be good. There were several areas where the surface of the floors was not level, most notably in front of the fireplace (Picture 1). No predominant direction of slope was established.

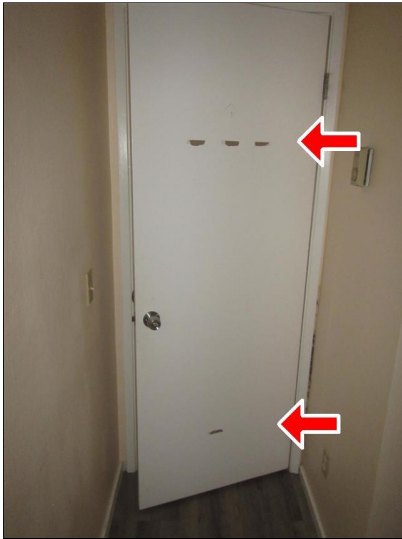
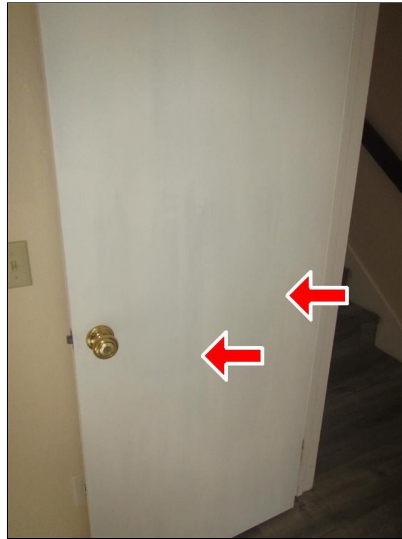
The overall condition of the interior and closet doors was noted to be serviceable. All interior and closet doors were functional and easy to operate. Handles and latches were present and functional throughout. Guides were present at all sliding closet doors. Cosmetic damage was noted at several doors (Picture 1&2).

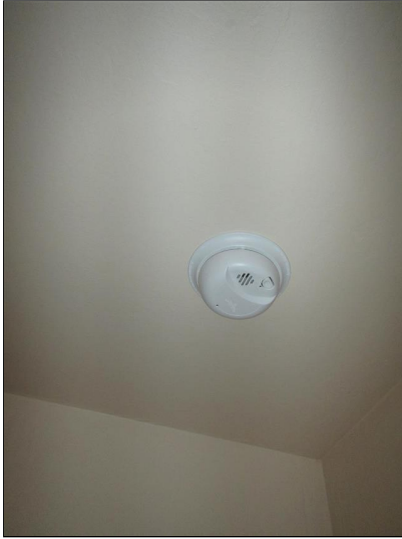
1

Insufficient smoke detectors were present, and of those which were, one (1) or more were antiquated ionization-type unit(s) (Picture 1). Smoke detectors are required in all bedroom(s) and in area(s) outside of bedrooms.

*Recommendation: Install modern photoelectric-type smoke detectors with ten (10) year batteries in each of the bedrooms and in area(s) outside of bedrooms. Periodic testing of smoke detectors is highly recommended.*

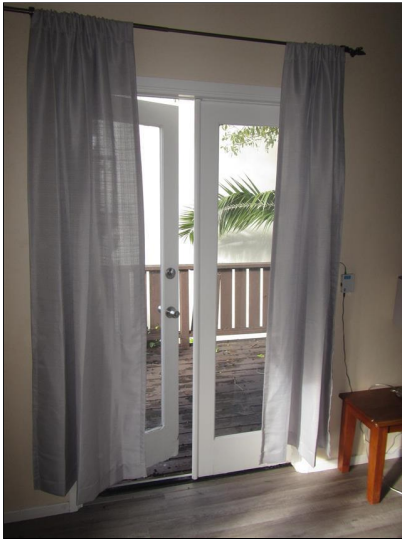
1

(1) The three (3) sets of double exterior doors at the living and dining area were examined and found to be in adequate to serviceable condition (Picture 1). All doors were operable. The doors have been glazed with modern tempered safety glass which is marked accordingly. There were several examples of moisture-related damage and/or peeling paint at the doors and at the exterior frames and sills (Picture 2-3). All three (3) latches and the two (2) dead bolts were intact and were smooth to operate. No screen doors were present.

*Recommendations: Replace all damaged wood in the doors and at the exterior frames and sills. All loose paint should be removed before repainting. Any exposed untreated wood should be primed and/or painted as appropriate. Consult a specialist Wood Destroying Organisms (WDO; Termite) inspector with regard to the condition of these areas.*

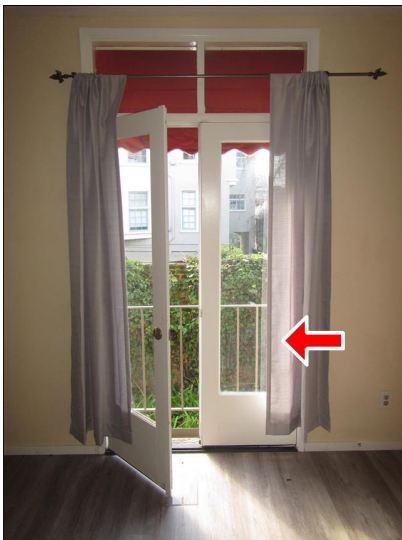
4

(2) Doors at the rear of the of the living area have been fitted with exterior safety bars which were found to be secure (Picture 4). Water was infiltrating into the living area in the area adjacent to these doors (Picture 5). It was not clear whether the water originates from the double doors however there was no other obvious source.

*Recommendations: Determine the origin of the water intrusion and make repairs as necessary.*

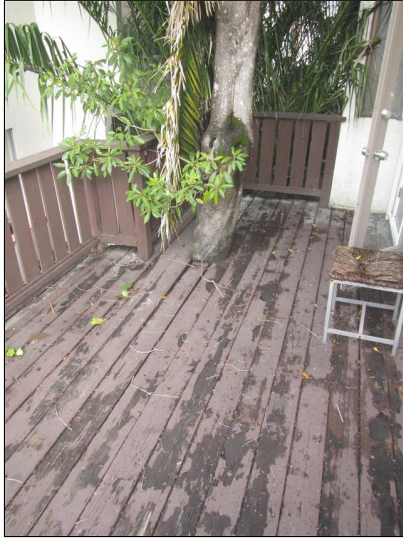
1

(1) The exterior deck and stairs were examined and found to be in adequate condition (Picture 1). The deck boards were in adequate condition with a number of examples of moisture-related damage.. The tree which passes through the deck has outgrown the space available resulting in lifting of the adjacent boards (Picture 2). The area below the deck was inaccessible. The supporting structure was not evaluated. Several sections of the enclosures were missing (Picture 3). There was no graspable handrail present at either section of the stairs.

*Recommendations: Replace all damaged wood in the deck and supporting structure. Repair or replace the enclosures. Remove the tree of increase the space available for the trunk to pass through the deck. Install a graspable handrail at*

each section of the stairs. Consult a specialist Wood Destroying Organisms (WDO; Termite) inspector with regard to the condition of the deck.

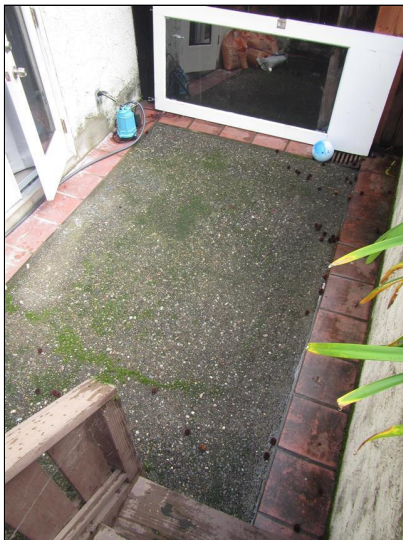
4

(2) The exterior patio was examined and found to be in serviceable to good condition. The surface of the patio was free from significant staining (Picture 4). A surface drain was present at the patio (Picture 5). A sump pump was also present which implies that the patio area is prone to flooding (Picture 6). The sump pump discharges to the front of the lot.

*Recommendations: Monitor the performance of the drainage system at the patio under wet conditions. Improvements may be require in order to prevent flooding at the patio.*

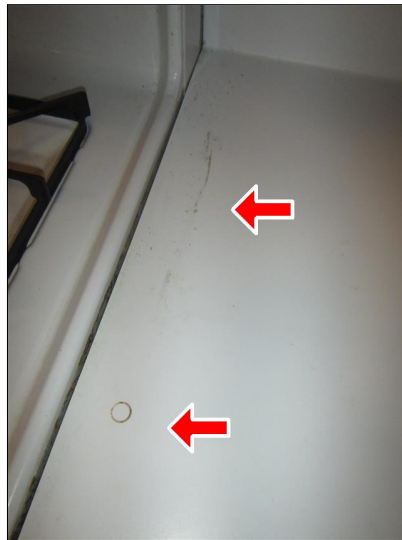
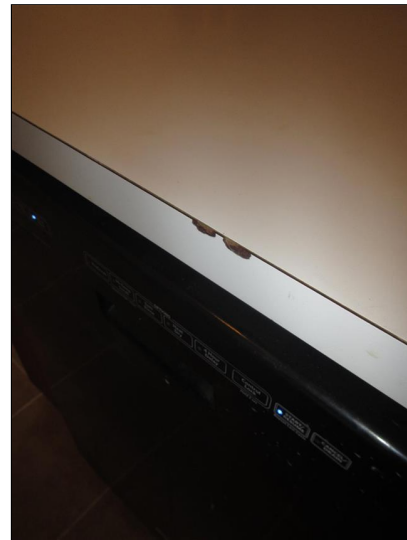
The built-in cabinets were found to be in overall serviceable condition. Drawers and cabinet doors were all fully operable. Cabinet hardware was installed throughout and was fully functional. There was some cosmetic damage at the interior of the cabinets and/or at the cabinet doors (Picture 1). Countertops were found to be in overall serviceable condition. There was some cosmetic damage at the surface of the countertops (Picture 2&3).

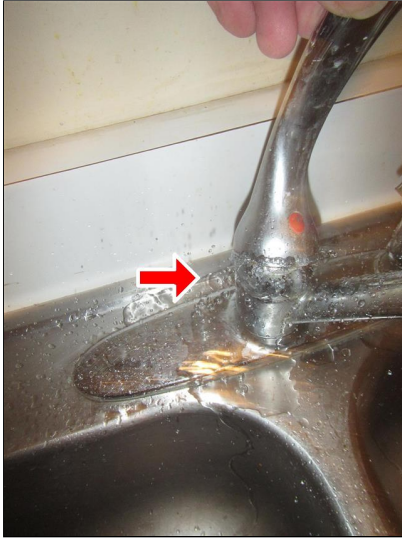
1

(1) The sink was found to be in serviceable condition with no signs of leaks around the sink, at the drain line, or in the cabinet below the sink. The sink faucet was leaking (Picture 1). Plumbing fixtures were fully operable.

*Recommendations: Repair the leak at the sink faucet.*

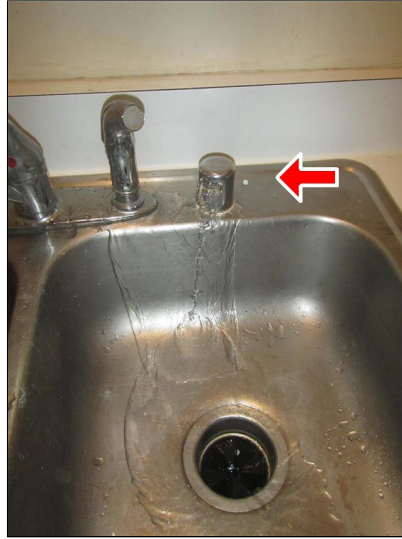
2

(3) The dishwasher was run for an extended period and found to drain through the air gap at the sink (Picture 2). The dishwasher has been installed such that it is not parallel with the edge of the countertop.

*Recommendations: Clear the blockage in the dishwasher/garbage disposal waste line. Re-alignment of the dishwasher may be desirable.*

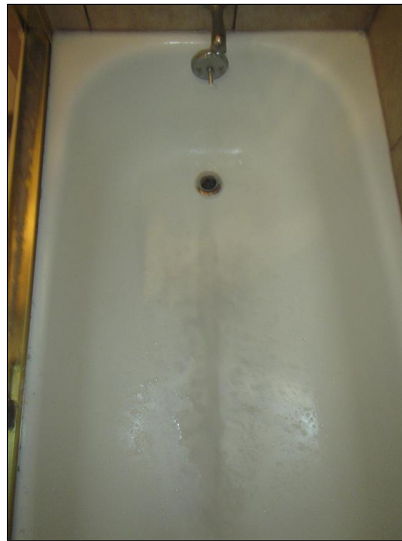
2

(3) The tub was tested and found not to leak inside the bathroom. Tub faucet(s) and spout were secure and functional. There was some cosmetic damage to the surface of the tub (Picture 2).

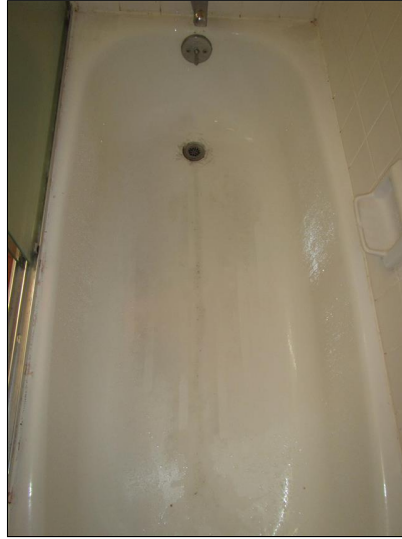
2

(3) The tub was tested and found not to leak inside the bathroom. Tub faucet(s) and spout were secure and functional. There was significant cosmetic damage to the surface of the tub (Picture 2).

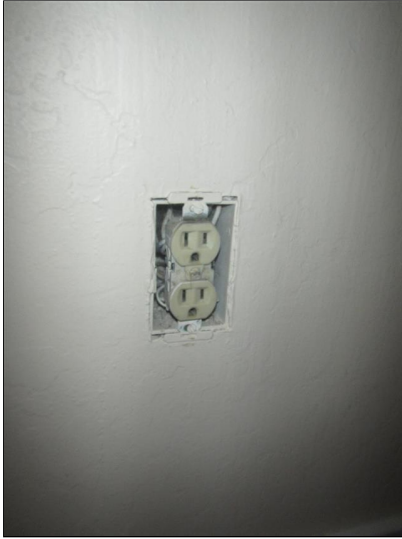
1

(3) One (1) cover plate was damaged and/or missing in the front entry level bedroom (Picture 1).

*Maintenance: Replace damaged and/or missing cover plate(s) and/or fastener(s).*

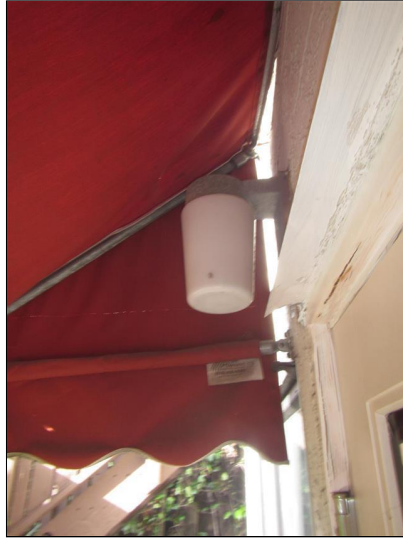
2

(4) The exterior lighting fixture at the patio was not working, was damaged, or was missing bulb(s) (Picture 2). All interior lighting fixtures were functional. There are no integral lighting fixtures in the bedrooms; wall switches in these areas control outlets where lamps may be connected.
