## Property Condition Report

### Couick's Marine

3613 Providence Rd S, Waxhaw, NC 28173

January 30, 2024

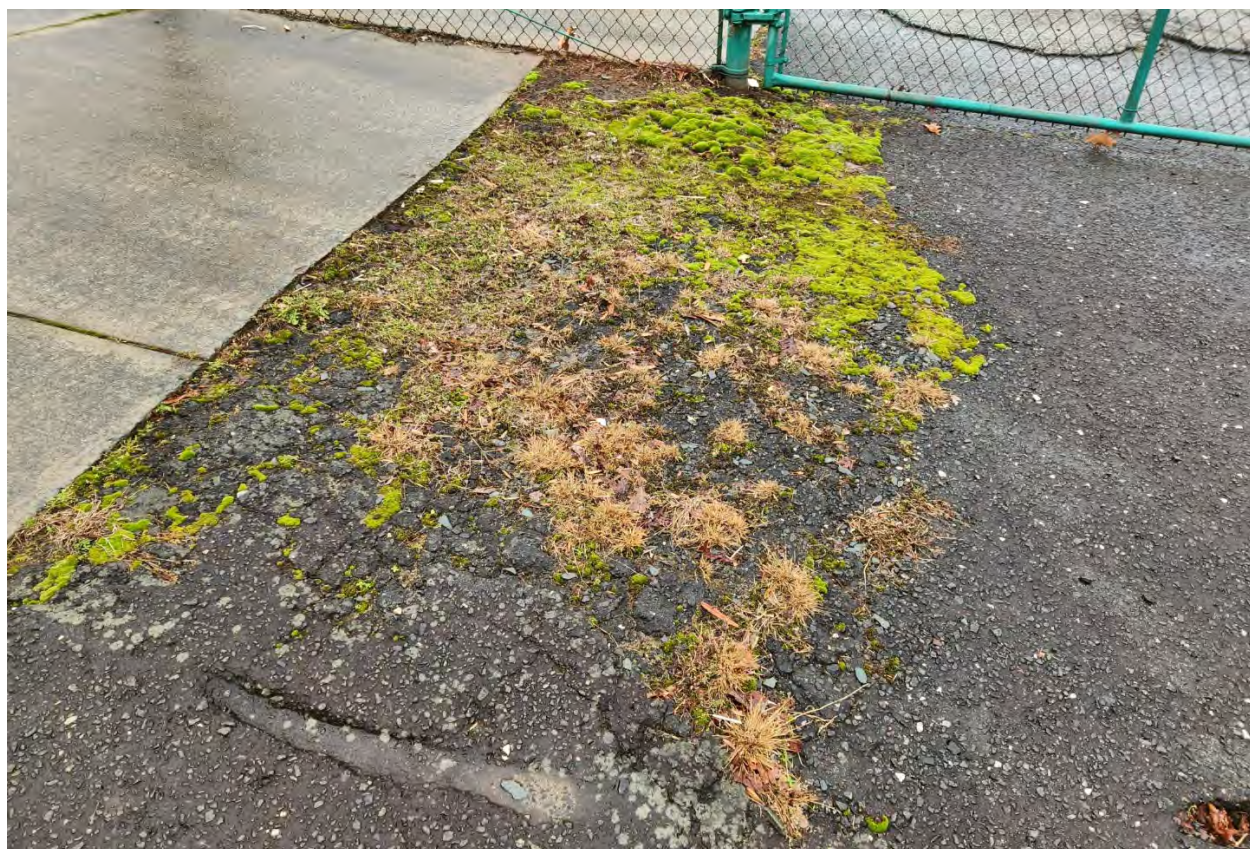
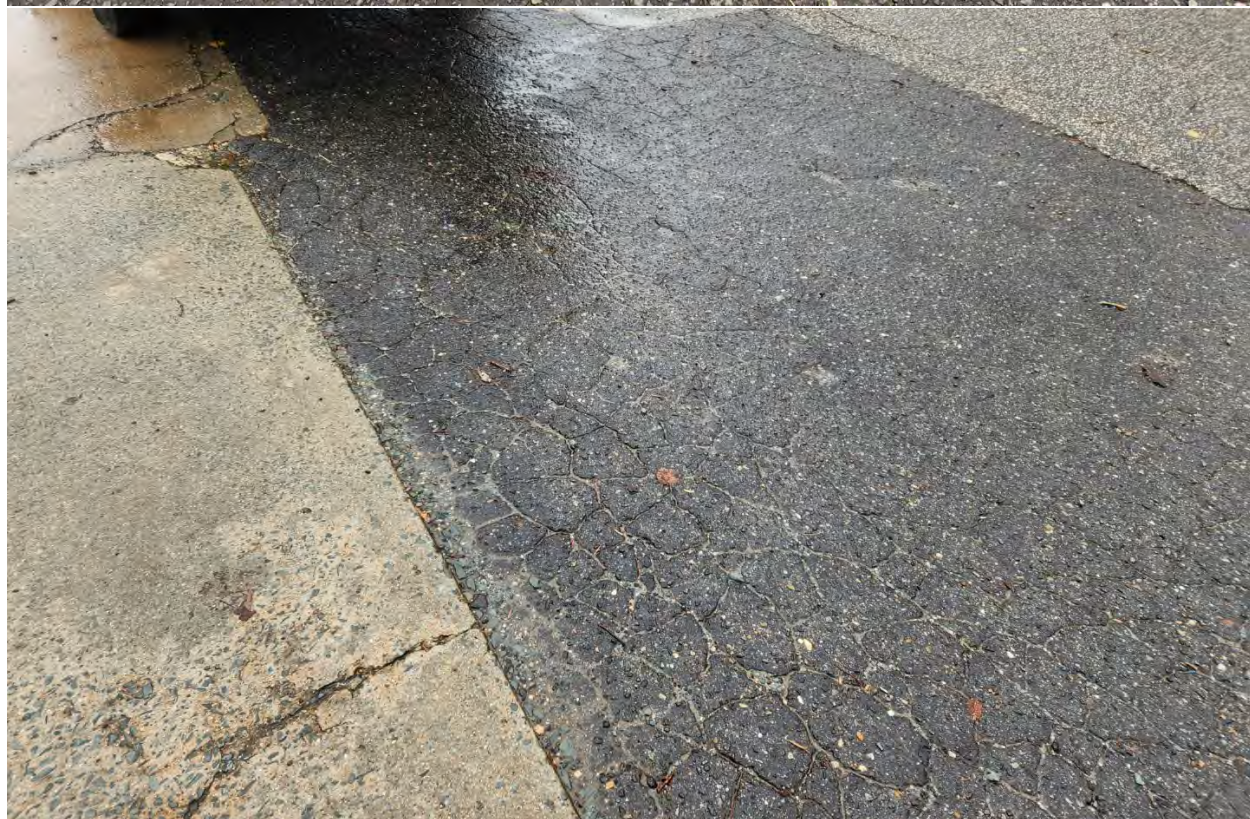
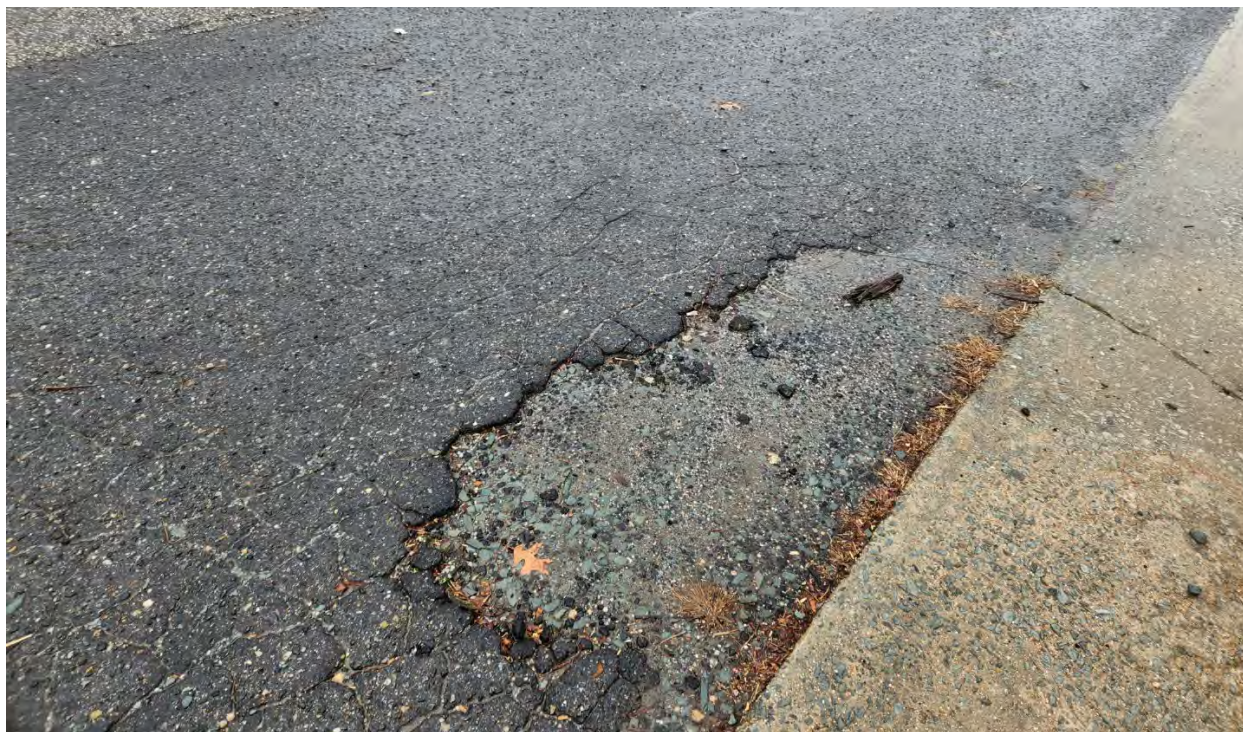
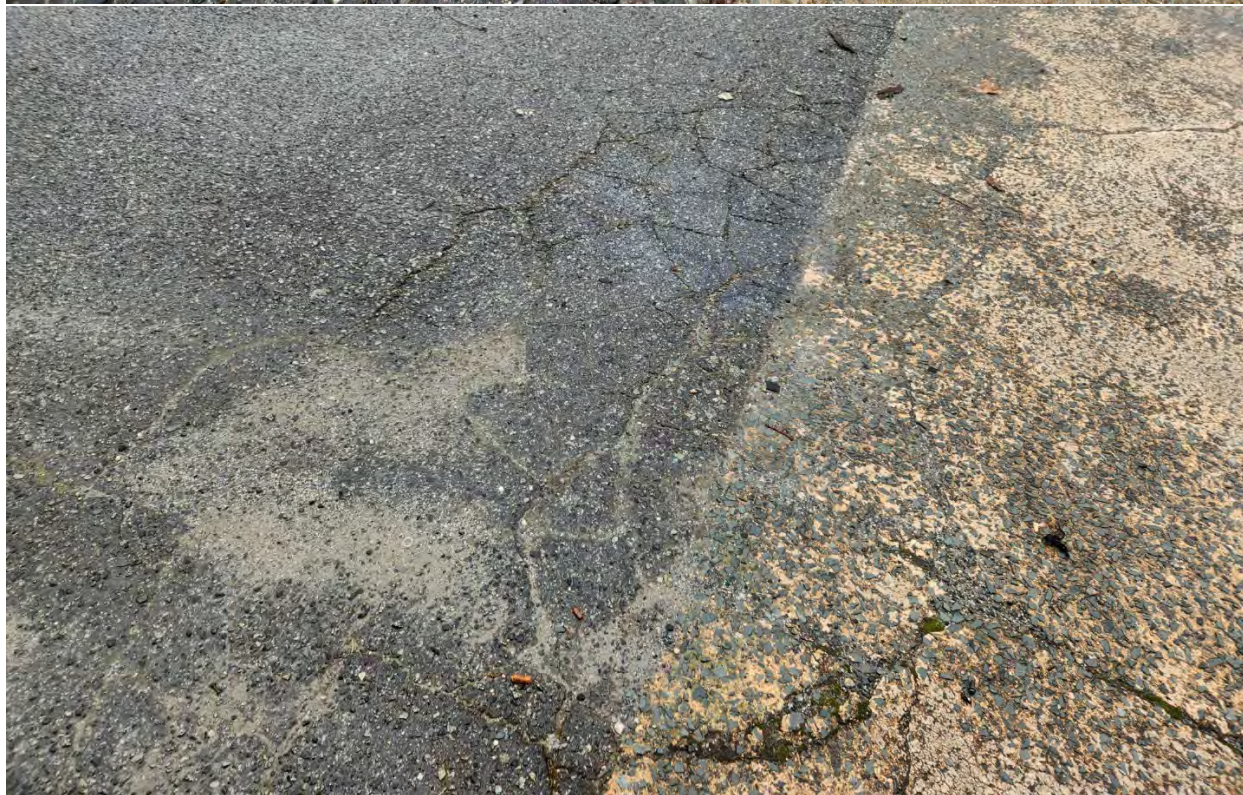
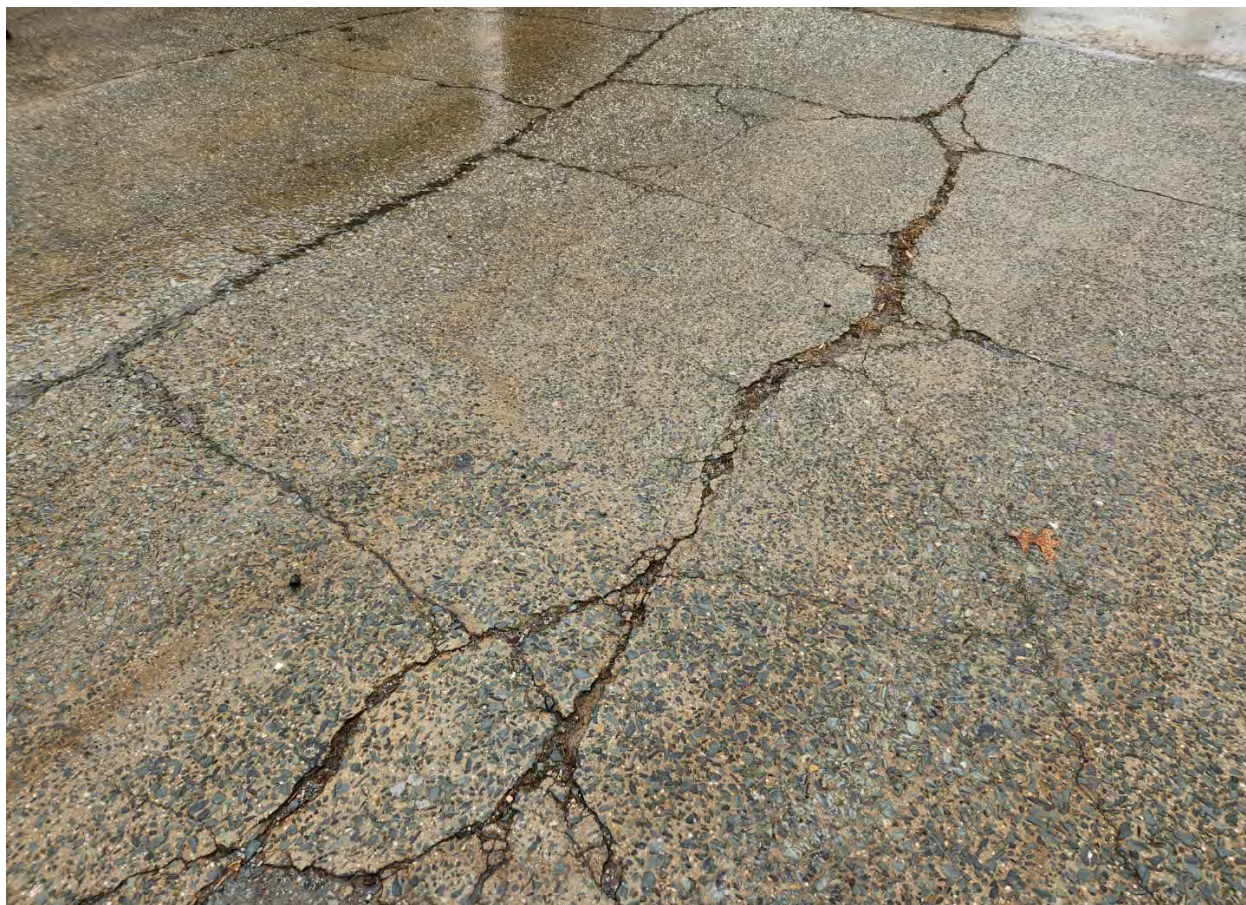
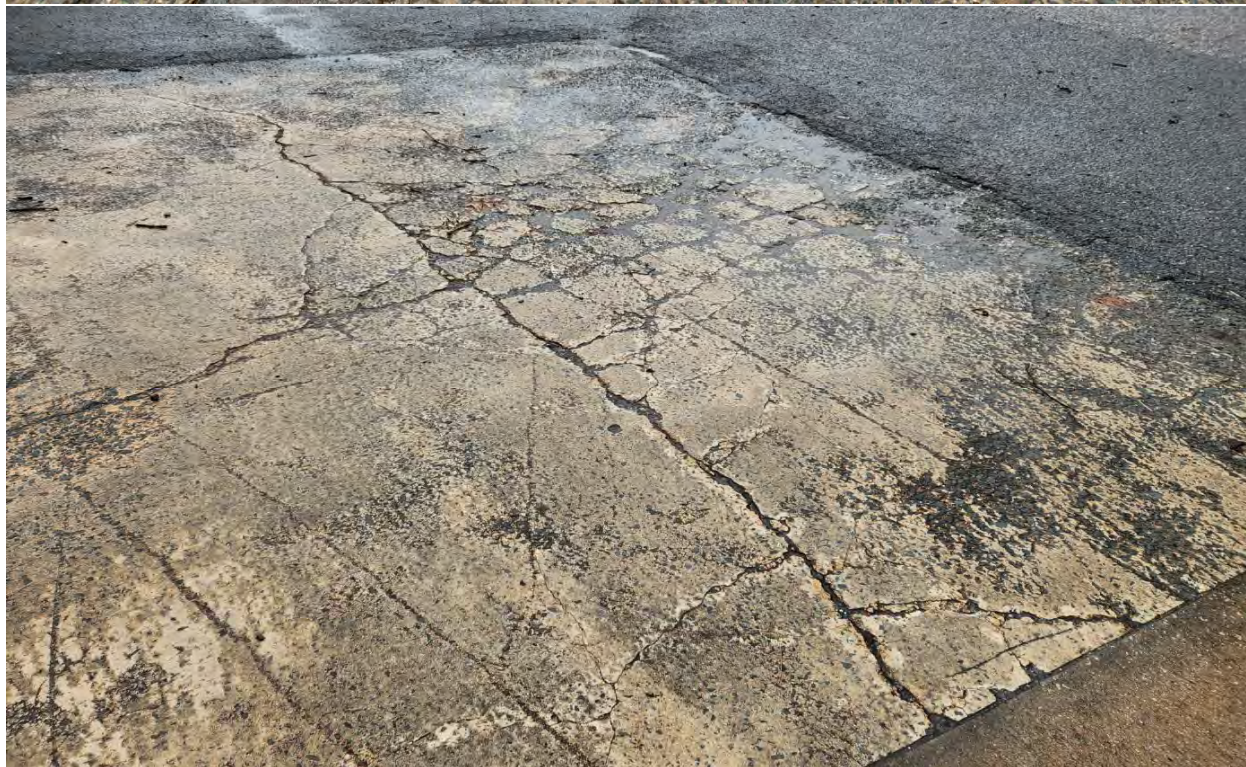
3.8.1 The asphalt and concrete pavement is cracked, spalling and deteriorated in some places. There are no parking stripes. We recommend patching the worst sections, filling the cracks, and sealing and striping the asphalt.

- 1.3.1 The asphalt and concrete pavement is cracked, spalling and deteriorated in some places. There are no parking stripes. We recommend patching the worst sections, filling the cracks, and sealing and striping the asphalt.

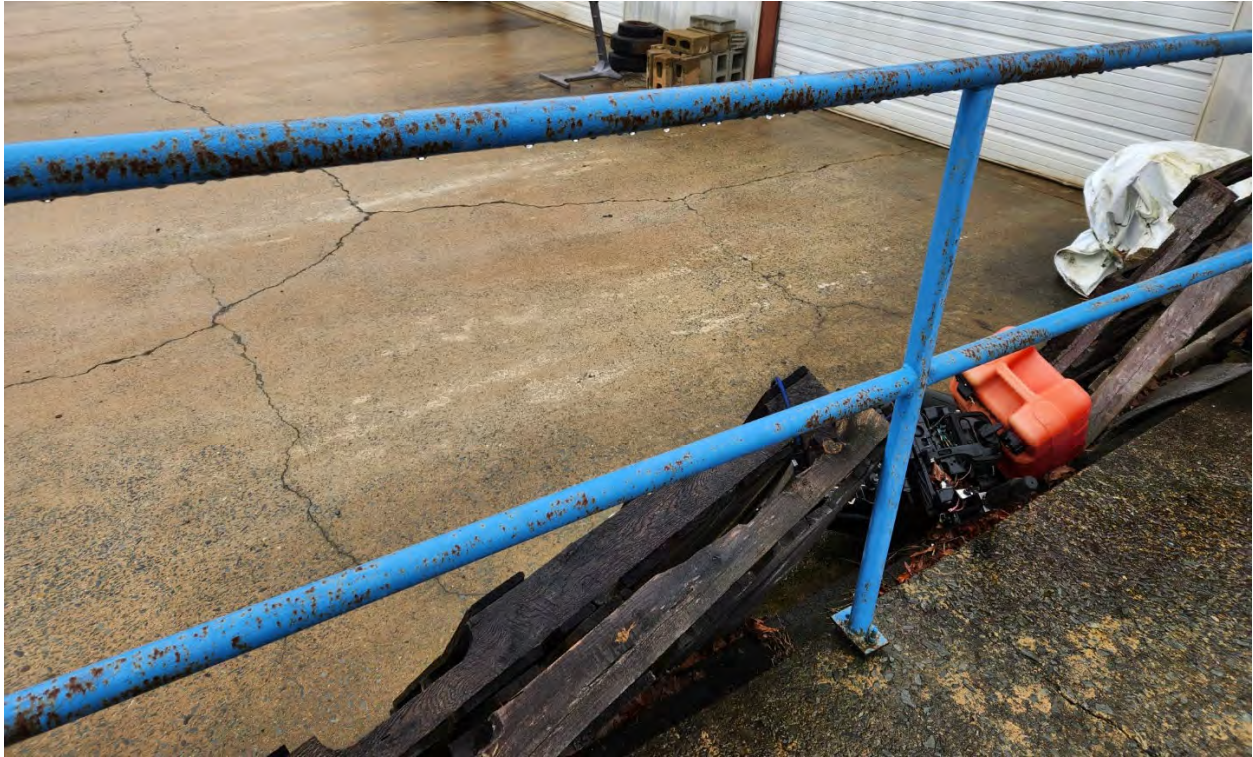
- 3.8.2 The exterior steel rails need to be wire brushed and painted.

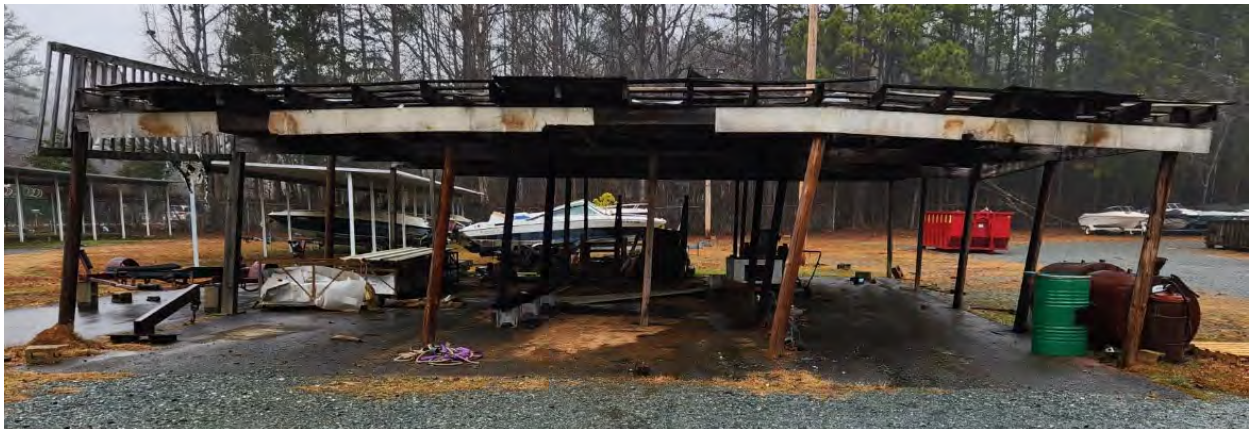
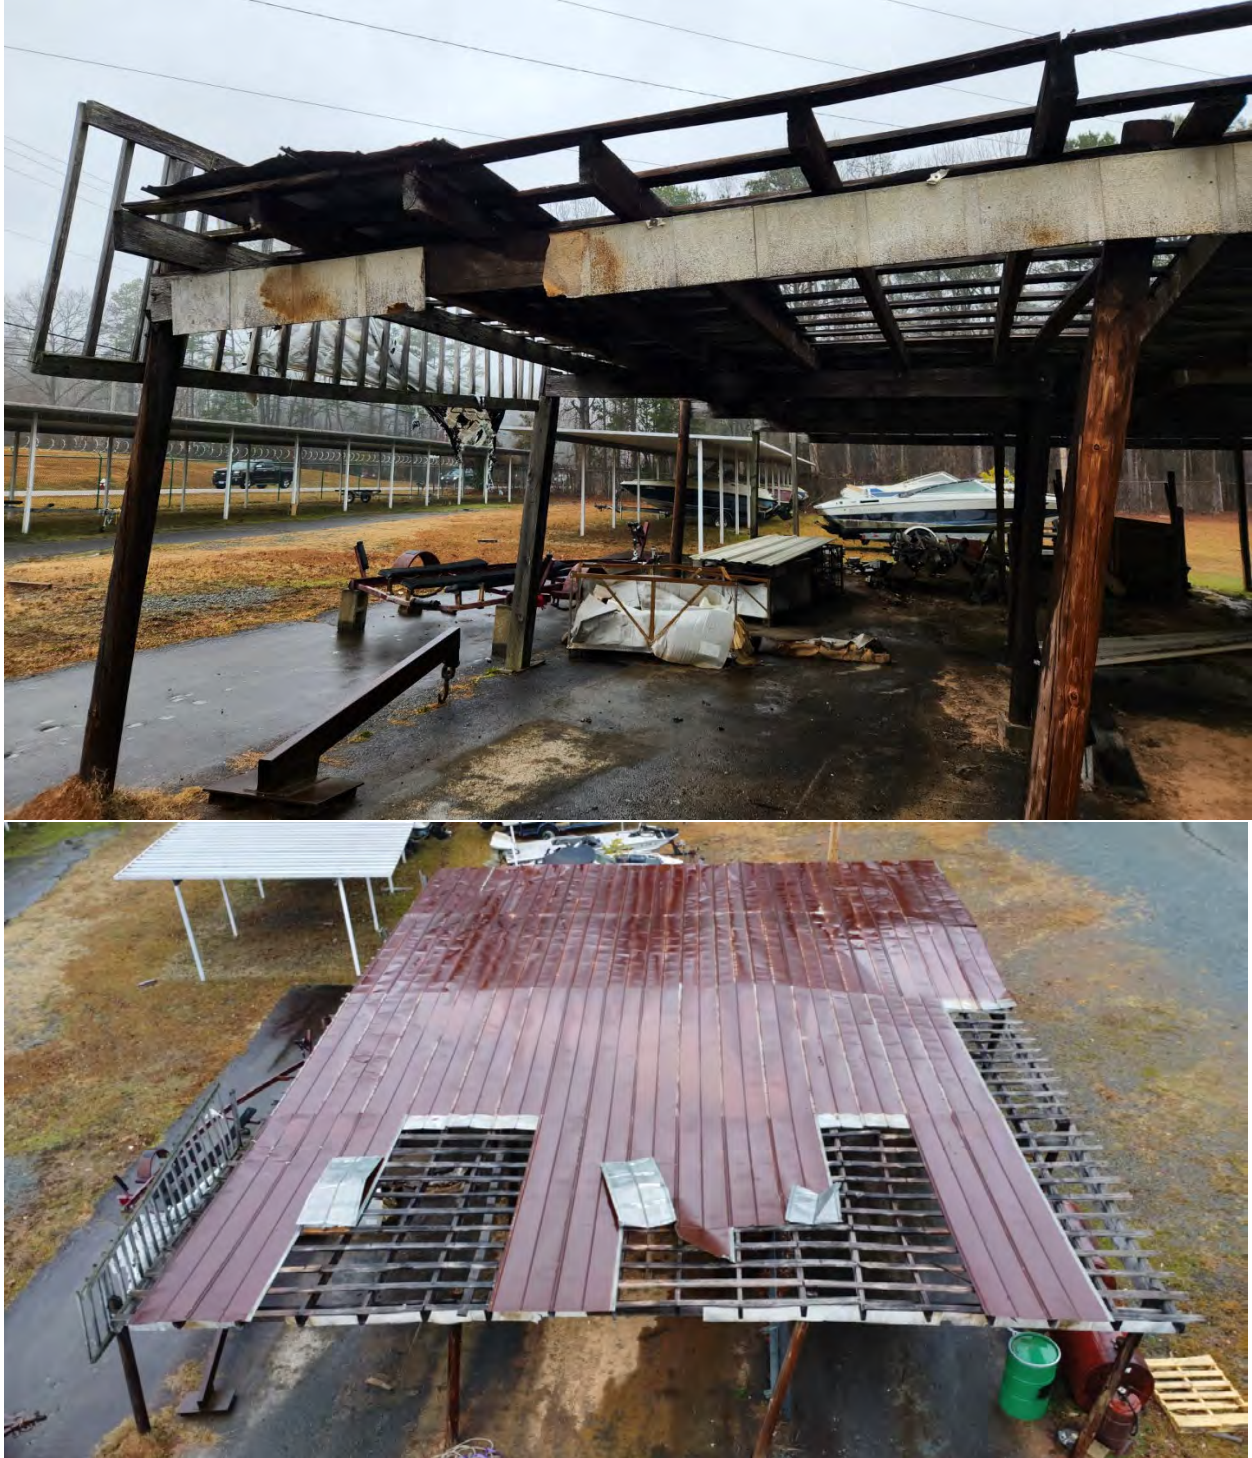
- 3.8.4 There is a canopy that is in poor condition and needs to be repaired or replaced.

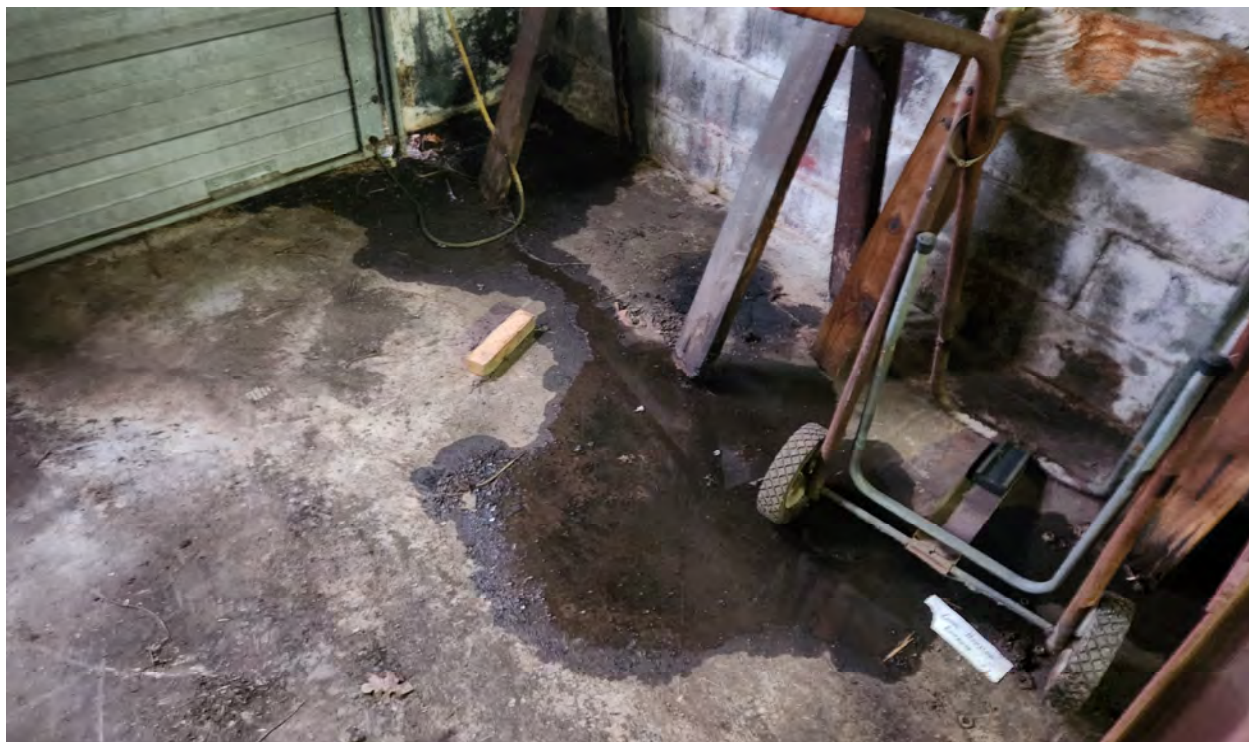
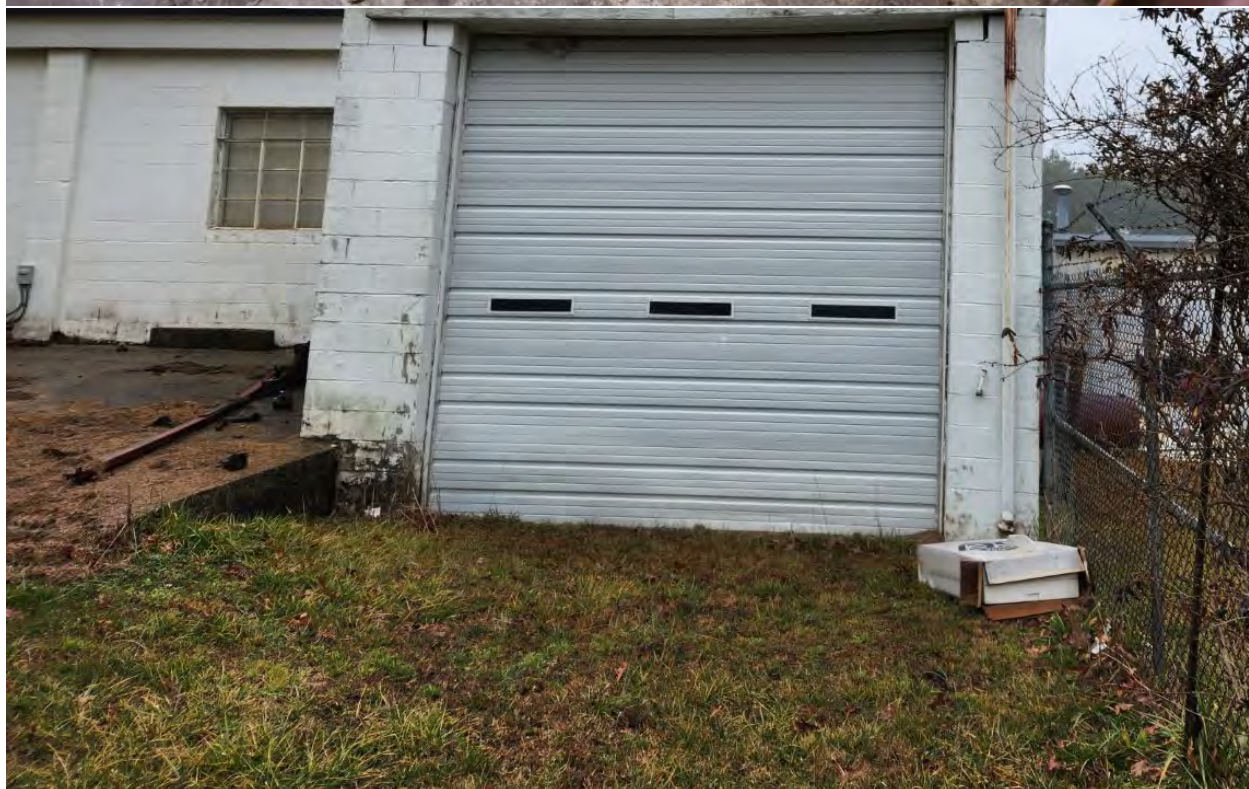
- 3.8.5 There is a leak into the building at the overhead door on the south side of the north building. Adding drainage in this area or finding a way to seal the door or building is needed.

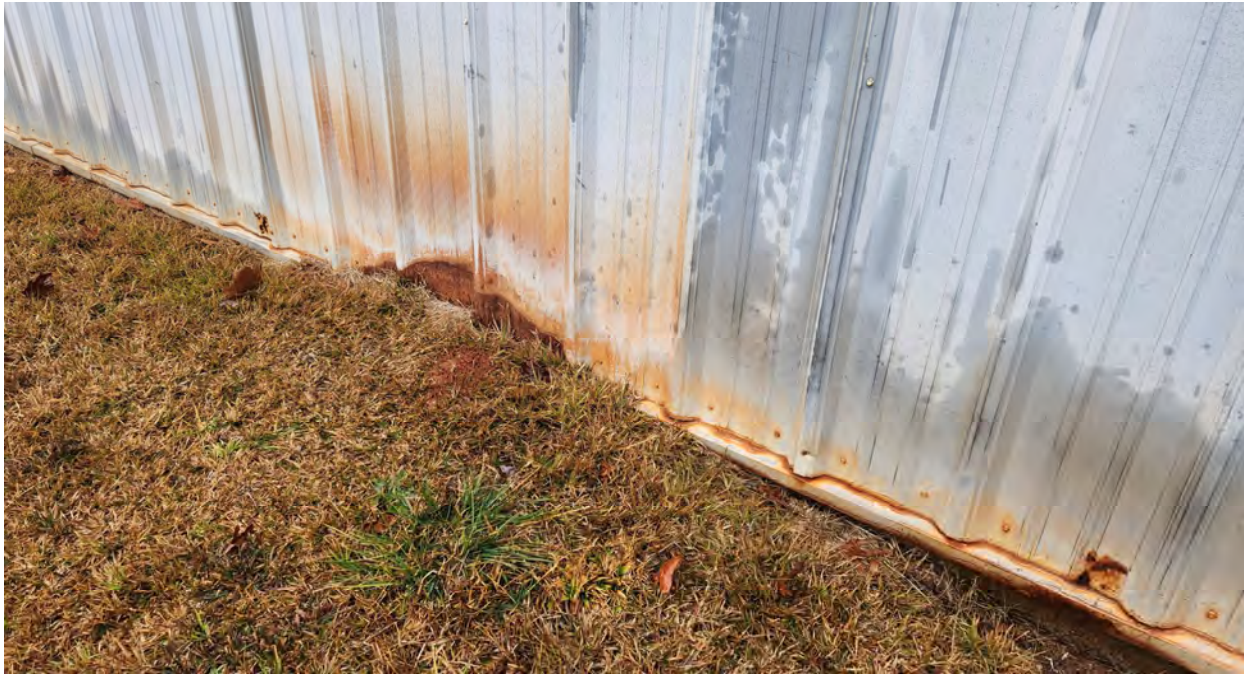
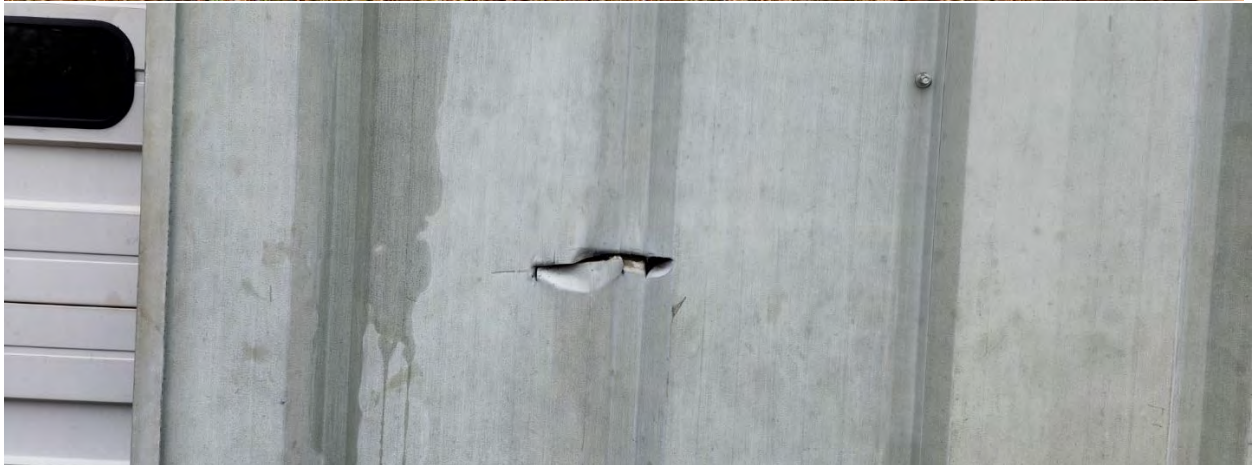
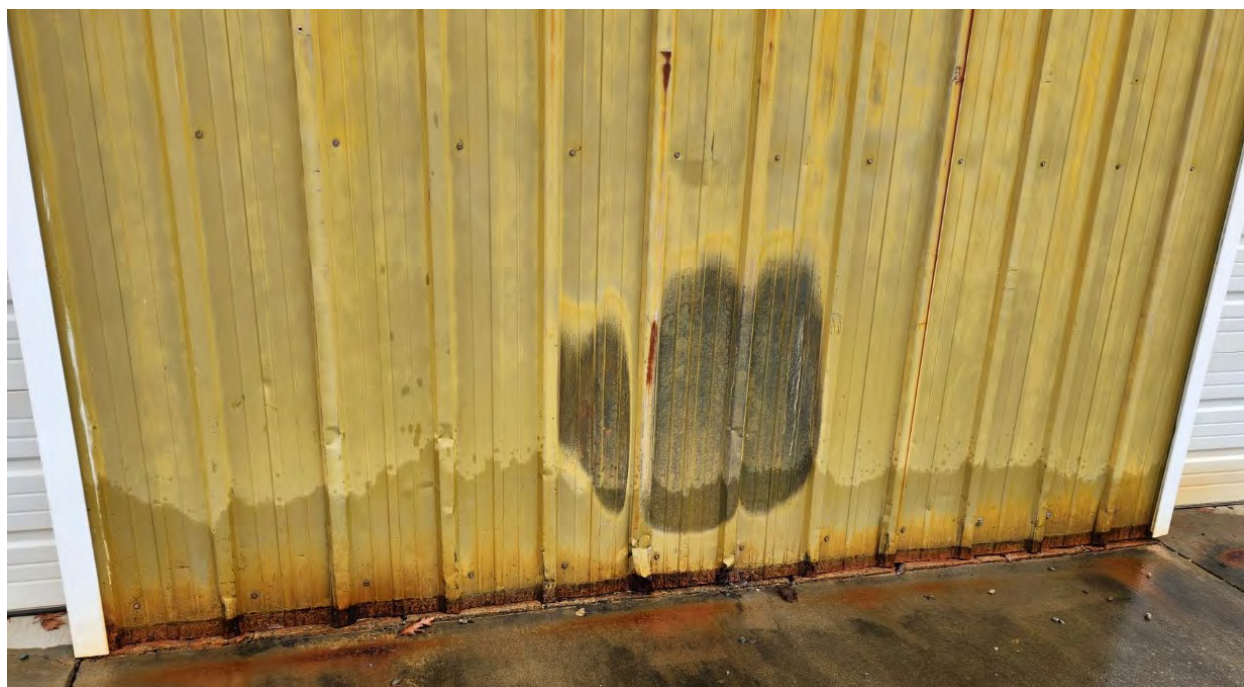
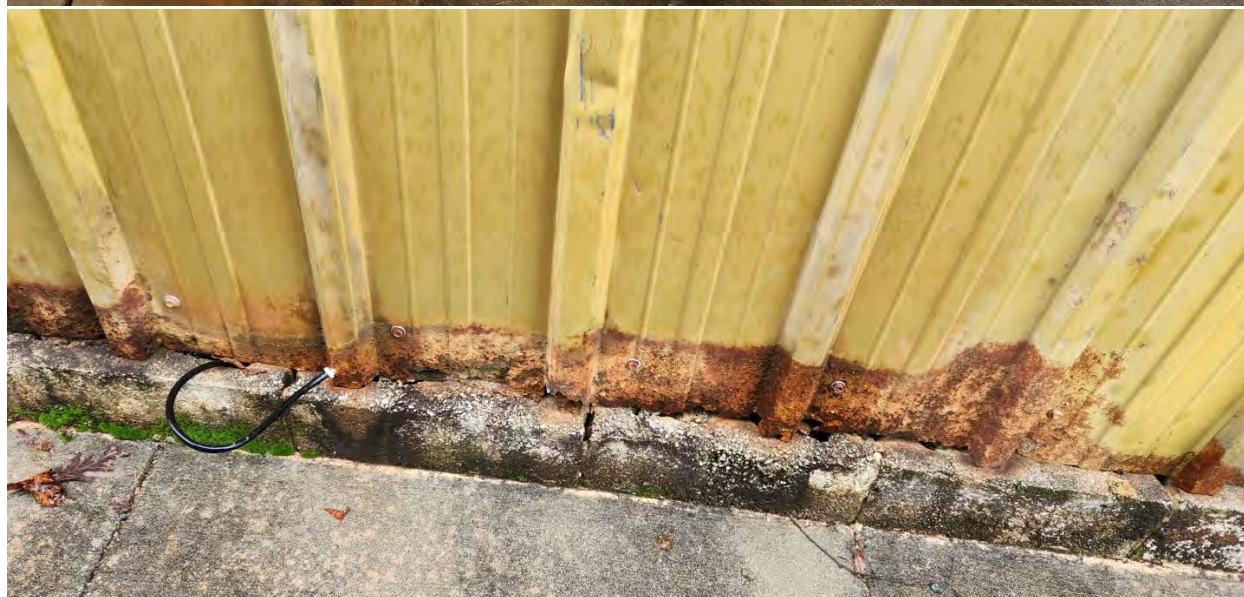
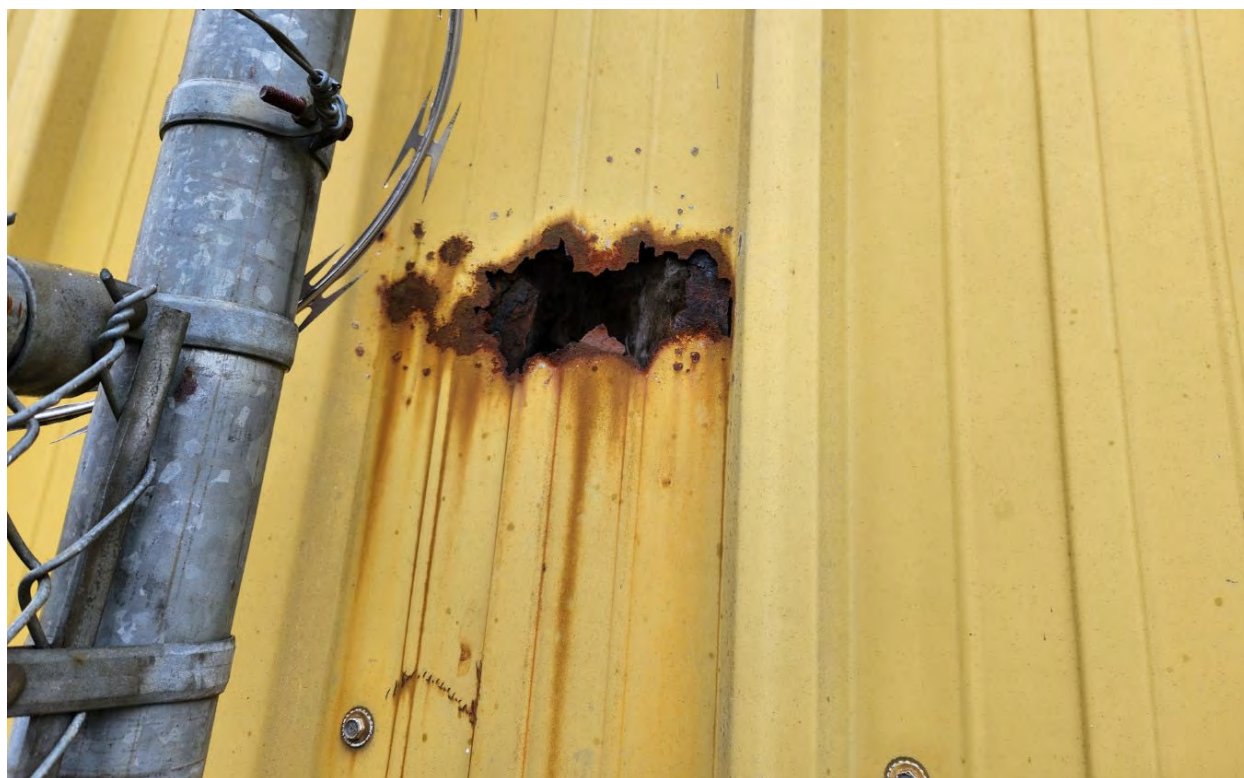
- 4.5.1 The metal siding is corroded or damaged in many places and needs to be repaired or replaced.

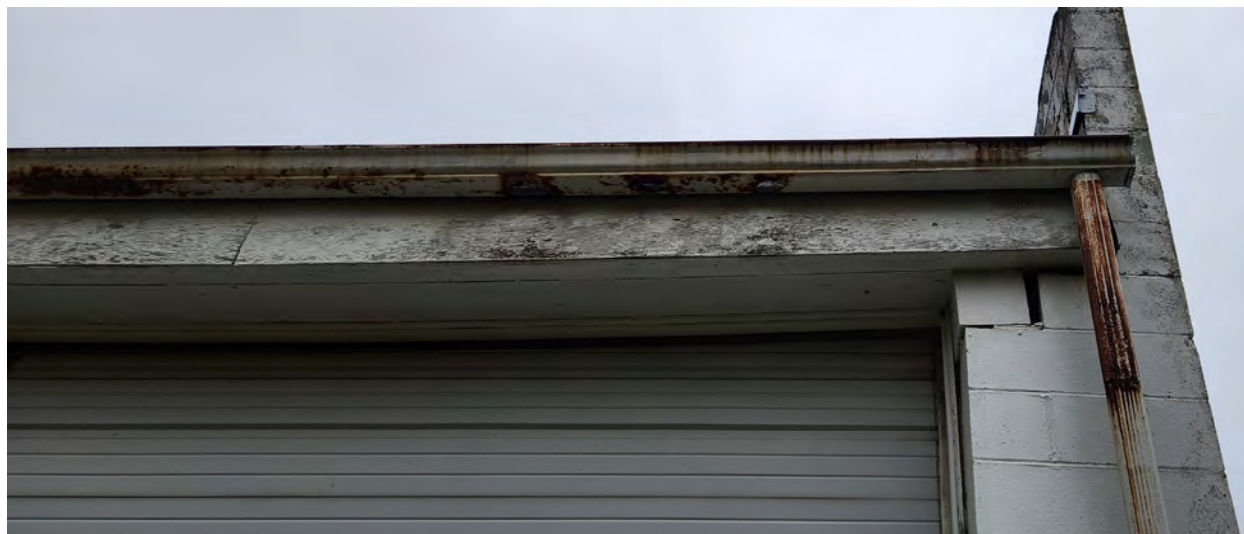
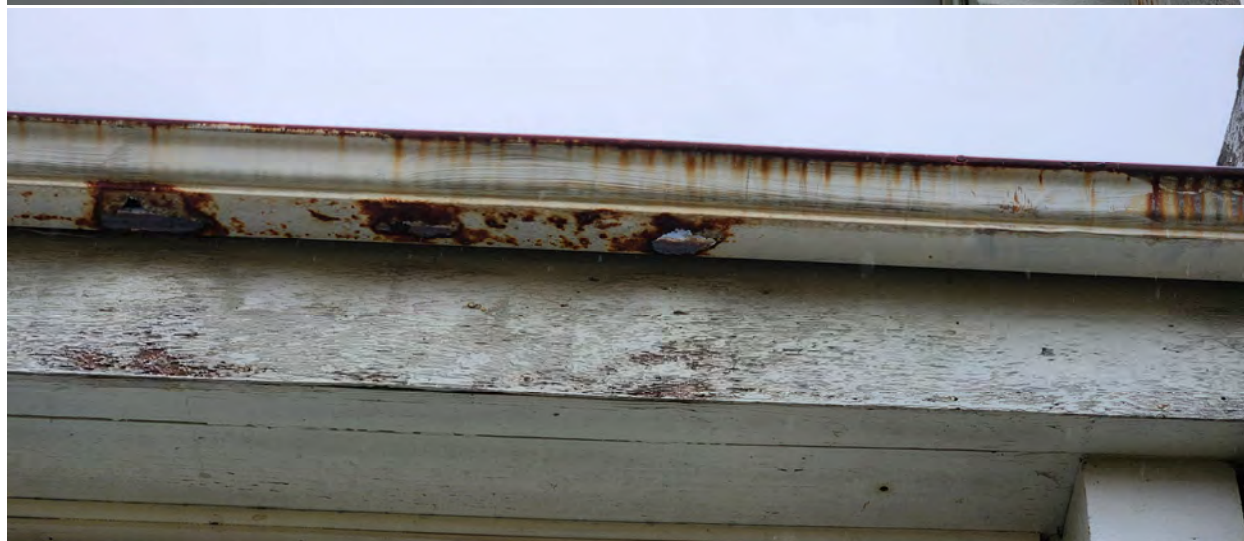
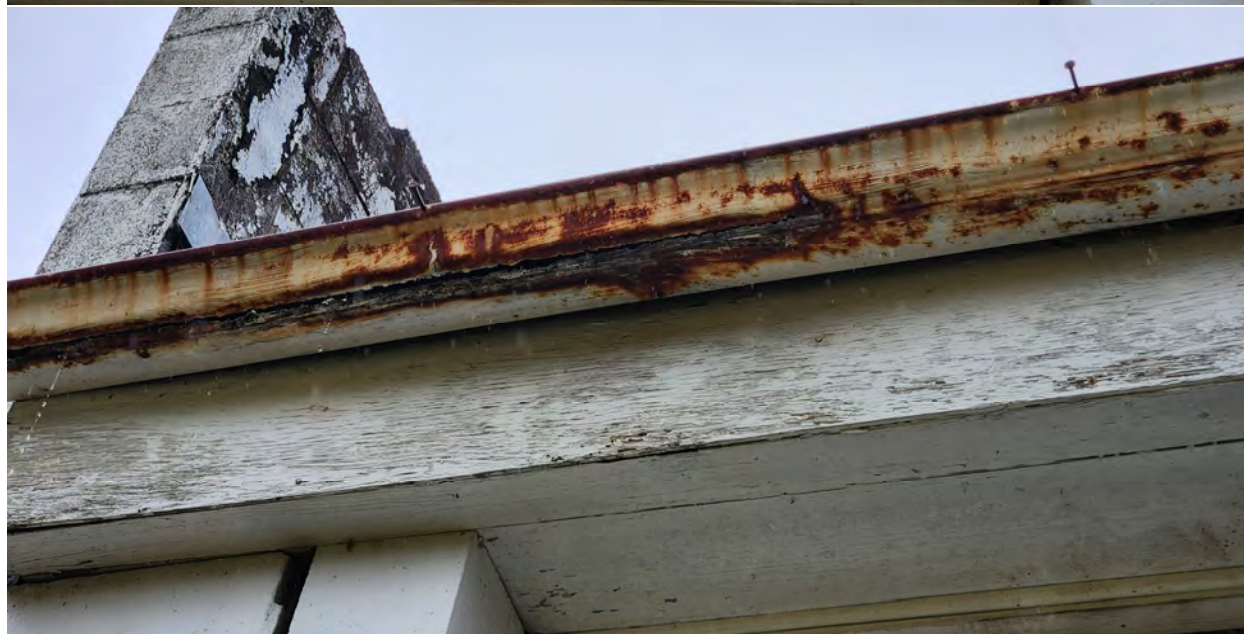
5.4.1 Some portions of the gutters and downspouts are severely corroded and need to be replaced.

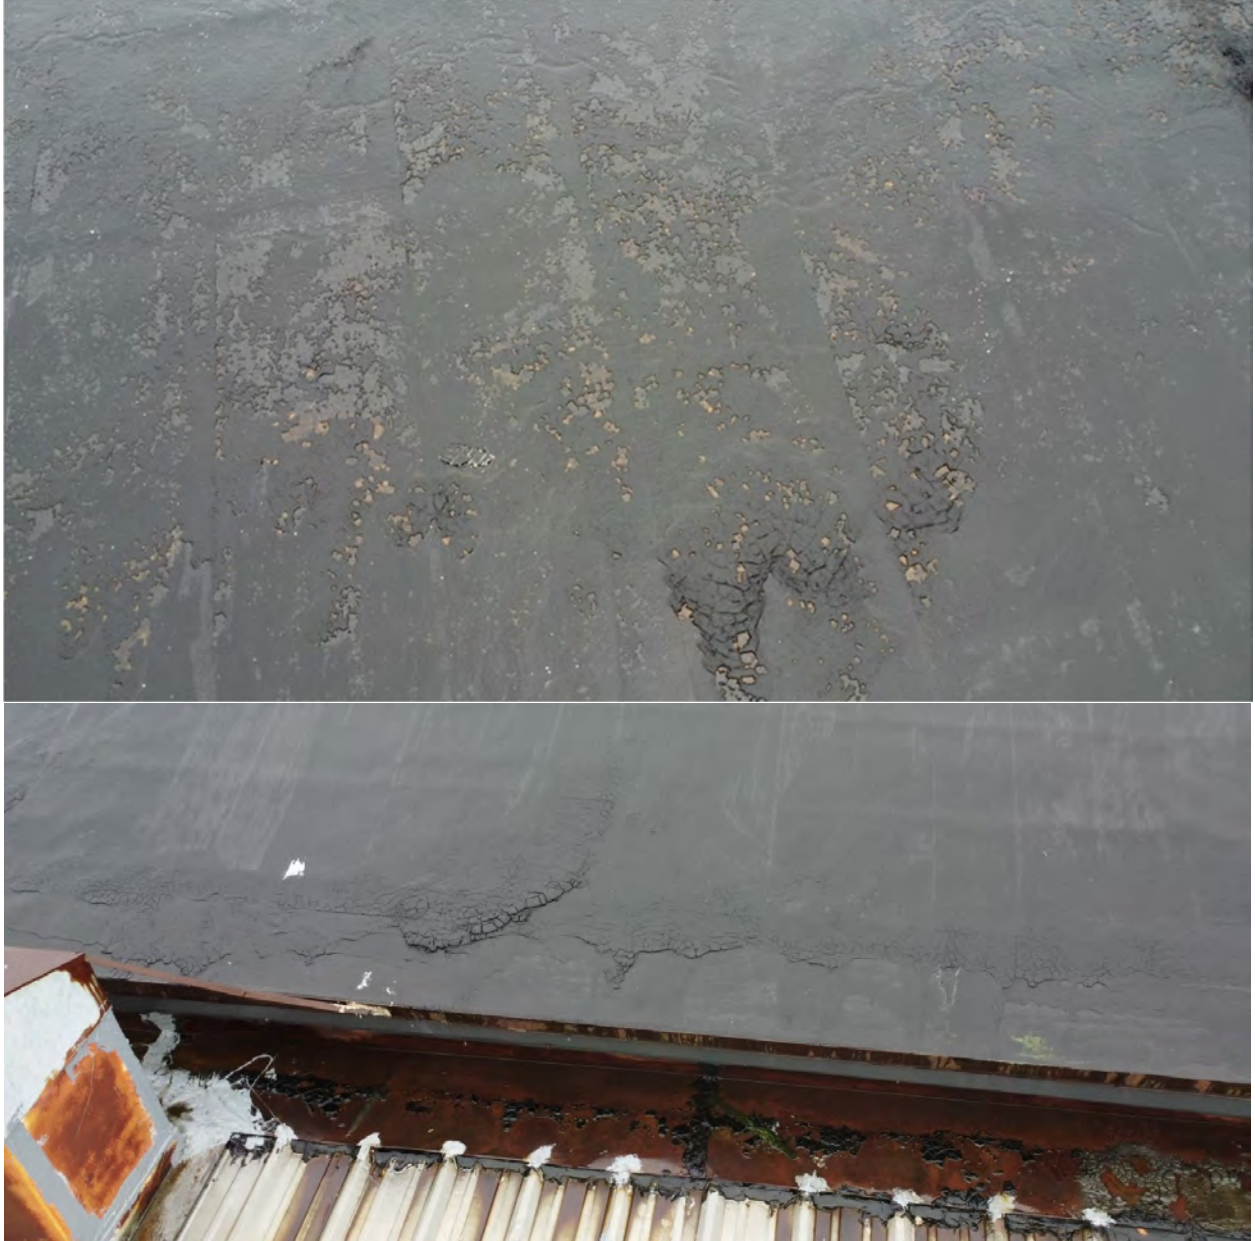
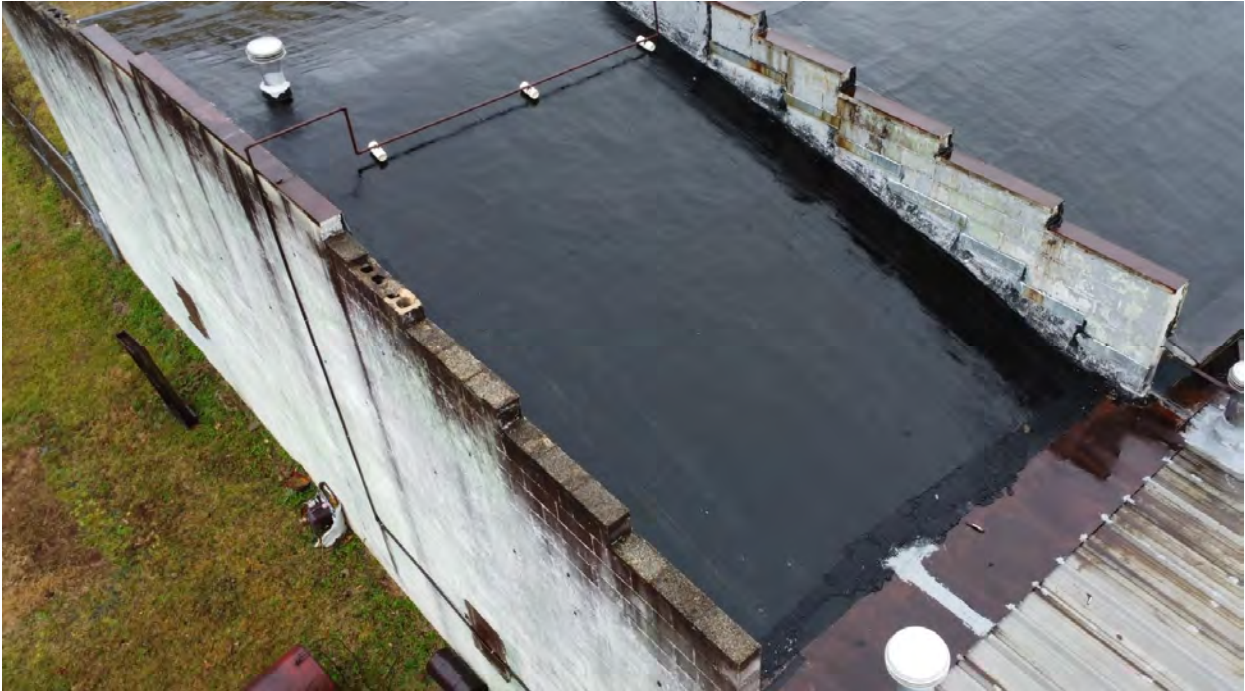
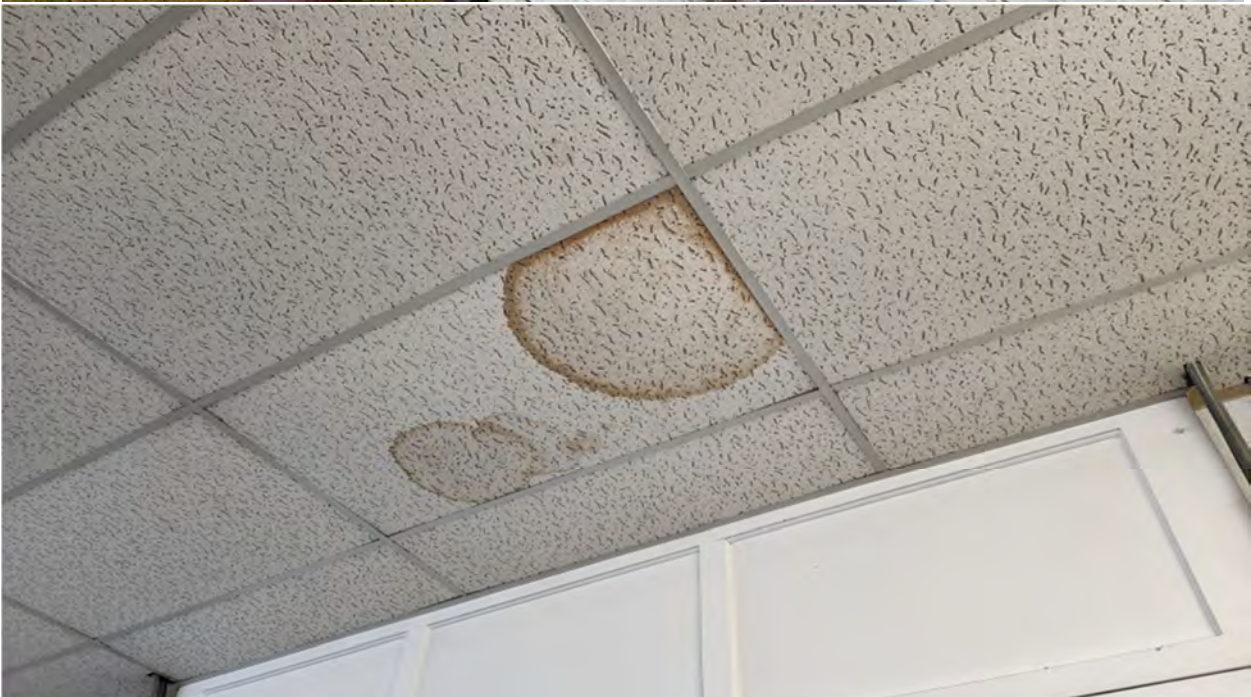
- 5.4.2 The curved roof membrane on the north building is starting to crack and deteriorate. The metal parapet wall coping is corroded or missing. Evidence of past roof leaks in this area was observed. We recommend replacement with a new membrane and coping in the next 0-5 years.
