## Property Condition Report

### Couick's Marine

3613 Providence Rd S, Waxhaw, NC 28173

January 30, 2024

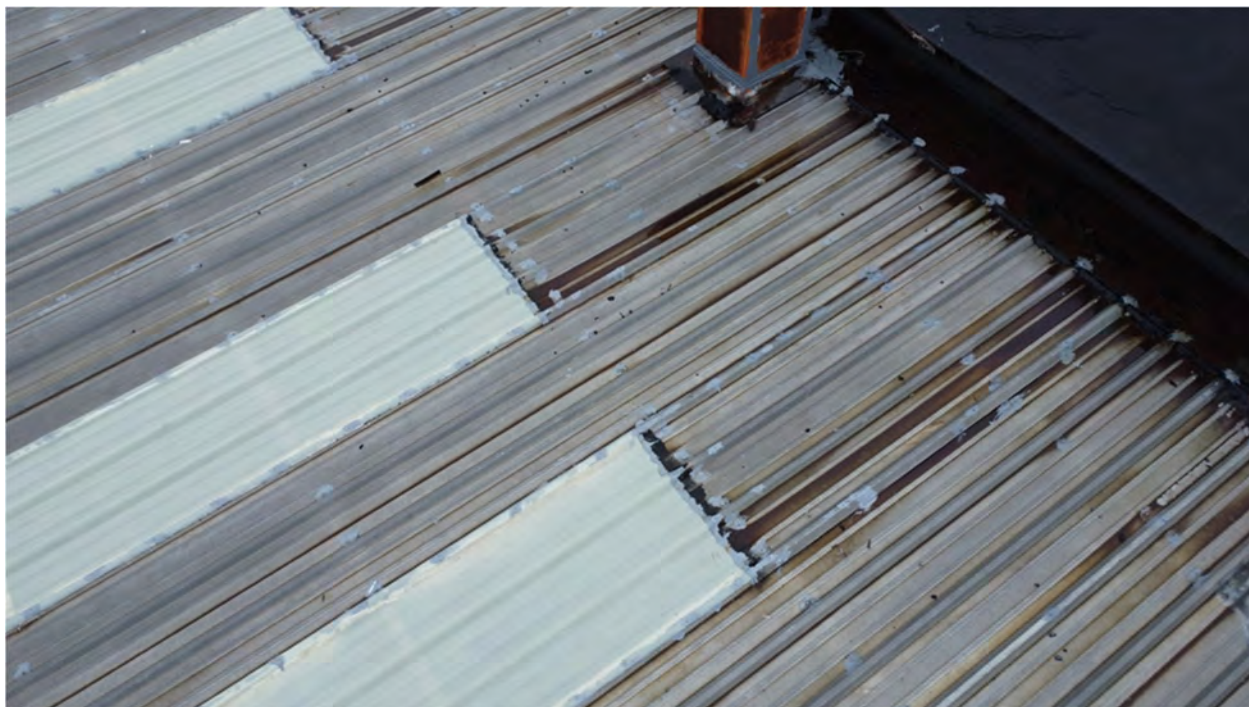
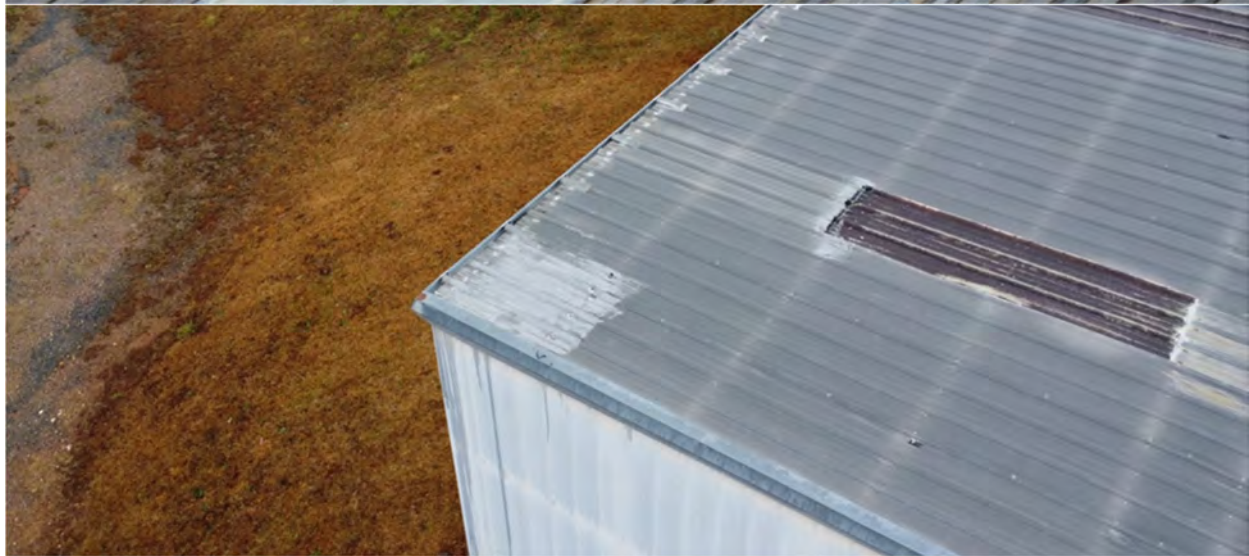
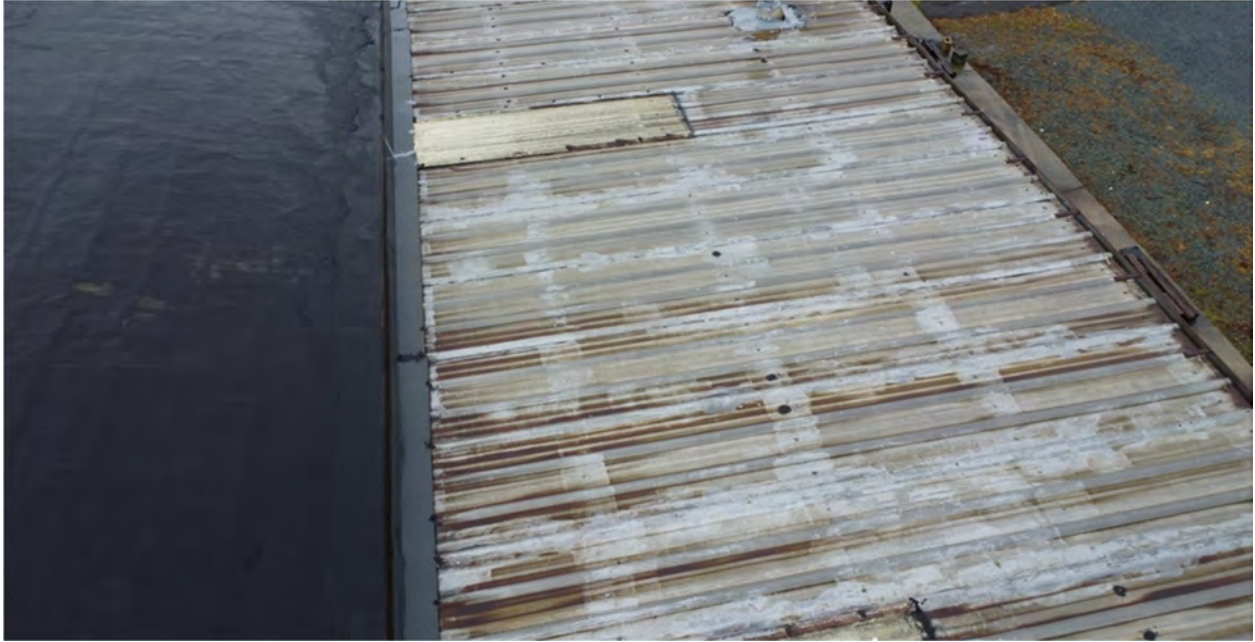
- 5.4.3 Past roof leaks under the metal roofing of the north building were reported. Multiple past repairs to this portion of roof were also observed. We recommend coating and sealing this entire section of roof with an elastomeric roof coating to stop any current leaks, prevent future leaks and extend the life of the metal panels.

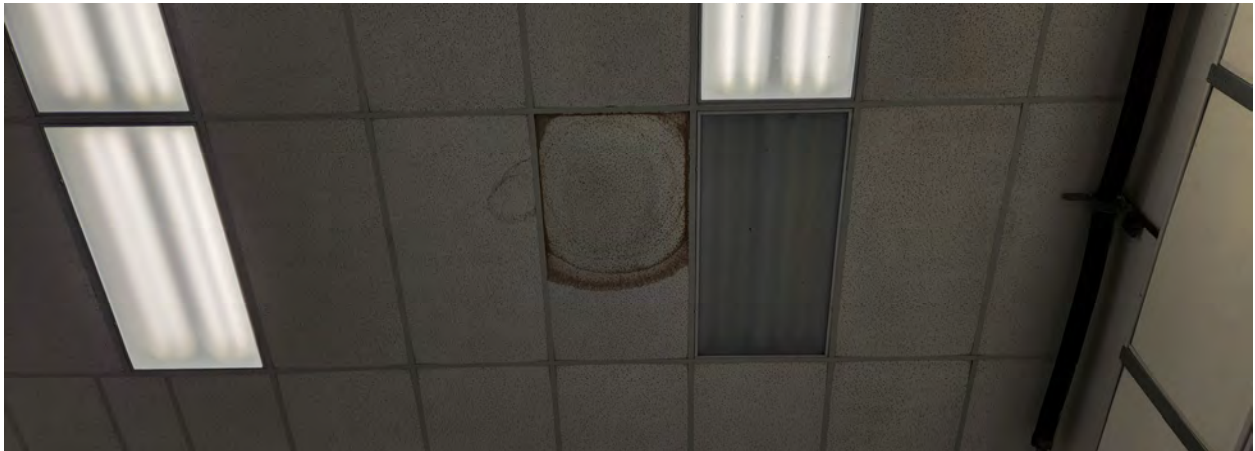
- 5.4.4 Evidence of past roof leaks from the metal roof of the south building was observed. This roof has been completely coated and sealed in the past. However, it appears that a few leaks may have appeared. We recommend having a roofer apply additional sealant to the roof as needed to stop any leaks.

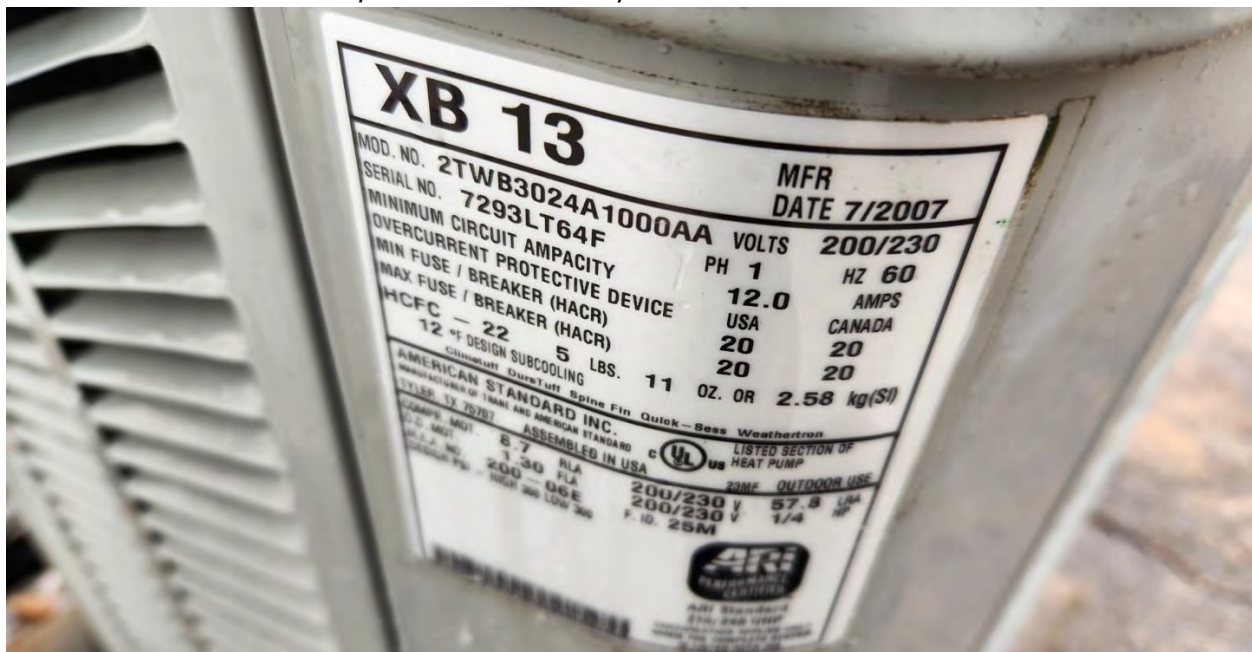
7.5.1 There is a split HVAC system for the north building that is 17 years old and near the end of its expected useful life of 15-20 years. It uses an obsolete refrigerant (R22) that is no longer being manufactured. We recommend replacement of this system in the next 0-3 years.

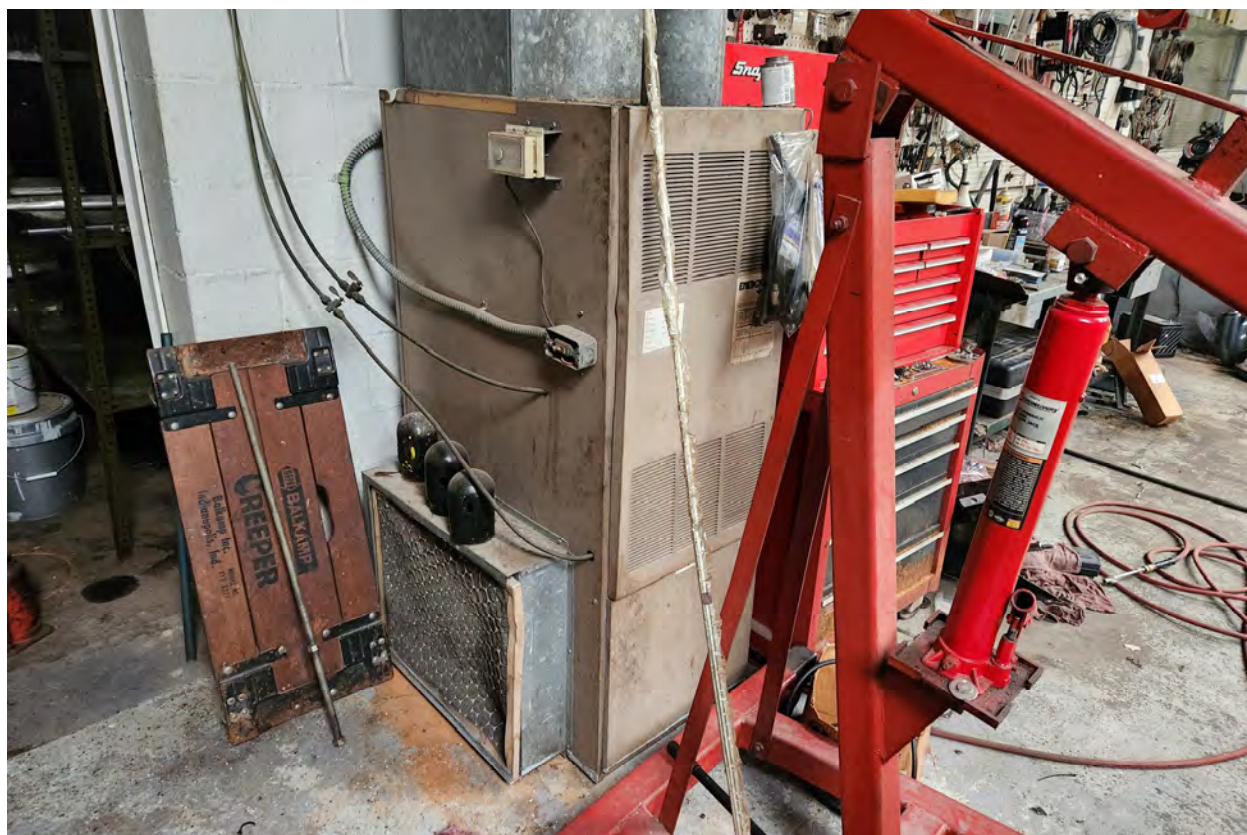
7.5.2 There is a furnace in the workshop area of the north building that no longer functions and needs to be removed.

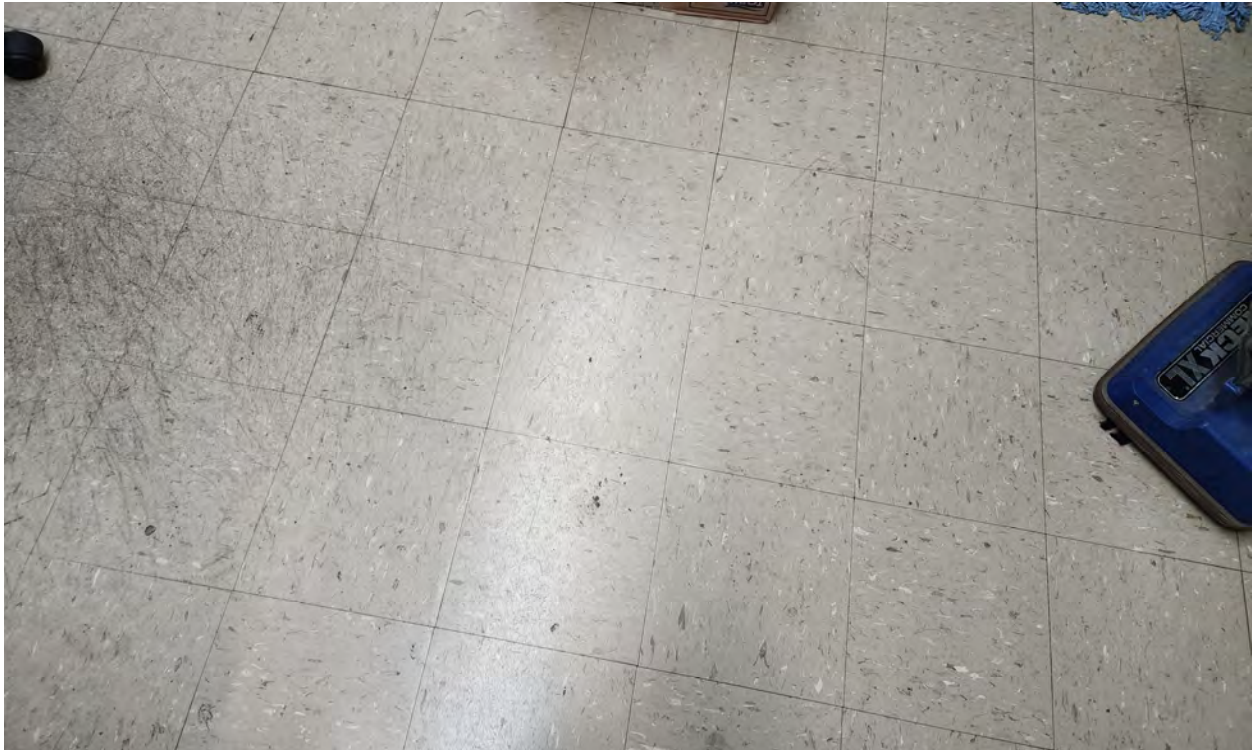
11.6.1 There is some tile floor that probably contains asbestos. Due to the age of some portions of the building, there is likely to be more asbestos containing materials. We recommend conducting a full asbestos survey of the property and properly removing or encapsulating any remaining asbestos.

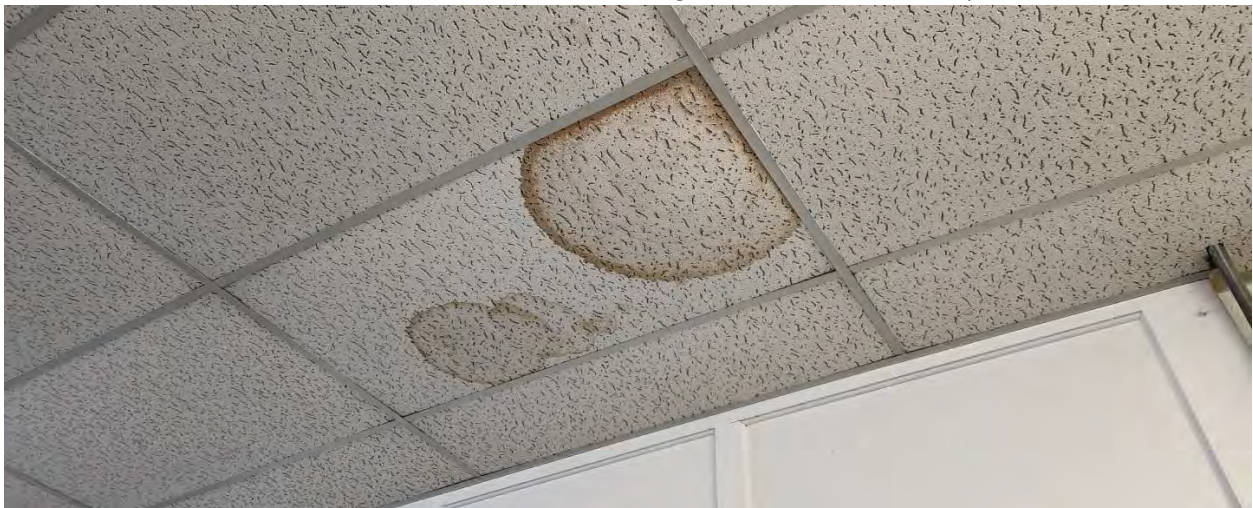
11.6.2 There are numerous stained ceiling tiles that need to be replaced.

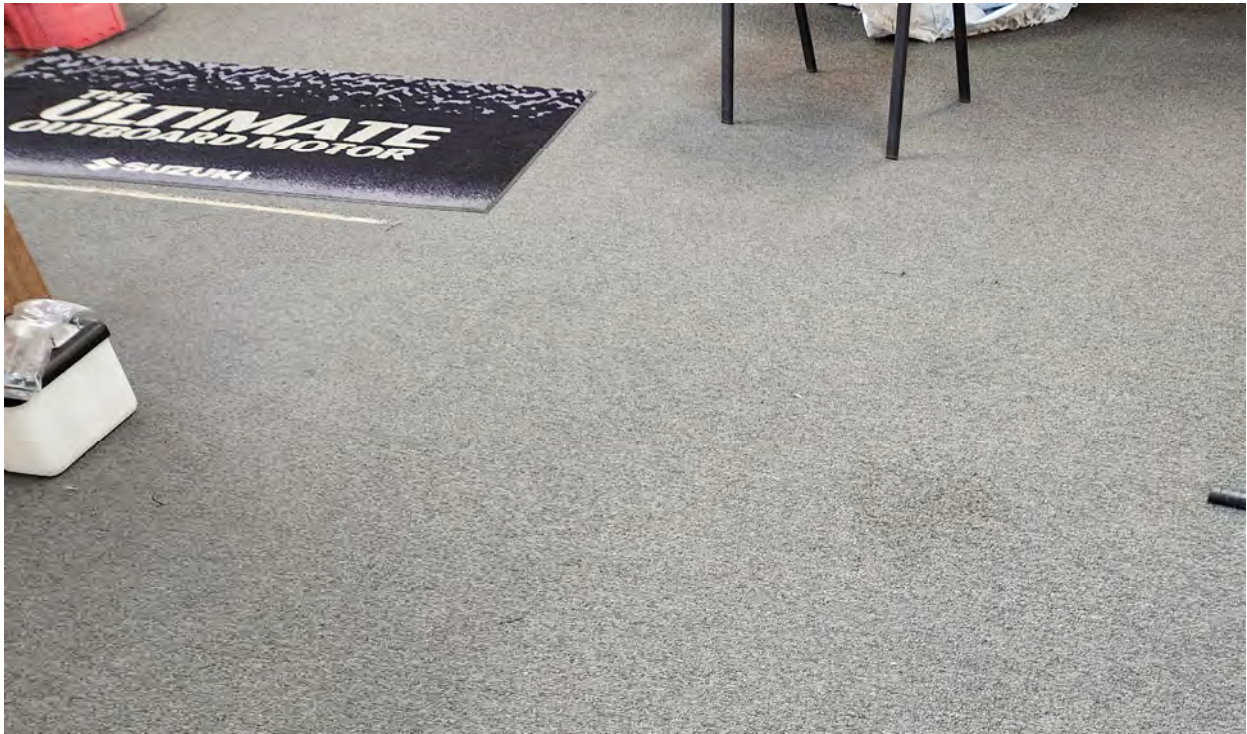
11.6.3 The carpet in the showroom is worn and frayed and needs to be replaced.
