Elbow River Estates Cooperative Ltd

2026 Reserve Fund Study

4.1 Water | Distribution System

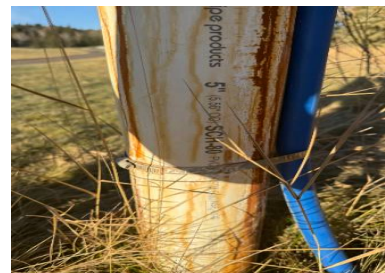
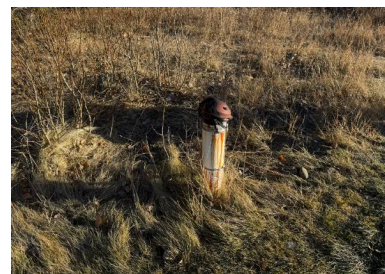
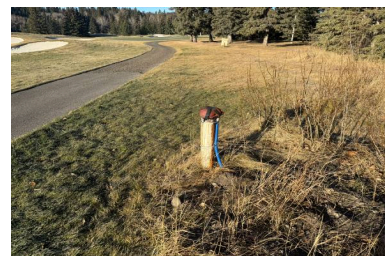
4.2 Water Wells | Piping

- Sections of the underground piping have been replaced as they were damaged while the Golf Course was digging near them.
- The PVC piping will not experience degradation due to UV exposure and should last 50-70 years.

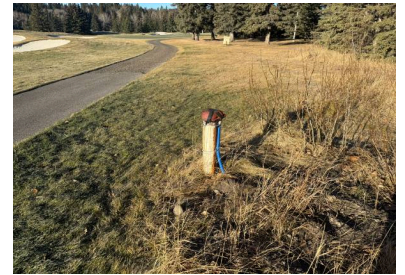
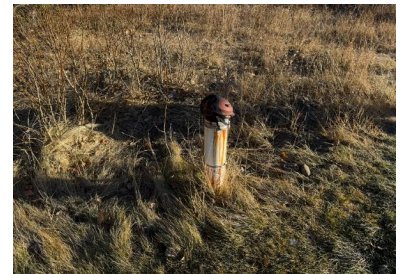
4.3 Water Wells | Supply Pumps

- The pumps could not be accessed during the site inspection, but there are currently no known issues or concerns with the performance of the pumps.

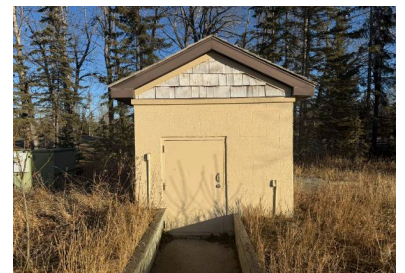
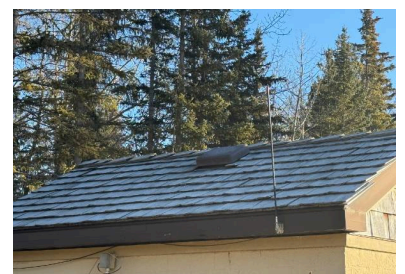
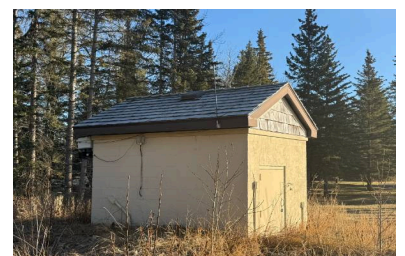
4.4 Pump House | Building Envelope

- The cinder block is painted and appears to be in average condition. New applications of paint will be required as the paint weathers.
- The cedar shakes appear to be in average condition with limited signs of deterioration.

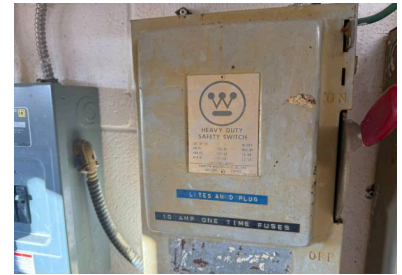
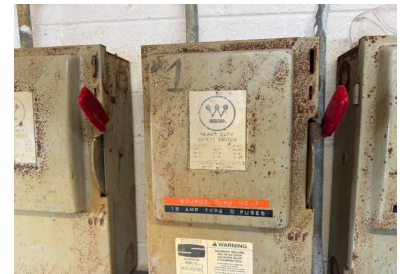
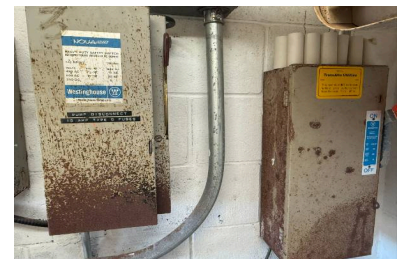
4.5 Pump House | Electrical System

- The heavy-duty electrical switches exhibit visible corrosion on their housings. It is likely similar corrosion is occurring on the internal components that may cause failure of the electrical switches.

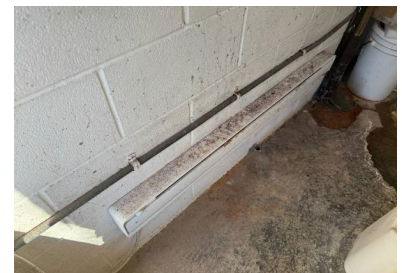
4.6 Pump House | Heater Baseboard

- The heater was assumed to be in working condition during the site inspection. Corrosion on the housing was noted.

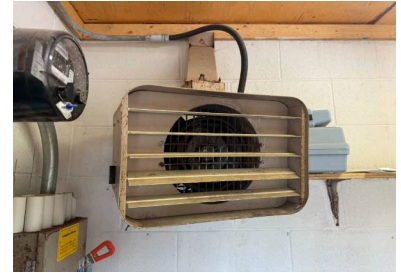
4.7 Pump House | Heater Electric

- The heater looks original to the property and during the site inspection it was discussed that the heater should be replaced in the near future.

- A new heater has been purchased and will be installed. No budget has been set for the upcoming year as this will be paid for in 2025.

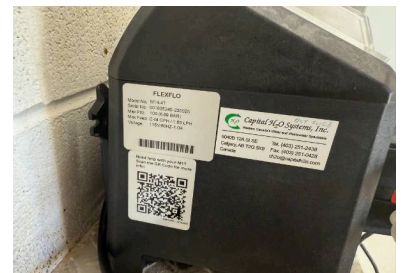
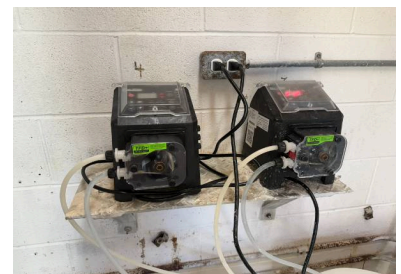
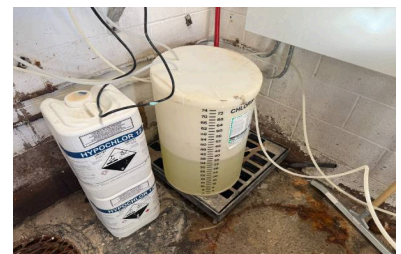
4.8 Pump House | Pre Chlorination

- The pumps were determined to be replaced in October 2018. No issues with the pumps were observed or reported.

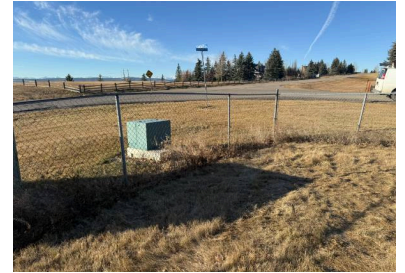
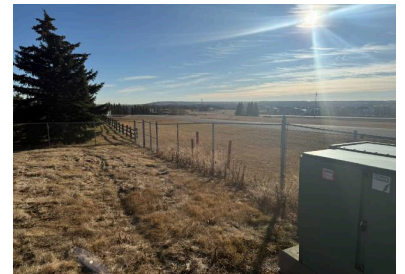
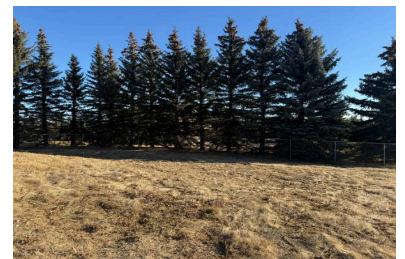
4.9 Treatment Plant | Fence

- No signs of significant damage were found on the fence. The fence posts were providing adequate structural stability to support the fence.

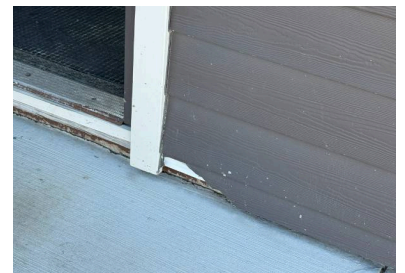
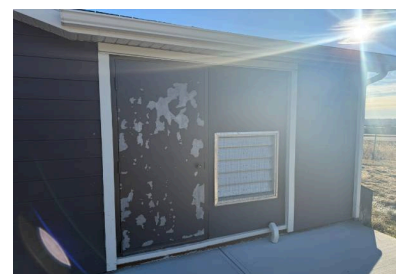
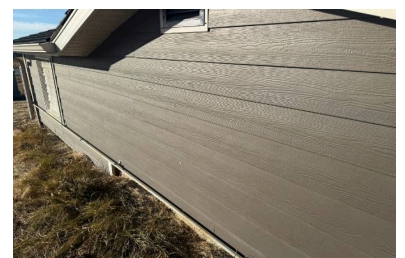
4.10 Treatment Plant | Hardie Board

- The paint on the door to the generator was found to be peeling.
- One section of the Hardie Board near ground level is damaged.

- The doors should be painted periodically to prolong the life of the doors.

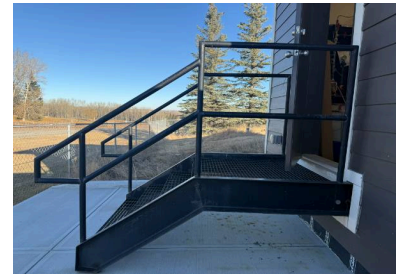
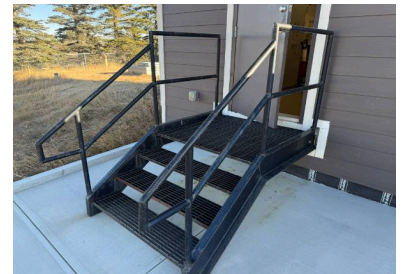
4.11 Treatment Plant | Metal Stairs

- Some rust was present on the stair treads and near the base of the railings.

- The surface rust should be removed and a new paint application should be made.

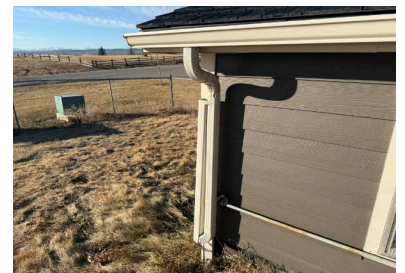
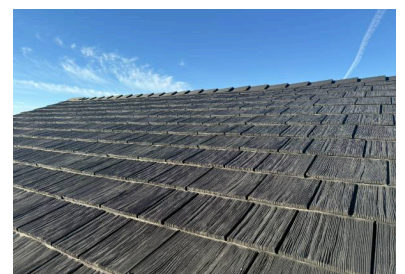
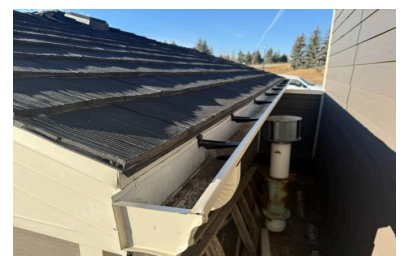
4.12 Treatment Plant | Roofing System

- Adequate joint lapping was noted which is an indication of proper installation. No areas of concern were noted during the inspection.
- A section of the downspouts has fallen off the side of the treatment plant. The downspout should be reinstalled.

- The roof is the most important component of any given structure and should be prioritized. Any defects or damages identified should be repaired as soon as possible to prevent further damage to the roof and interior structure of the building.

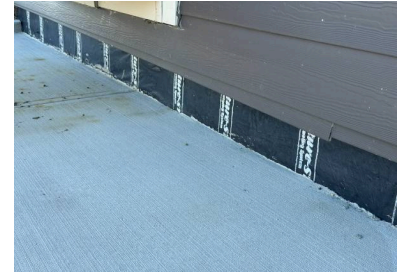
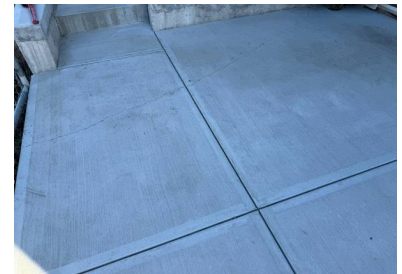
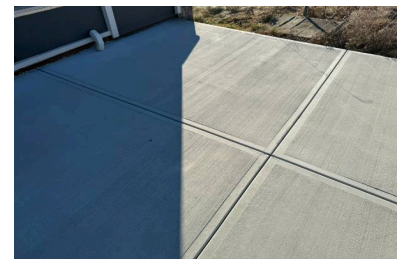
4.13 Treatment Plant | Concrete

- The concrete was found in serviceable condition as only minor cracks and/or spalling was found on the service of the concrete.

- Monitor the concrete, and once the damage is severe or becomes a safety issue like a tripping hazard, the concrete should be replaced.

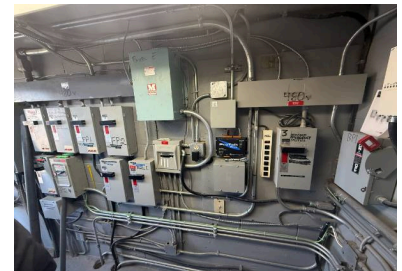
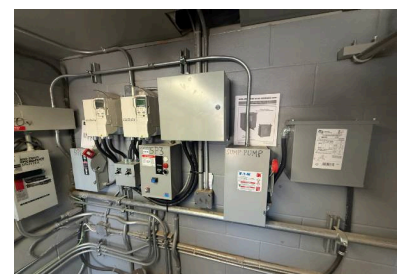
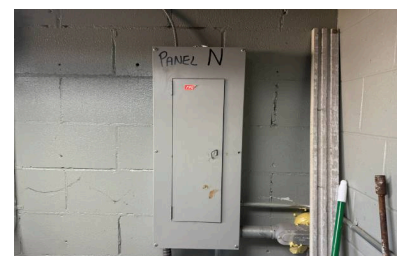
4.14 Treatment Plant | Electrical System

- The electrical equipment appeared to be in average condition with several updates that would have been completed in 2016.

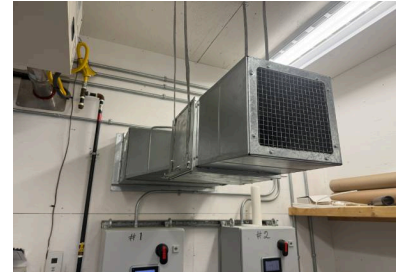
4.15 Treatment Plant | Exhaust Fans

- The exhaust fan should be maintained regularly to ensure that it is in serviceable condition.

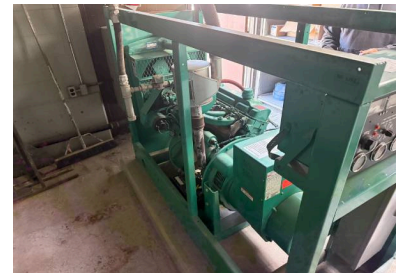
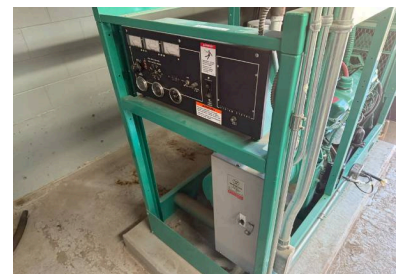
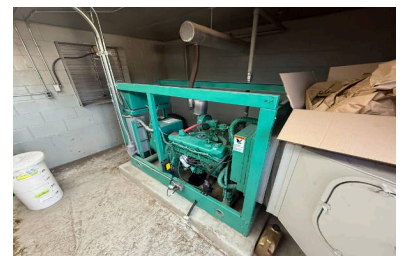
4.16 Treatment Plant | Generator

- It is assumed that the generator is tested per the local bylaws. Replacement of the generator is not required until it fails the required test and repairs cannot be made.

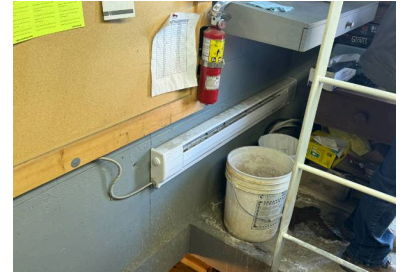
4.17 Treatment Plant | Heater Baseboard

- The heater was assumed to be in working condition during the site inspection.

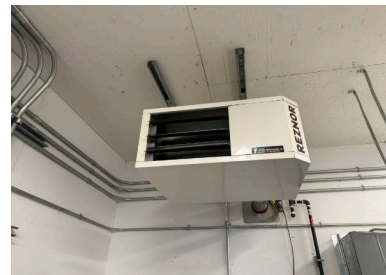
4.19 Treatment Plant | Heater Gas

- The heater was observed to be working during the site inspection. No issues were observed or reported.

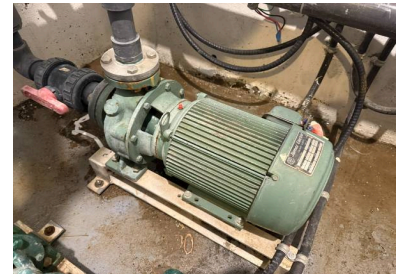
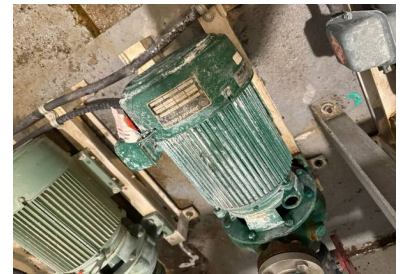
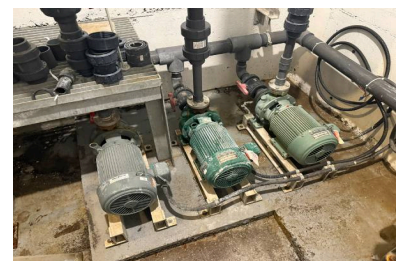
4.21 Treatment Plant | PumpsDistribution

- During the site inspection it was determined that the manufacturing date of the pumps were (1) 2012 and (2) 2016.

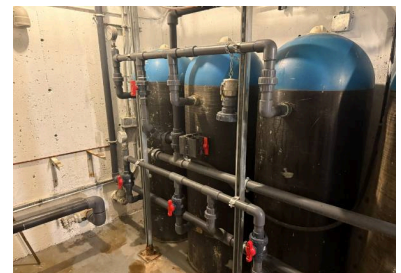
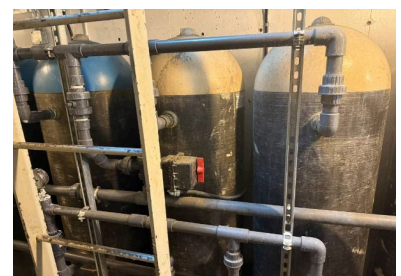
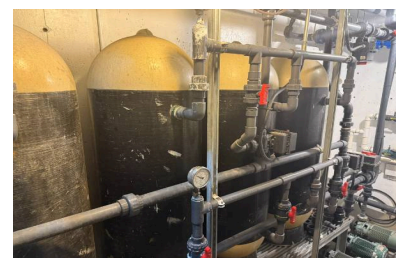
4.26 Treatment Plant | Greensand Filters

- Per the documentation provided the media was most recently replaced in 2018.
