Pre Purchase Survey Report

Boat Name: MY "XXXXX"

Boat Type: J 130

Date and Place of Survey: 25th and 30th August 23 at Marina San Giorgio di Nogaro, Italy

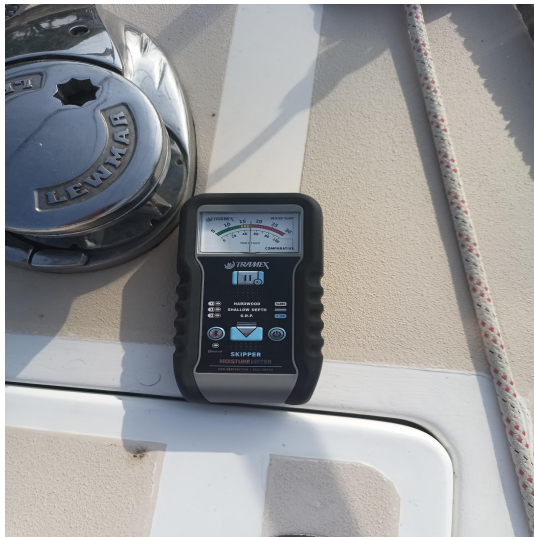
Two sections with higher moisture had been detected.

First the anchor compartment, there is a section where the wood structure is rotten. Especially around the hatch frame.

The reason for that is most likely that the paintjob around the wood wasn't done properly, especially on the inside part.

The anchor chain compartment has no Balsa Wood Core.

The compartment behind, where the anchor is placed, has no drainage.

This leads to that water that enters into that compartment will remain, and should be adjusted to enable rapid drainage.

The hatch and its frame needs to be redone and a drainage for the Anchor compartment installed. By inclination from the Anchor Compartment towards the chain compartment or additional through-hull drainage.

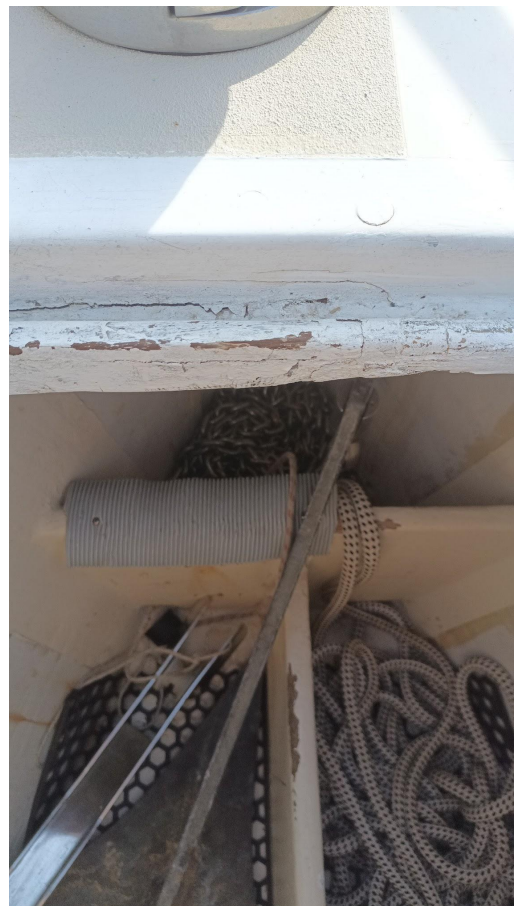
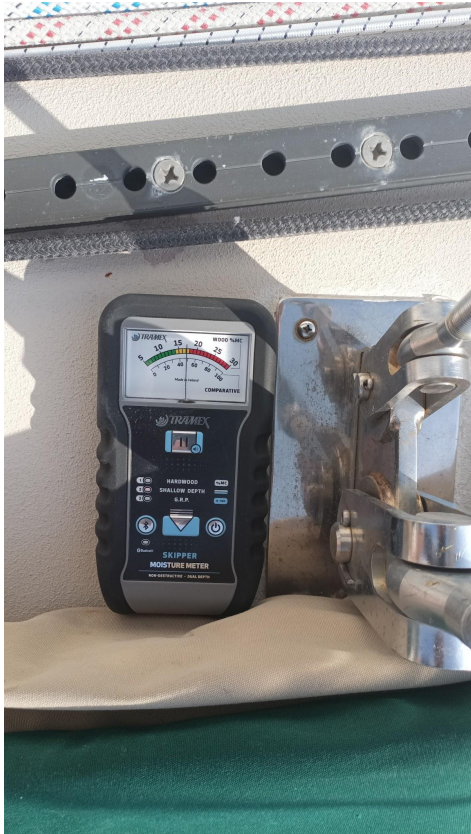
Second Area is the shroud connection Stb.

Most likely it is only the sealing of the cover plate.

In any case that area has to be dismantled and carefully inspected. Also the ceiling inside the Boat should be dismantled to be inspected.

Before closing the area again, ensuring it is completely dry.

It is always a good idea to close or cover cut outs and holes for screws with epoxy primer to prevent water from entering the core or fibre structure.

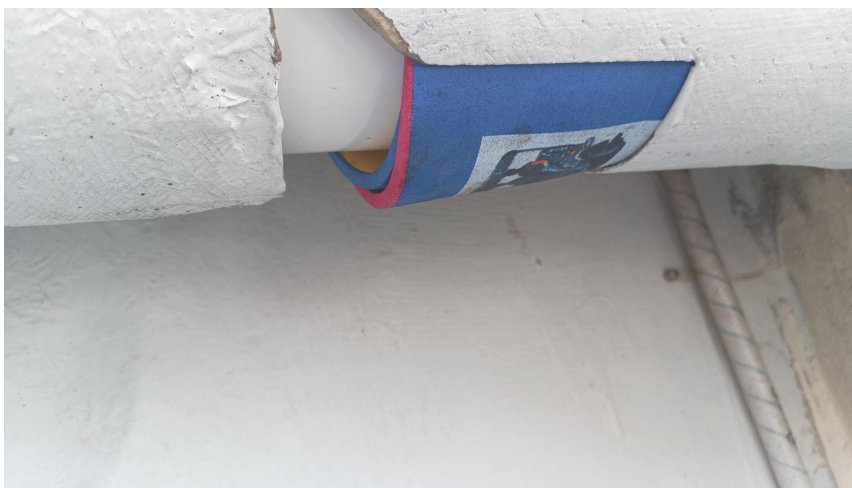
The Boom has a cut out for the water to drain.

Also there are some foam matts stuffed into the boom tube, for sure not original.

I assume it was made to prevent water from running back into the bow cabin and
I would recommend closing that area and installing proper drainage instead.

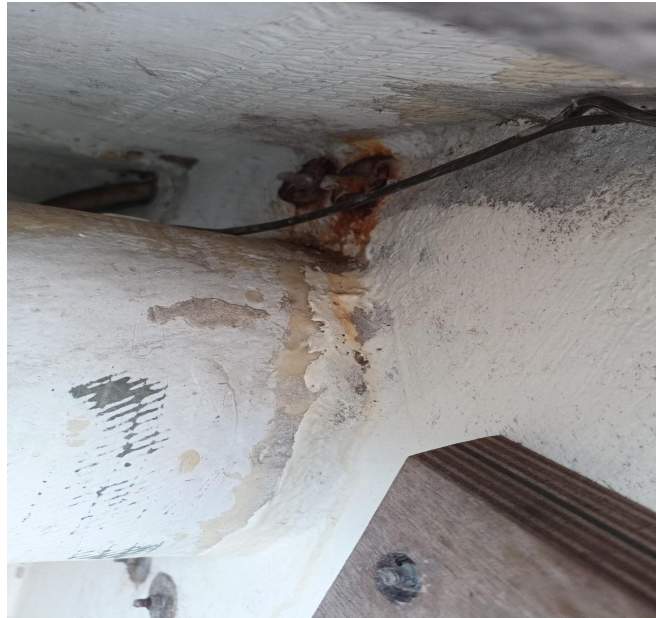
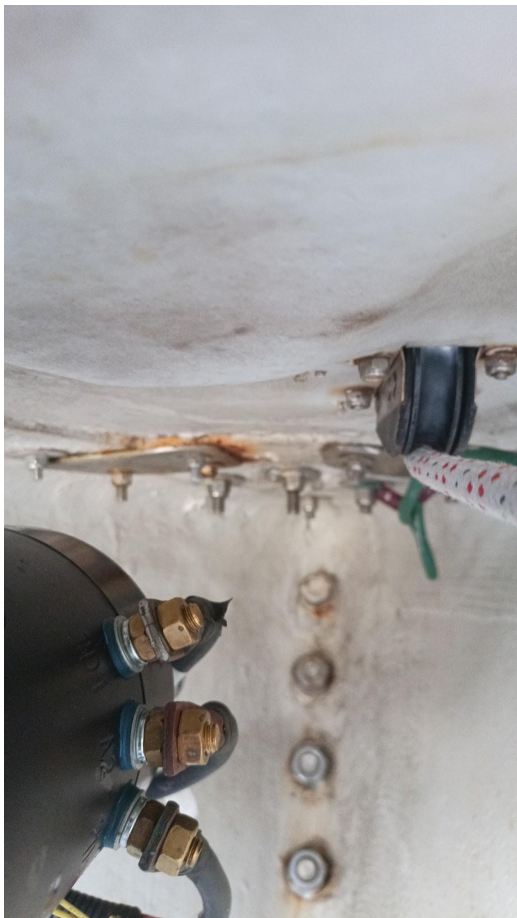
Only at the Bow / Anchor compartment the screws and nuts are oxidized.

On the top you can see the rust appearing on some connections.

It might be that some screws or nuts that had been used are not AISI 316.

It is better to replace them.

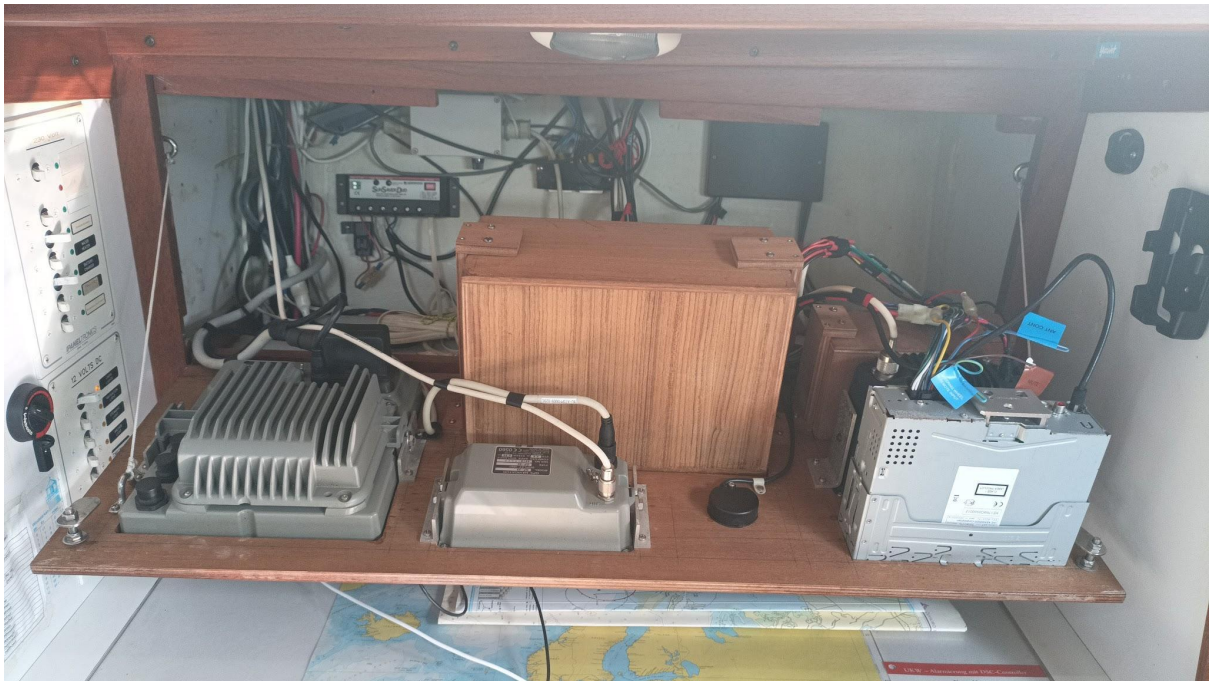
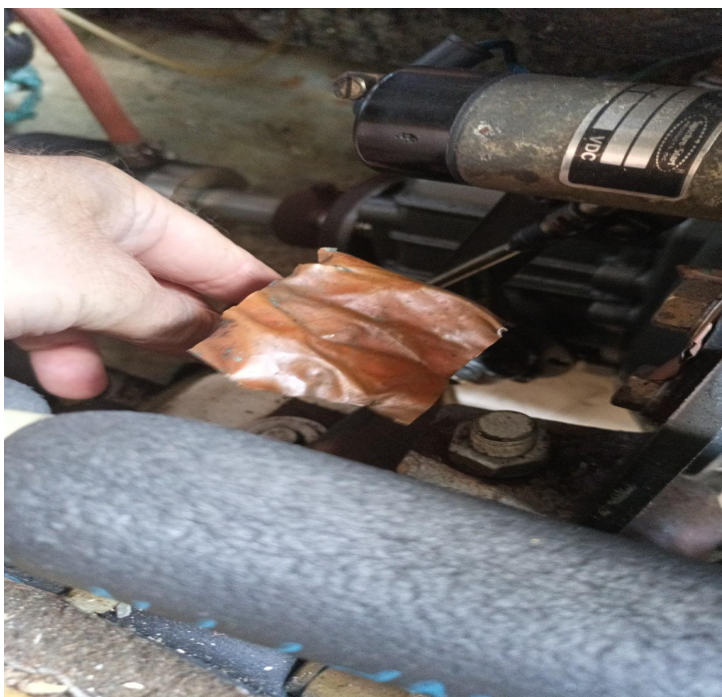
The grounding is not functioning.

Earthing cables from the engines are disconnected / broken

This boat has Zinc anodes only on the shaft.

If the connection of all grounding lines do not end on the engine , the system does not work. This causes oxidation / damage on metal parts especially Aluminium.

All Metal parts on / inside the boat should be connected with the Zinc Anodes in the water.

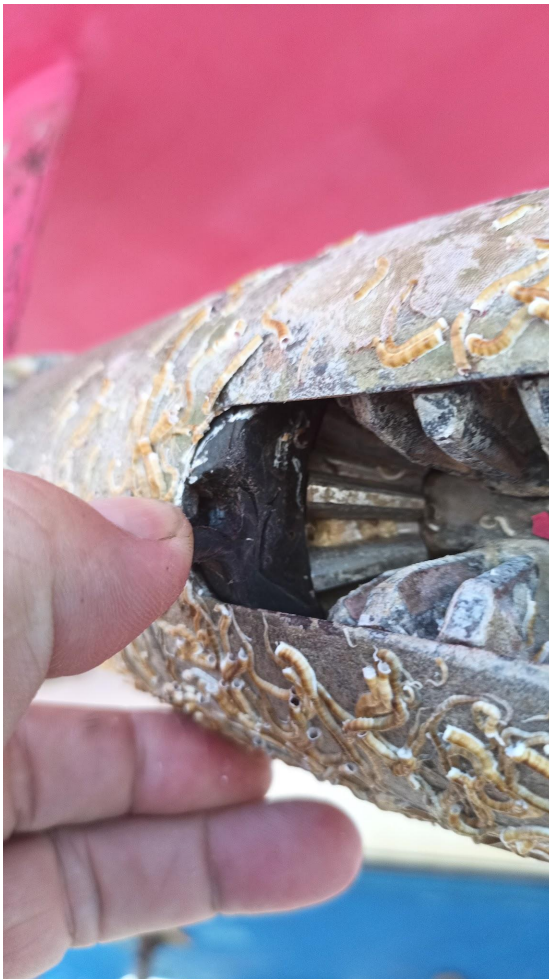
In low RPM there is quite some vibration when the boat is in movement.

This is caused by the worn shaft bearings and by the fouling on the propeller.

The propeller Rubber inserts are broken and need to be replaced as well

It might be that due to the installation of the shaft sealing PSS the inner bearing is missing.

That causes those vibrations as well, because the shaft has its connection only on the engine and on the cutless bearing support outside.

All the sealings / bearings have to be changed.

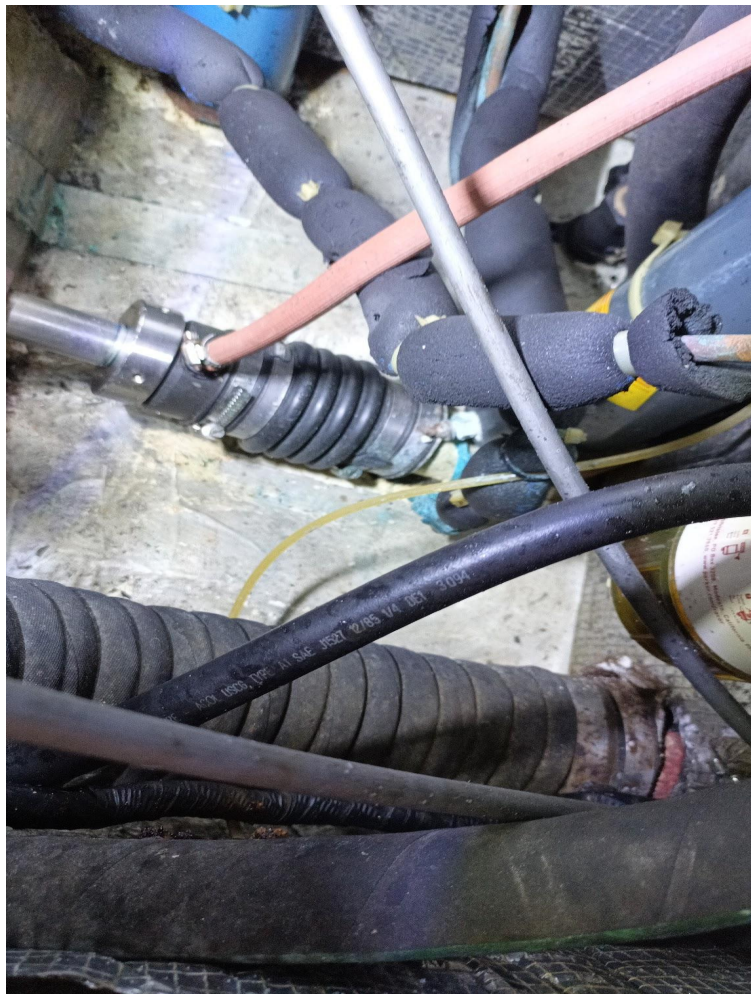
The PSS Shaft Seal and its installations (not connected to active cooling), indicate that the bearing is not installed.

The missing inner bearing might be the indication for the consuming rubber on the second bearing.

The red tube is usually used for the connection with an active seawater cooling.

Here it is just leading over the water line.

While driving you can feel how it sucks air. It does not have any cooling effect.

But for a smooth running which gives less stress to parts of the propulsion and engine the inner bearing is essential.

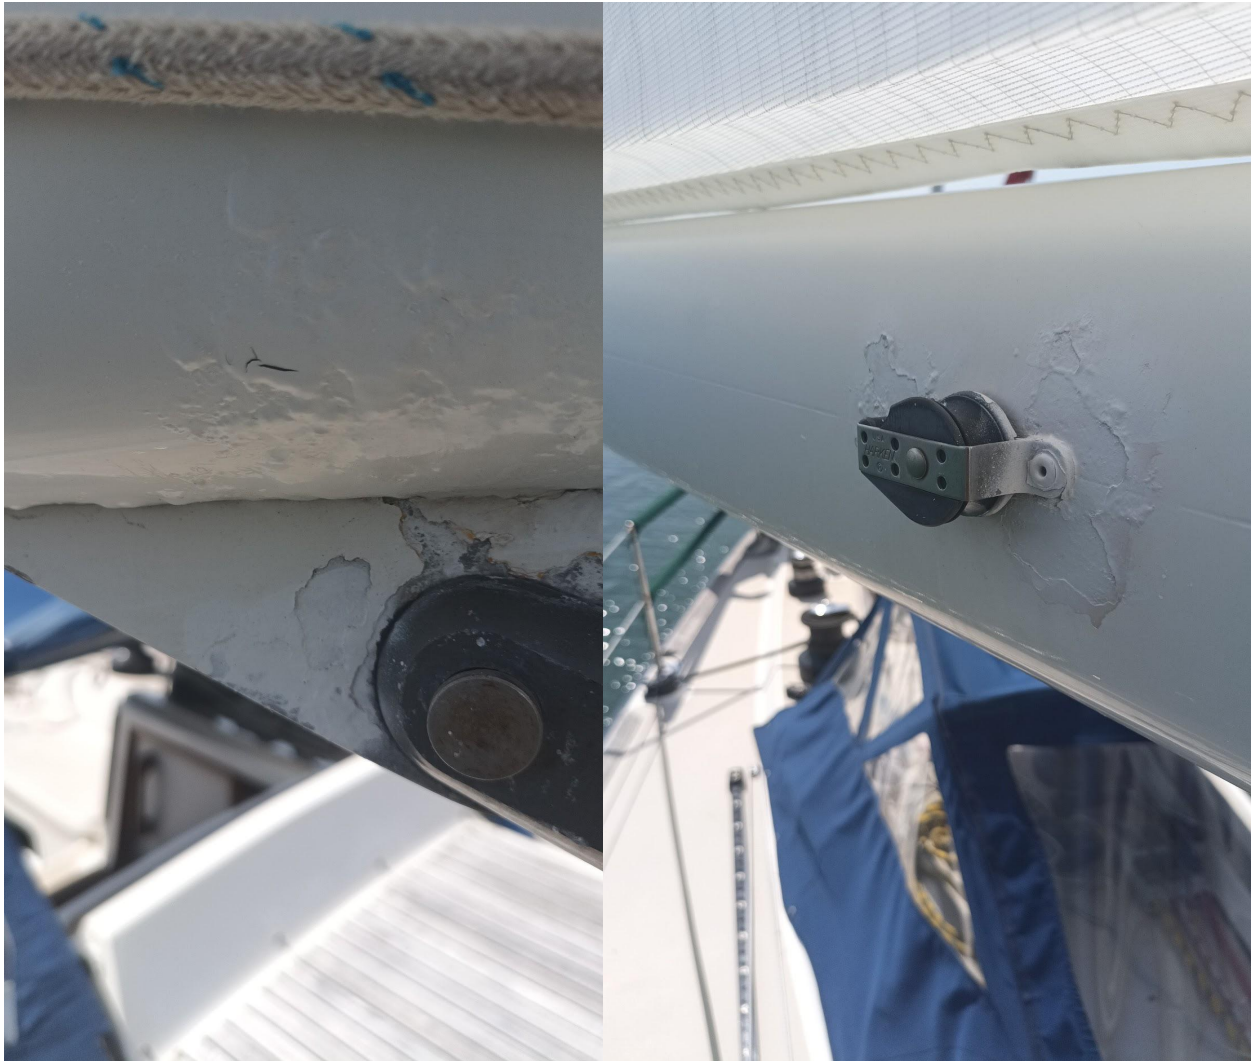
The boom shows light oxidations. It is made out of aluminum.

It is always recommended to isolate different materials like stainless in Aluminium from each other. There are special paints and or fittings for that purpose. The now oxidised boom parts need to be addressed with lemon acid and covered up with epoxide primer and best acrylic paint.

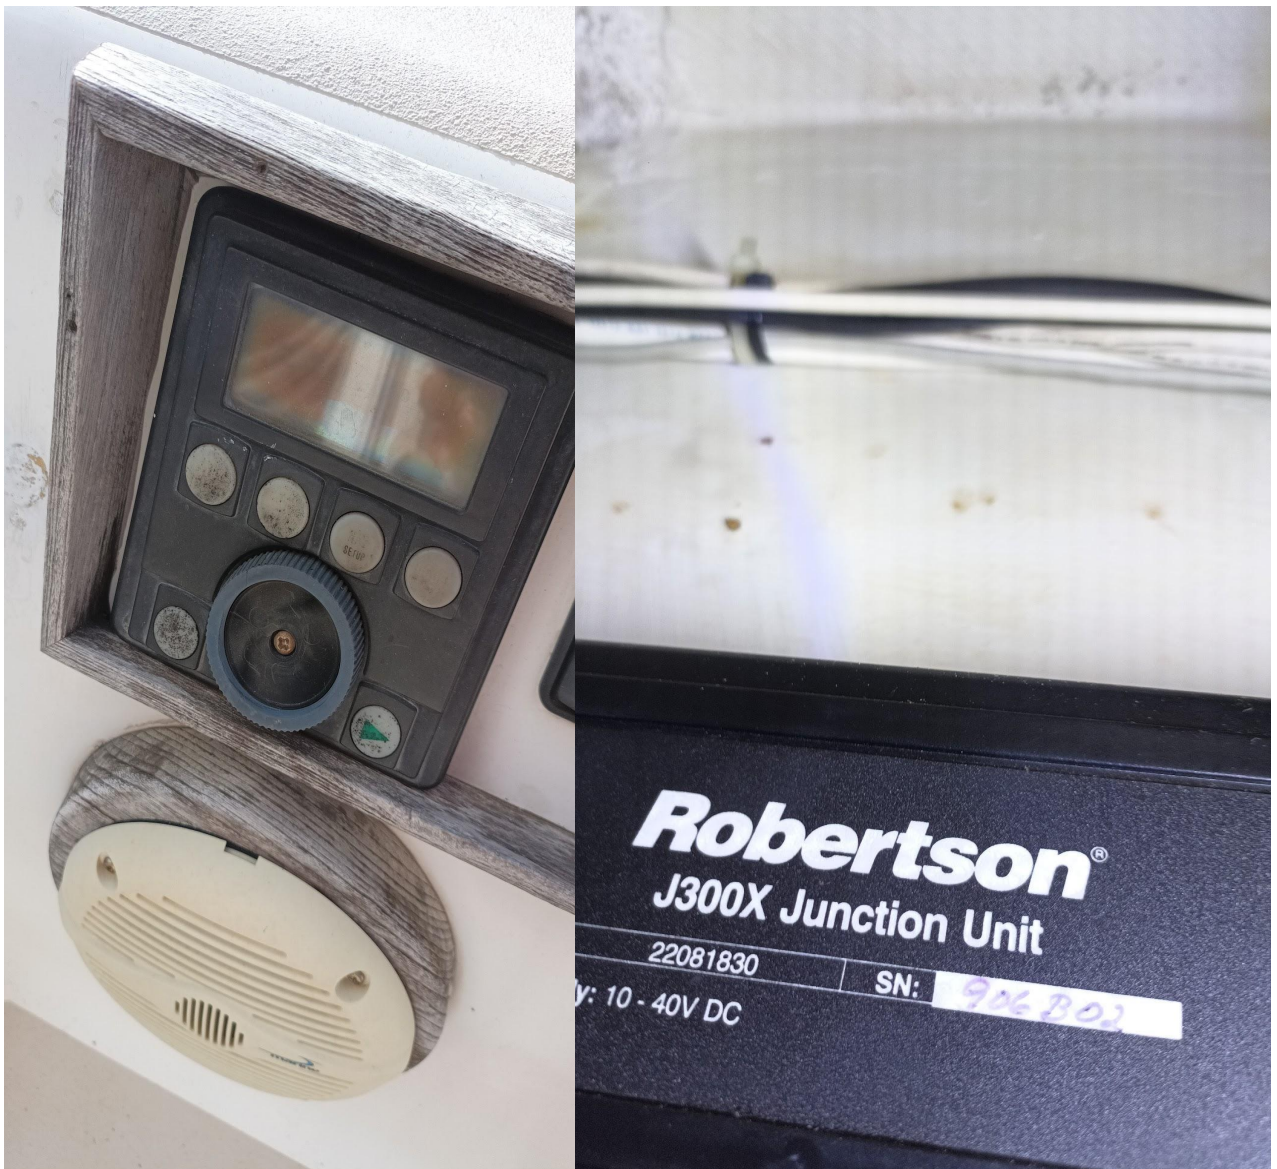
The navigation computer is functioning, but the controllers aren't. The handheld control works but its display does not and the main Autopilot controller does not work at all.

It is now to find compatible new Instruments.

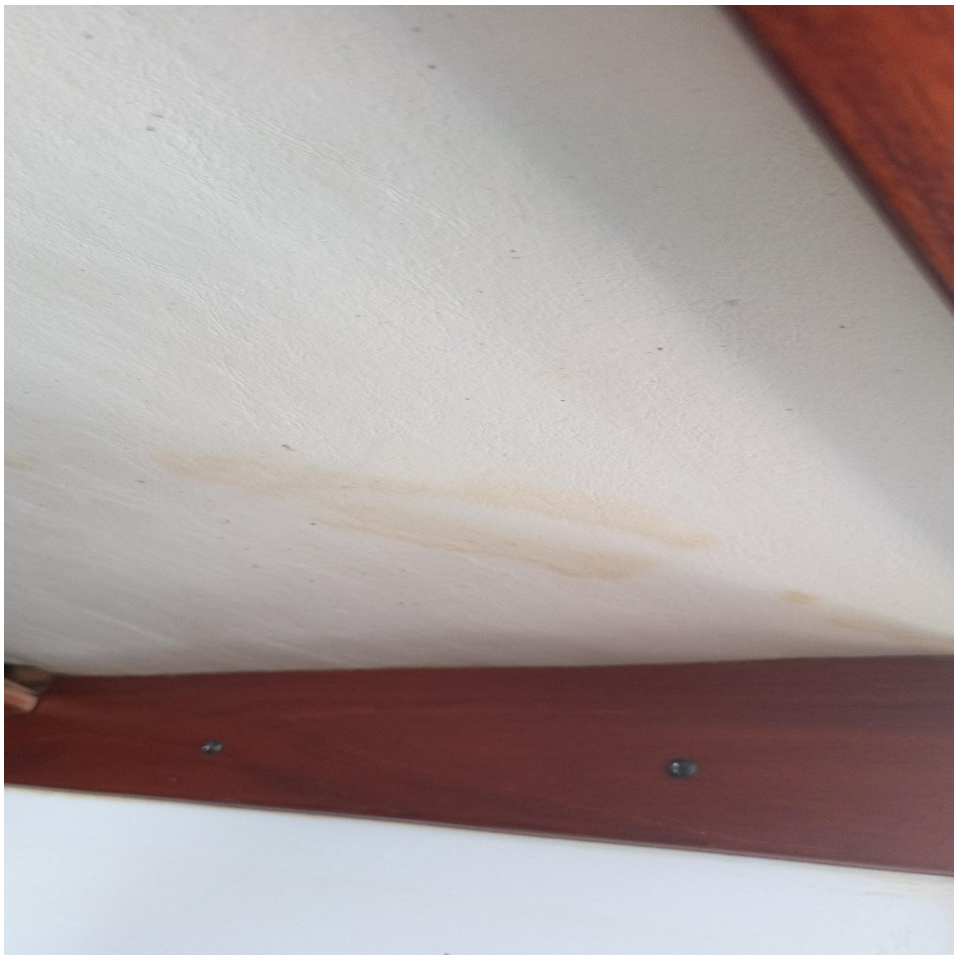
Some of the head linings are loose and it appears that the glue on the base plate is not sticking anymore. This indicates humidity in the cabin over a longer period.
