Inspection report for the property at  
**Sample Property, Washington**

This report is prepared exclusively for **Sample Report**  
Inspected On: **04-24-2026**

High Peak Home Inspections, LLC  
360-319-4245

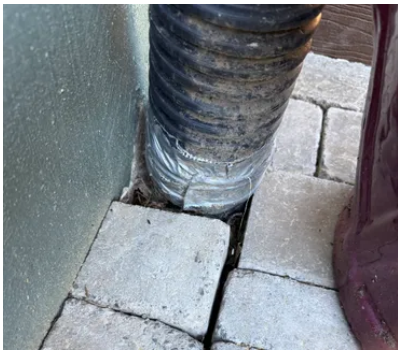
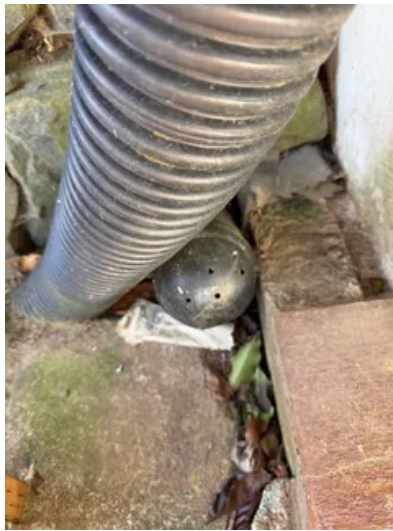
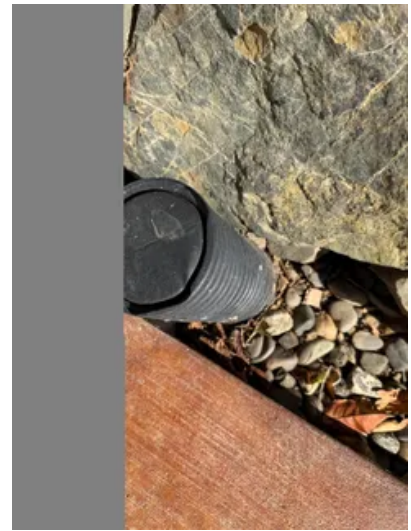
### (G1-2) Monitor: **CORRUGATED SUBSURFACE DRAIN PIPE NOTED**

This is a common product that can have limited useful service life. These drains are designed to capture roof runoff and divert the water away from the building. This pipe cannot be reliably cleaned due to the corrugations and softer plastic. It is generally more prone to clogging and crushing. No signs of failure were noted during the inspection. Monitor during heavy rains.

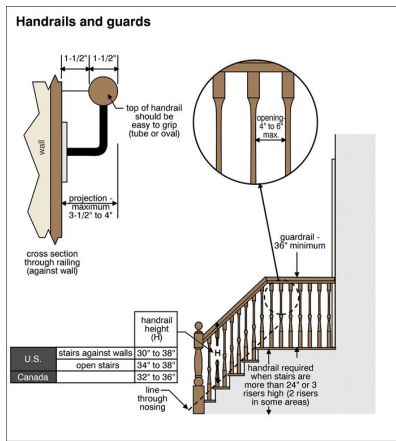
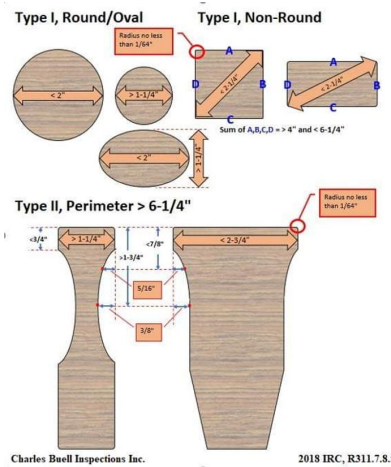
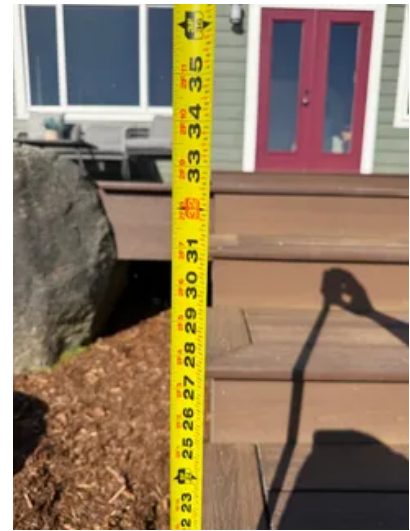
The graspable handrail for the back deck stairs has not been installed with a graspable profile. Handrails should be provided on not less than one side of each flight of stairs with four or more risers. This may be simply recommended for yard stairs, depending on the situation or jurisdiction.

- *Graspable handrails have specific recommended profiles - shown in the illustrations below. They should be a round railing 1 and 1/4 inches - 2 inches in diameter. If the railing is not round it must have a finger groove that is 3/4 of an inch down from the tallest point of the rail. The graspable handrail should also be 1.5 inches from the wall. 2x material is not considered a graspable handrail. Have a qualified contractor build suitable railings to reduce the potential for falls.*

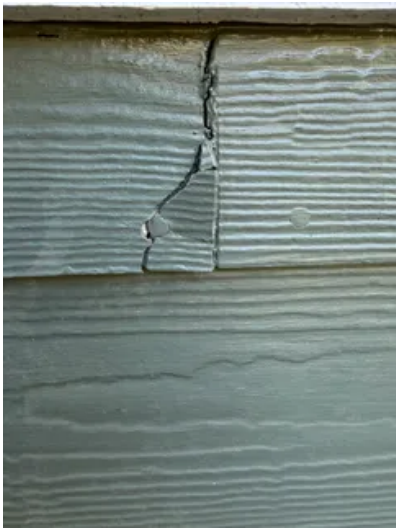
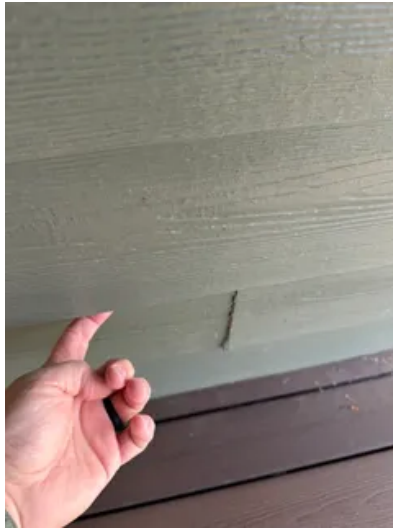
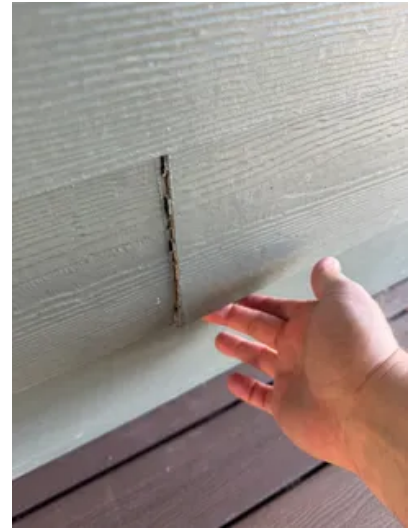
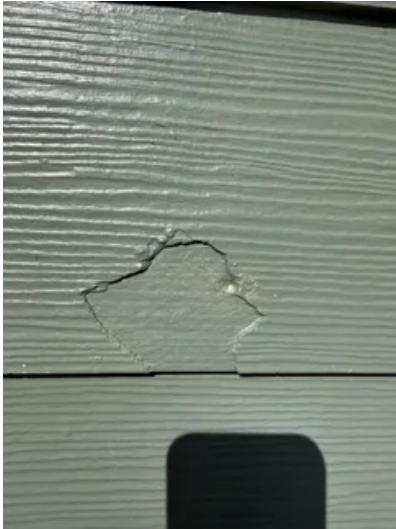
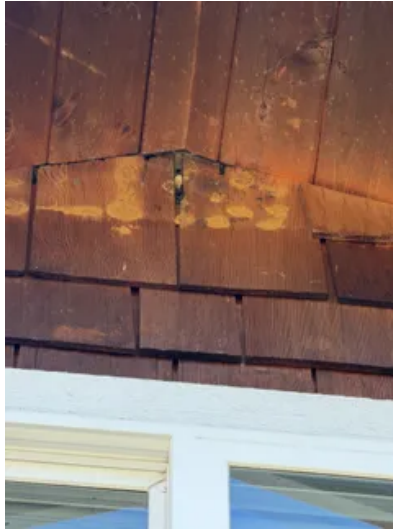
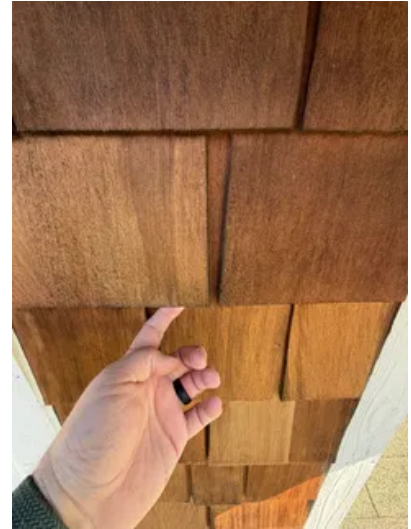
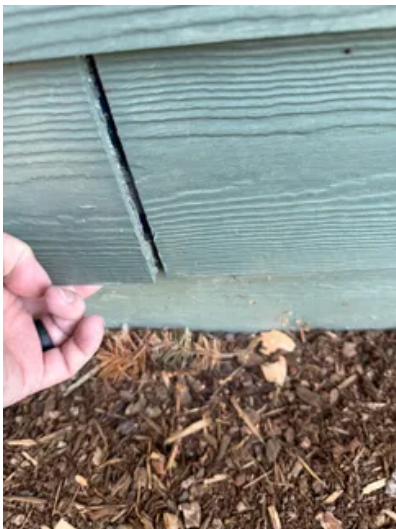
### (E-1) Repair: **LOCALIZED SIDING REPAIRS**

Localized exterior siding repairs and maintenance are needed. Examples of observations noted during the inspection include:

- Loose siding
- Broken siding may be caused by over driven nails.
- Missing cedar shakes
- Chipped siding, may have already been repaired, I recommend monitoring the section.

Hire a qualified general contractor to further evaluate and repair as needed for moisture control.

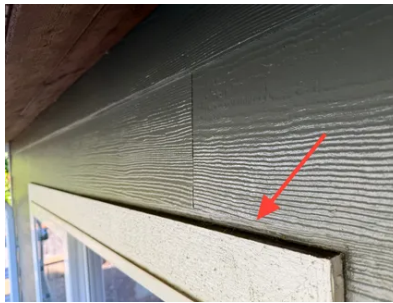
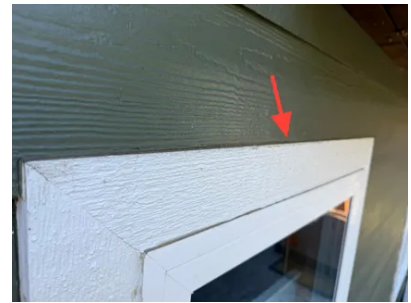
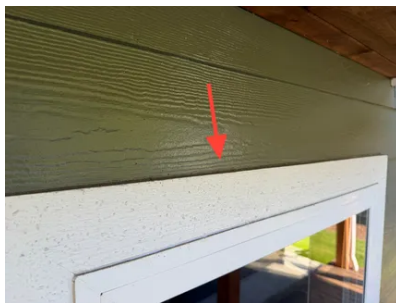
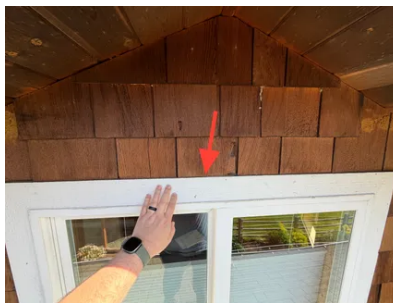
### (E-2) Repair: **INCONSISTENT FLASHING DETAILS**

Inconsistent flashings were noted for the horizontal trim above horizontal junctures. This can lead to concealed water entry and damage to those horizontal junctures that have not been flashed, especially where they are exposed to the weather. A metal flashing shall be provided for areas like this that could allow water entry. Metal flashings should be sloped to drain. Also noted that the eaves extend out far enough to catch the majority of rainfall.

Hire a licensed general contractor to evaluate further and repair to ensure reliable performance.

- Please note that flashings can be tricky to retrofit and it is often best to maintain this juncture with caulking and only retrofit a flashing if needed or if doing other siding repairs.

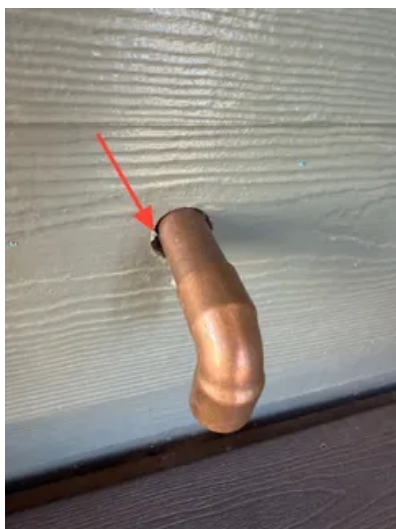
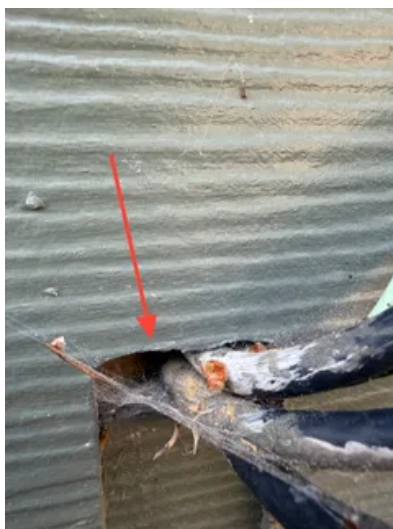
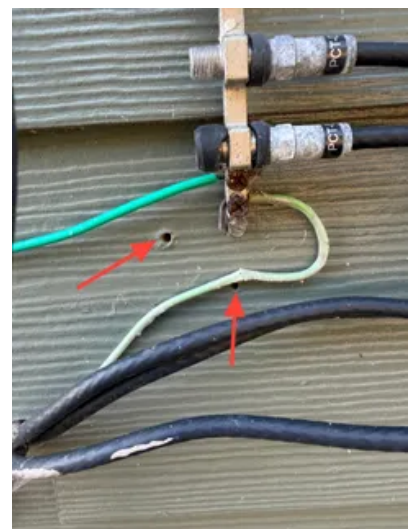
## (E-3) Recommended Maintenance: SIDING MAINTENANCE NEEDED

Localized caulking repairs are needed to the exterior of the building. This is common maintenance between completed exterior paint jobs to ensure that the more exposed areas continue to perform reliably. Caulking these areas will improve the space from water/moisture entry into the home.

Implement painting and/or caulking repairs as recommended by a qualified contractor.

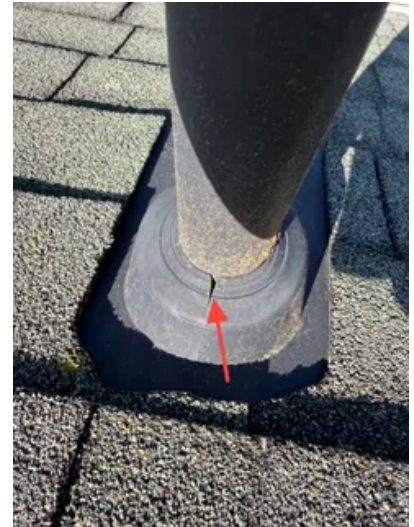
#### **DAMAGED VENT COVER**

The exterior vent termination on the south side of the home has a slight tear at the seam of the vent boot. Repair as needed to ensure reliable performance from the fan vent cover. Consider heavy gauge metal covers where possible as these tend to perform the longest and have the most reliable dampers. I recommend having a licensed contractor re-evaluate and make the necessary repairs.

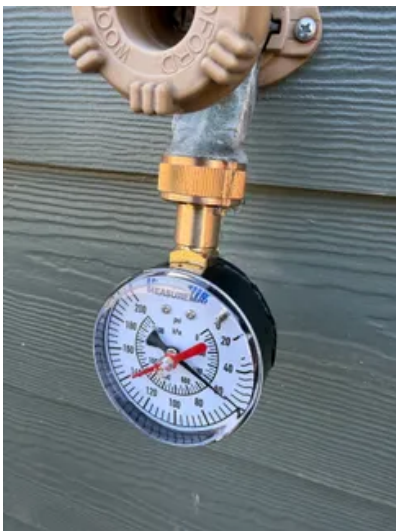
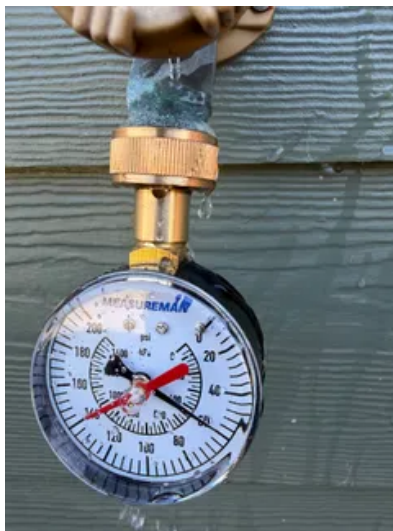
### 🔧 (E-5) Repair: **LEAKING HOSE BIB**

The leaky hose bib at the side of the house requires repair or replacement - it leaked from the faucet handle when the faucet was turned on and under pressure. This often requires tightening the packing around the handle stem.

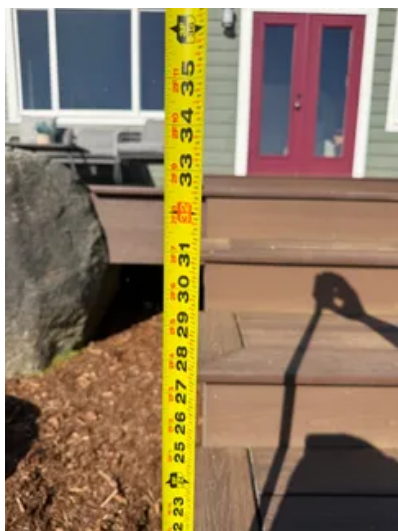
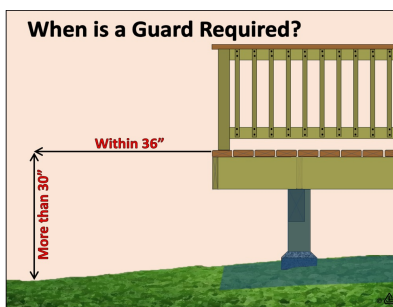
**(DPB-1) Improve or Upgrade:** With the height of the steps heading down the deck to the lawn, I recommend having a licensed contractor install a graspable handrail for safety.

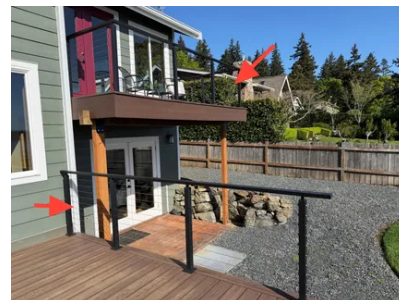
### **HORIZONTAL GUARDRAIL**

The deck guardrail has been run horizontally. While this is generally standard, it does have a safety risk as the railing creates a ladder effect. This can be a safety hazard for young children. Improve as desired for safety.

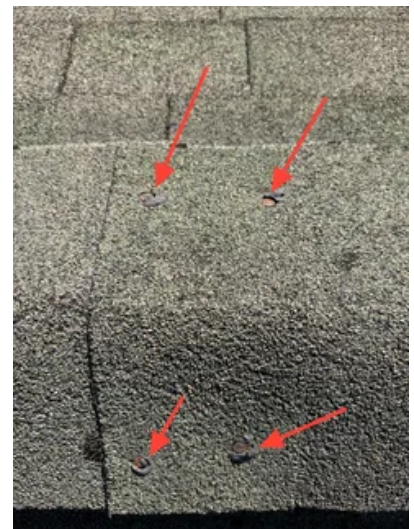
### 🔧 (RCG-1) Repair:

Exposed nails were present, the nails should be recalked/resealed. I recommend having a licensed contractor re-evaluate and make the necessary repairs.

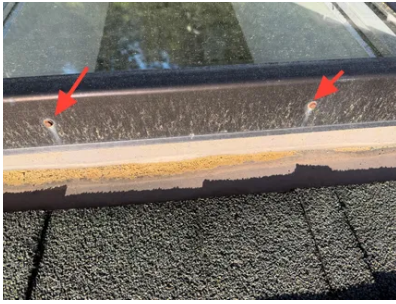
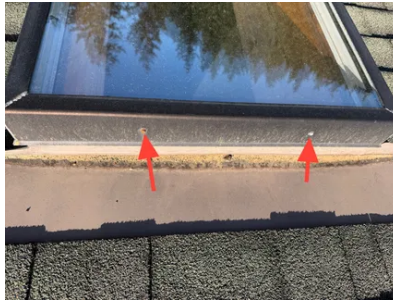
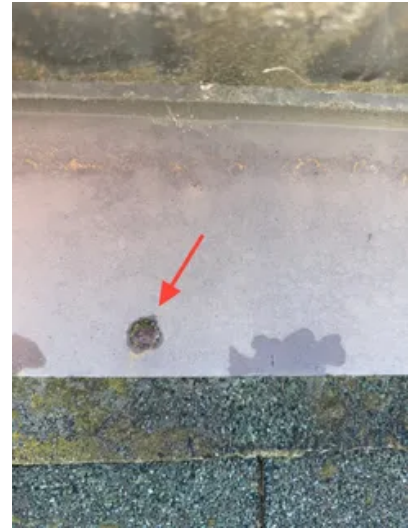
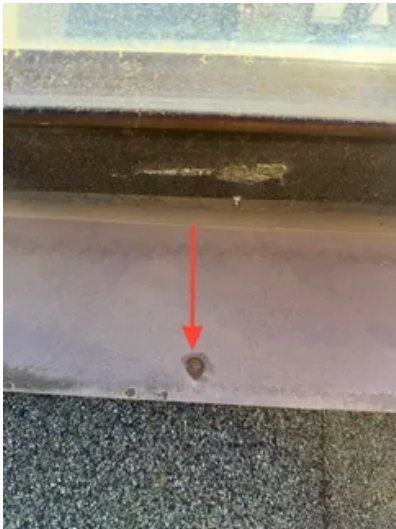
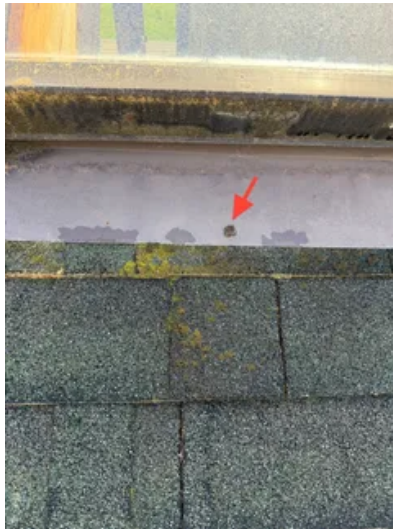
These skylights are fastened with exposed fasteners. These fasteners rely on rubber gaskets to seal the holes made by the fasteners.

I recommend having a licensed contractor re-evaluate and make the necessary repairs.

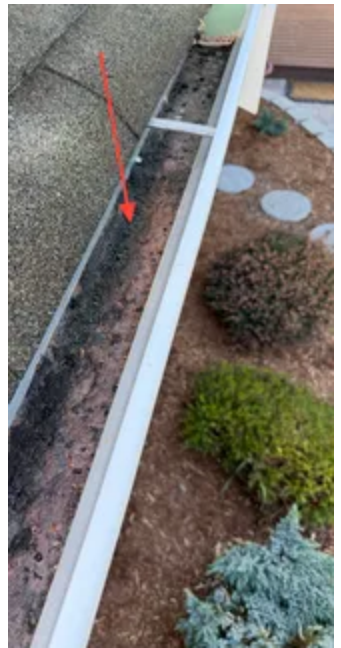
### (RCG-3) Recommended Maintenance: **GUTTER CLEANING NEEDED**

The gutters are clogged with organic debris and require cleaning to ensure proper control of roof runoff. Clean the gutters and ensure they are unobstructed, leak-free and properly sloped to drain. This is routine house maintenance; I would expect the need to clean gutters and downspouts regularly.

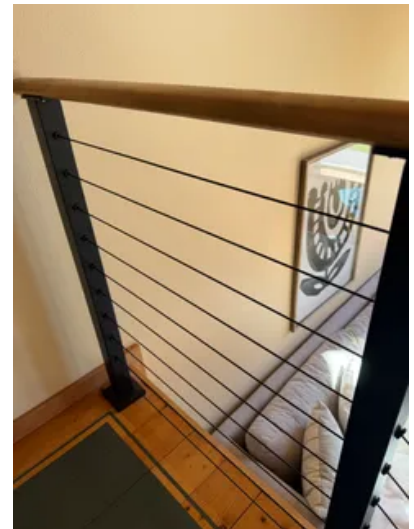
**(I-1) Monitor:**  
**HORIZONTAL GUARDRAIL SYSTEM**

The stair guardrail has a horizontal baluster design. This is allowed, but it can be unsafe for children as it can create a ladder effect. Use caution if small children are in the building.

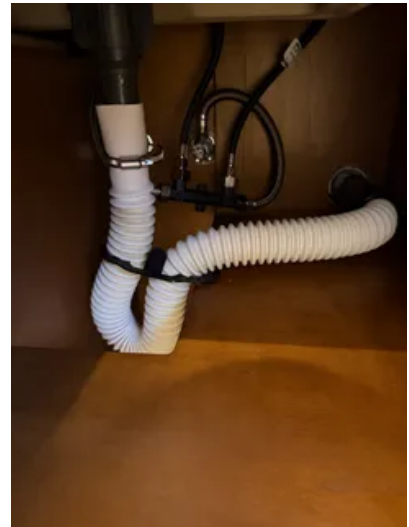
**(K-1) Repair:**  
**CORRUGATED WASTE PIPE**

Corrugated waste pipe was used to drain the kitchen sink. This is an unlisted plumbing product. Use smooth wall pipe only. Hire a licensed plumber to further evaluate and repair as needed.

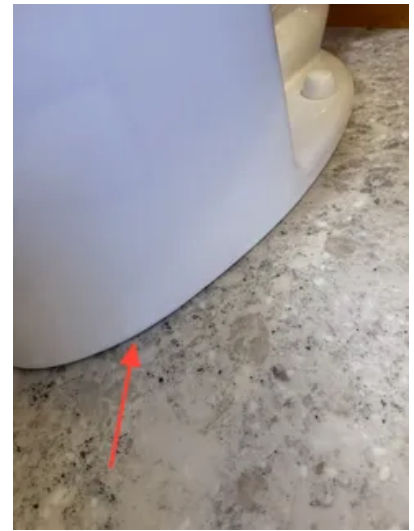
The toilet in the upstairs bath has not been caulked to the floor. Caulking the toilet to the floor is recommended and even required though opinions on this can vary. I prefer caulking the toilet to the floor, but leaving a gap on the back of the toilet that remains un-caulked so if the toilet leaks, water has an escape route. The biggest risk of not caulking the toilet to the floor is that the toilet

can become loose which is the biggest problem here. Repair as recommended by a licensed plumber.

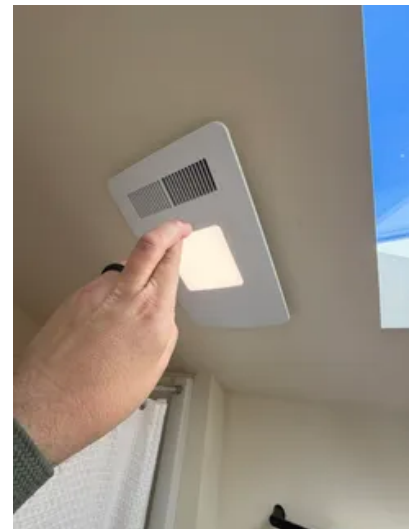
### 🔧 (PB-2) Repair:

The bath fans appear to be working poorly and may no longer provide adequate air exchanges to keep the bathrooms dry. The fans were not able to lift a piece of toilet paper during testing. Updating or repairing these fans is recommended and ensure the fans are properly venting these bathrooms and terminated to the exterior. Have these fans further investigated and repaired as needed by a qualified general contractor.

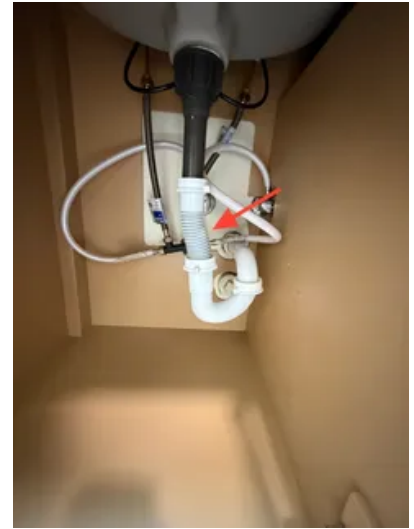
#### WASTE PIPE NOT SMOOTH WALL

Corrugated waste pipe was used to drain this bathroom sink. This is not a listed plumbing product and tends to indicate plumbing work that has not been done by a licensed plumber. Use smooth wall pipe only. Hire a licensed plumber to further evaluate and repair as needed.

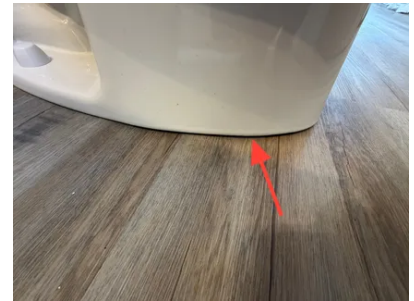
#### TOILET NOT CAULKED TO THE FLOOR- MAIN FLOOR BATH

The toilet in the hall bathroom has not been caulked to the floor. Caulking the toilet to the floor is recommended and even required though opinions on this can vary. I prefer caulking the toilet to the floor, but leaving a gap on the back of the toilet that remains uncaulked so if the toilet leaks, water has an escape route. The biggest risk of not caulking the toilet to the floor is that the toilet can become loose which is the biggest problem here. Repair as recommended by a licensed plumber.

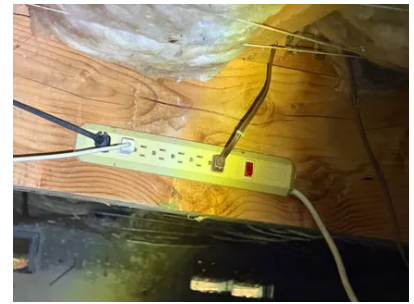
### ✂ (CS-1) Repair:

A power bar/strip was installed in the crawlspace with various cords powering crawlspace lights. If you feel incline to, I recommend having a licensed contractor re-evaluate and make

any necessary repairs. At the time of the inspection, I didn't see or note any issues.

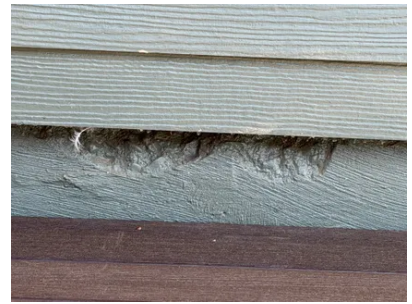
Previous or recent repairs appear to have been done, I recommend monitoring the area for any moisture or pest

intrusion.
