# Mason & Oak

### RESIDENTIAL SURVEY REPORT

#### Level 3 Survey

Sample Report  
Sample Property  
Location Withheld

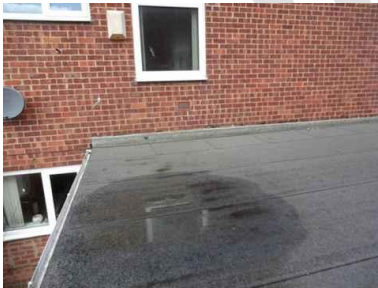
Ponding occurs where the roof does not have sufficient falls, where localised depressions have developed or where the outlet is restricted. Although limited temporary ponding can occur following rainfall, water that remains for prolonged periods increases the loading on the roof and accelerates deterioration of the covering and its joints. This may ultimately result in premature failure and water penetration.

The combination of ponding to the external covering and staining to the supporting timbers indicates that the roof has experienced moisture penetration. A competent flat-roofing contractor should therefore inspect the covering, falls, outlets, junctions, roof deck and accessible supporting structure before legal completion. Localised repair may be possible; however, depending upon the condition found when the covering is opened, more extensive repair or renewal may be required.

VIEW FULL SIZE  
Ponding was seen
