John Client

123 Some Street
Somewhere, US 12345

Wiseman Home Inspection, LLC

1 of 25
04/12/2021 05:14 PM
Prepared for: John Client
123 Some Street

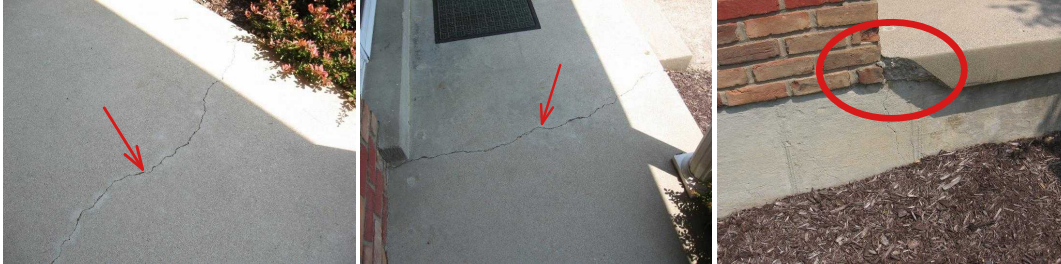
1. Driveway: Concrete
2. Walks: Concrete
3. Porch: Concrete - Settling away from foundation with surface cracks noted

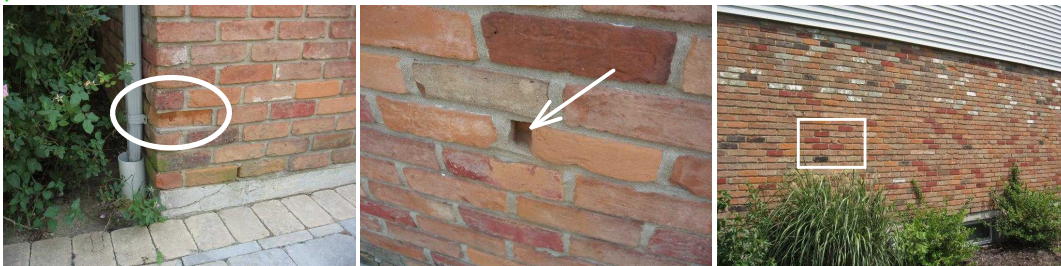
1. Type: Brick veneer - Some damaged bricks, Recommend sealing brick with penetration sealer products

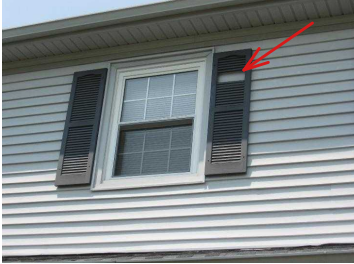
2. Type: Vinyl siding - Damaged front shutter, Chalking noted due to age, One panel needs to be repositioned at rear elevation

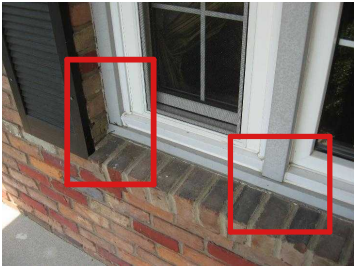
3. Trim: Aluminum - Chalking noted due to age, Loose nails in areas
4. Fascia: Aluminum
5. Soffits: Vinyl - Loose/sagging at front porch
6. Door Bell: Hard wired
7. Entry Doors: Wood
8. Patio Door: Vinyl sliding - Resecure loose handle hardware, Screen damage noted
9. Windows: Vinyl insulated - Reseal caulking at window perimeters at brick window openings

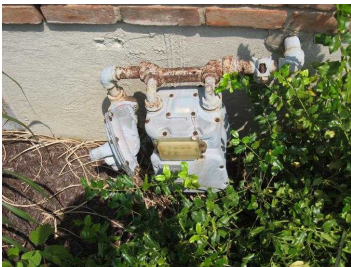
10. Window Screens: Metal
11. Basement Windows: Vinyl casement
12. Exterior Lighting: Surface mount
13. Exterior Electric Outlets: 110 VAC GFCI
14. Hose Bibs: Gate - Properly secure fixture(s) to exterior wall with fasteners
15. Gas Meter: Exterior surface mount at side of home - Rust present, Keep bushes and shrubs away from meter

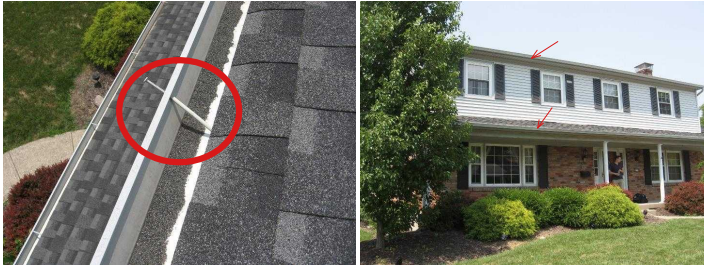
- 2. Unable to Inspect: 0%
- 3. Material: Fiberglass shingle
- 4. Type: Gable
- 5. Approximate Age: 5
- 6. Flashing: Metal
- 7. Plumbing Vents: Copper
- 8. Electrical Mast: Underground utilities
- 9. Gutters: Aluminum - Loose nails, Sagging gutters at front and rear

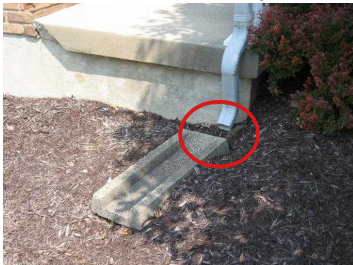
- 10. Downspouts: Aluminum
- 11. Leader/Extension: Splash blocks - Splash block(s) not properly installed

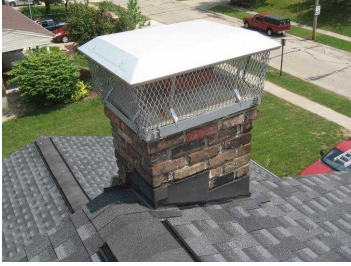
13. Flue/Flue Cap: Clay tile - Weather cap obstructed view of flue

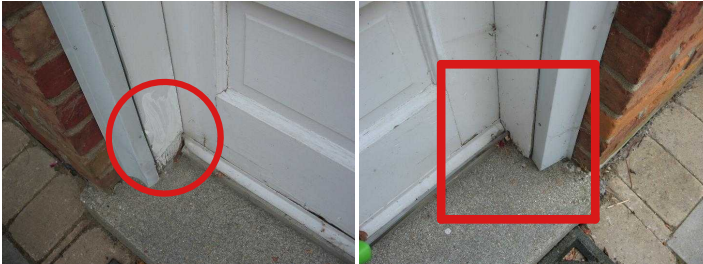
1. Type of Structure: Attached Car Spaces: 2
2. Garage Doors: Insulated aluminum
3. Door Operation: Mechanized
4. Door Opener: Overhead Door
5. Exterior Surface: Brick veneer
6. Roof: Asphalt shingle
7. Roof Structure: 2x6 Rafter
8. Service Doors: Wood - **Wood rot at bottom of door and frame**

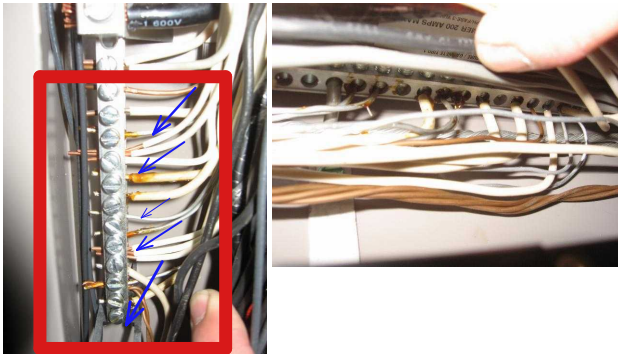
3. 120 VAC Branch Circuits: Copper and aluminum - Evaluation by a licensed electrician is recommended, See aluminum wiring notes below

5. Aluminum Wiring: Present at several circuits - Aluminum branch wiring has had a history of problems relating to poor connections due to galvanic corrosion, dissimilar metals, brittle conductors and type of aluminum alloy used during the time period of 1965 through 1972. These problems create unsatisfactory conditions at connections and splice locations and therefore create potential fire hazards. Recommend wiring update for aluminum wiring by a licensed electrician, Circuits are recommended to be upgraded with special compression type connectors at splices and branch circuits to reduce the potential risks of aluminum branch wiring.(Cop-Alum Crimp System)

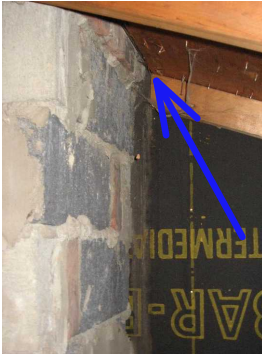
1. Method of Inspection: In the attic
2. Unable to Inspect: 15% - Safety and footing
3. Roof Framing: 2x3/4 Truss - Wood blocking components missing at chimney perimeter

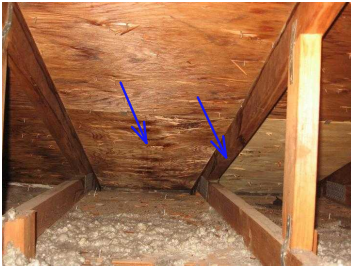
4. Sheathing: Plywood - Water stains and slight damage present, Areas of sheathing have been repaired

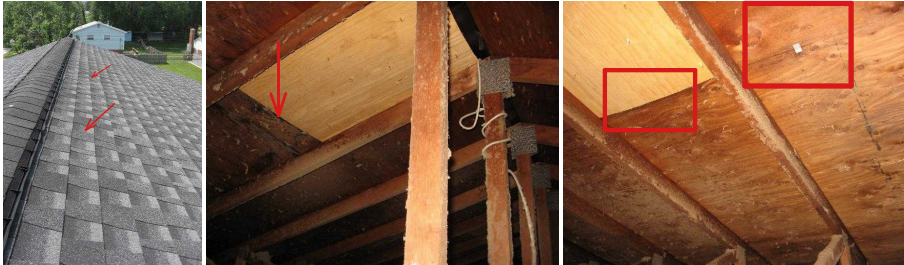
12. Sheathing: Plywood - Poor repair at 2 areas near ridge at rear slope - No H clips installed and repair only spanned one truss - Recommend additional support be installed

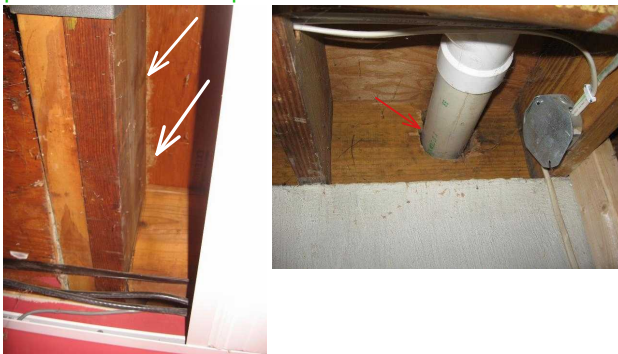
1. Structure Type: Wood frame
2. Foundation: Poured concrete
3. Differential Movement: Slight settlement present - Minor settlement at front porch, Cracks will require monitoring
4. Beams: Steel I-Beam
5. Bearing Walls: Wood frame
6. Joists/Trusses: 2x10 - Areas not visible due to ceiling finishes or other obstructions, Framing joist near fireplace chimney shows evidence of previous termite infestation - No repairs required, Seal penetration as required

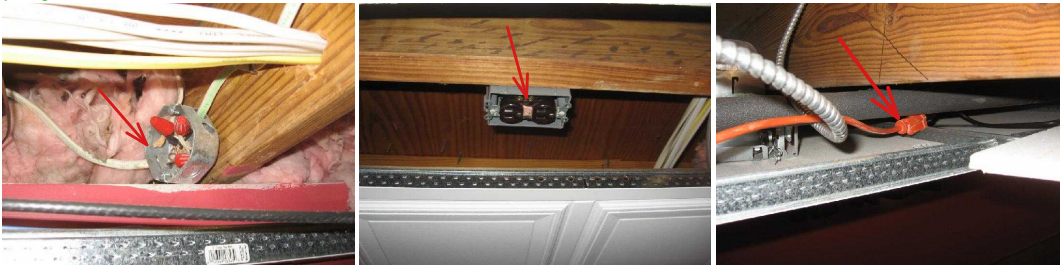
2. Ceiling: Suspended Acoustical System - Evidence of past water staining
3. Walls: Drywall
4. Floor: Carpet - Carpet stains noted
5. Floor Drain: Surface drain
6. Doors: Hollow wood
7. Windows: Vinyl casement
8. Electrical: 110 VAC - Loose junction boxes, missing and mis-sized covers, extension cord wiring to projector

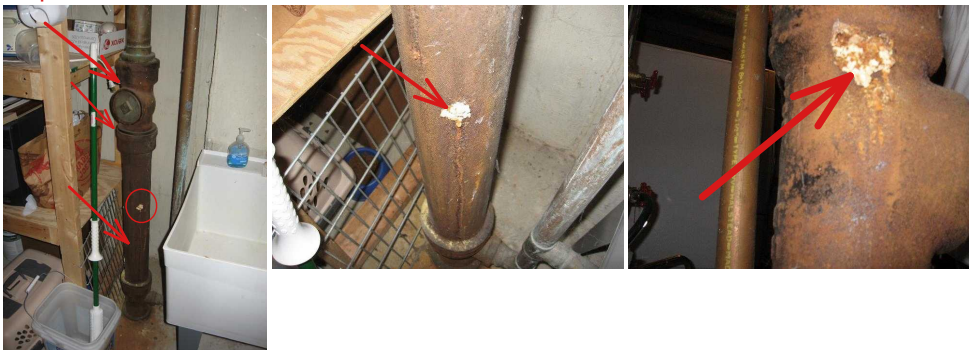
1. Service Line: Copper
2. Main Water Shutoff: Basement
3. Water Lines: Copper
4. Drain Pipes: Cast iron, Copper - **Pitting cast iron drain piping stack - replace affected sections where required**

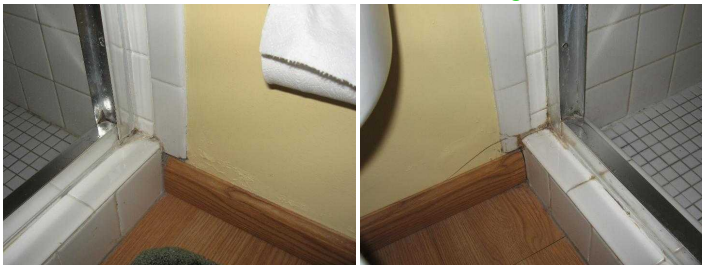
- 1. Ceiling: Drywall
- 2. Walls: Drywall
- 3. Floor: Laminated flooring - **Gapping noted in planks**
- 4. Doors: Hollow wood
- 5. Windows: Vinyl Insulated
- 6. Electrical: GFCI
- 7. Counter/Cabinet: Wood
- 8. Sink/Basin: One piece sink/counter top
- 9. Faucets/Traps: Delta
- 10. Shower/Surround: Ceramic tile - **Leaking at corner of door frame**

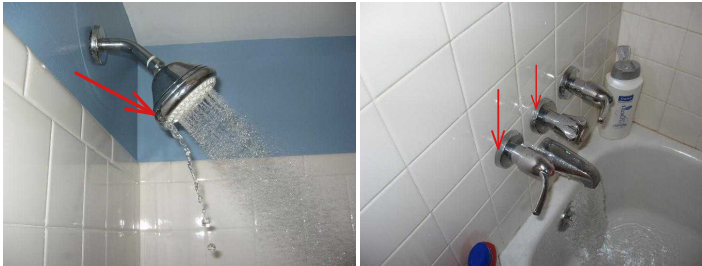
- 19. Windows: Vinyl Insulated
- 20. Electrical: GFCI
- 21. Counter/Cabinet: Wood
- 22. Sink/Basin: One piece sink/counter top
- 23. Faucets/Traps: Delta fixtures with a metal trap - **Leaking shower head, Loose trim rings**

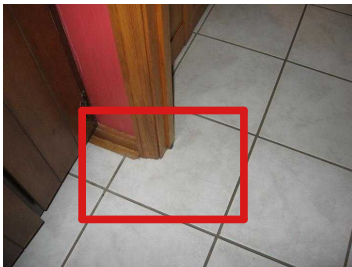
- 28. Ceiling: Drywall
- 29. Walls: Drywall
- 30. Floor: Ceramic tile - **Cracked tile noted**

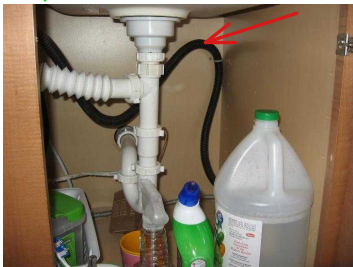
1. Cooking Appliances: Frigidaire
2. Disposal: General Electric
3. Dishwasher: Maytag - Properly secure the dishwasher discharge hose so that it creates a "high loop" above the basin drain to minimize food or water backup under dishwasher

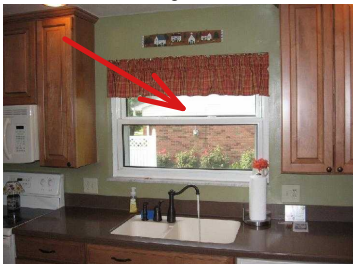
5. Refrigerator: Amana
6. Microwave: General Electric
7. Sink: Stainless Steel - Chipping at drain
8. Electrical: 110 VAC GFCI
9. Plumbing/Fixtures: Stainless Steel
10. Counter Tops: Solid Surface
11. Cabinets: Wood - Loose cabinet door hinges
12. Pantry: Large
13. Ceiling: Drywall
14. Walls: Drywall
15. Floor: Ceramic tile
16. Doors: Hollow wood
17. Windows: Vinyl Insulated - Insulated glass unit seal failure

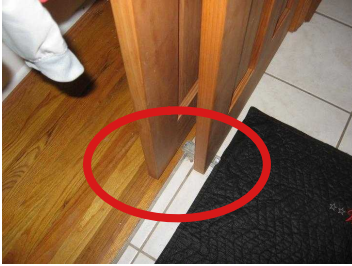
1. Closet: Various - Missing door glides at bypass closet door in Foyer

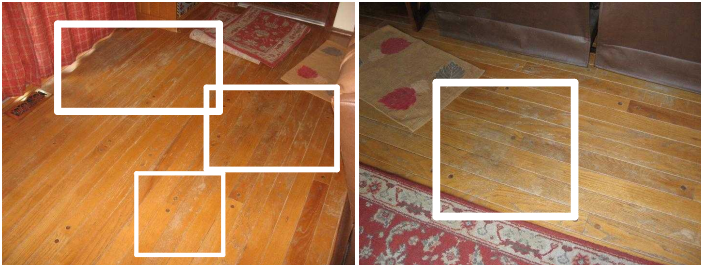
4. Floor: Ceramic tile, Carpet, Hardwood - Worn wood finish in Family room

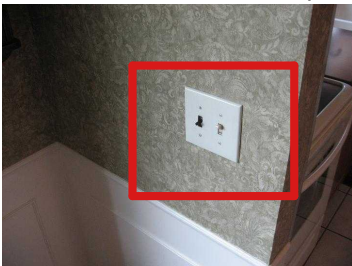
7. Electrical: 110 VAC - Replace missing dimmer switch in Dining room

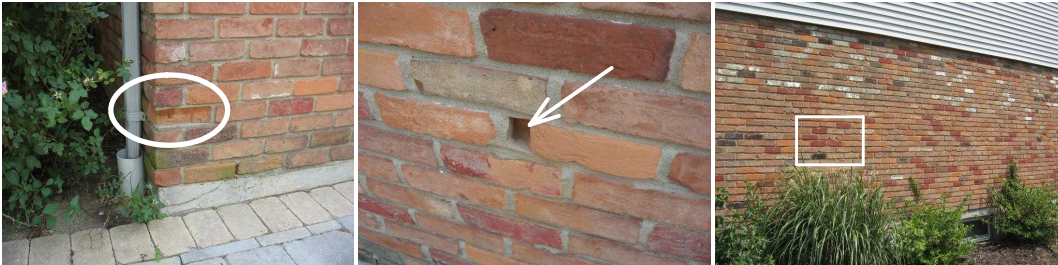
2. 1st Floor Exterior Surface Type: Brick veneer - **Some damaged bricks, Recommend sealing brick with penetration sealer products**

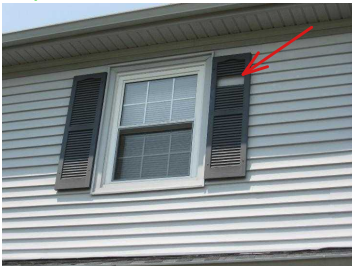
3. 2nd Floor Exterior Surface Type: Vinyl siding - **Damaged front shutter, Chalking noted due to age, One panel needs to be repositioned at rear elevation**

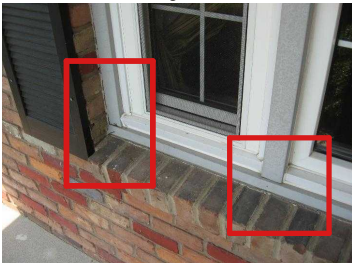
4. Trim: Aluminum - **Chalking noted due to age, Loose nails in areas**
5. Soffits: Vinyl - **Loose/sagging at front porch**
6. Patio Door: Vinyl sliding - **Resecure loose handle hardware, Screen damage noted**
7. Windows: Vinyl insulated - **Reseal caulking at window perimeters at brick window openings**

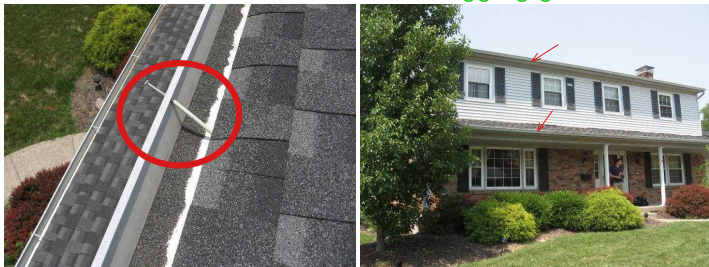
9. Gutters: Aluminum - Loose nails, Sagging gutters at front and rear

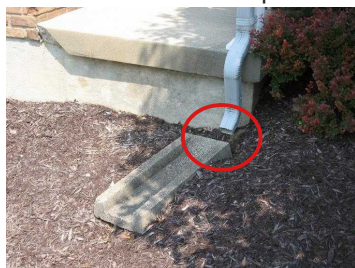
10. Leader/Extension: Splash blocks - Splash block(s) not properly installed

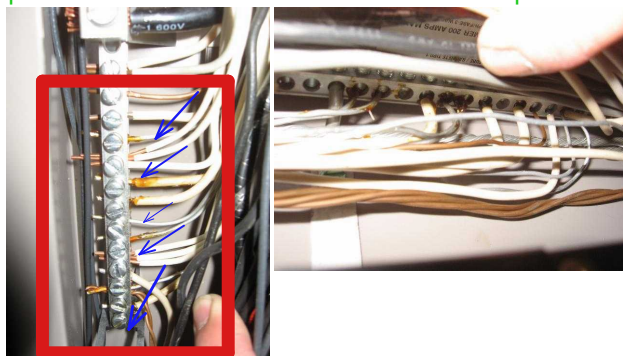
14. 120 VAC Branch Circuits: Copper and aluminum - Evaluation by a licensed electrician is recommended, See [aluminum wiring notes below](#)
15. Aluminum Wiring: Present at several circuits - Aluminum branch wiring has had a history of problems relating to poor connections due to galvanic corrosion, dissimilar metals, brittle conductors and type of aluminum alloy used during the time period of 1965 through 1972. These problems create unsatisfactory conditions at connections and splice locations and therefore create potential fire hazards. Recommend wiring update for aluminum wiring by a licensed electrician, Circuits are recommended to be upgraded with special compression type connectors at splices and branch circuits to reduce the potential risks of aluminum branch wiring.(Cop-Alum Crimp System)

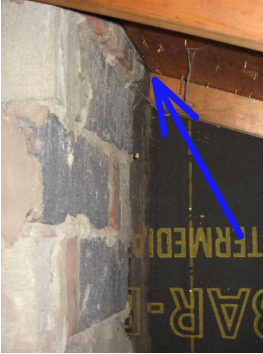
16. Attached Garage Attic Roof Framing: 2x3/4 Truss - Wood blocking components missing at chimney perimeter

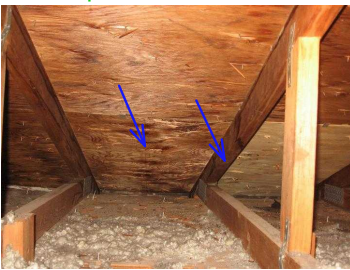
17. Attached Garage Attic Sheathing: Plywood - Water stains and slight damage present, Areas of sheathing have been repaired

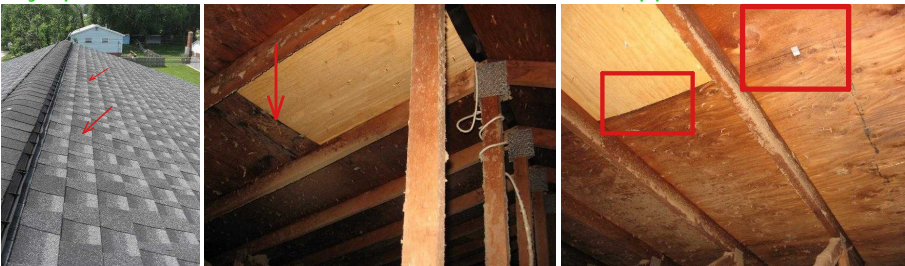
18. Main Attic Sheathing: Plywood - Poor repair at 2 areas near ridge at rear slope - No H clips installed and repair only spanned one truss - Recommend additional support be installed

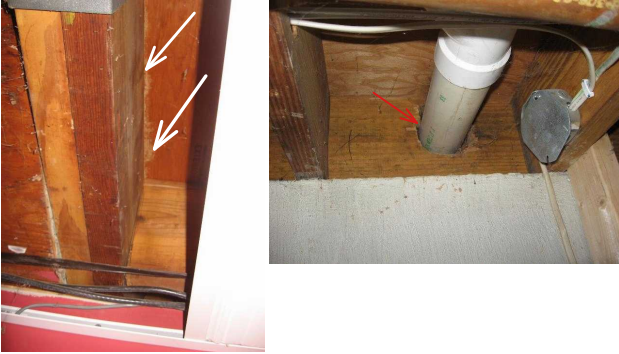
19. Joists/Trusses: 2x10 - Areas not visible due to ceiling finishes or other obstructions, Framing joist near fireplace chimney shows evidence of previous termite infestation - No repairs required, Seal penetration as required

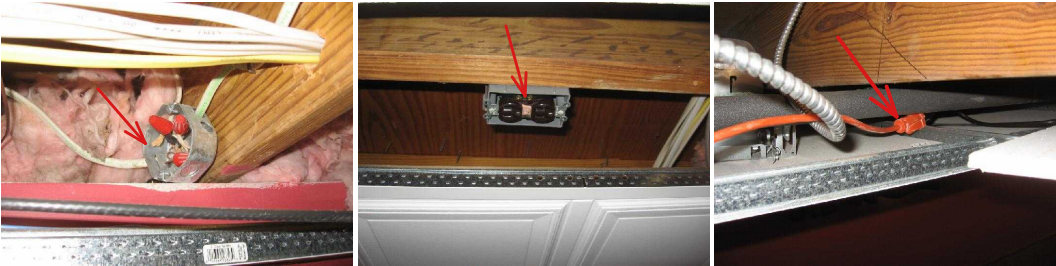
- 20. Main Basement Floor: Carpet - **Carpet stains noted**
- 21. Main Basement Electrical: 110 VAC - **Loose junction boxes, missing and mis-sized covers, extension cord wiring to projector**

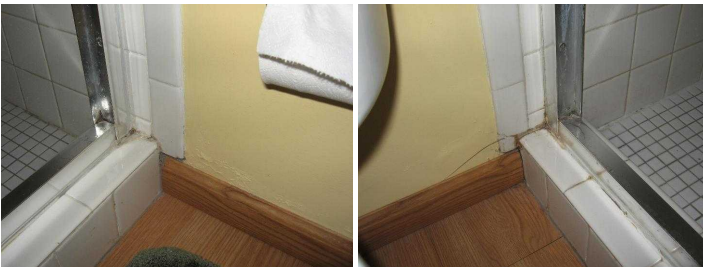
- 22. Master Bathroom Floor: Laminated flooring - **Gapping noted in planks**
- 23. Master Bathroom Shower/Surround: Ceramic tile - **Leaking at corner of door frame**

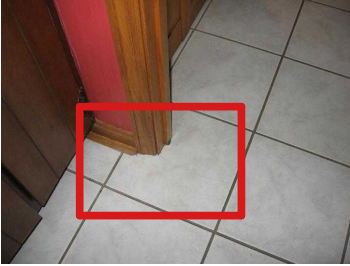
26. 1st Floor Hall Half Bathroom Floor: Ceramic tile - Cracked tile noted

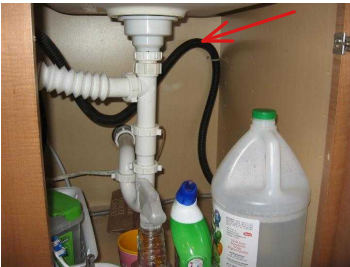
27. 1st Floor Kitchen Dishwasher: Maytag - Properly secure the dishwasher discharge hose so that it creates a "high loop" above the basin drain to minimize food or water backup under dishwasher

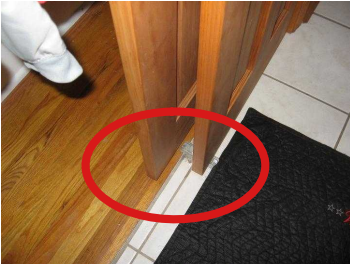
29. 1st Floor Living Space Closet: Various - Missing door glides at bypass closet door in Foyer

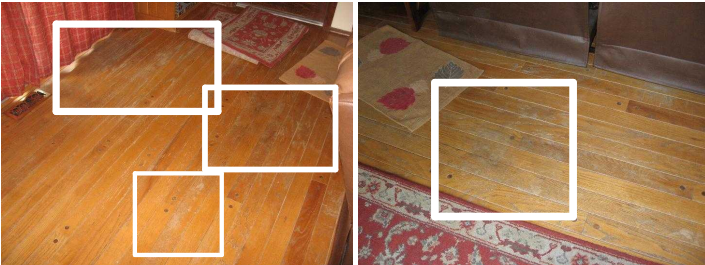
30. 1st Floor Living Space Floor: Ceramic tile, Carpet, Hardwood - Worn wood finish in Family room

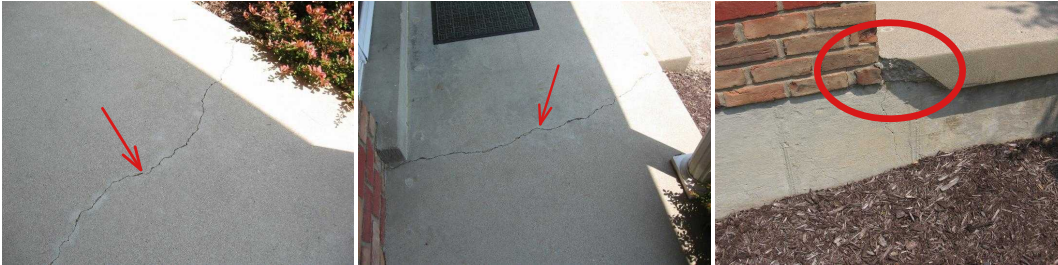
1. Porch: Concrete - Settling away from foundation with surface cracks noted

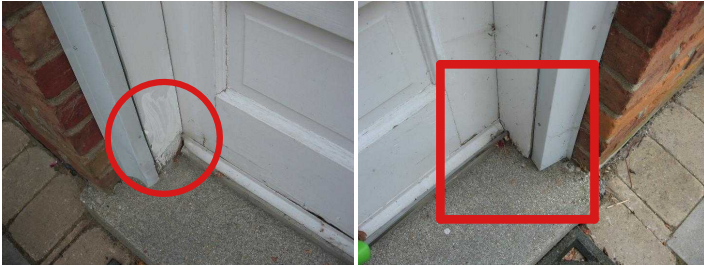
2. Attached Garage Service Doors: Wood - Wood rot at bottom of door and frame

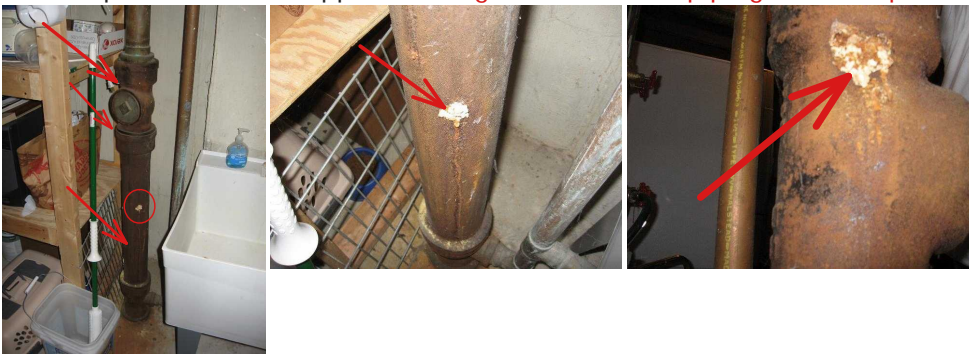
4. Drain Pipes: Cast iron, Copper - Pitting cast iron drain piping stack - replace affected sections where required

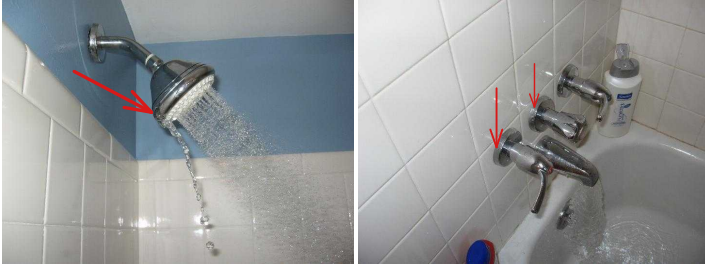
5. 2nd Floor Hall Bathroom Faucets/Traps: Delta fixtures with a metal trap - **Leaking shower head, Loose trim rings**

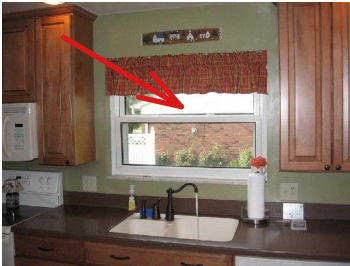
6. 1st Floor Kitchen Windows: Vinyl Insulated - **Insulated glass unit seal failure**
