Millbrook Homeowners Association
Littleton, CO

Report #: 43766-0
Beginning: January 1, 2025
Expires: December 31, 2025

RESERVE STUDY
"Full"

July 24, 2024

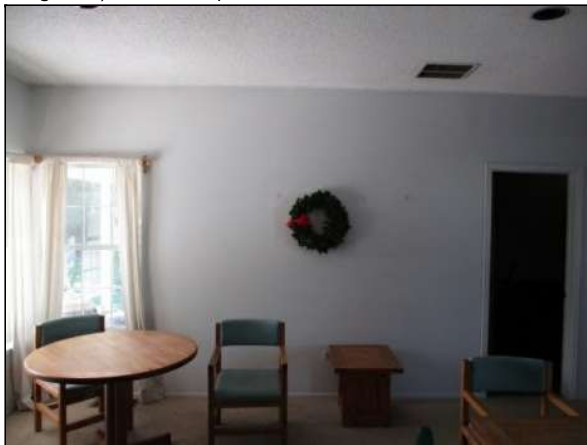
Comments: Includes all interior walls and ceiling. Interior areas exhibit some minor, routine marks and scuffs, small sections of peeling paint, etc. Overall appearance is satisfactory. Regular cycles of professional painting are recommended to maintain appearance. Small touch-up projects can be conducted as needed as a maintenance expense, but comprehensive painting of interior areas will restore a consistent look and quality to all areas. Best practice is to coordinate at same time as other interior projects (flooring, furnishings, lighting, etc.) whenever possible to minimize downtime and maintain consistent quality standard.

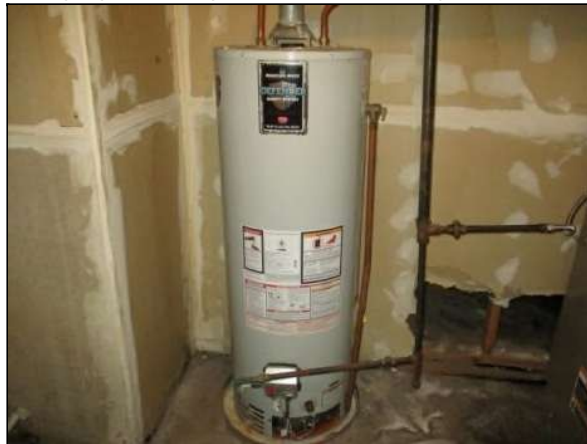
Comments: Includes (1) Bradford White, Defender, M/N RG240T6N, S/N NK38437838, 40 Gallon, Input 40000 BTU. Minimal or no subjective/aesthetic value for this component. Useful life is based primarily on normal expectations for service/performance life in this location. Unless otherwise noted remaining useful life expectancy is based primarily on original installation or last replacement/purchase date our experience with similar systems/components and assuming normal amount of usage and good preventive maintenance. Water heater life expectancies can vary greatly depending on level of use type of technology amount of preventive maintenance and other factors. Should be inspected and repaired as needed by servicing vendor or maintenance staff. Unless otherwise noted expected to be functional. Plan to replace at the approximate interval shown below. When evaluating replacements we recommend choosing high-efficiency or tankless models if possible in order to minimize energy usage.
