Millbrook Townhomes Canyon Trail & Depew Street Littleton, CO80128

Level 2, Platinum Reserve Analysis Report Period – 01/01/17 – 12/31/17

Client Reference Number - 7780
Property Type – Townhome Style

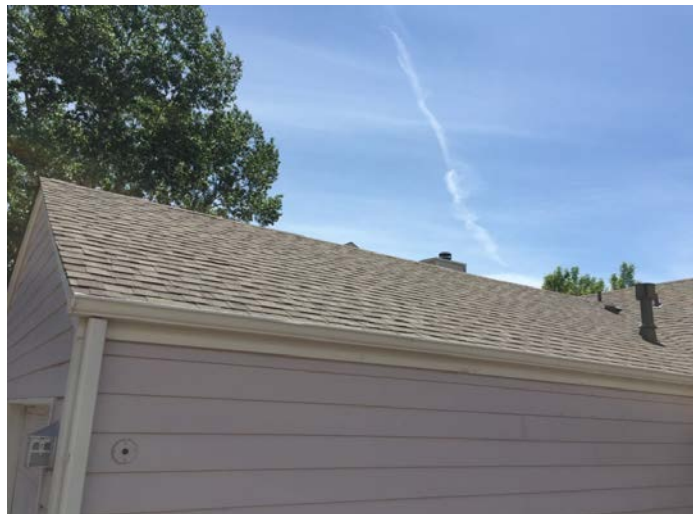
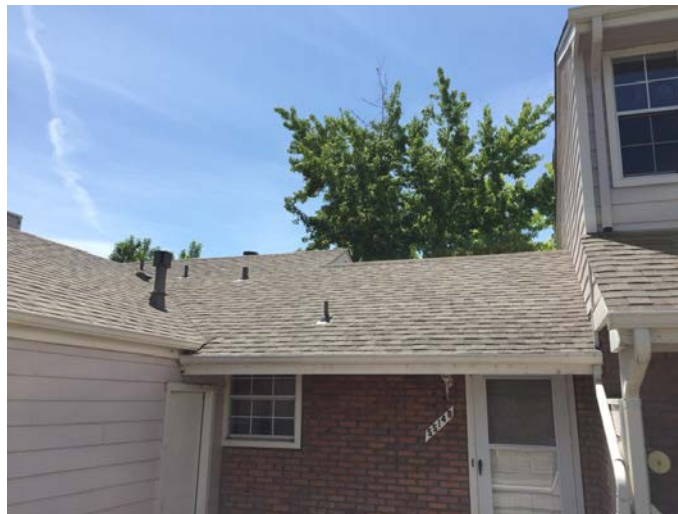
Comp #: 105 Comp Shingle Roof - Replace (New)

- At the time of our site visit, we noted that these roofs appeared to be much newer compared to other buildings. The shingles were a different color, no major damages, and granules in tact. According to Gardner Roofing, these roofs were replaced in 2013.
- It appears this roof material is rated as a 30 year product. Despite this rating, a life expectancy of 20 - 25 years is expected in this environment.
- Due to the potentially harsh winters, extensive freeze/thaw cycle, and likelihood of hail events over the useful life of the roof, we typically see associations replacing roofs sooner than the manufacturer's suggested useful life.

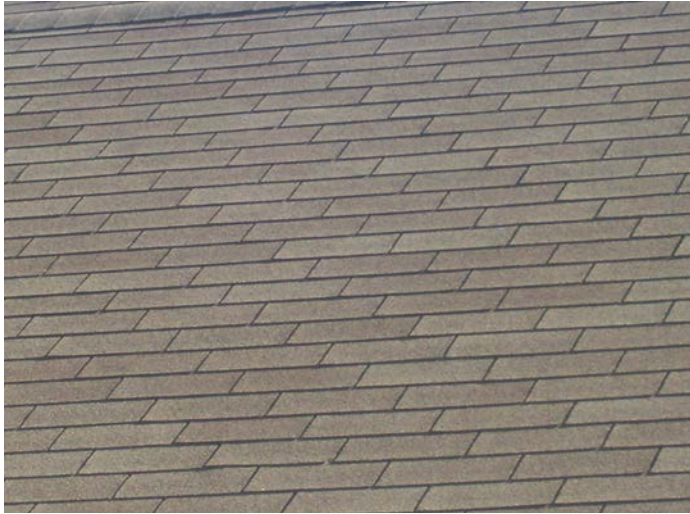
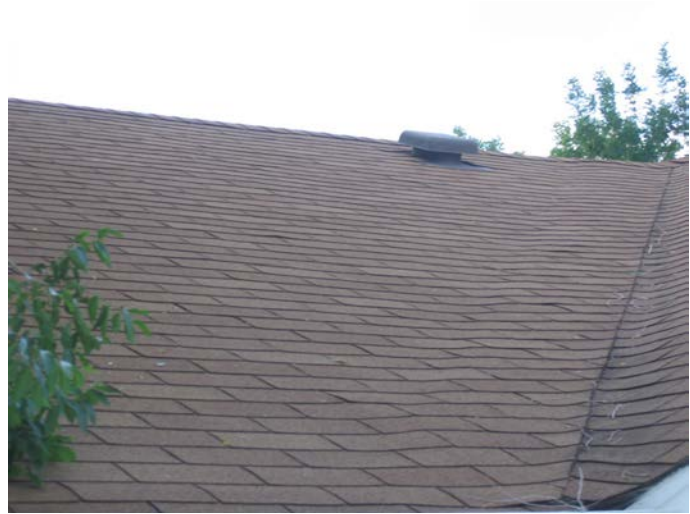
Comp #: 105 Comp Shingle Roof - Replace (Old)

- At the time of our site visit, we noted that these roofs appeared to be much older compared to other buildings. The shingles were a different color and appeared to have a major loss of granules.
- It appears this roof material is rated as a 30 year product. Despite this rating, a life expectancy of 20 - 25 years is expected in this environment.
- Due to the potentially harsh winters, extensive freeze/thaw cycle, and likelihood of hail events over the useful life of the roof, we typically see associations replacing roofs sooner than the manufacturer's suggested useful life.
- Remaining life is based on age of roof and observed conditions.

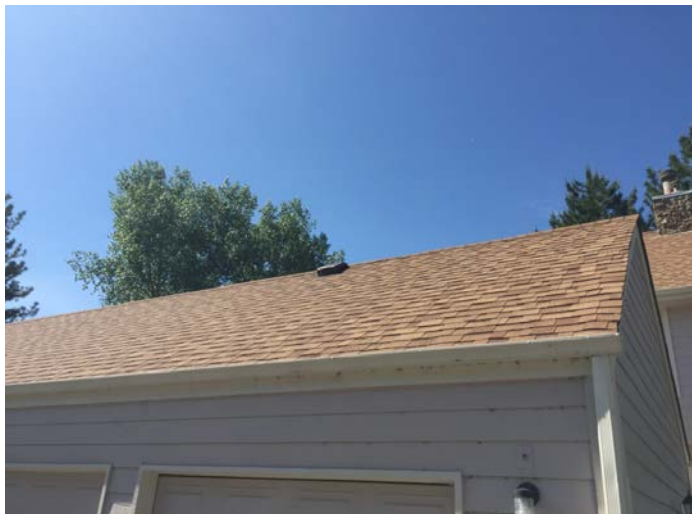
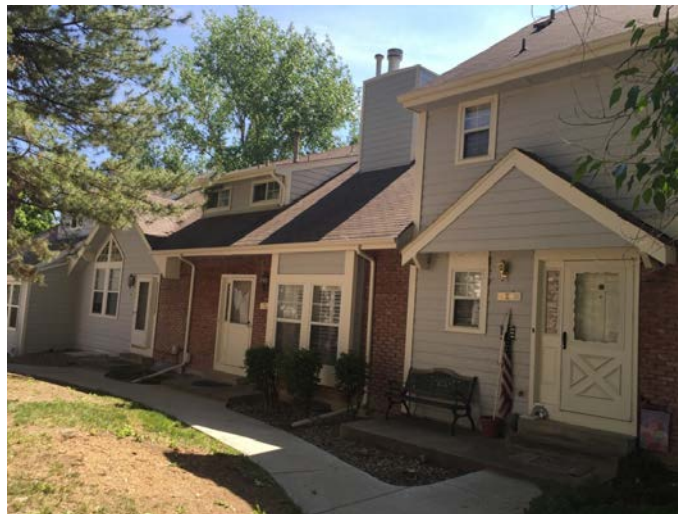
Comp #: 120 Gutters/Downspouts - Replace (New)

- There were no unusual conditions with the installation of the lines or any evidence of damage.
- It is typical for debris, such as roof granules and dirt, to build up in the lines. When debris remains in the rain gutters, it will stay wet after rains and snow melt which will cause premature deterioration of the materials.
- Therefore, we recommend cleaning out the lines at least once a year as a maintenance expense to ensure full life expectancy.
- It is typical to replace rain gutters and downspouts at the same time as roof materials for best cost estimate.
- Therefore, Reserve to replace these lines every 25 years.

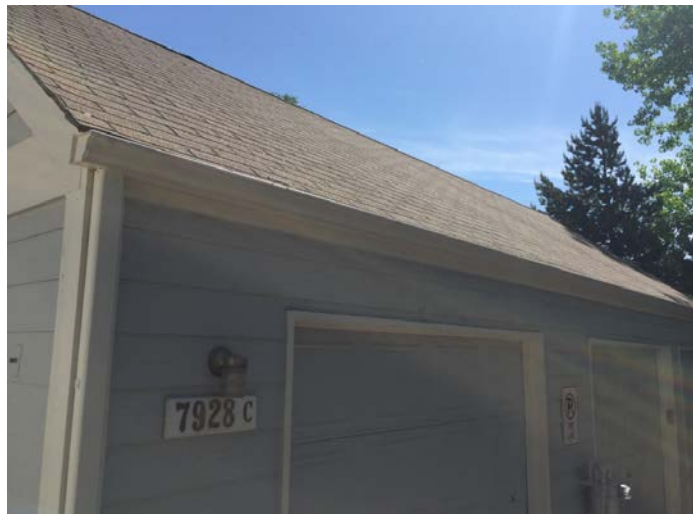
Comp #: 120 Gutters/Downspouts - Replace (Old)

- There were no unusual conditions with the installation of the lines or any evidence of damage.
- It is typical for debris, such as roof granules and dirt, to build up in the lines. When debris remains in the rain gutters, it will stay wet after rains and snow melt which will cause premature deterioration of the materials.
- Therefore, we recommend cleaning out the lines at least once a year as a maintenance expense to ensure full life expectancy.
- It is typical to replace rain gutters and downspouts at the same time as roof materials for best cost estimate.
- Therefore, Reserve to replace these lines every 25 years.

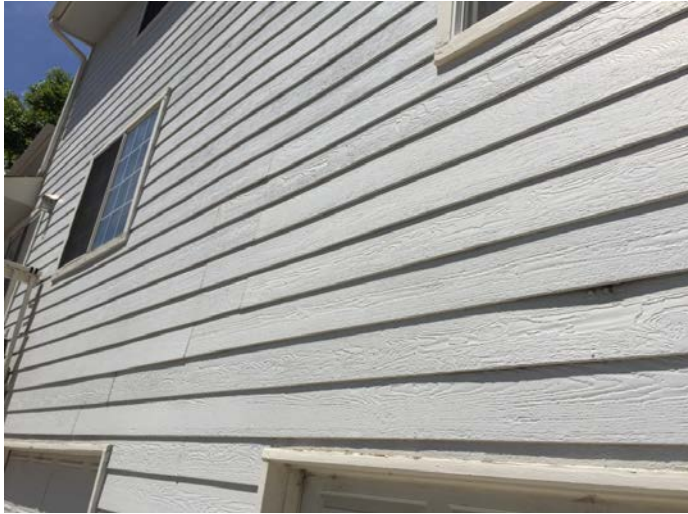
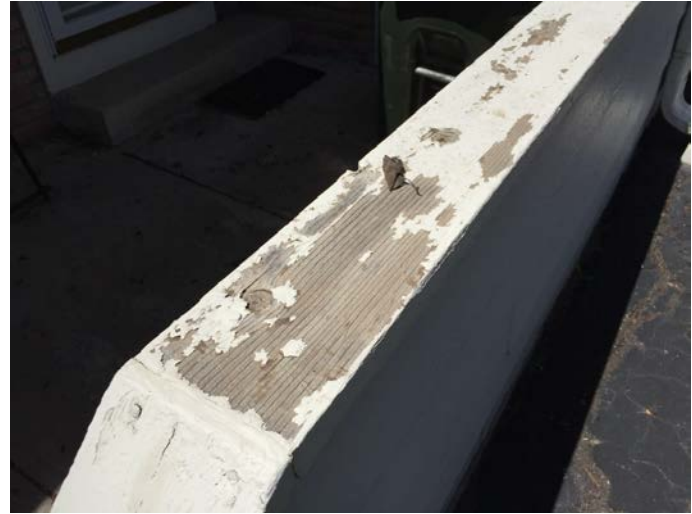
Comp #: 203 Building Ext Surfaces - Repaint (2013)

- Conditions vary throughout the community as the buildings are painted in phases. See general notes as to when buildings were painted.
- In this climate, it is recommended that exterior surfaces are painted every 5 - 7 years.
- The exact timeframe depends on the color chosen and the level of exposure to elements, as well as the quality of past paint jobs.
- The remaining life is based on the observed conditions and when the surfaces were last painted.

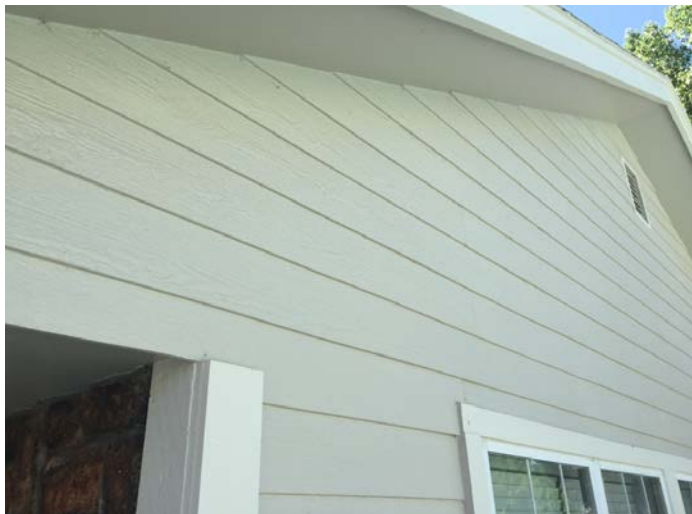
Comp #: 204 Building Ext Surfaces - Repaint (2015)

- Conditions vary throughout the community as the buildings are painted in phases. See general notes as to when buildings were painted.
- In this climate, it is recommended that exterior surfaces are painted every 5 - 7 years.
- The exact timeframe depends on the color chosen and the level of exposure to elements, as well as the quality of past paint jobs.
- The remaining life is based on the observed conditions and when the surfaces were last painted.

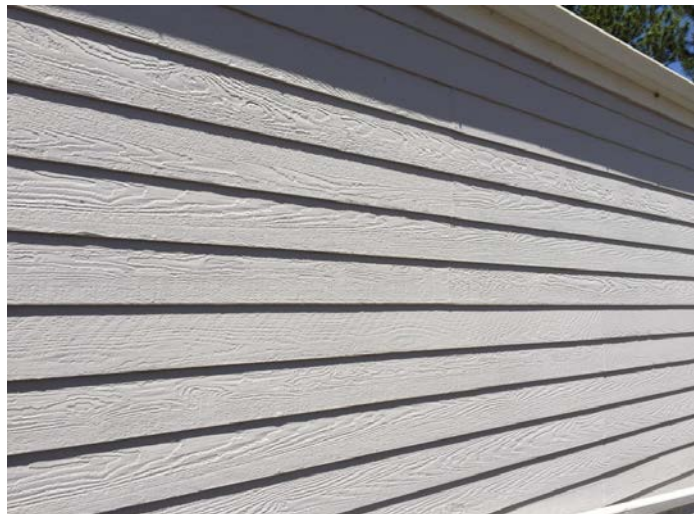
Comp #: 204 Building Ext Surfaces - Repaint (2014)

- Conditions vary throughout the community as the buildings are painted in phases. See general notes as to when buildings were painted.
- In this climate, it is recommended that exterior surfaces are painted every 5 - 7 years.
- The exact timeframe depends on the color chosen and the level of exposure to elements, as well as the quality of past paint jobs.
- The remaining life is based on the observed conditions and when the surfaces were last painted.

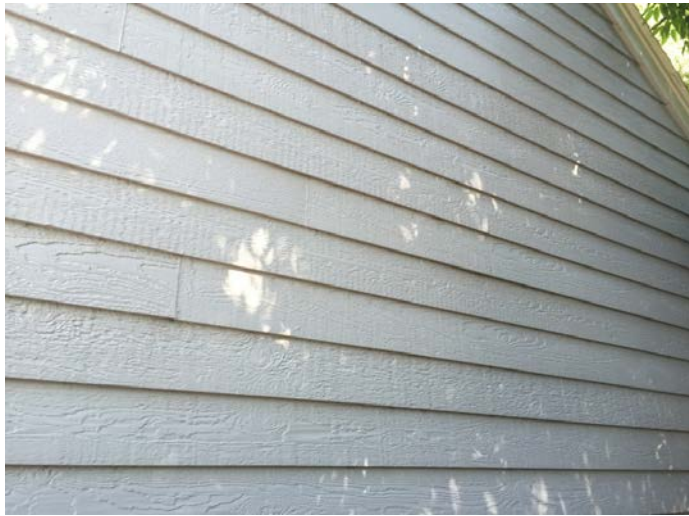
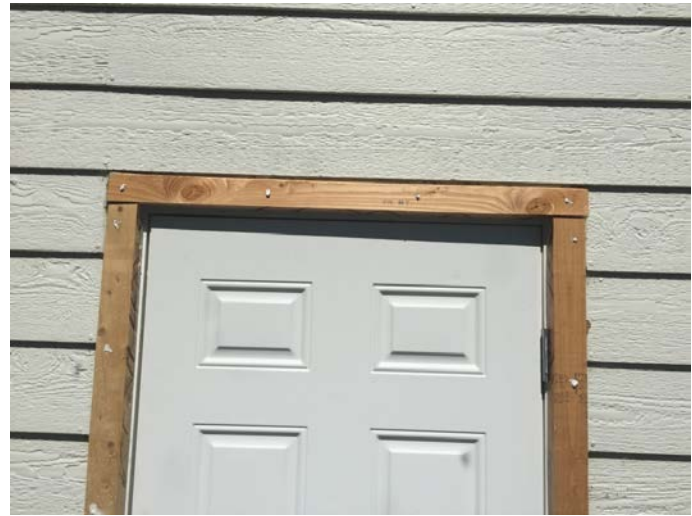
Comp #: 206 Building Ext Surfaces - Repaint (2016)

- Conditions vary throughout the community as the buildings are painted in phases. See general notes as to when buildings were painted.
- In this climate, it is recommended that exterior surfaces are painted every 5 - 7 years.
- The exact timeframe depends on the color chosen and the level of exposure to elements, as well as the quality of past paint jobs.
- The remaining life is based on the observed conditions and when the surfaces were last painted.

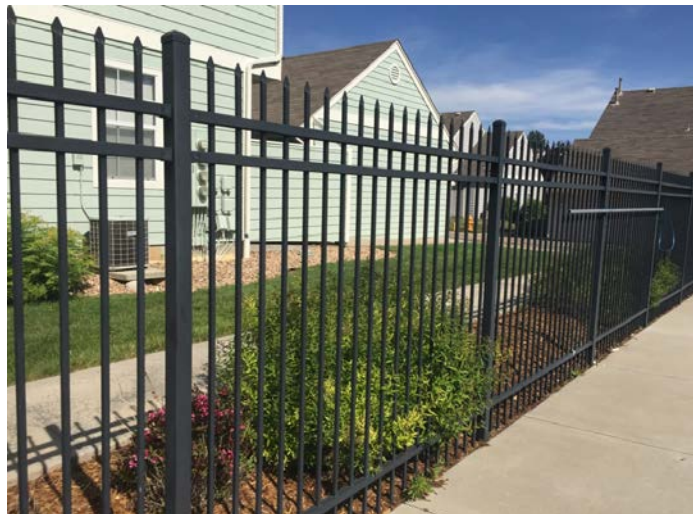
Comp #: 207 Iron Fencing - Repaint

- In general, the paint conditions on the metal surfaces was in fair to poor condition. Areas that had longer sun exposure are fading more rapidly. Railings needed minor repairs due to rust corrosion. These can be done prior to the next paint cycle.
- Based on the observed conditions, we recommend painting these surfaces this next year to protect the materials against further deterioration.
- In this climate, we recommend repainting this component every 3 - 4 years to maintain appearance and protect metal surfaces. Remaining life based on current condition.

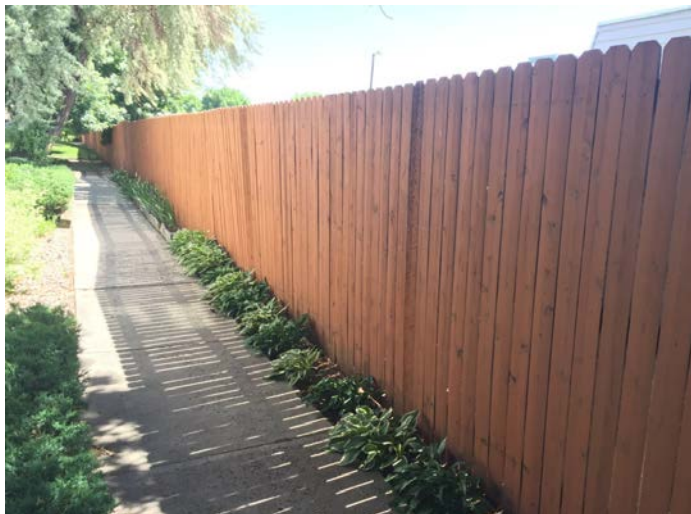
Comp #: 209 Wood Fencing - Restain

- In general, the fence stain was in fair condition. It appears that the fence was stained in the last couple of years.
- In this climate, we recommend staining wood fences every 2 - 4 years to protect the materials against splintering and cracking.
- The remaining life is based on the observed condition.

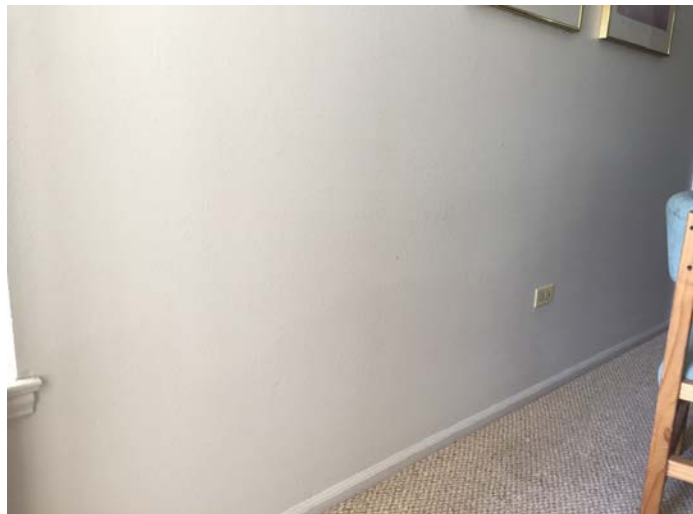
Comp #: 216 Interior Surfaces - Repaint

- In general, the paint on interior surfaces was in fair to poor condition. No major wall damages, but base boards were scarred up and discolored.
- Based on observed conditions, we suggest waiting until the next time exterior surfaces are scheduled to be painted. The exterior surfaces need to be painted in the next year or two. By scheduling the interiors at the same time as the exteriors, the association will be able to obtain the best painting cost possible.
- In between painting cycles, we recommend touching up areas on an as needed basis with general operating funds. Remaining life is based on the current conditions.

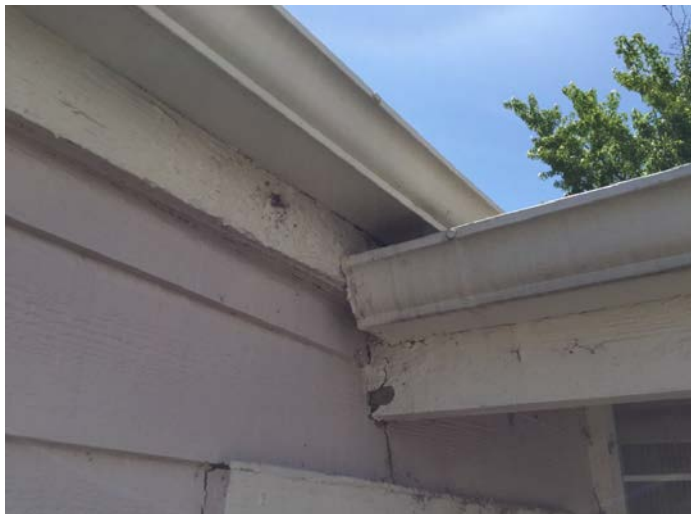
Comp #: 301 Siding/Trim - Repair (2013)

- The trim work is in fair condition and could use some repairs before being painted again.
- We recommend coordinating these repairs prior to painting the buildings.
- As the property ages, it is possible the estimate for repairs will need to be increased in future Reserve Study updates.
- This material typically has an overall life expectancy of 25 - 30 years and can be extended with proper care and maintenance.

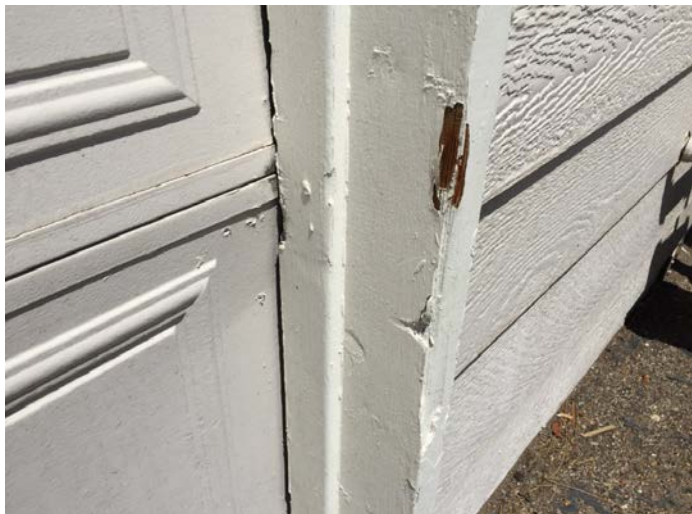
Comp #: 302 Siding/Trim - Repair (2014)

- The majority of damages noted were located around the garage doors and other minor damages were noted throughout.
- We recommend coordinating these repairs prior to painting the buildings.
- As the property ages, it is possible the estimate for repairs will need to be increased in future Reserve Study updates.
- This material typically has an overall life expectancy of 25 - 30 years and can be extended with proper care and maintenance.

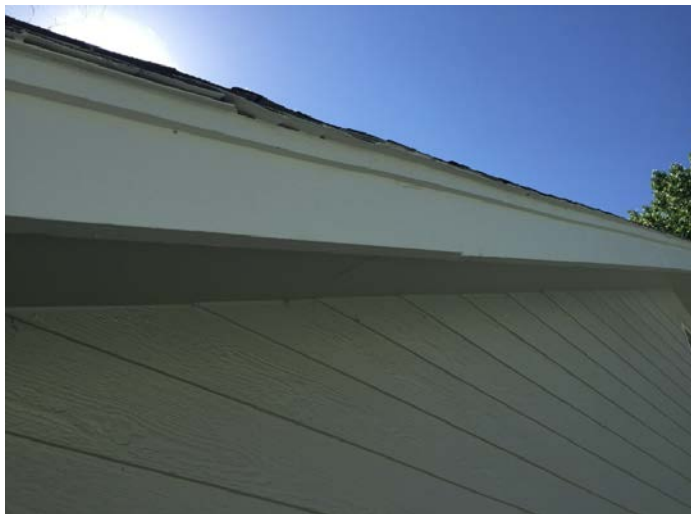
Comp #: 303 Siding/Trim - Repair (2015)

- The trim work at these addresses was in good condition with no major damages noted at the time of our site visit.
- We recommend coordinating these repairs prior to painting the buildings.
- As the property ages, it is possible the estimate for repairs will need to be increased in future Reserve Study updates.
- This material typically has an overall life expectancy of 25 - 30 years and can be extended with proper care and maintenance.
- Remaining life is based on the current conditions.

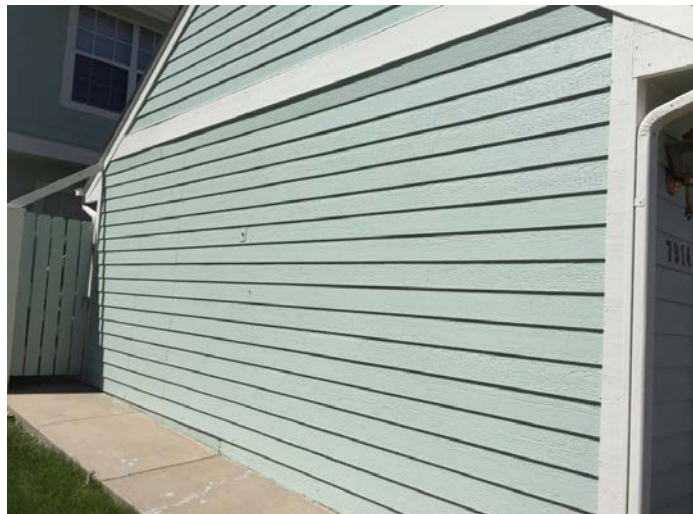
Comp #: 304 Siding/Trim - Repair (2016)

- The trim work at these addresses was in good to fair conditions. Only minor damages were noted at the time of our site visit.
- We recommend coordinating these repairs prior to painting the buildings.
- As the property ages, it is possible the estimate for repairs will need to be increased in future Reserve Study updates.
- This material typically has an overall life expectancy of 25 - 30 years and can be extended with proper care and maintenance.

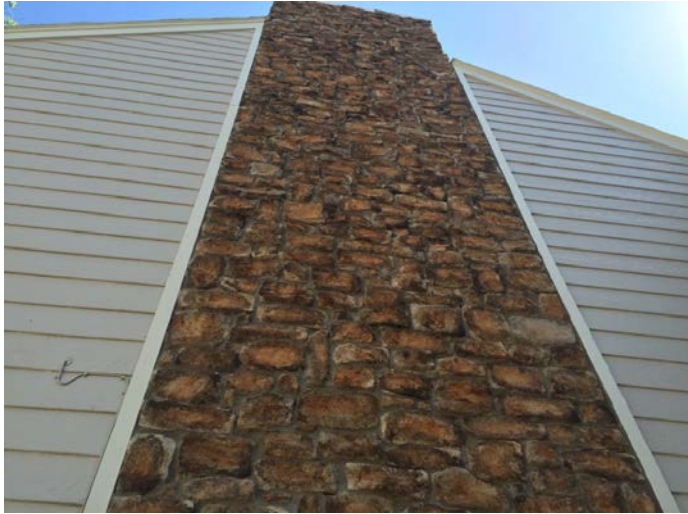
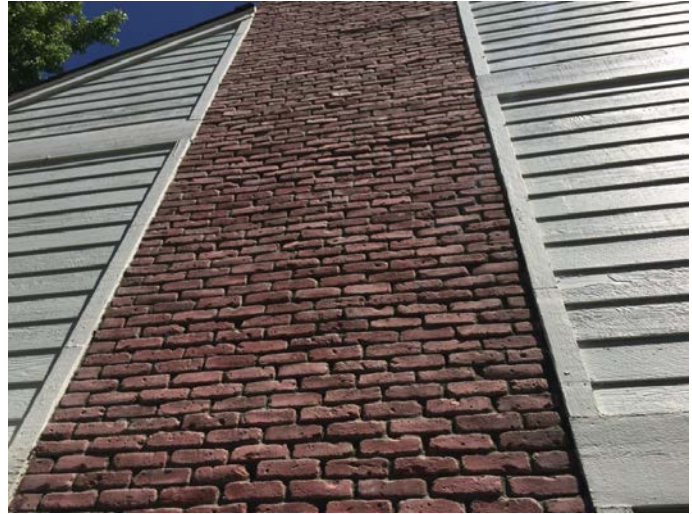
Comp #: 306 Brick/Flagstone - Replace

- In general, the stones and bricks were in good condition with no major damages noted.
- Typically, these stones or bricks have an extended life expectancy and complete replacement is unlikely.
- There are times where some stones or bricks will loosen and fall off, but this is unpredictable when and how much would occur.
- Repairs should be handled as a maintenance issue on an as needed basis. No reserve funding is required for this component at this time.
- If it later turns out that frequent repairs are necessary, then funding could be added in future Reserve Study updates.

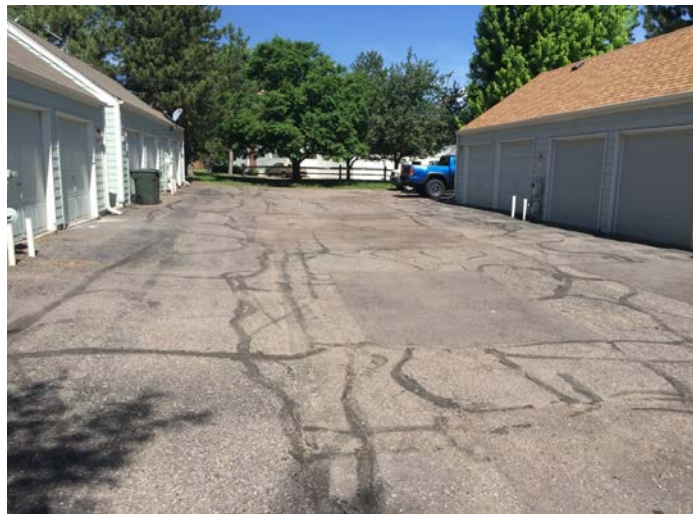
Comp #: 401 Asphalt - Overlay

- At the time of our site visit, the asphalt was in poor conditions. Major cracking throughout, major spalling, and pot holes were noted at the time of our site visit.
- The average life expectancy for asphalt surfaces ranges between 20 - 25 years for surfaces that are maintained on a regular schedule.
- Maintenance includes crack fill and repairing small potholes annually as an operating expense. In addition, asphalt should be seal coated every 2 -3 years, depending on the level of traffic and snow removing techniques.
- Remaining life is based on the current conditions.

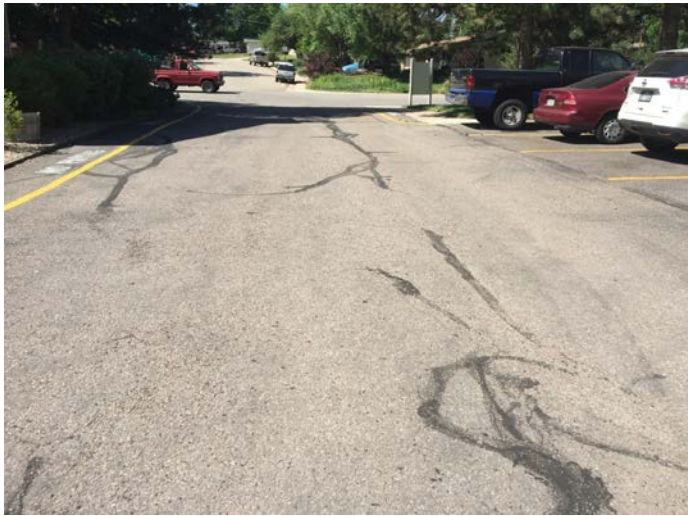
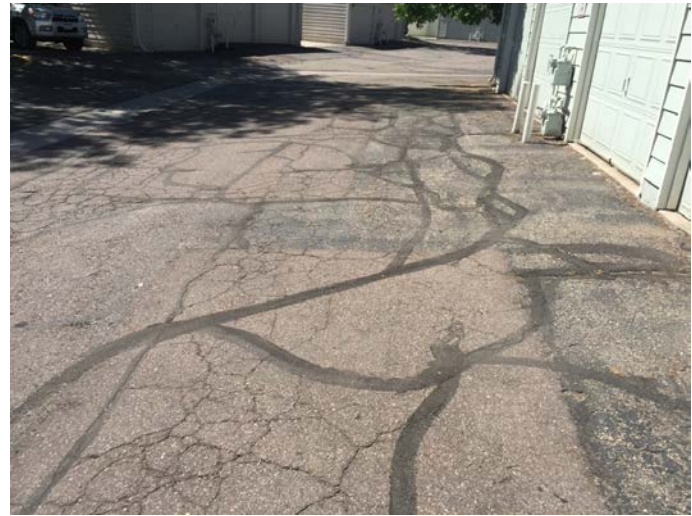
Comp #: 402 Asphalt - Seal Coat/crack fill

- The asphalt was very poor condition and should be seal coated with the new overlay. Asphalt was very dry looking and faded in color.
- Maintenance includes crack fill and repairing small potholes annually as an operating expense.
- In addition, asphalt should be seal coated every 2 -3 years, depending on the level of traffic and snow removing techniques.
- Remaining life is based on the current conditions observed at the time of our site visit.

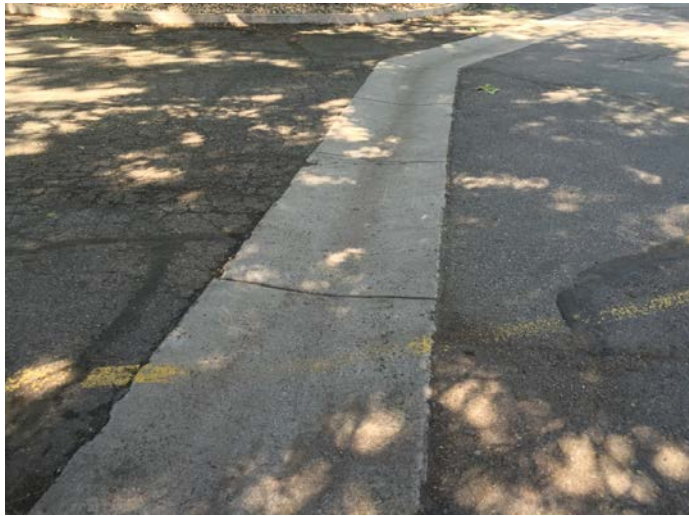
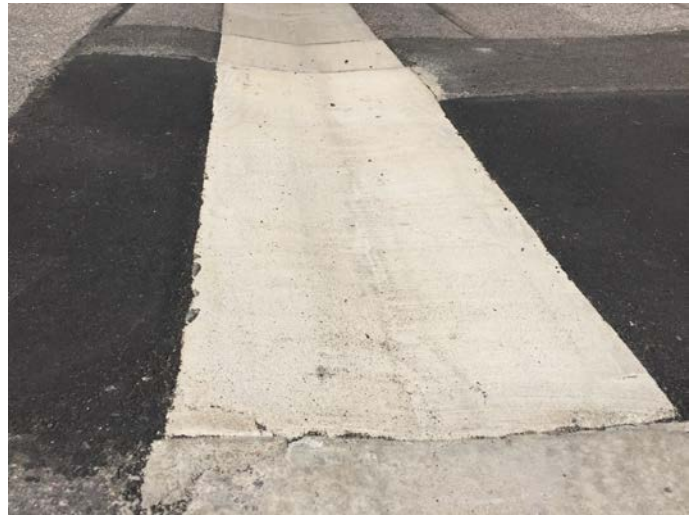
Comp #: 406 Concrete - Repair/Replace

- At the time of our site visit, we noted that a few repairs have been made throughout the previous years. Drain swales are generally in fair condition.
- No expectation to completely replace concrete swale.
- Reserve to make repairs and replacements to approximately 10% of total area (610 GSF) every 4 years.
- Remaining life is based on the current conditions.

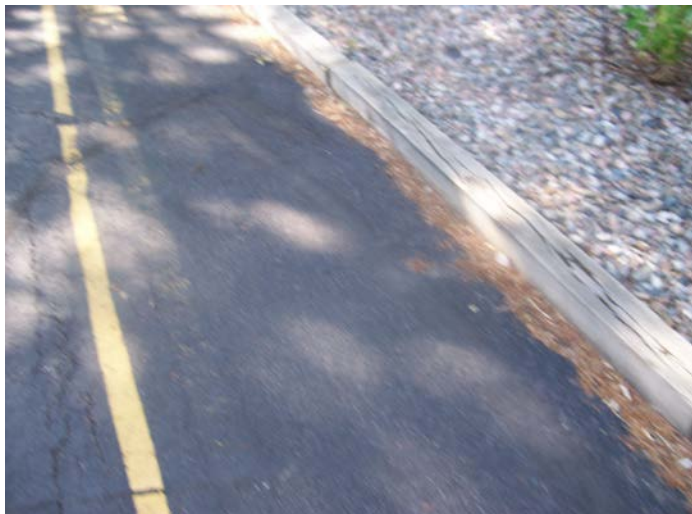
Comp #: 407 Timber Borders - Partial Replace

- In general, the timber borders adjacent to the asphalt drives was in poor condition. We noted major rotting and deterioration throughout.
- Typically, we see the need for replacement every 5 - 8 years due to water rot, damages from snow removal, etc.
- Remaining life is based on the current conditions observed at the time of our site visit.

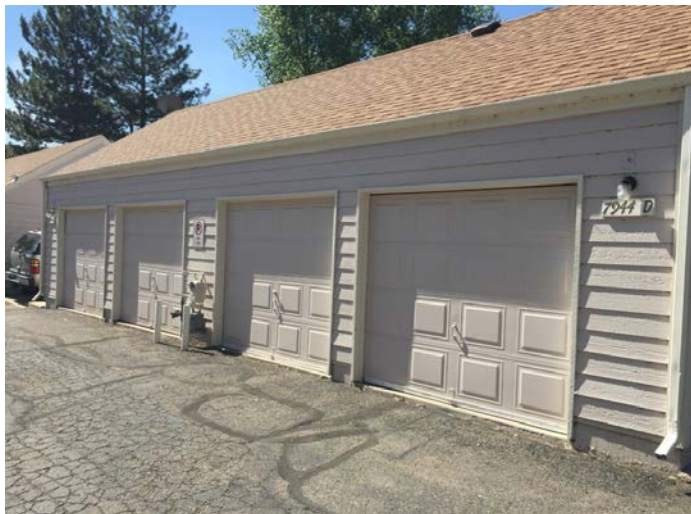
Comp #: 502 Garage Doors - Replace

- In general, the garage doors are in fair condition. No major problems were noted, but minor dings and dents were present. Paint varied as well throughout, but in general, was in fair condition.
- The declarations do not specifically state who is responsible for replacement of the doors.
- It was reported these doors are the responsibility of the individual owner, not the association.
- Therefore, Reserve funding is not required for this component.

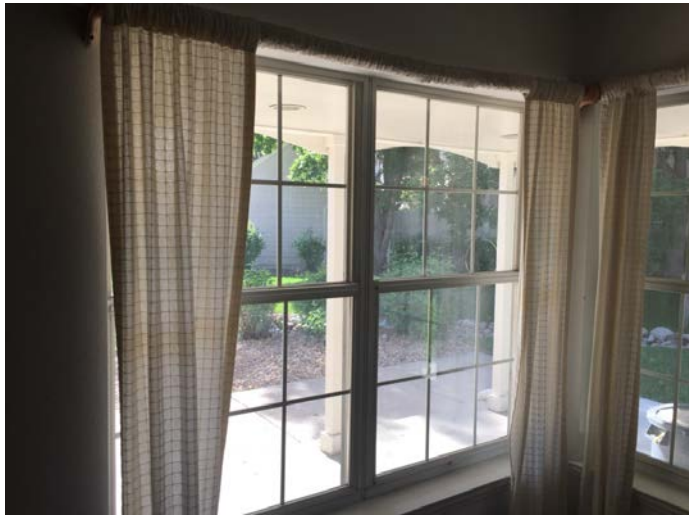
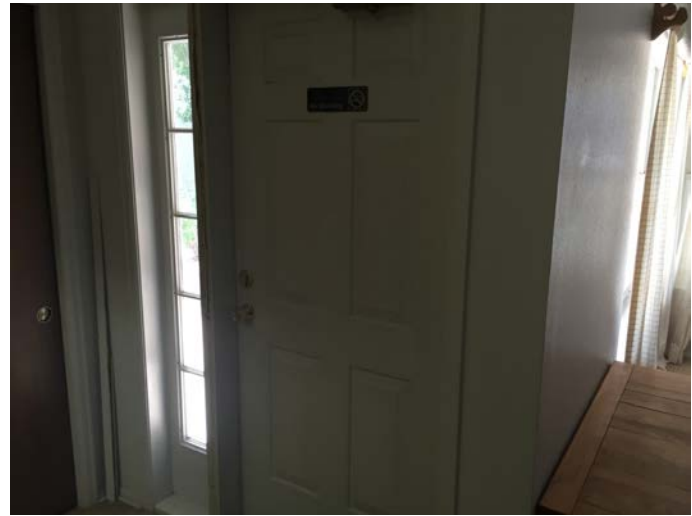
Comp #: 506 Windows - Replace

- Interior doors are brown and do not match. Windows are still functional, but appeared to be outdated, scuffed up in areas, and in need of caulking and paint.
- In our experience, we have seen the need to replace pool buildings windows and doors every 20 - 25 years on average.
- The remaining life is based on age and conditions.

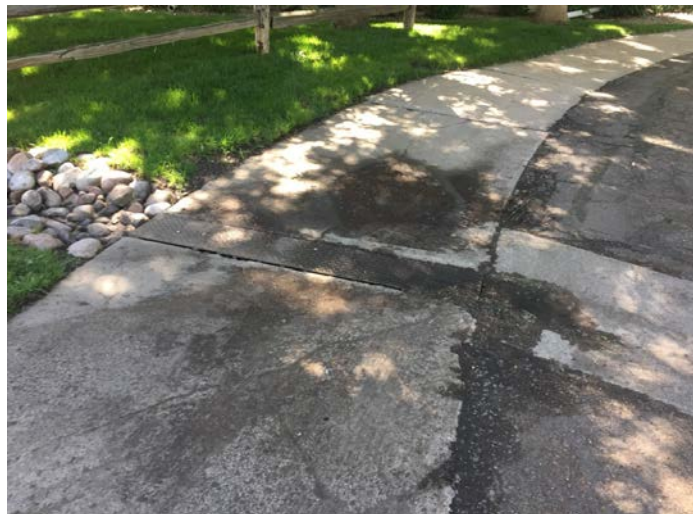
Comp #: 601 Concrete Sidewalks/Decks - Repair

- In general, the concrete sidewalks/decks were in fair to poor condition. We noted some repairs have been made throughout the community, but still needs many more repairs.
- While it is unlikely that all concrete surfaces will fail and need to be replaced at the same time, frequent repairs and replacement to a percentage of the area (10% or 4,440 GSF), should be anticipated every 4 years.
- Remaining life is based on the current conditions.

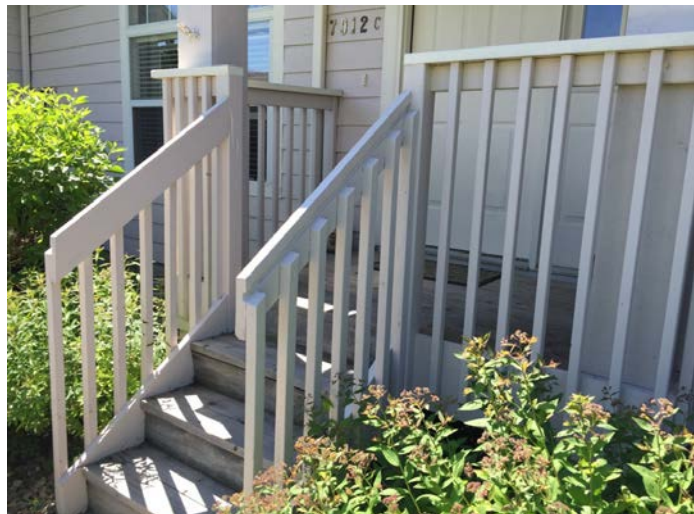
Comp #: 607 Wood Deck - Replace

- Conditions, sizes, and types of decks vary throughout the community. In general, the decks appeared to be outdated and nearing the end of their lives. We noted wood rot on the majority of the decks.
- According to the declarations, it appears the association will be responsible for painting/staining the decks (funding included with exterior building surfaces - repaint).
- Typically, these are considered to be exclusive use common areas, and in most situations, the individual owner is responsible when major repairs or replacement is necessary.
- Therefore, at this time, separate Reserve funding for replacement is not recommended.

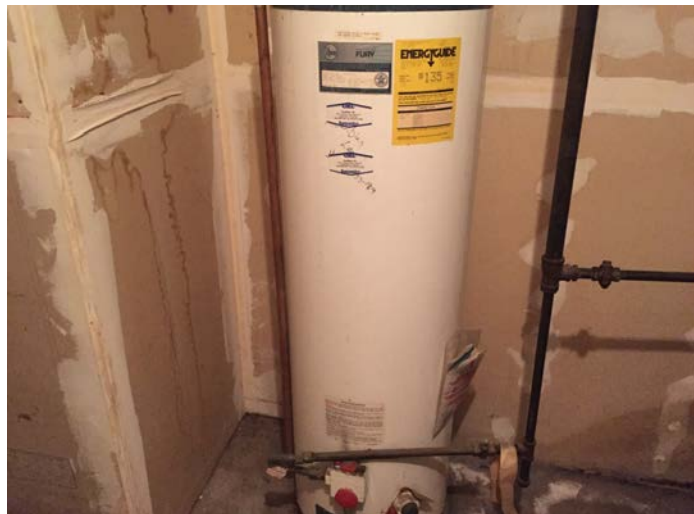
Comp #: 703 Hot Water Heater Tank - Replace

- There were no major problems reported or noted at the time of our site visit. However, the hardware and fittings are corroding and we believe this heater is nearing the end of its life.
- Due to the minimal replacement cost associated with this component when compared to the life expectancy, Reserve funding is not required.
- Repair and replace water heater on an as needed basis with operating funds.

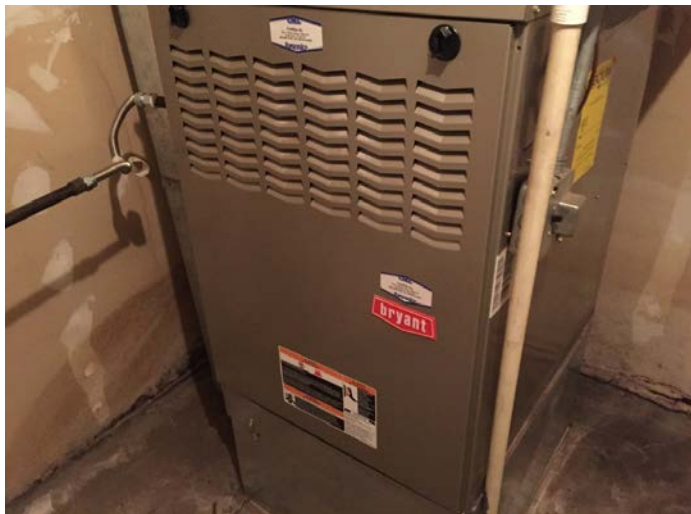
Comp #: 706 HVAC Furnace - Replace

- We noted that the furnace had been replaced in 2011. In general, the furnace is good condition with no reported problems.
- Expect a useful life of approximately 20 - 30 years from this component.
- Remaining life is based on the current conditions and overall age.

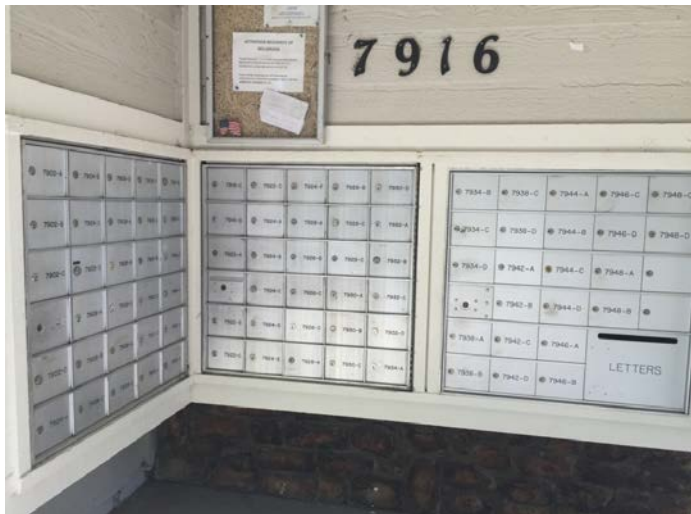
Comp #: 803 Mailboxes - Replace

- At the time of our site visit, the mailboxes were in fair condition. Some marking and discoloration noted throughout mailboxes. No broken boxes were noted.
- Expect to replace this component approximately every 18 - 20 years to maintain appearance and function.
- Remaining life based on current age and condition.

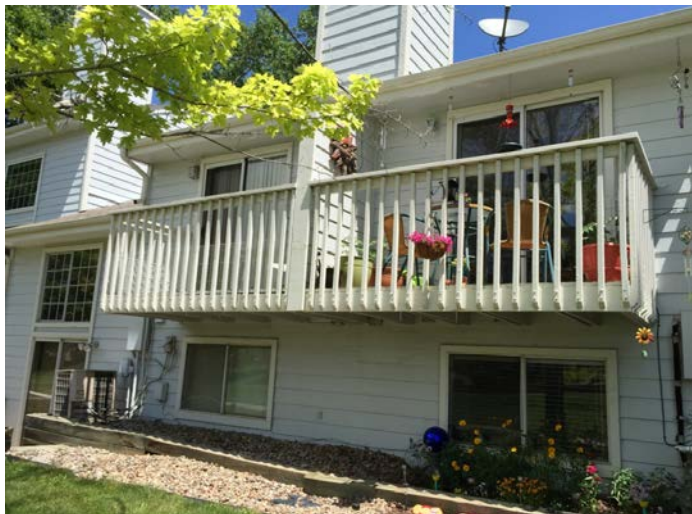
Comp #: 1001 Wood Handrails - Replace

- At the time of our site visit, the hand rails were in fair condition. We did not note any broken rails. Paint is in the same conditions as the exterior surfaces.
- This material should be painted at the same time as the units. Make necessary repairs as part of prep work before the painting cycle.
- Reserve funding is not necessary.

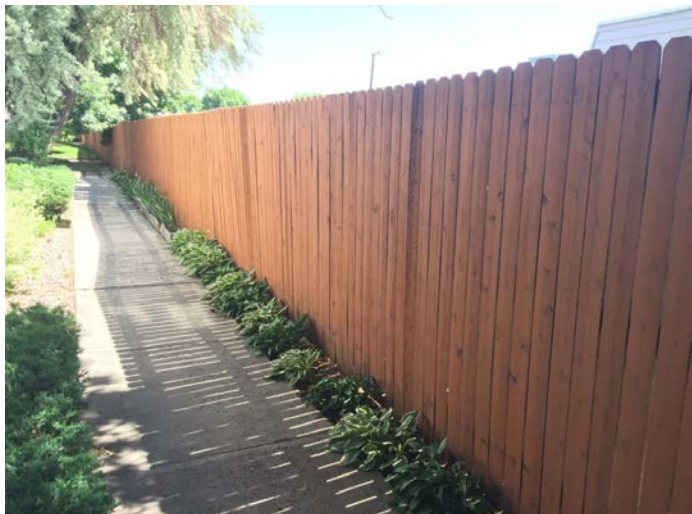
Comp #: 1001 Wood Fencing - Replace

- The fencing is aging appropriately with no major damages noted at the time of our site visit. Some boards were warped and stain varied in conditions.
- As long as proper weatherproofing is performed, the overall life of the fence should range between 15 - 20 years.
- Without maintenance, expect to replace every 10 - 12 years.
- The remaining life is based on the observed condition.

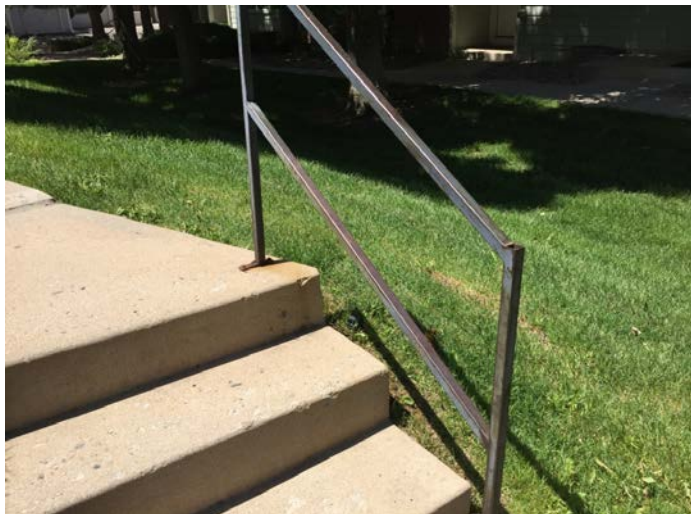
Comp #: 1002 Ironwork Fencing - Replace

- In general, the fence was in good to fair condition with no structural problems observed. However, the metal railings were in fair to poor condition. We did note major and minor rust/corrosion in some areas.
- The average replacement cycle for this type of fencing typically ranges between 25 - 35 years, depending on maintenance levels and exposure to elements.
- These surfaces should be repaired prior to being painted.
- Remaining life is based on the current age and conditions of the metal surfaces.

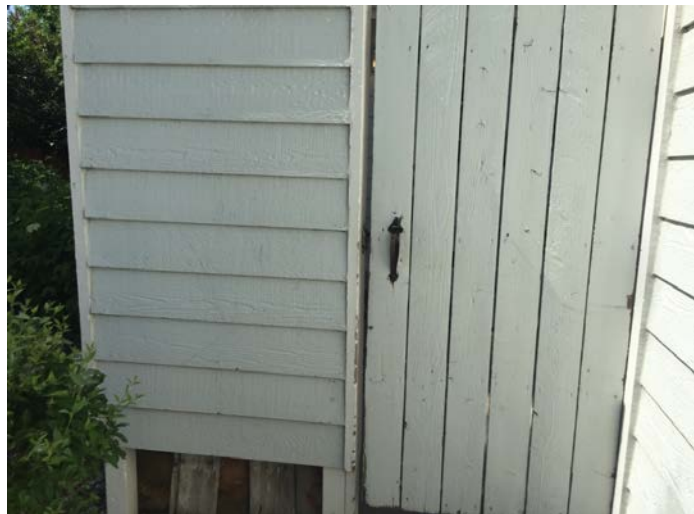
Comp #: 1006 Hardboard Rear Dividing Fence - Replace

- These dividers had not been replaced at the time of our site visit. The hardboard siding and trim work was in poor condition. We noted cracking, paint chipping, etc throughout the community.
- These walls should be painted at the same time as the units are in order to keep a consistent appearance throughout the community.
- Based on observed condition, we suggest replacing these walls within the next couple years.

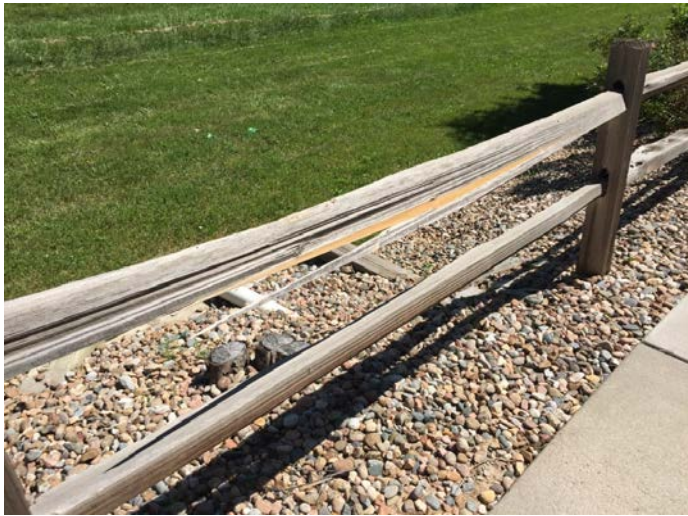
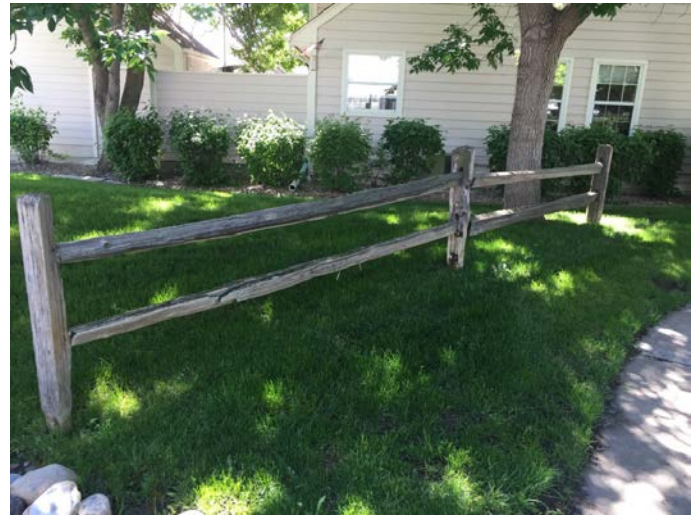
Comp #: 1009 Split Rail Fencing - Replace

- The split rail fencing was in fair to poor condition and has not been stained or painted in the past. We noted some railings having splits or cracks in them. Other rails had wood rot throughout.
- This type of fence has an average life expectancy of 10 - 15 years, depending on level of maintenance and exposure to elements.
- Remaining life is based on the current conditions and overall age of the fencing.

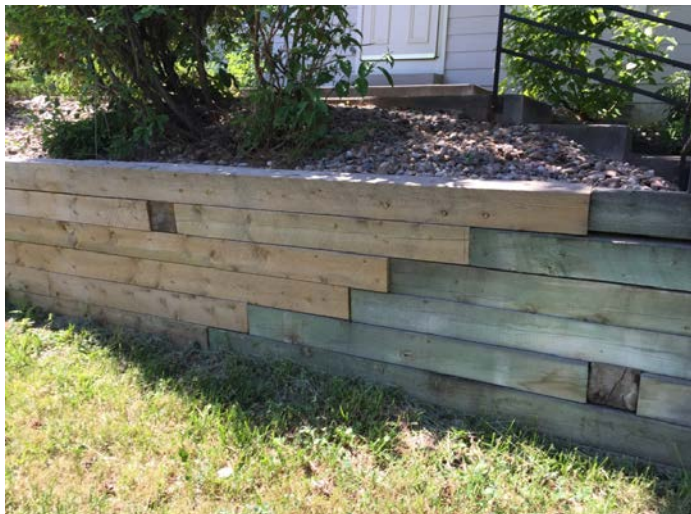
Comp #: 1011 Timber Retaining Wall - Repair

- At the time of our site visit, we noted that approximately half of the retaining wall in the greenbelt area had been replaced/repared. The remainder of retaining walls were in fair condition with shifting and settling timbers present.
- Generally, in most conditions, these walls have an overall life expectancy of 20 - 25 years.
- However, with periodic repairs, the life of the wall can be extended. The top timber tends to become the first piece to deteriorate and need to be replaced.
- This type of wall also tends to be susceptible to movement and leaning. When replacement is necessary, most associations are converting to block wall for longer life expectancy and less maintenance.

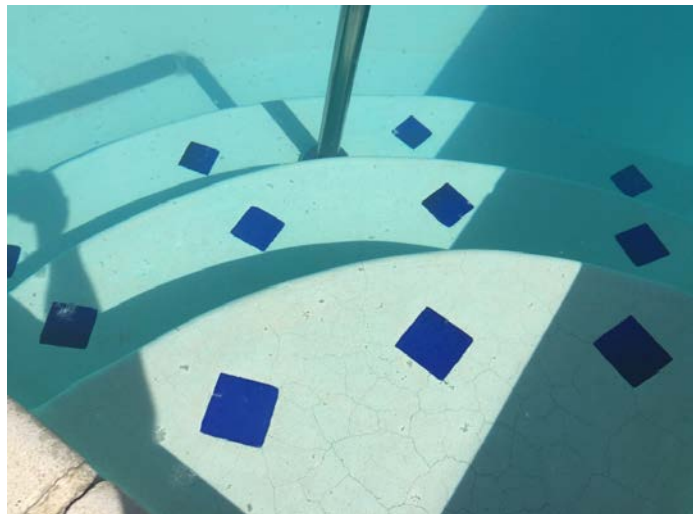
Comp #: 1101 Pool - Resurface

- In general, the pool surface is in fair to poor condition with cracking noted on steps and throughout.
- The average resurfacing cycle for pool surfaces ranges from 8 - 10 years, depending on the quality of the water and the chemical levels in the water.
- In this climate, frequent acid washes are required to clean the surface after being winterized for 9 months a year.
- These acid washes gradually "eat" away the plaster and the surface becomes rough.
- The useful life and remaining life is based on the condition and age of property.

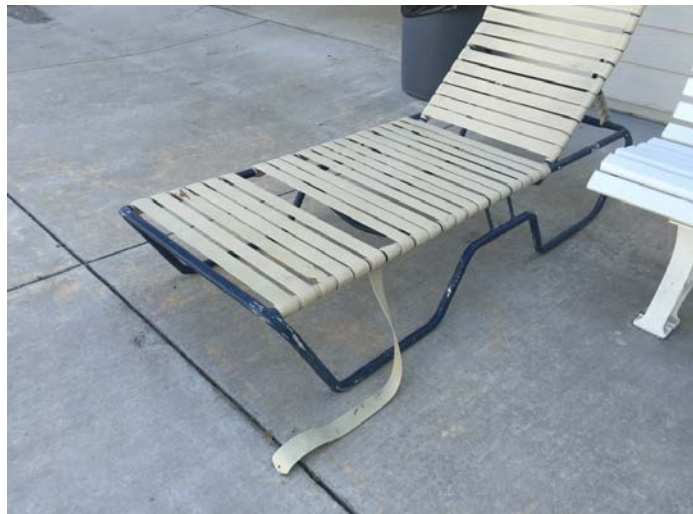
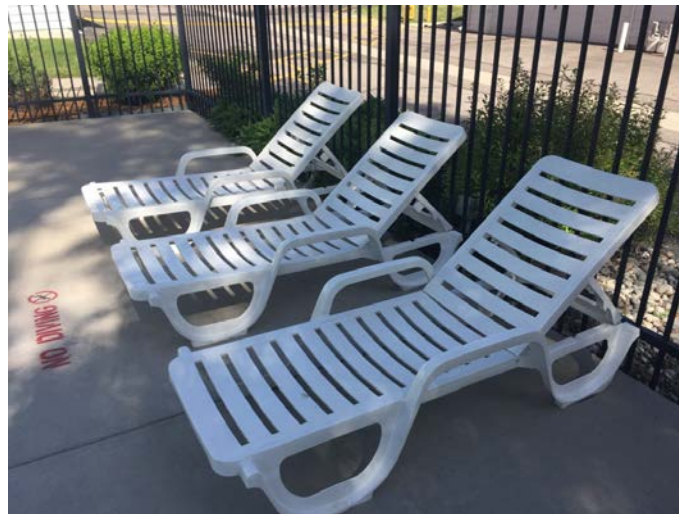
Comp #: 1121 Pool Furniture - Replace

- The pool area had all the same furniture. However, some of the straps were broken or missing. The pool furniture, in general, is in fair to condition.
- Due to minimal replacement cost, fund for this component as an operating expense.
- No reserve funding necessary.

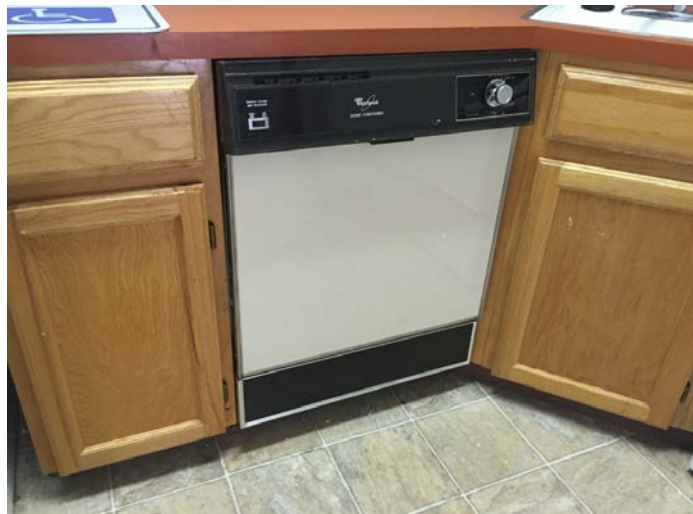
Comp #: 1402 Appliances - Replace

- All of the appliances were the same at the time of our site visit.
- Due to the minimal use these appliances receive expect a useful life of approximately 15 - 20 years from these units.
- Remaining life based on current age and condition.

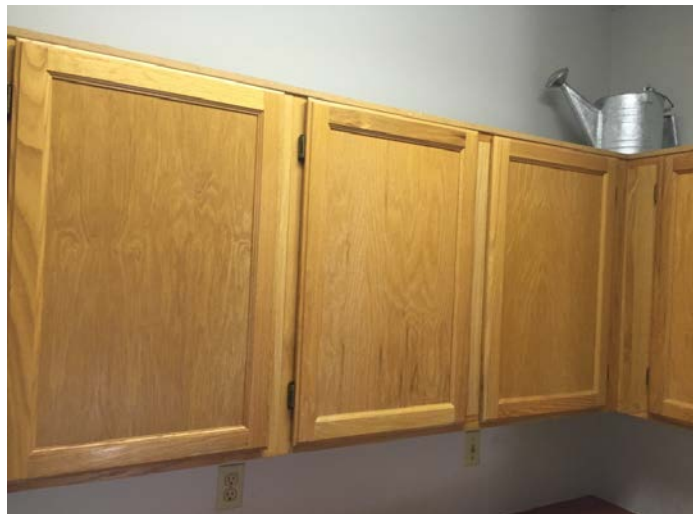
Comp #: 1403 Cabinets and Countertops -Replace

- At the time of our site visit, the cabinets and countertops were still the same and functional. However, these items have reached an age where they are no longer aesthetically pleasing and are out of date.
- When replacement is scheduled, we suggest replacing the countertops with an upgraded product that has a longer life expectancy than Formica.
- The timing of replacement is at the BOD's discretion since this is considered a cosmetic issue.
- We suggest updating kitchens every 20 - 25 years to maintain an appropriate and modern appearance for the community.
