Millbrook Townhomes Canyon Trail & Depew Street Littleton, CO80128

Level 2, Platinum Reserve Analysis Report Period – 01/01/17 – 12/31/17

Client Reference Number - 7780
Property Type – Townhome Style

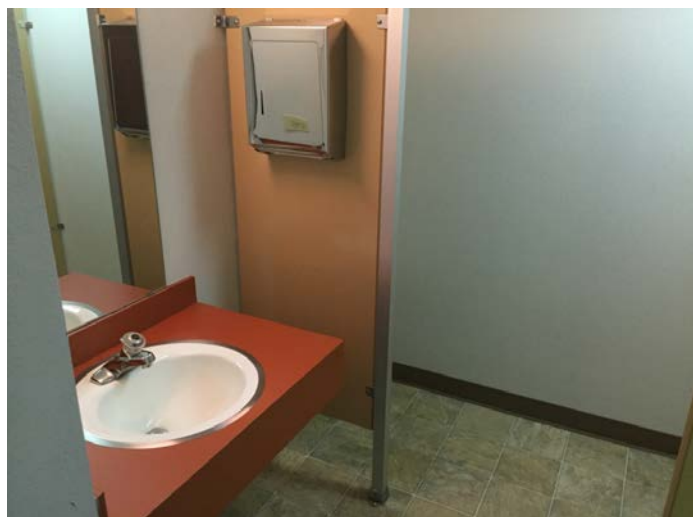
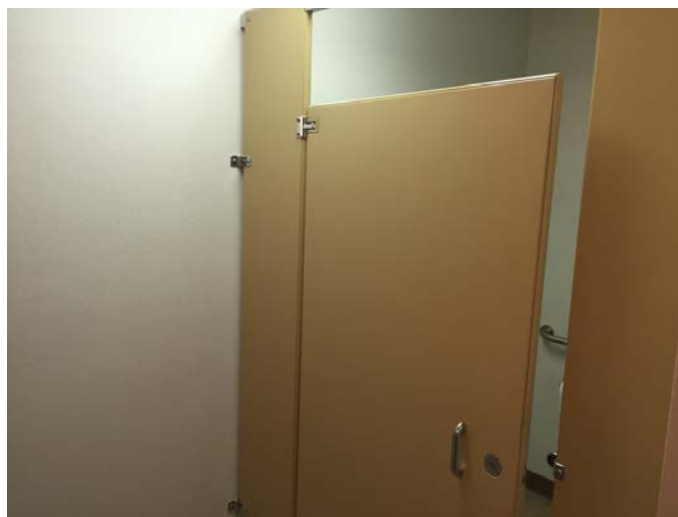
Comp #: 1413 Restroom - Remodel

- At the time of our site visit, the bathrooms appeared to be the same, but were still in fair condition with no major damages.
- Most associations perform a general remodel of the restroom/locker room interiors every 15 - 20 years to maintain appearance and keep up with current decorative trends.
- Based on the age of the community, we suggest planning a remodel of the interiors within the next couple years.
- The final decision is up to the community members in deciding when to spend the money to perform this project since it is considered cosmetic.

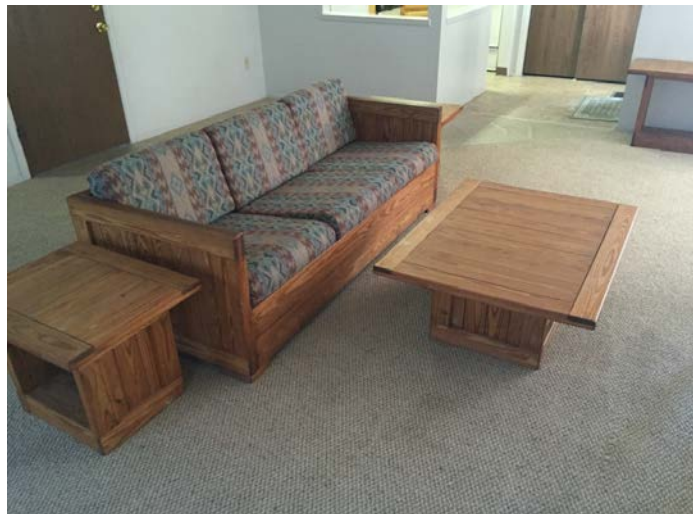
Comp #: 1415 Clubhouse - Remodel/Update

- In general, the lobby area of the clubhouse was dated, but functional. Overall, the area was in fair condition.
- General remodel of this area is suggested every 15 - 20 years in order to maintain current decorative trends and an appropriate appearance for the community.
- Remaining life is based on the current age and conditions of the lobby.

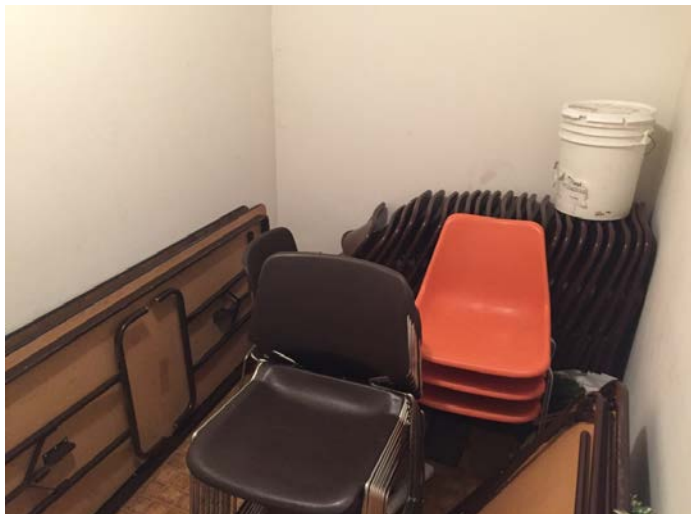
Comp #: 1417 Furniture - Replace

- This type of furniture is typically replaced on an as needed basis with general operating funds.
- Therefore, separate funding in the Reserve account is not necessary for this component.

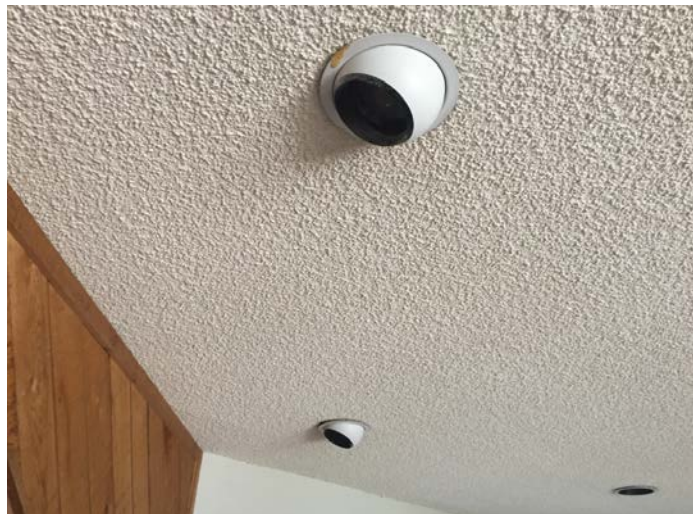
Comp #: 1601 Interior Lights - Replace

- There were no reported problems with the interior lighting at the time of our site visit. In general, the lights appeared to be in good working condition.
- Can lights and florescent lights are inexpensive to replace and should be replaced on an as needed basis with maintenance/operating funds.
- Reserve funds are not necessary at this time.

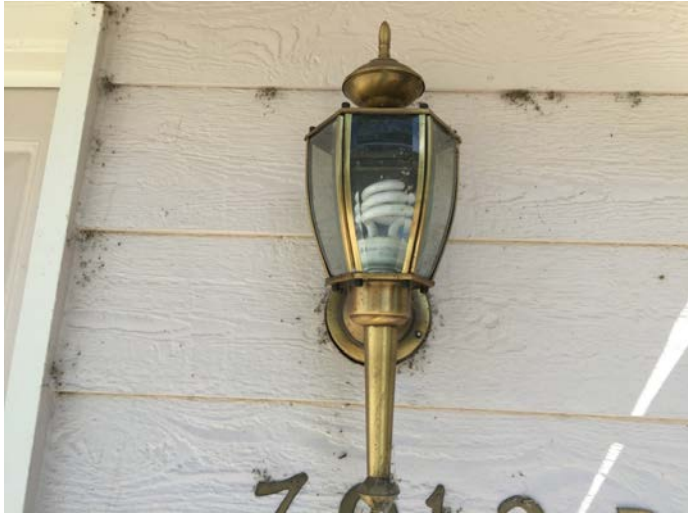
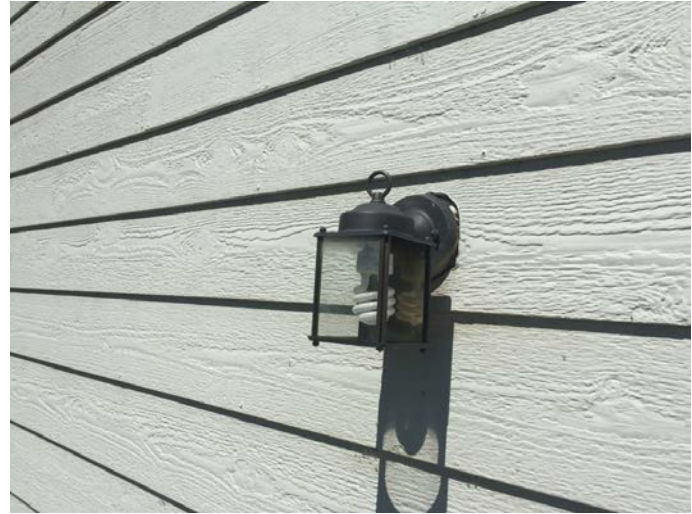
Comp #: 1602 Exterior Wall Mount - Replace

- Our field work was conducted during daylight hours, therefore, we were unable to see the lights in working condition. Aesthetically speaking, the lights are in fair condition. Minor rust and discoloration were noted. We did note that a couple of lights were broken.
- While replacement can occur on an as needed basis, it is our opinion and recommendation to replace all lights at the same time every 15 - 20 years to maintain a consistent appearance throughout the property.
- In addition, by replacing multiple fixtures, the association will be able to obtain a quantity discount for the fixtures. Estimated replacement cost includes labor for installation.
