Physical Security Audit Findings and Recommendations

Prepared for: [REDACTED]

Prepared By: Full Scope Security, LLC.

Date: 10 December 2023

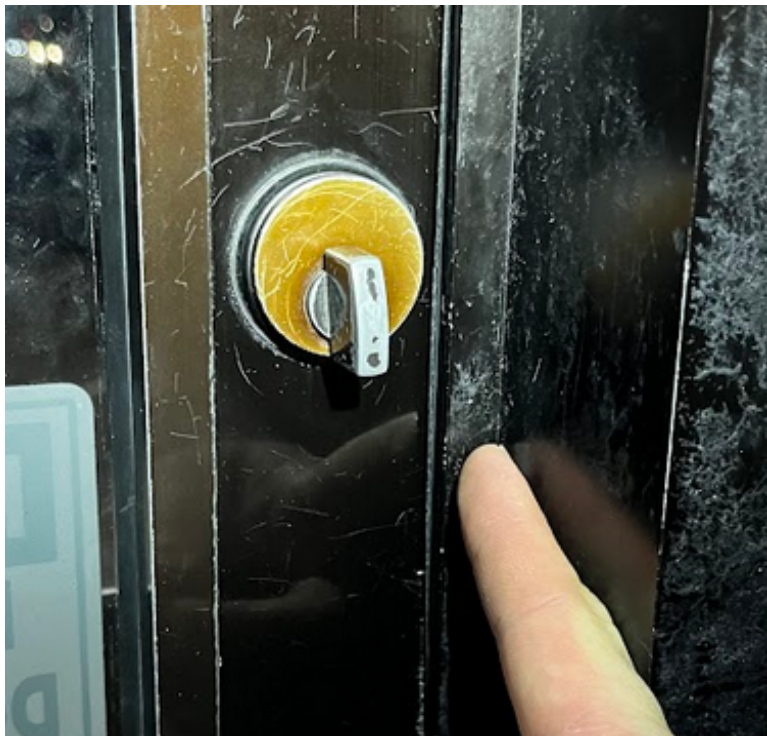
The Front Door is in a well-lit area of the building's East perimeter, and directly faces a strip of well-populated stores across the street. There is a camera in the window above the Front Door. The lighting, camera, and positioning of this door are moderately to highly likely to deter an attacker from attempting entry through this door. However, it should be noted that despite the heavily-trafficked area, there was no undue attention made to Consultant, nor any authorities called, as Consultant was attempting entry through this door, despite the obvious efforts to forcibly enter the door without a properly authorized key. The Front Door's security is moderate, and the pins of the lock were noticeably sticky, likely due to lack of normal use (locking from inside instead of with key) and exposure to the elements. Consultant attempted single-pin picking, raking, and using a lockpick gun to gain access, all of which were unsuccessful. This does not indicate that entry via picking through the Front Door is impossible, but that the state of the lock core and pins simultaneously provide an extra layer of difficulty and add the possibility of breaking the lock or getting a tool stuck inside the lock. Due to these risks, Consultant ceased lockpicking attempts on the Front Door after approximately 20 minutes. Consultant also attempted the use of a "J-Tool" (a.k.a. "Thumb Turn Flipper") to reach through the gap of the door, but was thwarted by an overlapping piece of metal (Figure 4, below) that did not allow the tool to pass through the gap, even with air wedges deployed to widen the gap.

Figure 4: Metal overlapping strip on inside of Front Door

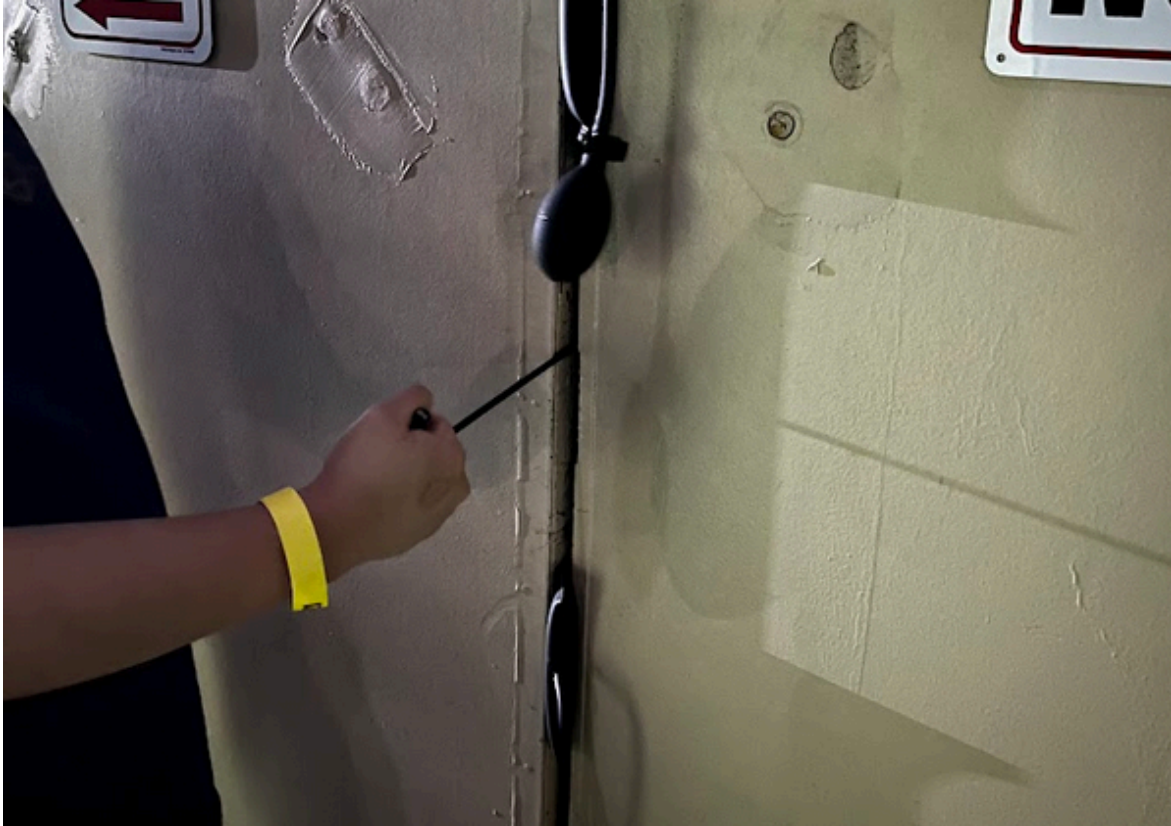
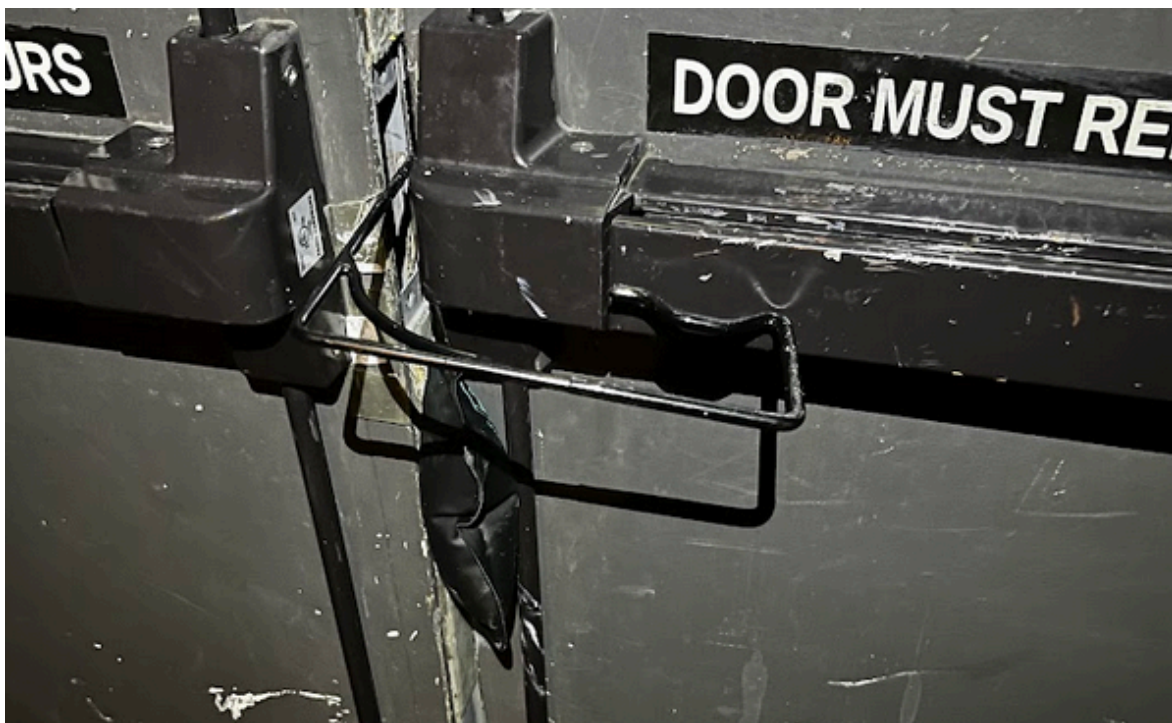
This opening and sightline can provide critical information for a potential attacker. With the gap widened, Consultant was also able to fit a “Double Door Tool” through the gap to reach around and manipulate the crash bars (Figures 6a and 6b).

Figure 6a: Consultant reaching through Double Door after widening gap with air wedges

Figure 6b: Inside angle of the Double Door Tool hitting the crash bar

The Double Door was completely unlocked, though the lack of a handle on the outside might stump low-skilled attackers. This in addition to the gap referenced above allowed for the successful use of tools through the gap to activate the crash bars. Consultant recommends adding a lock to the Double Door which will only be engaged during the closing process (door likely must remain unlocked during business hours for fire safety code).

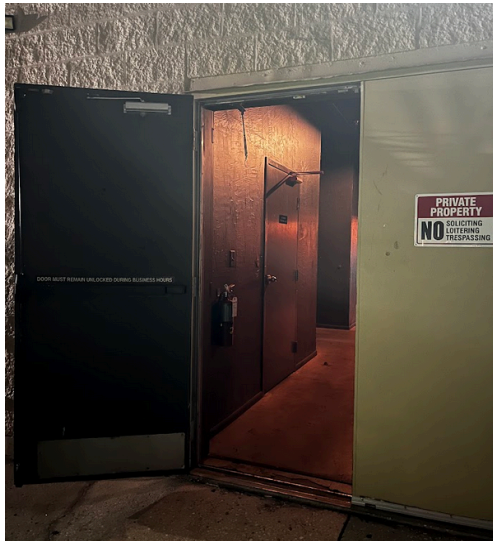
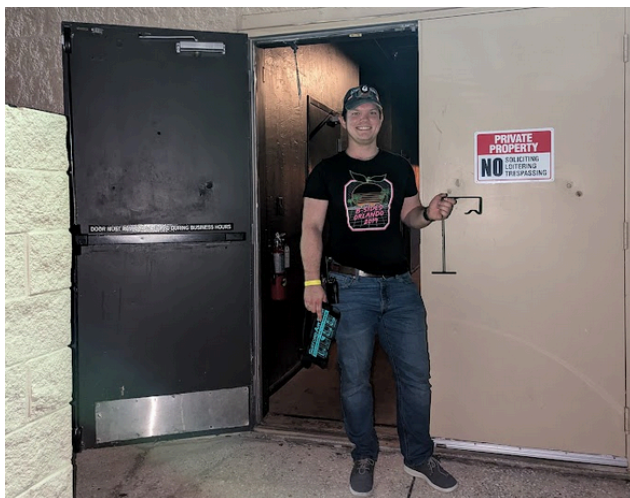
After some manipulation, Consultant was able to successfully engage the crash bar and open the Double Door (Figures 7 and 8 below), gaining unauthorized access to the building. Another possible method of entry to the Double Door is via removing the exposed, insecure, external-facing hinges and walking the door off the frame entirely. Consultant did not attempt this method due to its general 'destructive' nature, but was able to determine that the hinges are vulnerable to this type of attack from an attacker less concerned about maintaining the integrity of the door during the attack. Overall, the Double Door is the most vulnerable external entry into the building. The lack of security on the door, a general lack of deterrents, and a misaligned nearby camera all work to make this door the *most likely point of attempted entry for an attacker*.

Figure 7: Double Door successfully bypassed with air wedges and Double Door Tool

Figure 8: Consultant with the Double Door Tool and air wedges after having successfully bypassed the Double Door

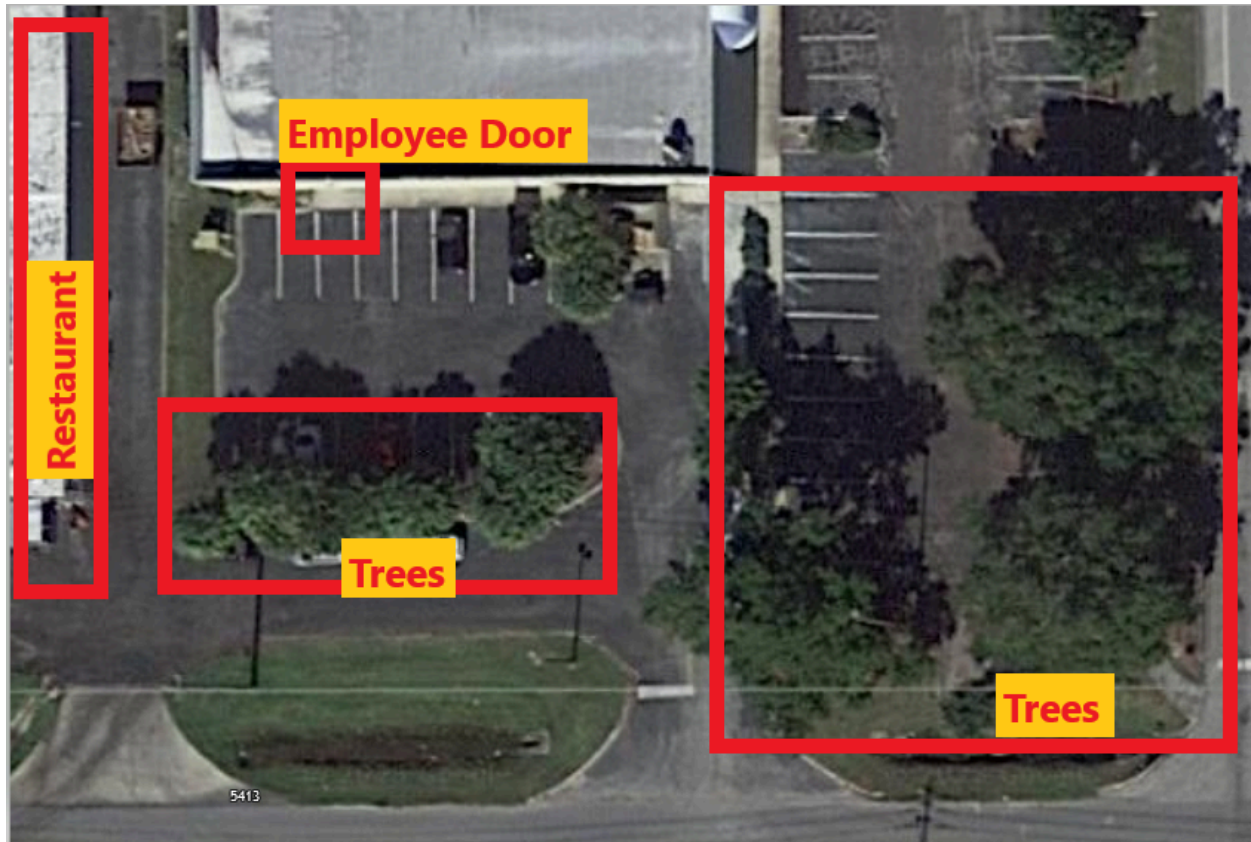
The Employee Door is in a well lit area of the Southern building perimeter, near the West edge of the building. This door is not easily visible from the surrounding areas due to a restaurant to the West, and trees to the South and East. Figure 9 shows the sightlines blocked by nearby restaurant and trees.

Figure 9: Employee Door visibility blocked by surrounding environment

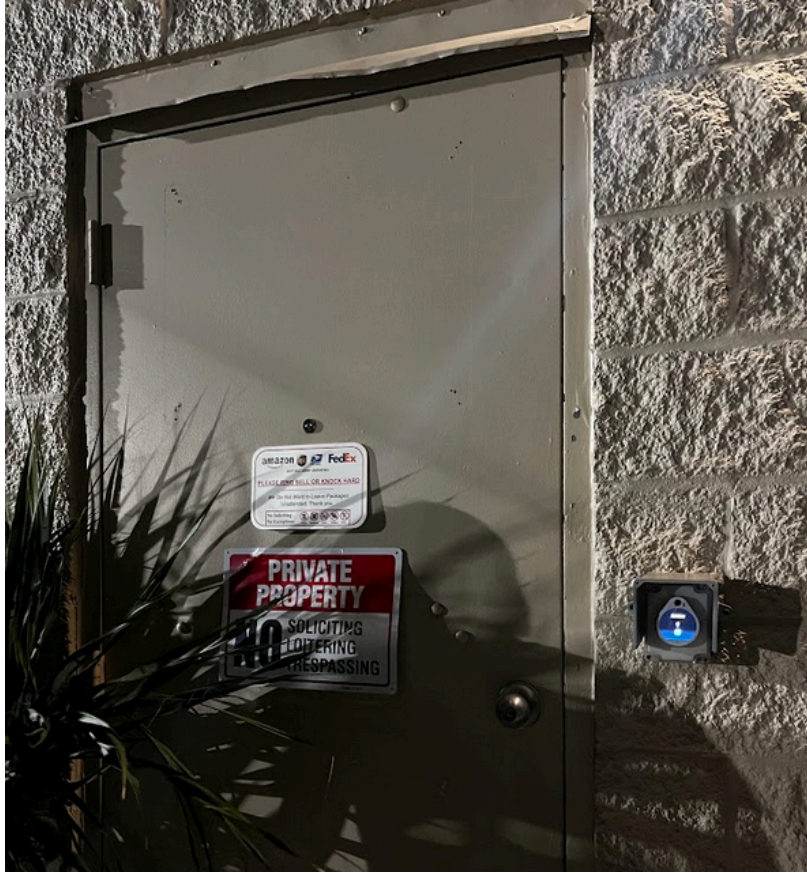
The lighting is a potential deterrent for an attacker. The door is locked by an electronic access control panel to the right of the door (Figure 10). A nearby camera on the Southwestern corner of the building and a camera on the access control panel are also potential deterrents. Another camera not owned by Client on the restaurant building's corner also acts as a deterrent. Overall, despite the large amount of concealment, an attacker would be moderately likely to be deterred by the nearby cameras and strong lighting. One possible method of entry to the Employee Door is via removing the exposed, insecure, external-facing hinges (also visible in Figure 10) and walking the door off the frame entirely. Consultant did not attempt this method due to its general 'destructive' nature, but was able to determine that the hinges are vulnerable to this type of attack from an attacker less concerned about maintaining the integrity of the door during the attack. This type of attack may be mitigated by the door's magnetic lock, unless the attacker is also able to disable the magnet or slip a disruptive item between the magnetic poles to reduce its effectiveness.

Figure 10: Employee Door, showing access control panel and exposed insecure hinges

The hinges of the Double Door and Employee Door were exposed and insecure. Consultant also recommends using more secure hinges or jamb pins to prevent attackers from removing the hinges and walking the door off the frame.

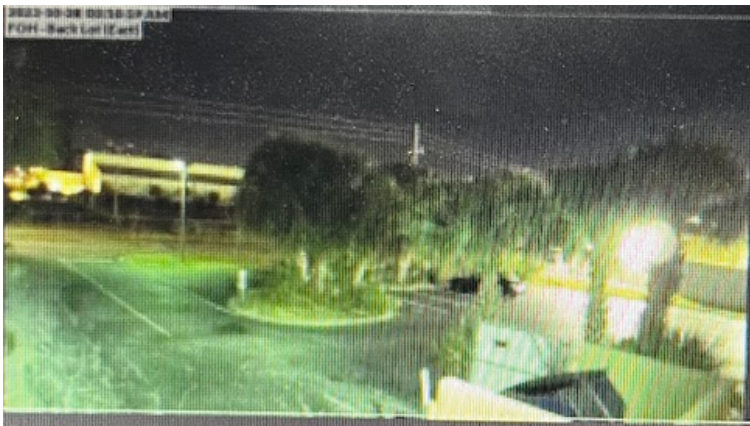
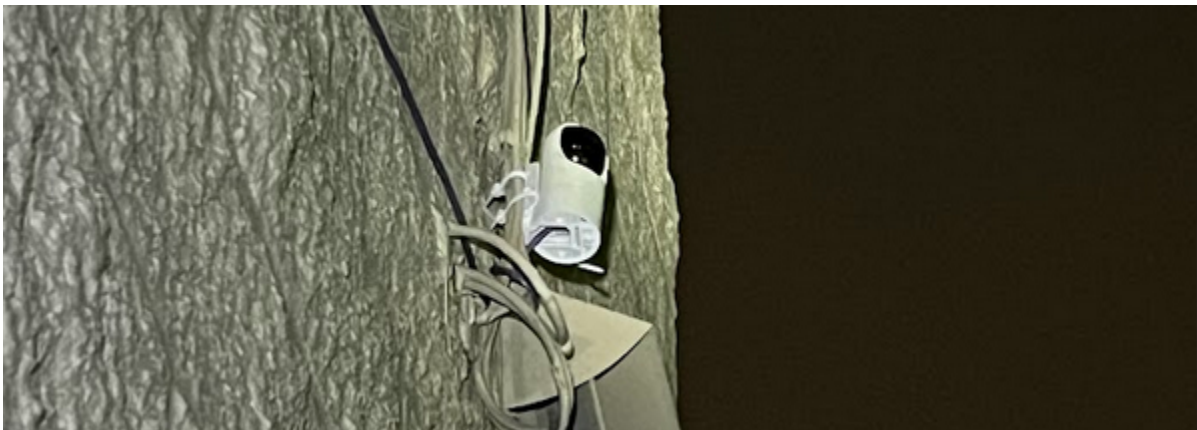
Figures 11a and 11b below show the camera pointing towards the employee parking lot, positioned on the Southeast corner of the building (the same camera referenced above the Double Door in 3.1.1.2). This camera is not able to see the area directly outside the Double Door, providing a blind spot for attackers to take advantage of. The angle of the camera is catching too much sky view, reducing the amount of relevant information in the picture.

Figure 11a: Exterior camera view on dumpster side (Southeast)

Figure 11b: Outside view of camera, visibly misaligned with bad viewing angle

Consultant recommends adding at least one camera to the Workshop. Consultant also recommends adjusting exterior-facing camera angles to more completely view all of the exterior doors and their immediate surrounding areas.

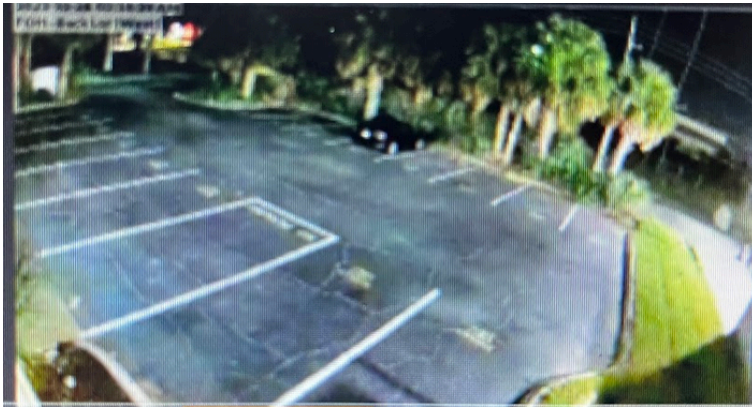
Figure 12 below shows a camera pointing towards the employee parking lot, positioned on the Southwest corner of the building (the same camera referenced above the Employee Door in 3.1.1.3). While this camera is angled slightly better and more downwards compared to the camera in Figures 11a and 11b, this camera still does not provide a very clear view of the area

in front of the Employee Door with fob access. This camera would still likely be able to capture the presence of an attacker, albeit with little detail on the image.

Figure 12: Exterior camera on restaurant side (Southwest)

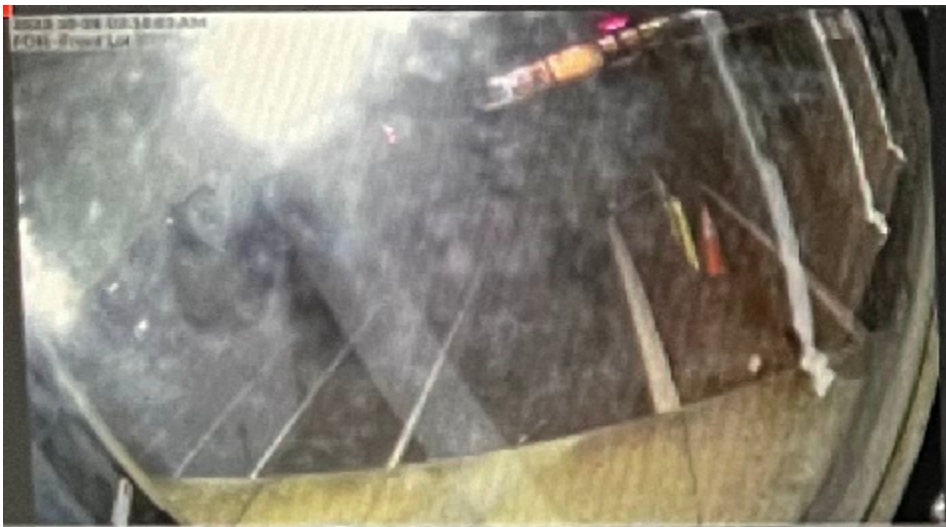
Figure 13 below shows a camera pointing towards the guest parking lot from the window above the Front Door (the same camera referenced above the Front Door in 3.1.1.1). This camera's view is obscured by the bright exterior lights and the general smudges and dust on the window. Additionally, the angle of the camera would not effectively capture a detailed view of an attacker attempting entry through the Front Door.

Figure 13: Camera in window above Front Door

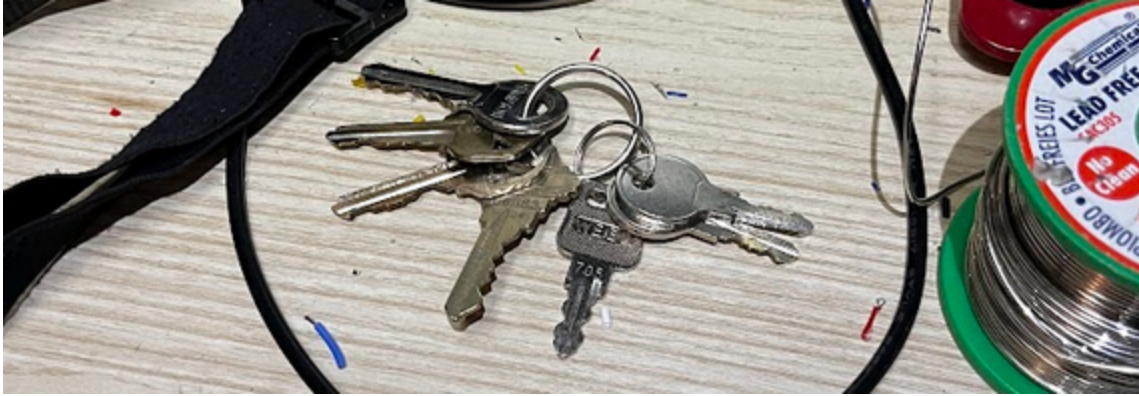
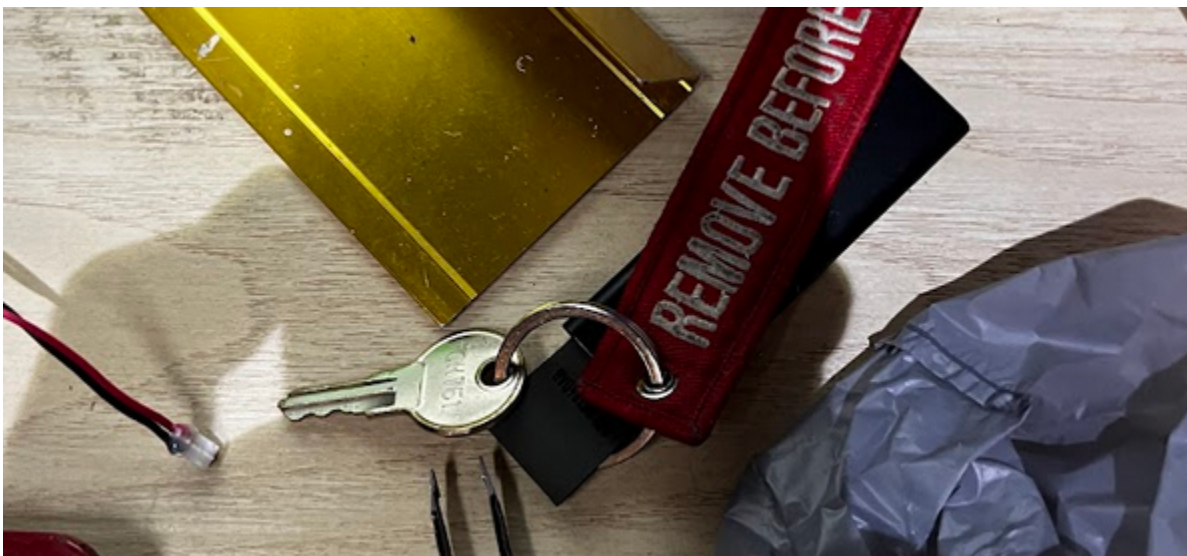
Figure 19a: Keys in [REDACTED] office

Figure 19b: Keys in [REDACTED] office

Primarily, Consultant found several sets of keys in the Control Room and [REDACTED] Office that allowed for even further access in the building. One of these sets of keys also included the fob for disabling the security system. Consultant recommends storing all keys and access control or security devices in a lockable key box that is securely affixed to the wall. With this implementation, even if an attacker makes their way into the building, they would have a harder time finding keys, and would then also have to know how to break into the key box to retrieve any keys. Accessing this key box could be managed by each employee having their own key to the key box. Each employee already has a key fob to get into the exterior Employee Door, so just attaching a key box key onto their keychain with their fob would be an accessible and easy solution for employees to retain access to the building keys while preventing access from attackers.

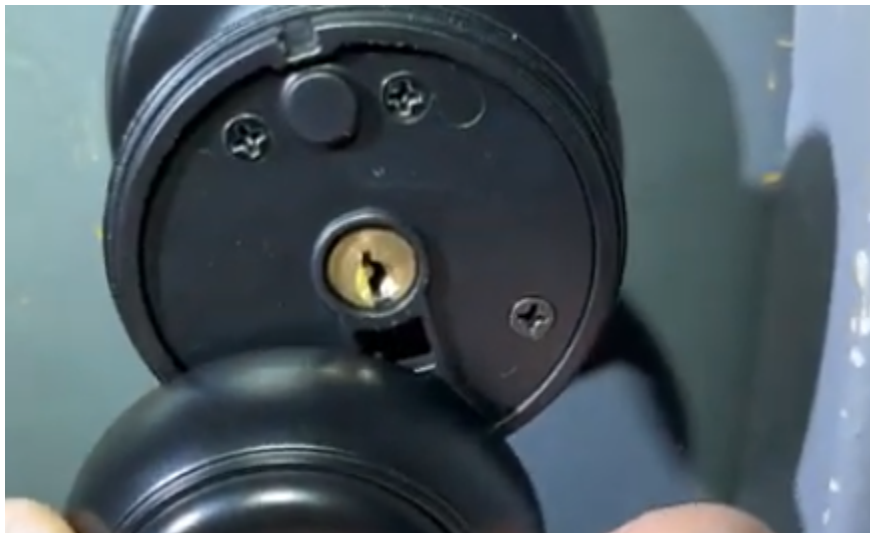
Consultant was able to use a plastic shim card to completely bypass the lock by reaching through the frame of the door and pushing the latch back to an unlocked position. Upon further examination, Consultant found that the locking mechanism does have a dead-latch, which should protect against such shimming attacks if installed correctly. The success of the shimming attack indicates improperly fitted doors/locks that do not engage the deadlatch at all, rendering it useless in this instance.

Figure 21: Management Office door lock with front plate rotated away, showing key hole

Consultant also found several doors that had locks, but whose locks either completely lacked a dead latch, or the fitment of the lock in the door frame was improper which made shimming the doors open possible. Consultant recommends that the locks on internal doors be equipped with properly fitting dead latches at the very least level of security, or electronic access controls (such as the one on the external Employee Door) at a higher level of security.

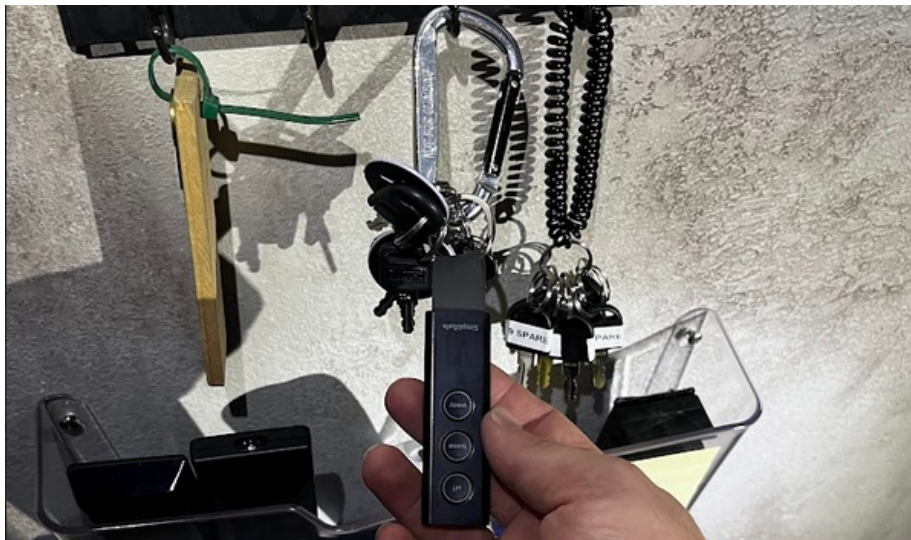
The Control Room contained several assets that seemed important or business-critical including, but not limited to: computers for controlling the [REDACTED], a set of keys that included a key to the Refreshment Area's cash register and a Simplisafe fob for the building's alarm system (Figure 22).

Figure 22: SimpliSafe fob and other keys left exposed in the unlocked Control Room

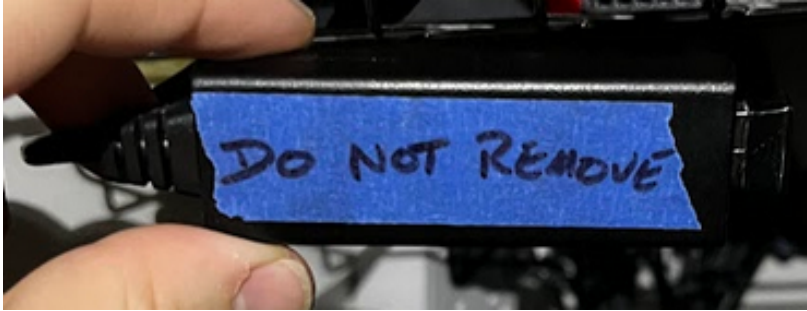
With easy access to the control room and the computers within, Consultant was able to implant a keylogger device on the center workstation (Figure 23). The device is a small, relatively innocuous looking piece that appears at a quick glance to be a keyboard adapter. Consultant took the added step of adding a strip of tape that said "DO NOT REMOVE" to both cover the arming button's hole and add a layer of deception to make it appear that this device was added by management and should not be tampered with.

Figure 23: Keylogger device

Consultant's implanted keylogger device was initially unplugged, which is generally good practice to unplug unknown or suspicious items while trying to learn from higher-ups if they're legitimate or intended devices. However, an employee eventually plugged the keylogger back into the computer, allowing for Consultant to gain more information. Consultant recommends that Client employees do not plug in devices without knowing their purpose or legitimacy from higher-ups. When in doubt, employees should default to asking management about a device before plugging it in.

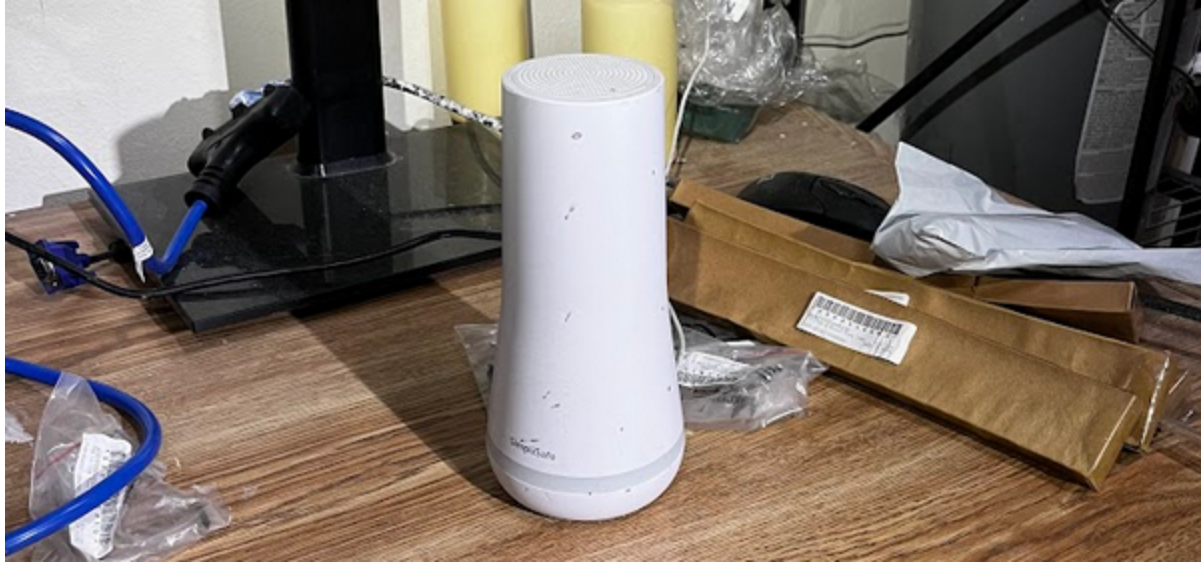
Figure 26: Exposed alarm base station

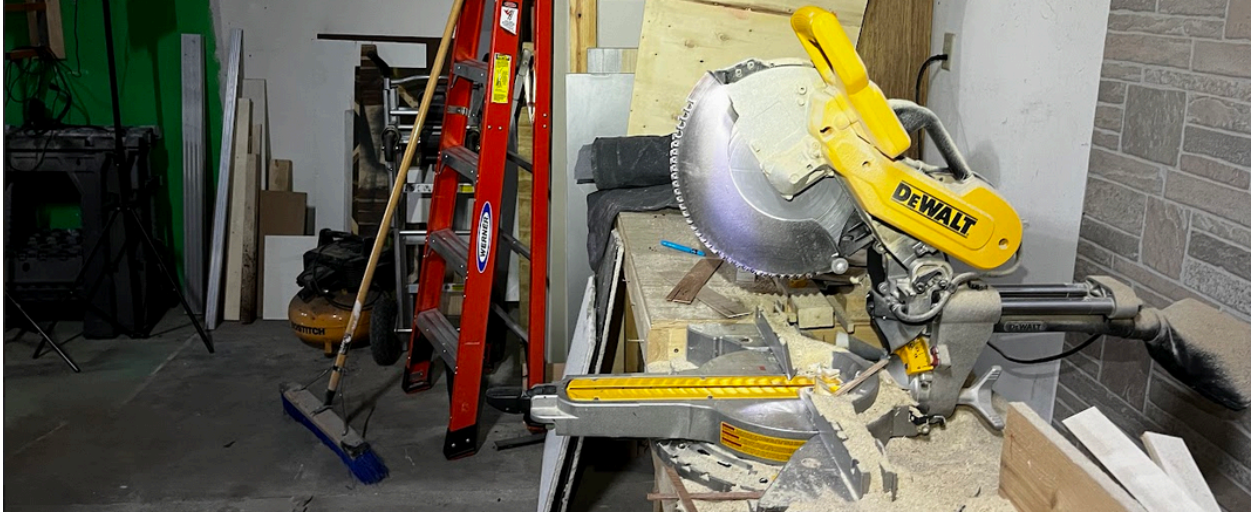
Figure 28: Easily accessible, dangerous equipment

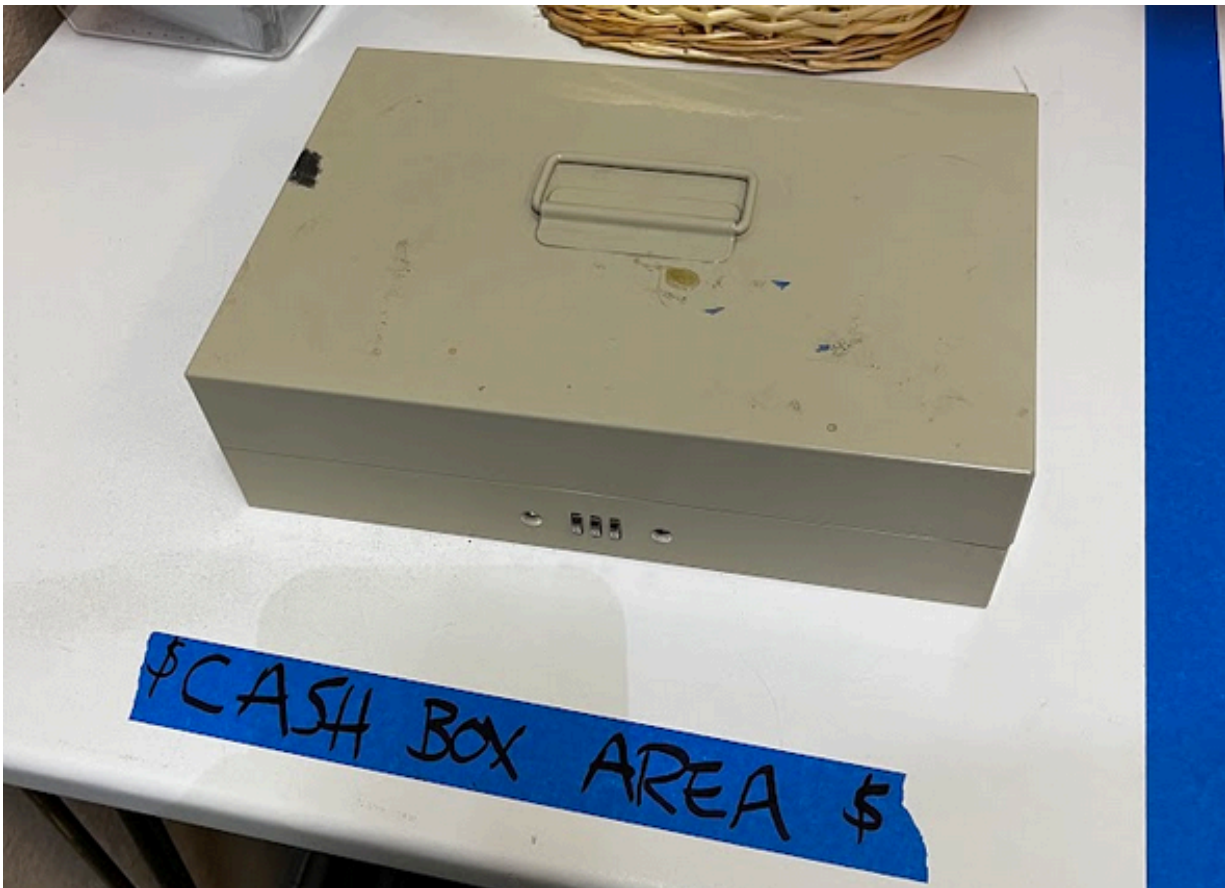
Figure 29a: Exposed, portable cash box (not secured to stable object)

Figure 29b: Weak security on cash box

Figure 29c: Cash box easily accessed

The cash box in the Stock Room was not affixed to a solid surface, and had low security. Consultant was able to visually decode the locking wheels and gain access to the box. Consultant recommends affixing the cash box to a stable surface and investing in a more secure box.

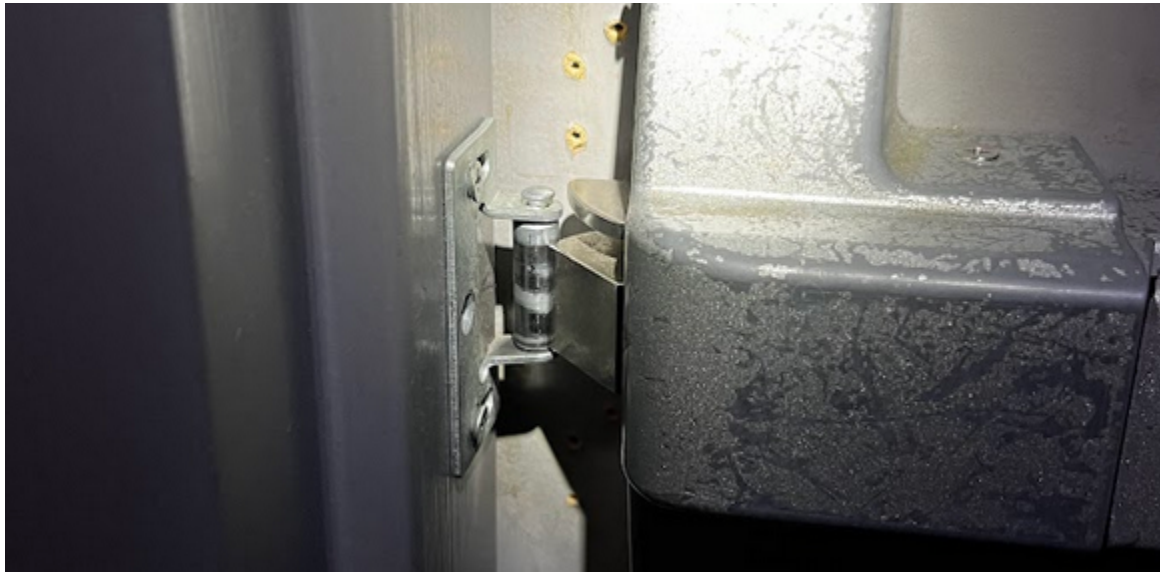
The Front Vestibule area would be the first area encountered by an attacker coming in through the Front Door. There are 2 doors from the Front Vestibule that lead into the rest of the building. One door is locked via an electronic lock and a magnet that is controlled by the employees on their computers. This door's security is effective. The other door to the left of the desk has no handle on the Vestibule-facing side, and is locked by a crash bar on the interior-facing side. The crash bar's locking latch sits over a bar on the inside (Figure 30). However, the latch sits only a couple millimeters onto the bar, and Consultant was able to grab the bottom of the door by hand and jiggle the door to free the latch and open the door.

Figure 30: Front Vestibule door's latch barely sitting on locking bar

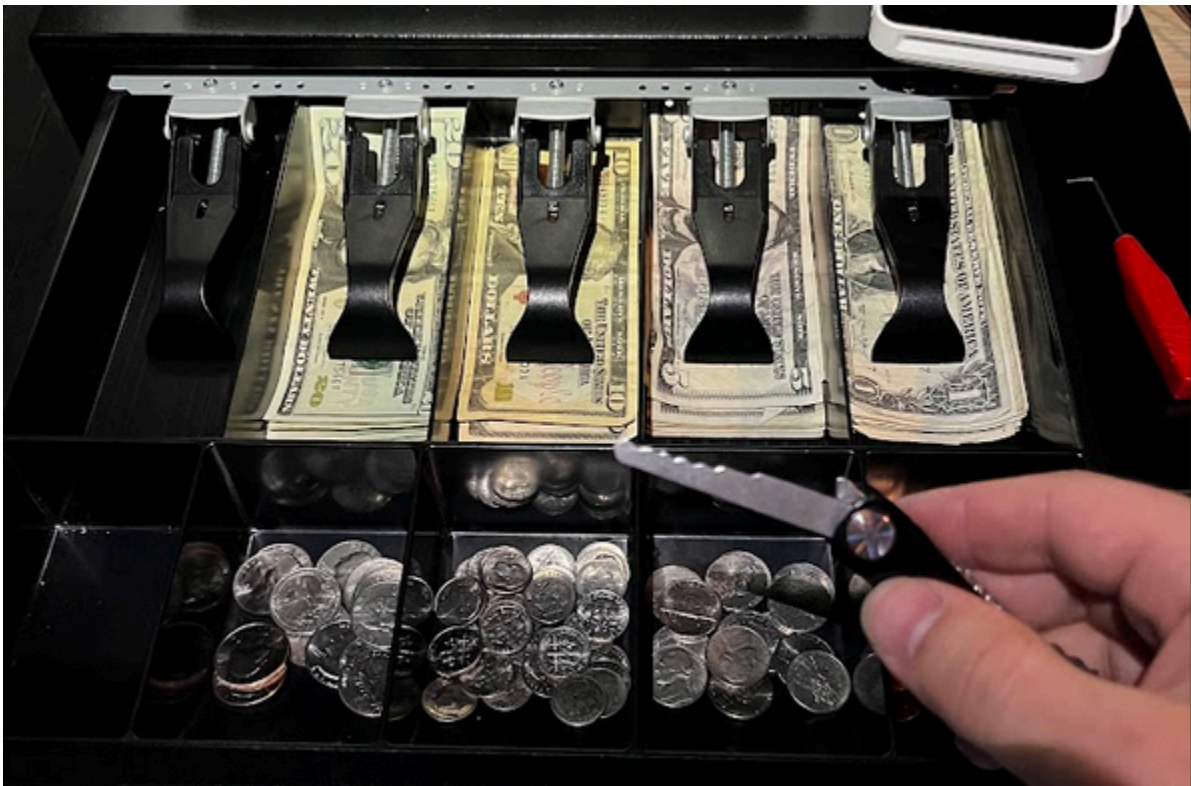
The Refreshments area contained several tablets (Figures 31 and 31b) and a cash register that was stocked with \$292 and change (Figure 32).

Figure 32: Cash register easily accessed

The cash register in the Refreshments Area was not affixed to a solid surface, and had low security. Consultant was able to jiggle the cash register open with a standard jiggle. Consultant also found the key for the cash register in the Control Room. Consultant recommends securing the cash register to a stable surface, and getting a more secure lock for the register. The key box recommendation above would be sufficient mitigation to cover the issue of the easily accessible key.

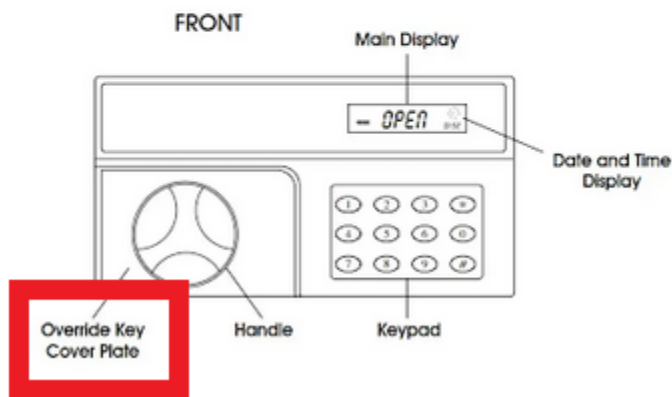
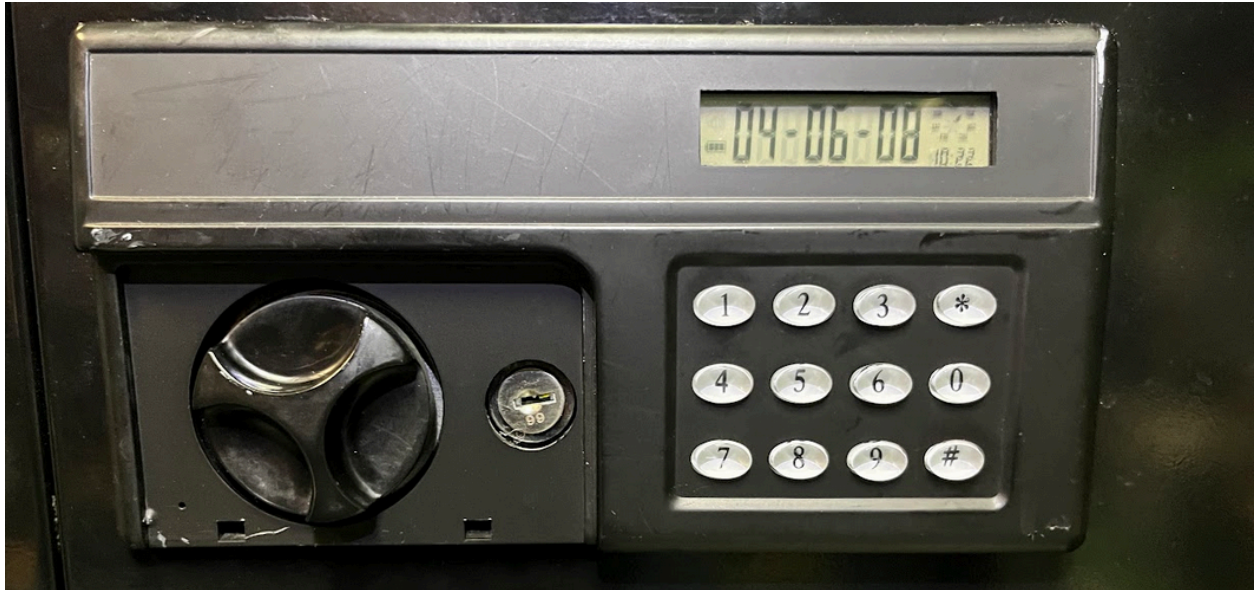
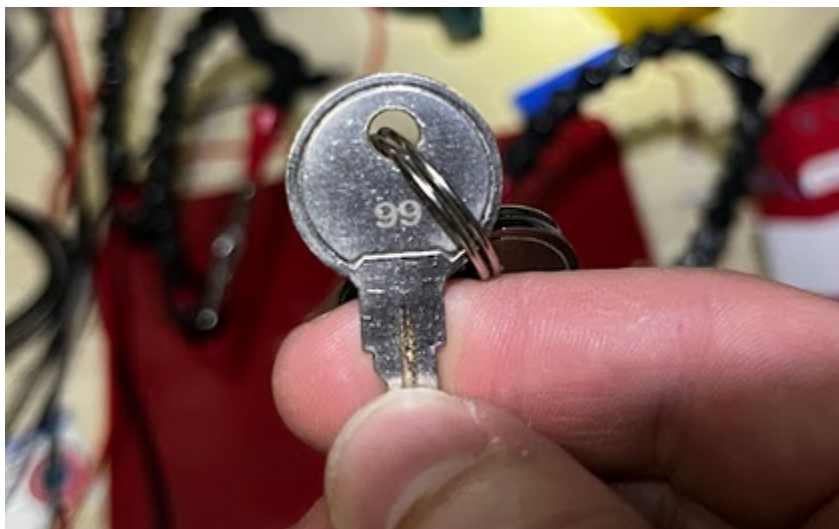
Figure 35: Recon identification of manual bypass to electronic access control

Figure 36: Consultant's removal of the override key cover plate

Figure 37: Matching key found in [REDACTED] Office

The electronic storage cabinet in the Employee Break Room is generally a good and secure option. However, Consultant was able to find a key in [REDACTED] Office to get into the cabinet without knowing the code. The key box recommendation above would be sufficient mitigation to cover the issue of the easily accessible key.
