CHANCE
MANUFACTURING CO., INC.

Service Information

Ride: TWISTER

Subject: INSTALLATION OF RESTRAINING BELTS

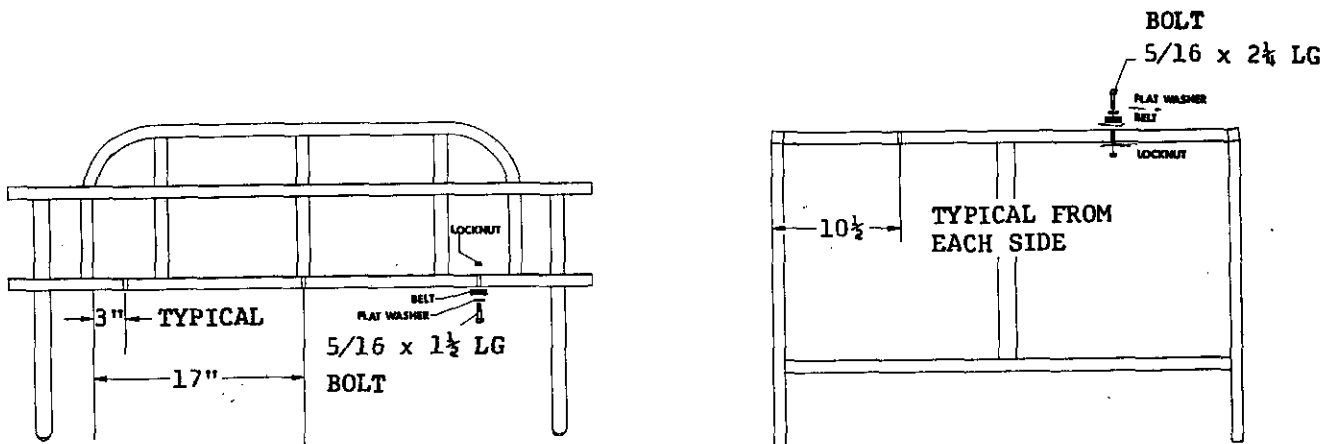
FRONT SEAT BACK

This Service Bulletin is to inform you as a TWISTER owner of a condition that makes the addition of restraining belts to your TWISTER cars necessary and desirable. A complete set of these restraining belts will be shipped to you immediately upon return to us of the enclosed card.

Should a ride patron reach his or her limit of endurance, blackout could possibly result. If this were to happen, they could possibly slide down and out of the car seat.

1. Remove the headrests from the cars and drill three 5/16" diameter holes in each one as shown.
2. Install 5/16 x 1½ LG bolt, flat washer and restraining belt from bottom side of tube on the headrest and secure with locknut.
3. Drill two 5/16" diameter holes down thru the square tube that supports the back of the front seat of each car.
4. Install 5/16 x 2¼ LG bolt, flatwasher and restraining belt from top side of tube and secure with locknut.

When installing belts make sure they are not twisted before bolting.

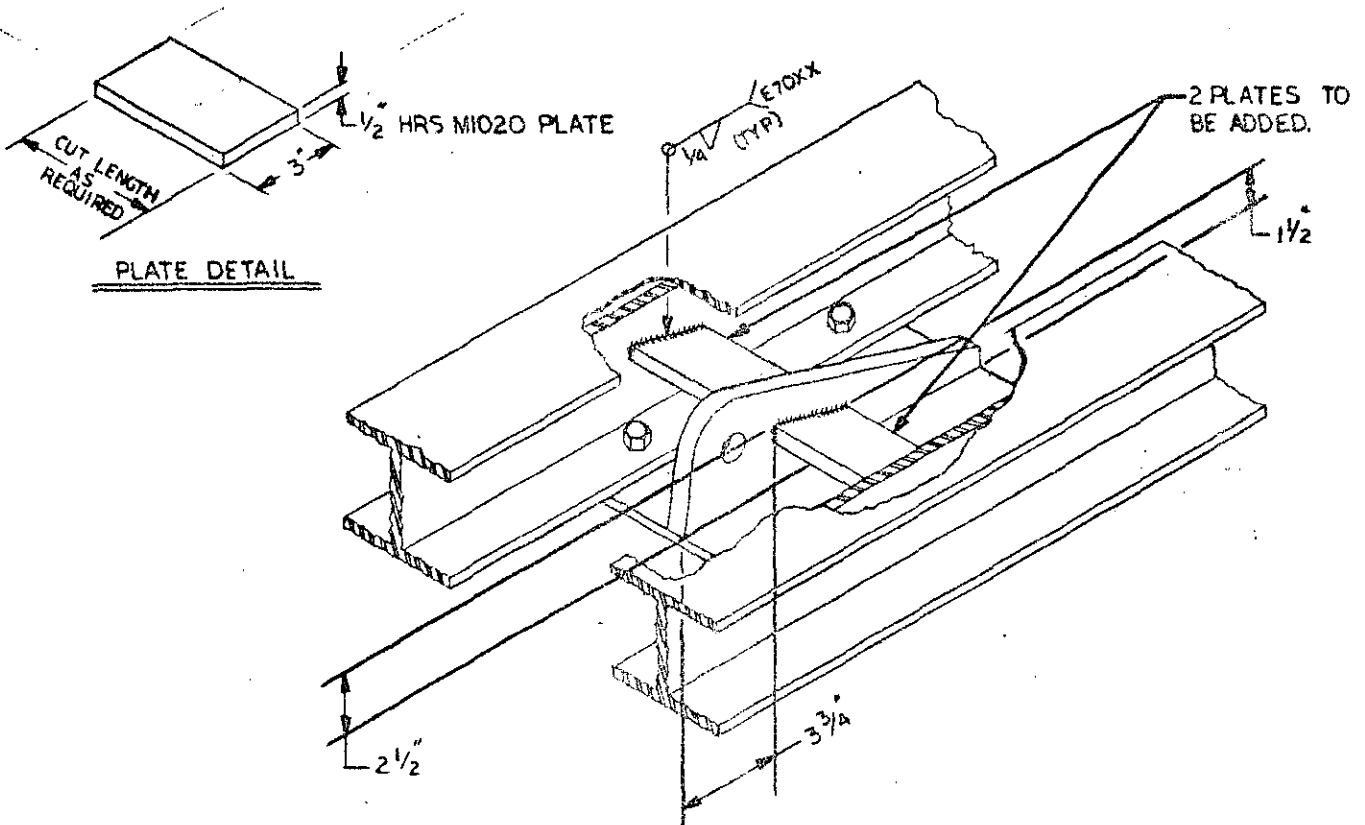
Subject: Floor lift cylinder-structure addition.

In order to improve the structure of the floor lift beam cylinder mounting bracket, we ask that the following change be added to both floor lift beams. Weld two $\frac{1}{2}$ " steel plates, one to each side of the hydraulic cylinder mount, in accordance with the dimensions shown in the detail section. Ride owner to furnish plates to be added.

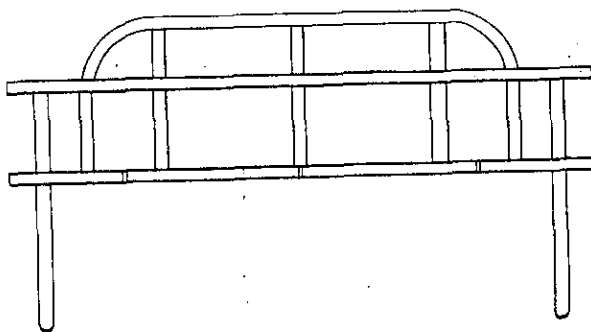
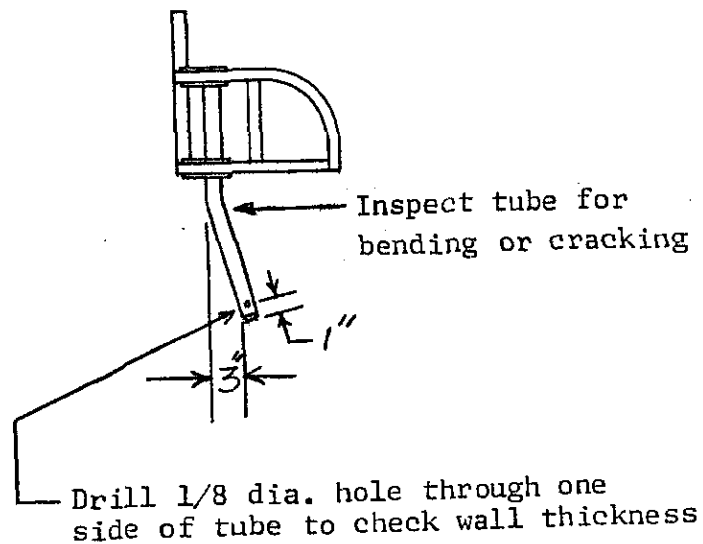
We are asking all TWISTER owners to inspect the head rests on all TWISTER cars immediately. Remove each head rest and inspect the support tubes that fit down in the sockets on each car. Inspect for any signs of physical damage, such as bending or cracking. Next, drill a small hole, 1/8 inch, near the bottom of the support tube approximately 1 inch from bottom. Drill hole through one side of tube only. Check wall thickness of tube. It should be 1/8 inch thick.

Any of the afore-mentioned conditions could result in a serious accident if the head rests are not inspected, and any faults corrected immediately.

If any of the tubes show signs of bending or cracking, or if any tube has less than a 1/8 inch wall, report such condition to Mr. Richard G. Chance, General Manager, Chance Manufacturing Company.

Inspect the head rest support tubes on a regular weekly basis as an added
Factory and General Office: 4219 Irving, Box 2397 Wichita, Kansas 67201

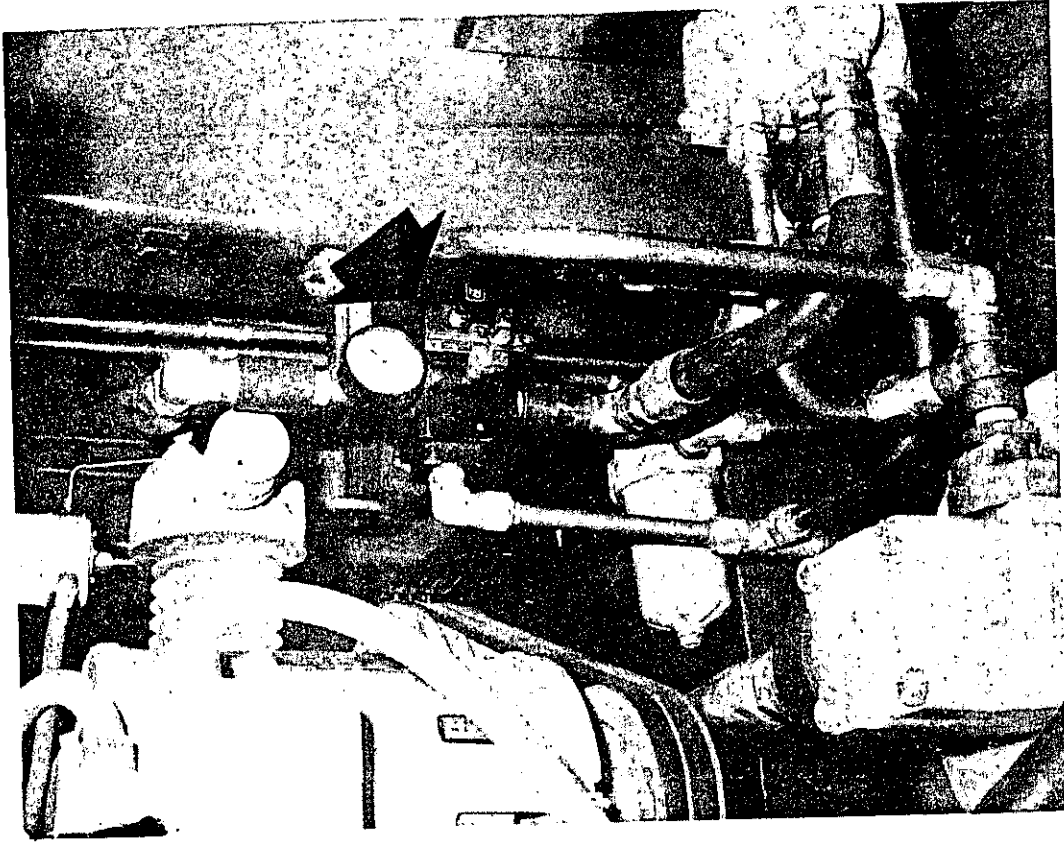
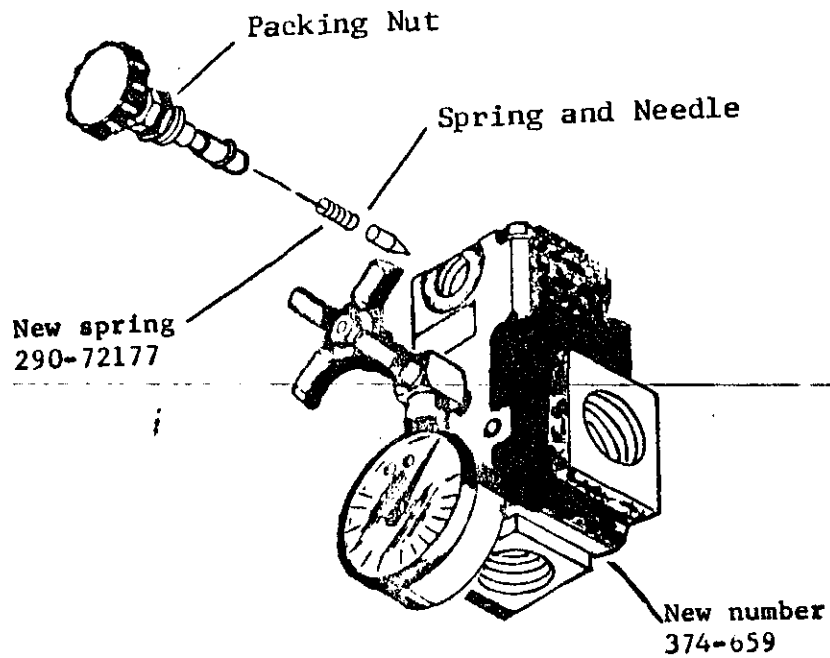
From field observations, it has become apparent that a number of TWISTER Rides are being operated with the "Brake Pressure Relief Valve" set at a higher pressure setting than the recommended 700 P.S.I. maximum.

This results in a severe braking action causing discomfort to ride passengers. In addition, it subjects the ride structure to undue stresses.

To eliminate this, we have enclosed a new spring that is to be installed in the relief valve. This will limit the valve to a maximum setting of approximately 700 P.S.I.

To replace spring, loosen the packing nut behind the Adjustment Knob, and carefully remove Adjustment Knob and Stem.

Replace spring and assemble in reverse order.

Run the ride and adjust Relief Valve to approximately 600-700 P.S.I.

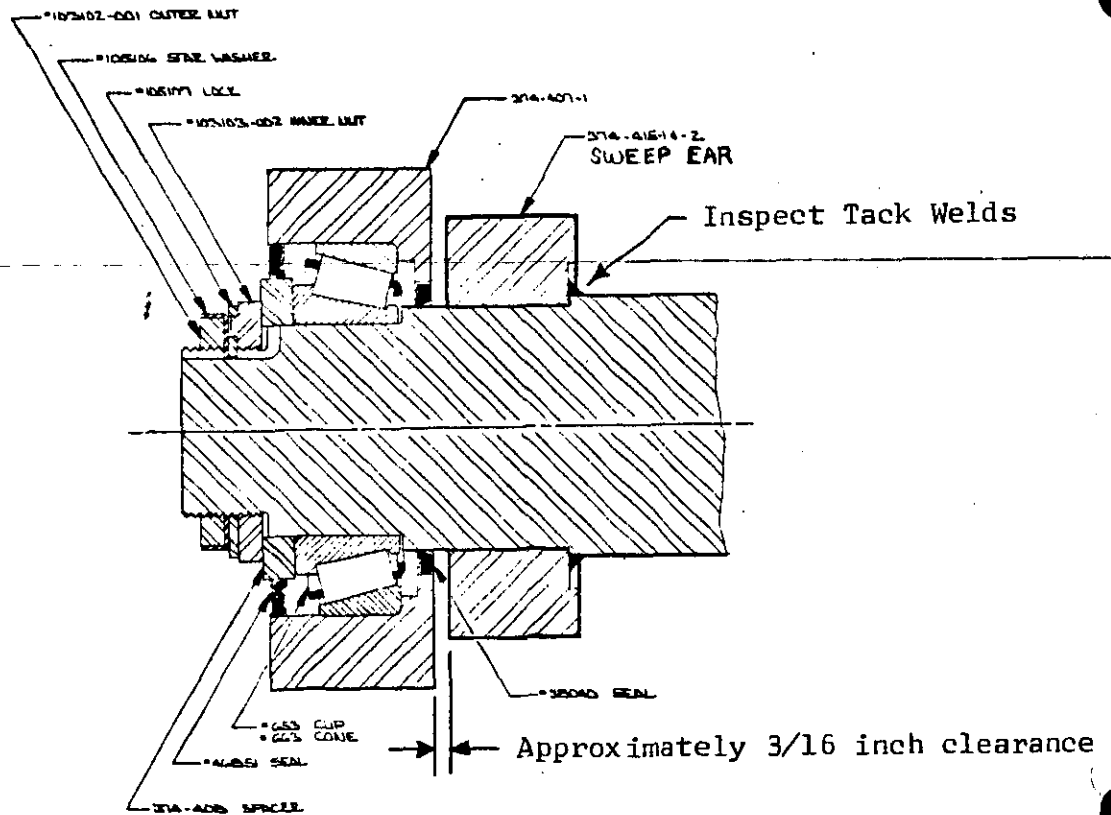
SECTION A-A

One ride has reportedly developed some problems with the sweep joints where they attach to the center hub. In order to evaluate the precise area and cause, more information is needed from the field.

1. Inspect the plate and ears that bolt onto the Center Hub, paying particular attention to the area around the bolt holes. "B-B" and ears that house the Bearings shown in section "A-A".

2. The sweep shaft is tack welded to the sweep ears as shown in "A-A". Inspect this area very carefully to see if welds are holding.

If an area is suspected of having cracks, clean area with solvent and apply thinned-down paint or dye penetrant, wiping off excess. Cracks should then show up as fine dark lines.

Also, check clearance between sweep ear and the bearing ear. There should be approximately 3/16 inch between the ears.

IF ANY CRACKS, ETC. ARE FOUND
DO NOT OPERATE RIDE

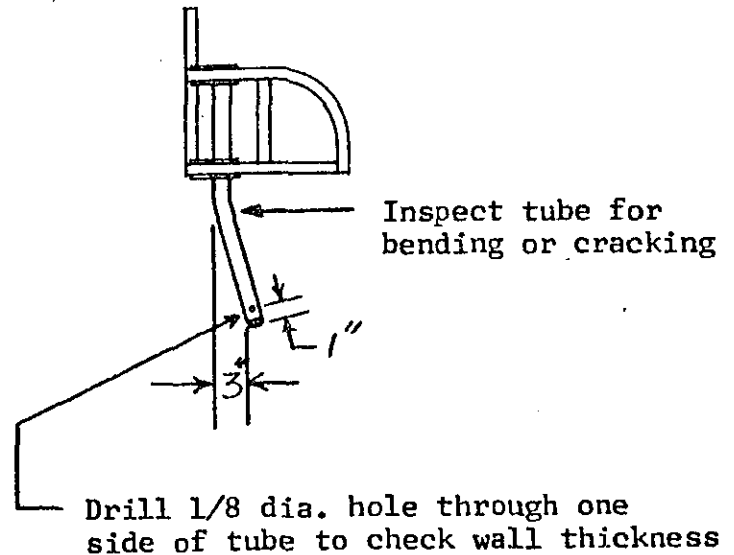
All TWISTER owners must inspect the head rests on all TWISTER cars immediately. Remove each head rest and inspect the support tubes that fit down in the sockets on each car. Inspect for any signs of physical damage, such as bending or cracking. Next, drill a small hole, 1/8 inch, near the bottom of the support tube approximately 1 inch from bottom. Drill hole through one side of the tube only. Check wall thickness of tube. It should be 1/8 inch thick.

Any of the afore-mentioned conditions could result in a serious accident if the head rests are not inspected, and any faults corrected immediately.

If any of the tubes show signs of bending or cracking, or if any tube has less than a 1/8 inch wall, immediately report such condition to Mr. Richard C. Chance, General Manager, Chance Manufacturing Company.

Inspect the head rest support tubes on a regular weekly basis as an added measure of safety.

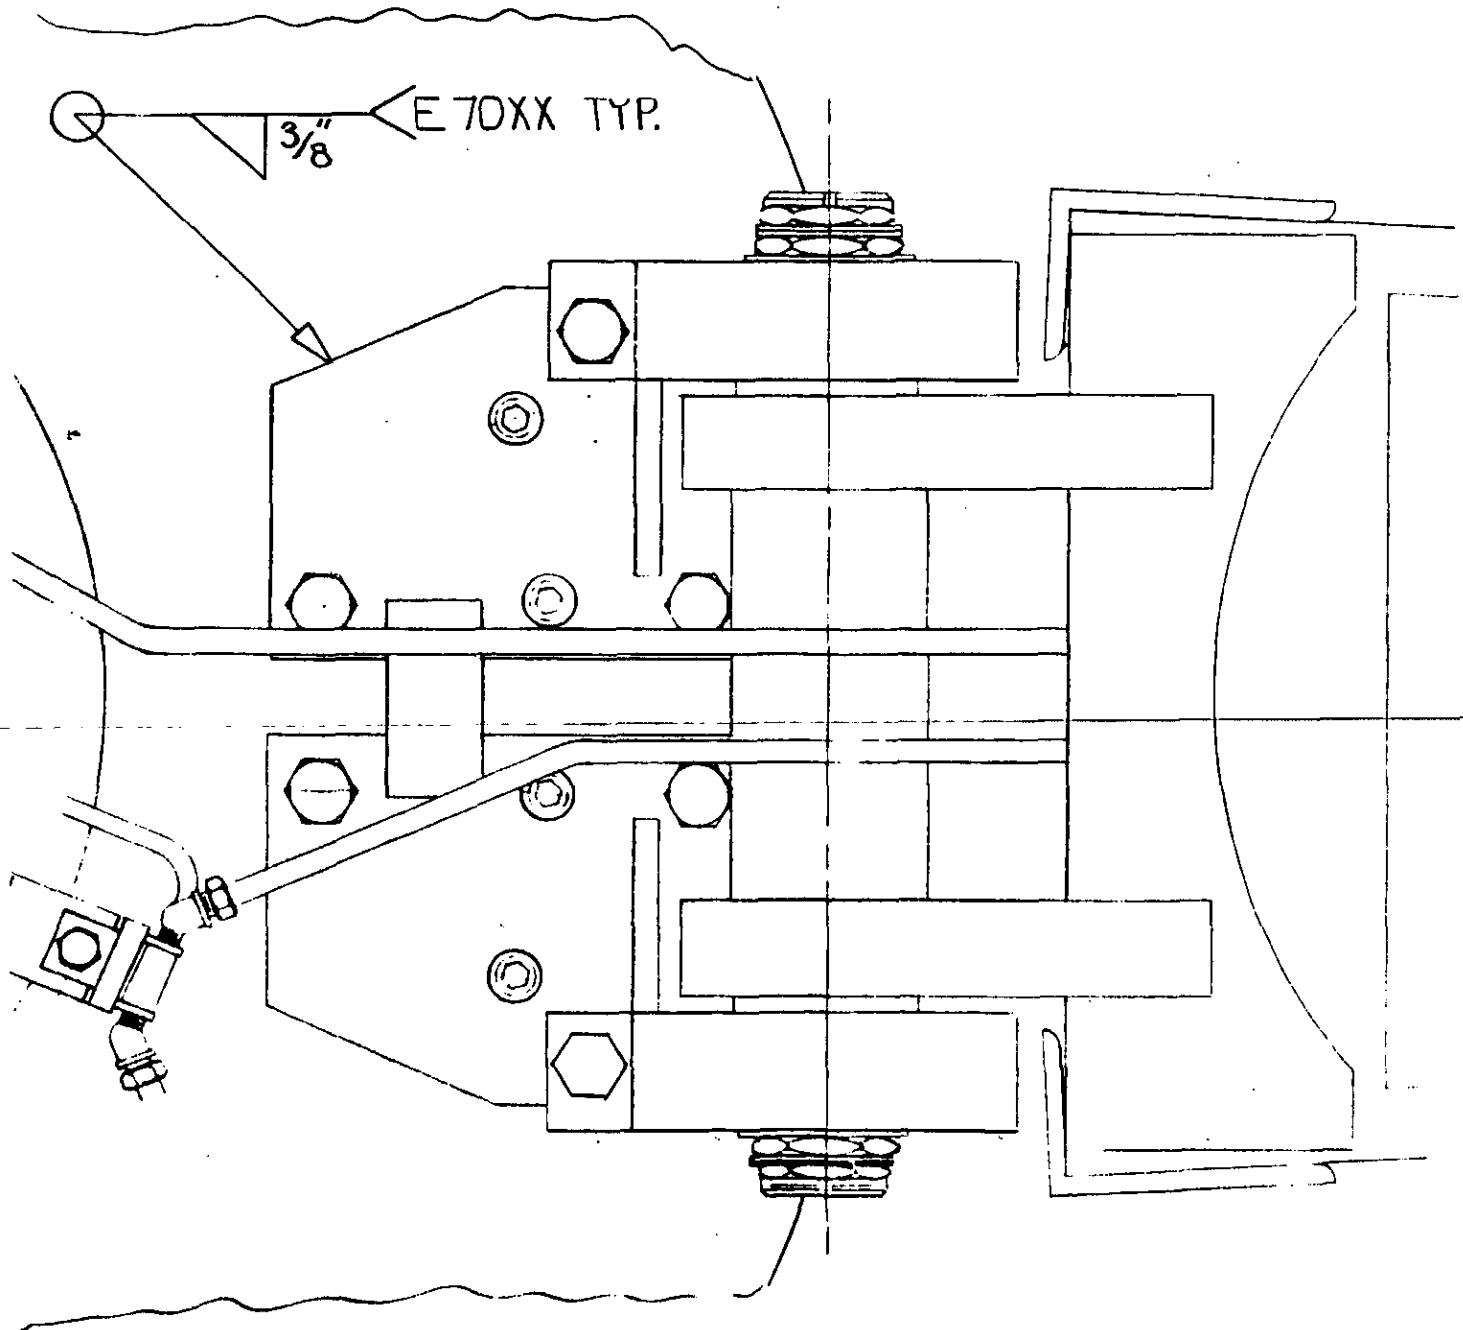
With ride set up remove outer sweep. Fold stub sweep up and lock into place. Use an air arc to cut the broken ear loose around the outer edge of hub plate. Lower stub sweep and cut broken ear loose all the way around.

Install stub sweep and new ear on hub plate. Insert bearing along with new seal in opposite ear. Start adjusting nut on shaft but do not tighten. Start all bolts in new ear but do not tighten. Shove new ear as far as possible away from opposite ear and tighten bolts.

Tack weld new ear to hub. Check adjustment of bearings and then weld ear to hub all the way around.

All welding must be performed by a welder that is certified under the American Welding Society Structural Welding Code DI. 1-75 or the equivalent.

Check torque on ear attaching bolts. Check bearing adjustment and lock adjustment in place. Install hoses, electrical connections and outer sweep.
