TECHNICAL BULLETIN — JUNE 2008

339. Over the shoulder passenger restraint Safety Alert

SAFETYALERT

Drawing No: SC-033-101
Item No:

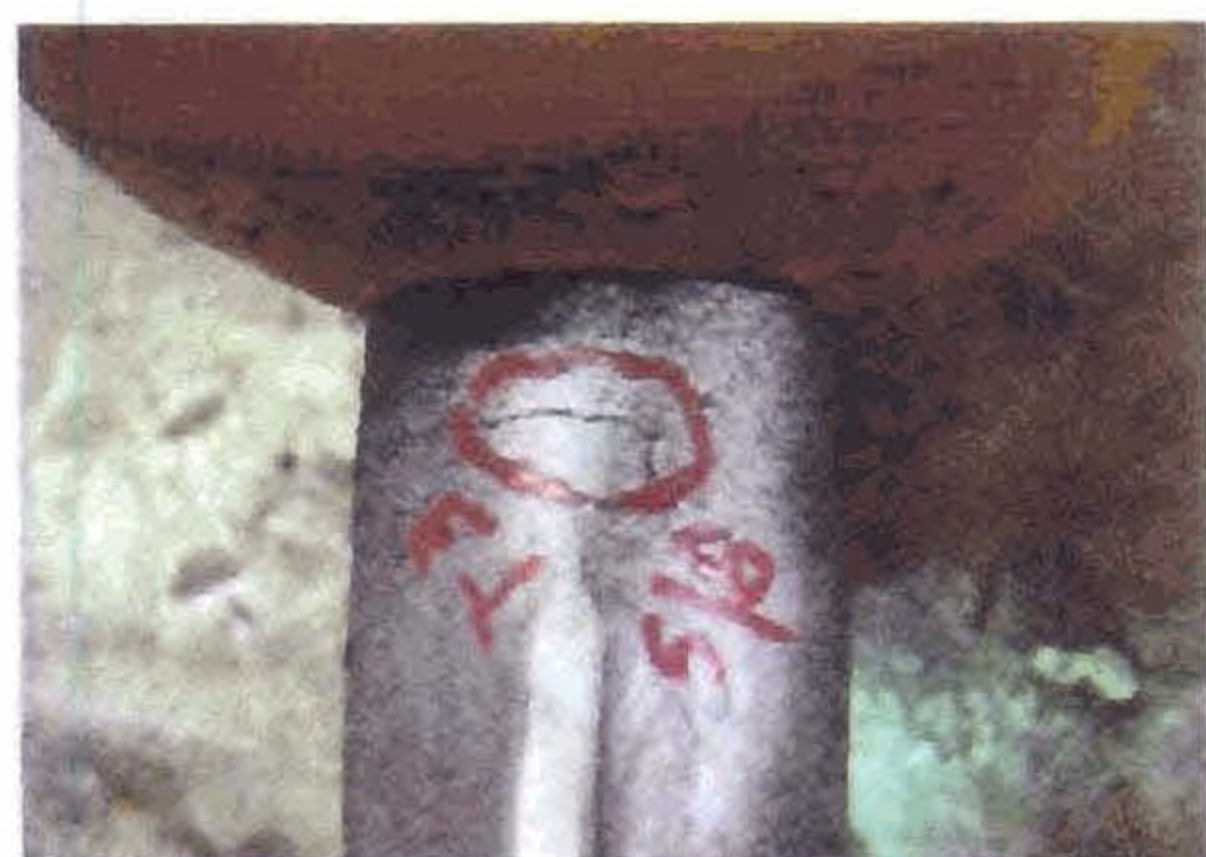
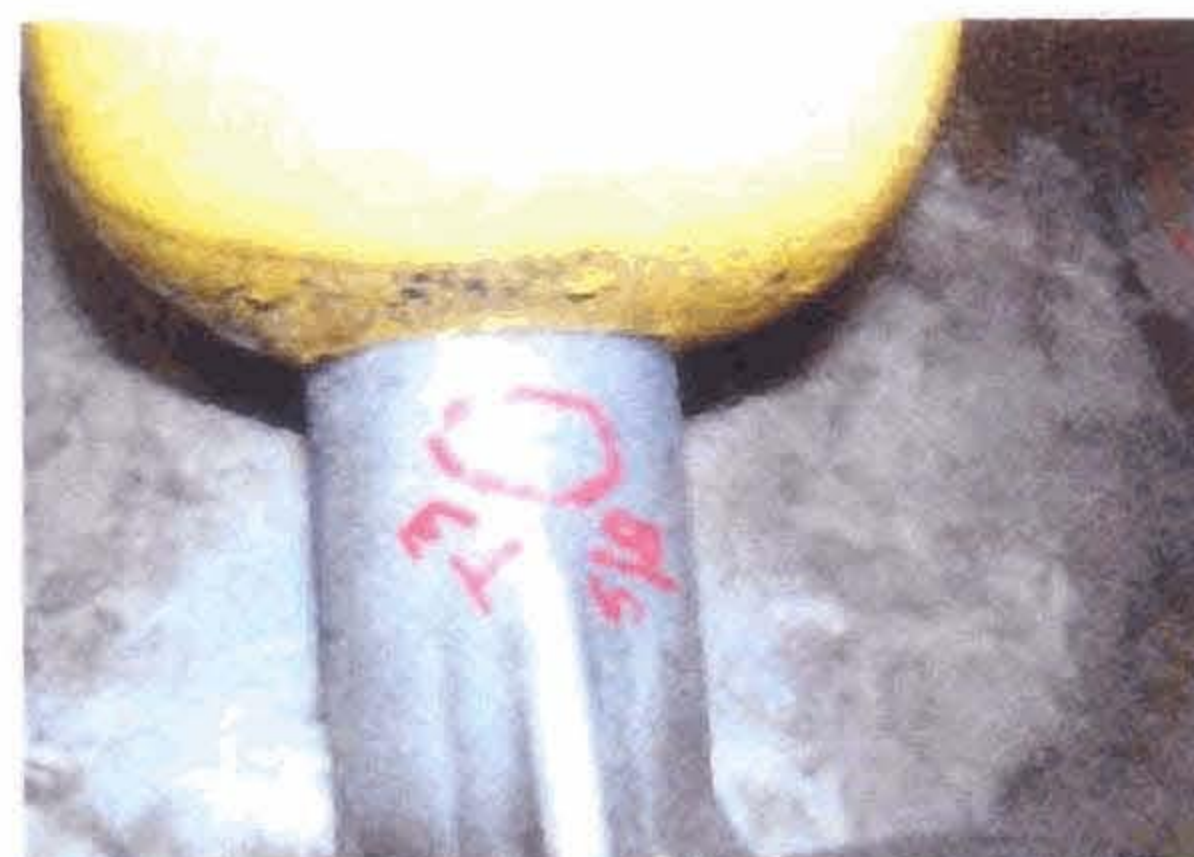
Cracks were discovered on several harnesses.

Indication found

⇒ harness can be repaired if the indication is smaller than 25 mm (1 inch) in length. Harness presenting larger indication must be rejected and replaced.
