NAFLIC

TECHNICAL BULLETIN - MAY 2003

258. PWS Twist Cracking

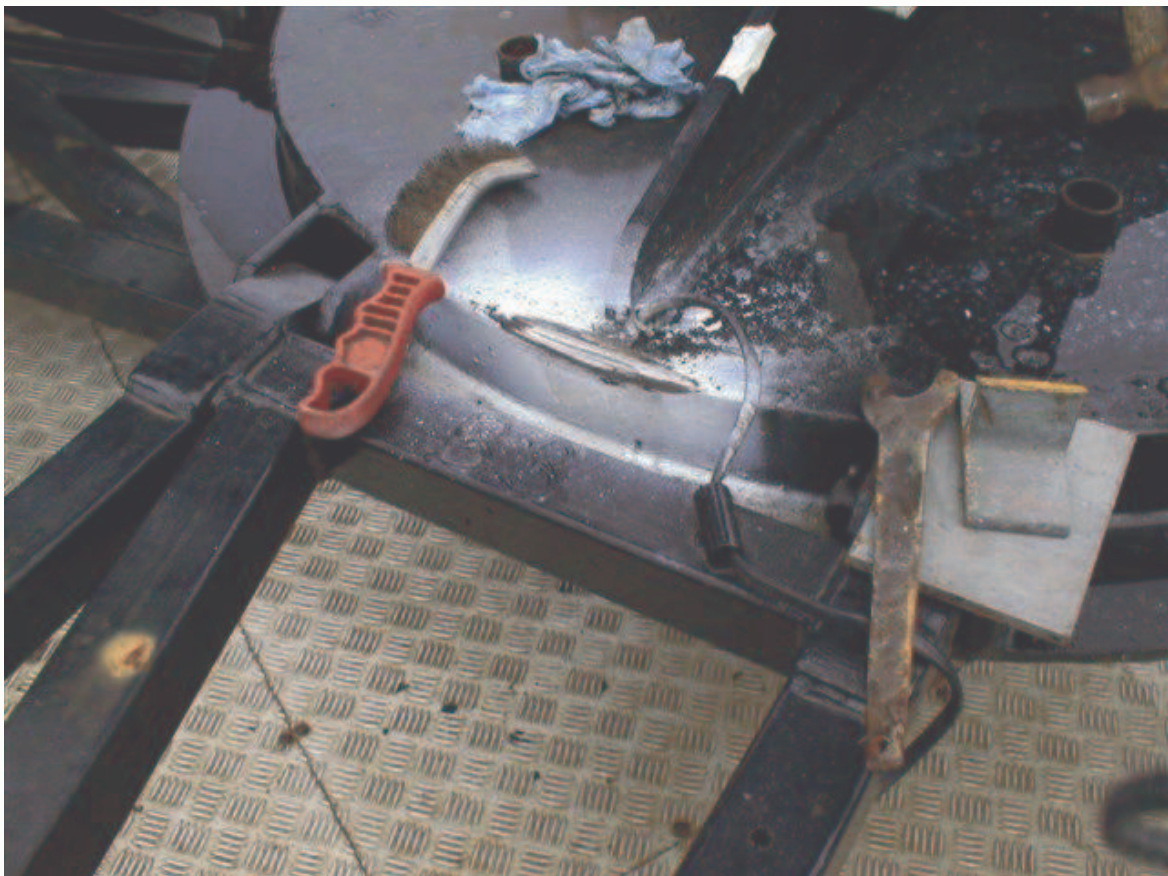
At the level of the horizontal car arms, each capstan has two large horizontal circular plates spaced about 50 mm or so horizontally apart by a vertical rolled steel ring. The lower of these discs is approximately 150 mm greater in diameter than the upper one. The top edge of the spacer ring is welded to the circumference of the smaller, top, disc and the lower edge is welded onto the surface of the larger, bottom, disc. There are 4 vertical gusset plates, 90° apart, attaching onto the top surface of each upper disc, and terminating some 20 mm or so short of the outer edge. At this region, some localised bending of the disc is likely to occur, translating into increased stress at the weld connecting the ring to the disc.

Tony Mogford Associates, using MPI, have detected 8 cracked welds (variously 20, 30, 60, 65, 70, 70, 80 and 95 mm long). The region in question is very accessible and visible and, at the stage detected, the cracking was probably not imminently dangerous. However, it would be unwise to leave such cracking undetected and unrepaired.
