Service Bulletin 2021-03#03 Risk Mitigation Measures on the Bobsled Coaster Vehicle Seat Compartment

Ride:	BC 2157 - Green Hornet
Object of Change:	1093-01-00-00-00
Reason for Information:	Mitigation of risks associated with intentional misbehavior of passengers.
Reason for Change:	In case of intentional misbehavior and physical capabilities of the passenger, it may happen that stationary objects installed on the side of the track could be reached and an impact may occur. This can result in serious injuries.
Measures to be taken:	<p>A: Information of passengers: Reevaluation of operation and use risk assessment of the ride in order to increase awareness of the passengers for the ride's safety rules.</p> <p>B: Mechanical adjustments: A proposal is issued by this service bulletin to add additional entrance panels to the vehicle entry and exit side openings.</p>
Regular Tests	Independent of the following described modifications, tests which are shown in the operating and maintenance instructions remain valid.

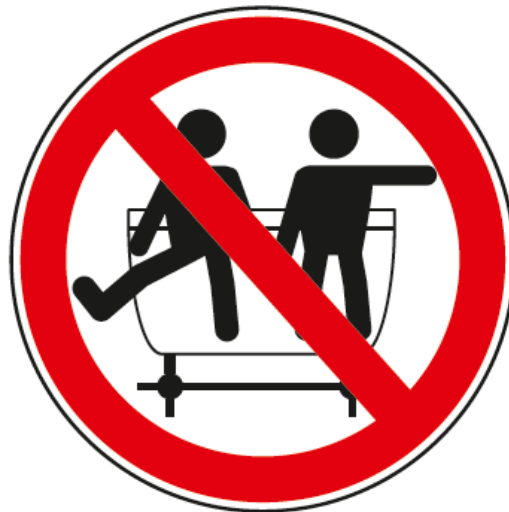
The operation and use risk assessment prepared by the ride operator shall incorporate the provided information. It shall be checked that appropriate signage e.g. at the entrance of the ride, the loading area and on each row of the vehicle is clearly visible, stating that legs and arms must be inside the vehicle at all times. Furthermore, it shall be stated that failure to follow these guidelines may result in serious injury. Figure 1 shows an example of such a signage.

Figure 1: Example of a signage

Furthermore, it shall be evaluated, if it is necessary to verbally announce this guideline to the passengers before starting of the ride – especially for younger passengers.

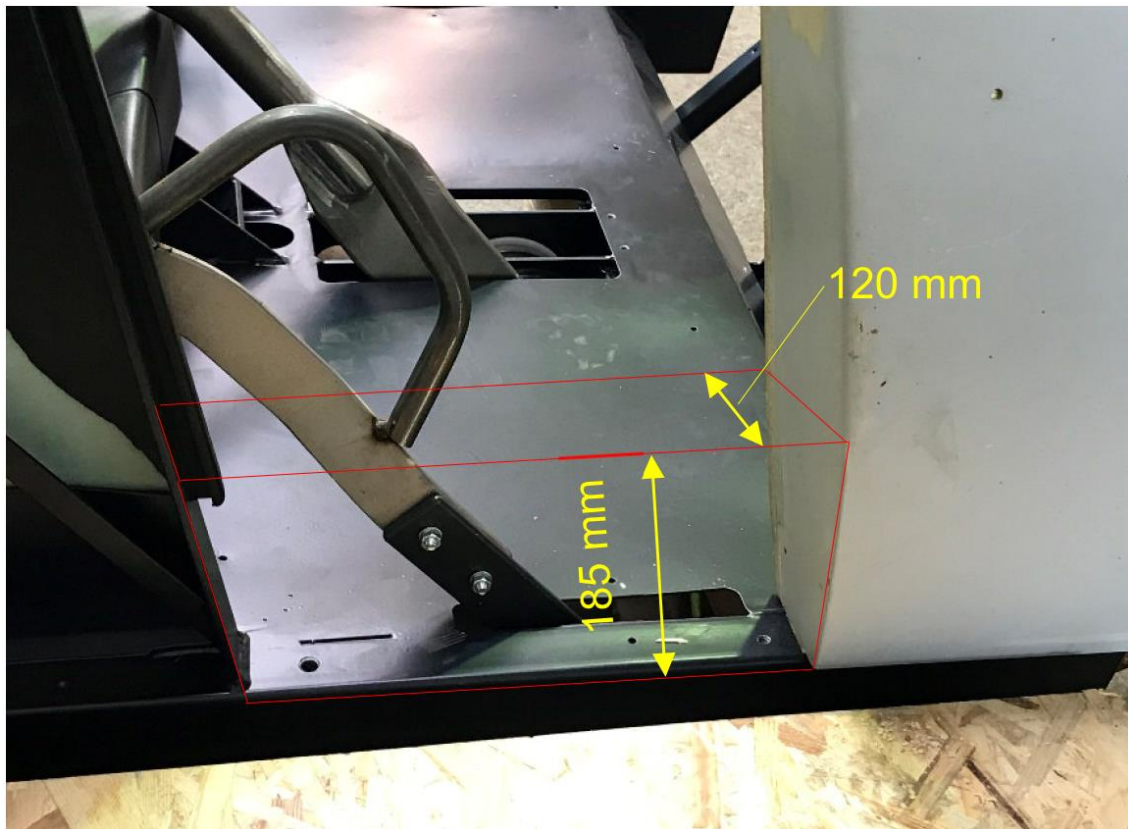
Together with a third party, it was investigated that a higher threshold in the lower area of the entrance and exit opening of the vehicle makes it more difficult to reach stationary objects installed on the side of the track with the toe of the foot. However, it shall be noted that this might create a tripping hazard during embarking and disembarking the vehicle. Therefore, the ride operator must evaluate in its own operation and use risk assessment these two risks since the tripping hazard might be influenced by the ambient condition of the station (e.g. lighting, color of floor, contrast between vehicle and floor etc.)

Figure 2: Entrance panels at the lower area in the front row

Reaching stationary objects installed on the side of the track with these entrance panels installed might be still possible but it requires even more effort to:

1. extend the foot beyond the outer contour of the vehicle and
2. extend the foot further down (extension opposite lower leg).

Therefore, the risk of a collision with stationary objects installed on the side of the track is minimized but not eliminated.

The proposed entrance panels shall have the following dimensions:

- Height of 185 mm
- Width of 120 mm (viewed in the lateral direction of the vehicle)

The shape of the entrance panel may vary due to different vehicle body designs. The entrance panels shall be installed at both rows and both sides filling the entire clear width of the openings.

Since the vehicle FRP is custom designed and varies from ride to ride, a custom designed solution for this additional entrance panels must be used. Therefore, we cannot offer a standard additional entrance panel. We can support you in the design and the fabrication of these panels if your operation and use risk assessment comes to the conclusion that these panels shall be installed.
