HEALTH AND SAFETY AT WORK ETC. ACT 1974

This Department is helping the police investigate a fatality where an 11 year old boy fell from a zip wire at a local attraction. It is hoped that through providing information on the circumstances leading up to the accident, Health and Safety Inspecting Officers will be able to identify potentially dangerous situations at similar establishments within their districts. I would ask officers to look specifically at rope attachments when carrying out inspections on establishments where ropes are used as part of the business e.g. high ropes, climbing walls, etc.

Digrams of Attachment Rope

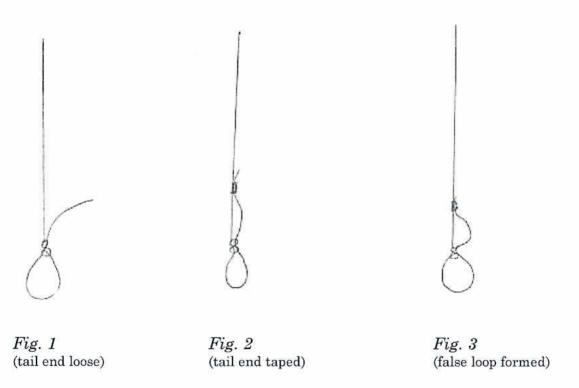
During our investigation into this accident, it has come to light that the accident was probably caused because of the client being 'mis-clipped' onto the zip wire. This took place because the company taped up the tail end of the lanyard rope back onto the main lanyard to make the ends neat and tidy. In order to explain this, please refer to the enclosed diagrams which should hopefully demonstrate the circumstances involved.

The fixing point for the karabiner is a loop resulting from the use of a figure of eight knot. A loose tail results from the formation of the knot (Fig. 1).

During the investigation it came to light that the company taped up this tail end back onto the main lanyard rope to make the ends neat and tidy (Fig. 2).

In this instance, taping up the end resulted in a false loop developing during use (Fig. 3.) This false loop could be confused for the actual connecting loop made using the figure of 8 knot. This actual loop is used to clip the harnessed person onto a zip wire, or similar rope course attachment.

We therefore urge Health and Safety Enforcement Officers to familiarise themselves to this potentially dangerous practice that could exist elsewhere in the Country, and take reasonable steps to ensure that a similar incident does not take place in future.
