## Homequest Home Inspections PROPERTY INSPECTED

El Paso, TX 79932

# PROPERTY INSPECTION REPORT

08/07/2019

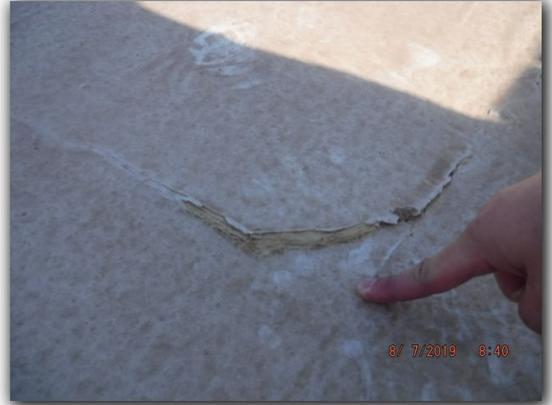
3. Surface is damaged above the second floor jack / jill bathroom and underlayment is damaged. There were indications of other roofing repairs that appear temporary.

**UNDERLAYMENT DAMAGED**

**Recommend further evaluation of the roof covering by a licensed roofing contractor.**
4. Evidence of water damage on the scuppers. Recommend replacement.

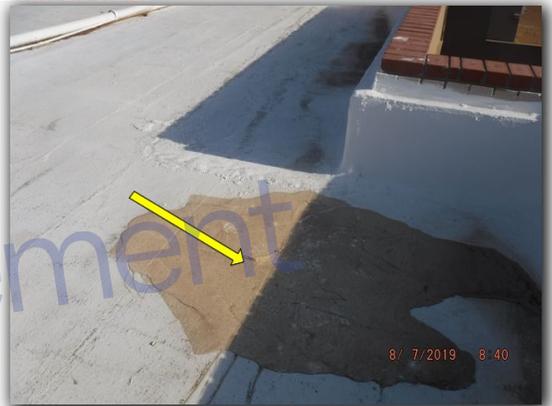
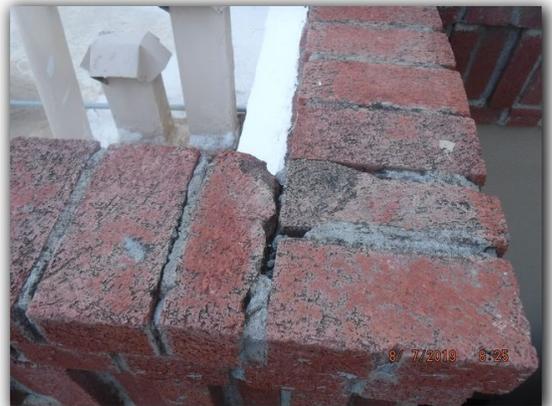
**REPAIR PERFORMED**

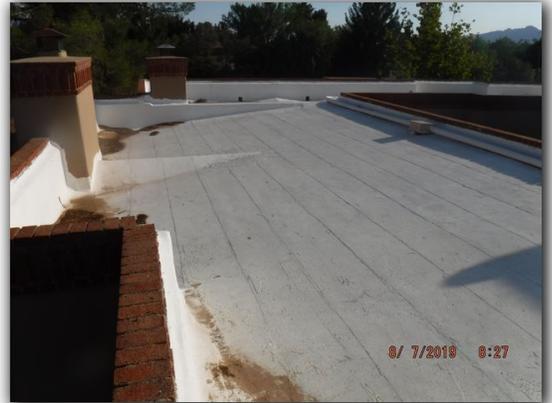
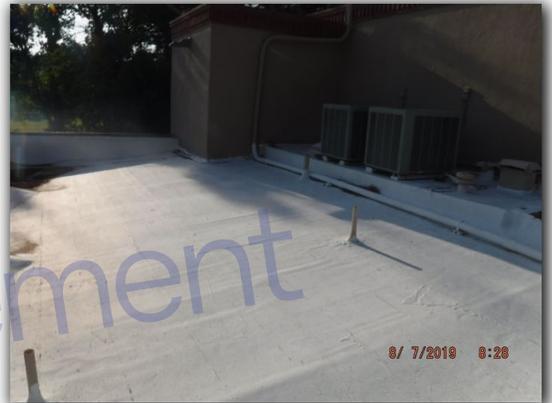
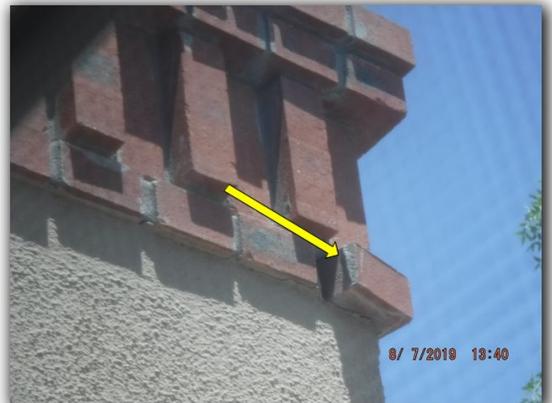
ALL WOOD SCUPPERS ARE DRY ROTTED

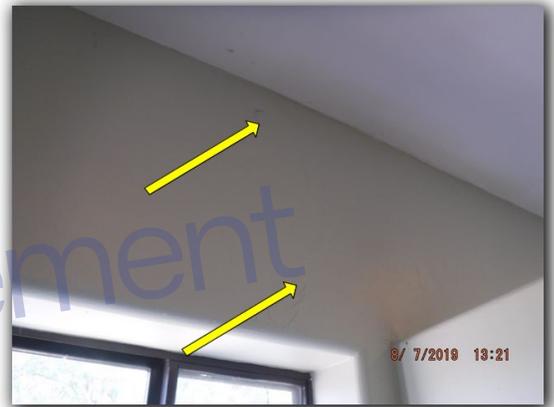
1. Bedroom 1: Evidence of prior moisture intrusion. Tested negative for moisture.
2. Bedroom 1 Upstairs : Evidence of prior moisture intrusion in the bathroom. Tested negative for moisture.
3. Bedroom 2 Upstairs : Drywall openings in the closet.
4. Main Hallway : Drywall is missing in the water heater/furnace closet and evidence of moisture intrusion on wall by the water heater.

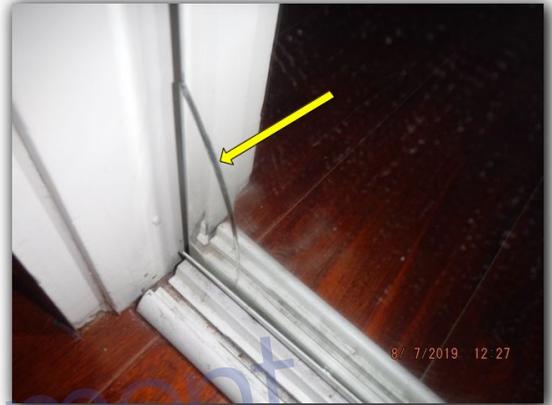
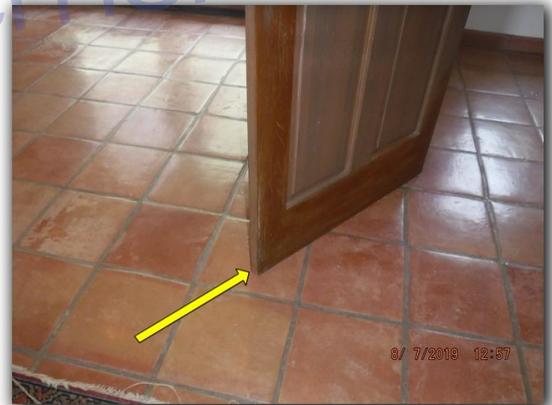
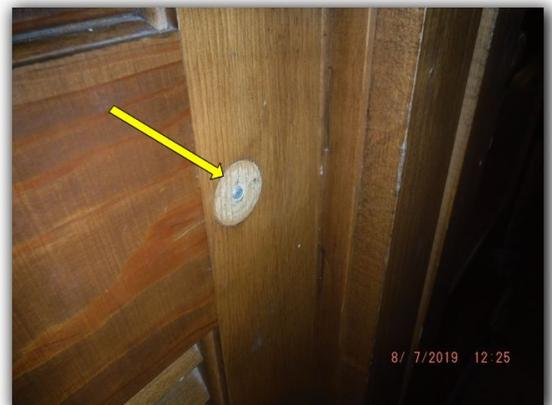
1. Bedroom 1 Upstairs : Does not latch.
2. Bedroom 2 : Door to bath does not latch and closet door mirror is cracked on lower left corner.
3. Some double closet latches are missing above the double door.
4. One or more door stops are missing or damaged and there is minor mechanical damage on some walls.
5. Bedroom 3 : Entry door drags on floor and does not open fully.
6. Main Hallway : Furnace closet door pull is missing.

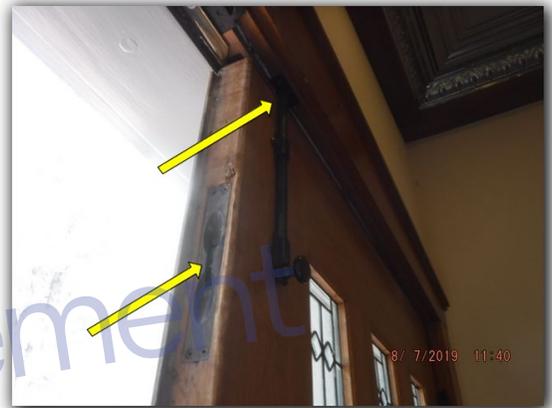
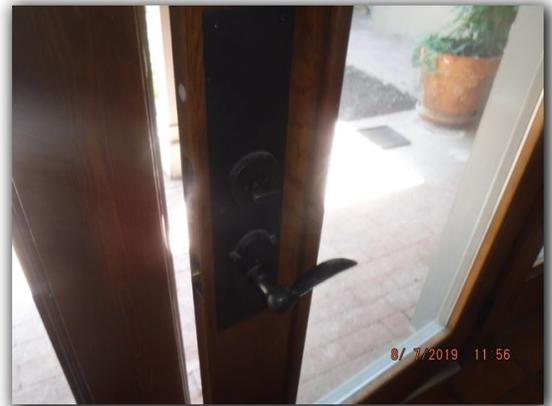
1. Front Entry : Unable to latch double door and main entry door rubs on threshold.
2. Central Courtyard : Several doors do not latch.
3. Kitchen : Door rubs on frame and is difficult to close.
4. Library : Difficult to lock.
5. Exterior doors and wood trim is weathered. Recommend re-paint.
6. Exterior doors to the upstairs verandas do not latch.
7. Laundry Room : Weather stripping is damaged.

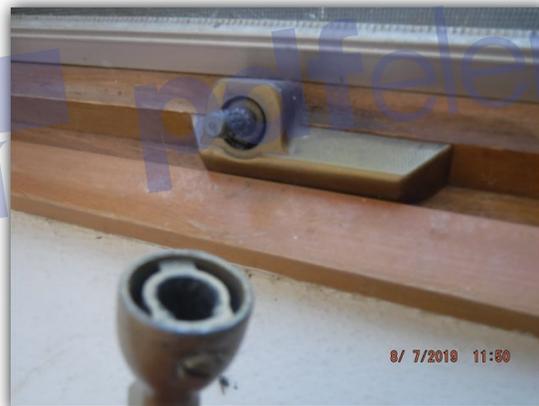
2. Some window crank handles are loose or damaged.
3. Bedroom 1 : Will not latch.
4. Bedroom 1 Upstairs : Evidence of moisture intrusion on the sill. Tested negative for moisture.
5. Bedroom 3 Bath : Window above exit door is cracked.
6. One or more screens are missing.
7. Game Room : Window seal is damaged and window does not latch.

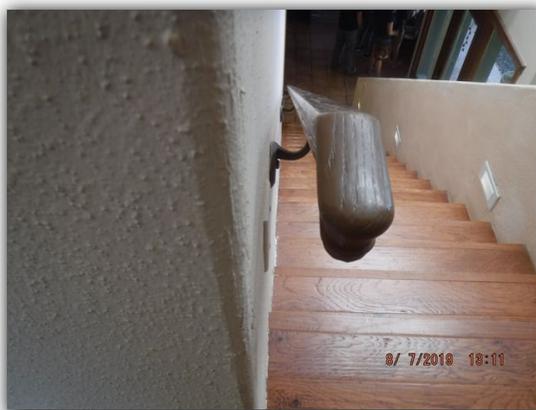
- Handrails were open on the ends; current building standards require turn backs on the ends. loose clothing can catch on the ends.

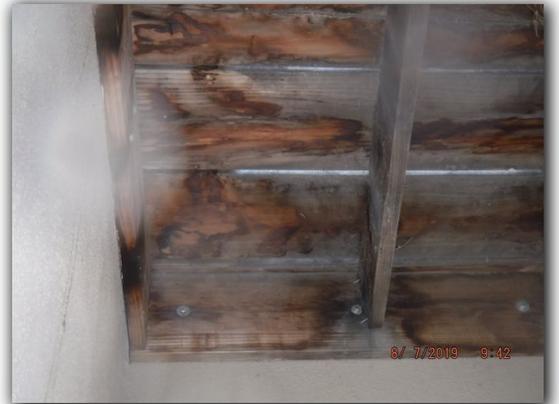
1. Hand railing is not terminated properly. Although home was constructed prior to this code revision, it must still be reported as a deficiency.
2. Wood is water damaged. Recommend sealing to prevent further damage.
3. Landing wall is separating from the main wall.

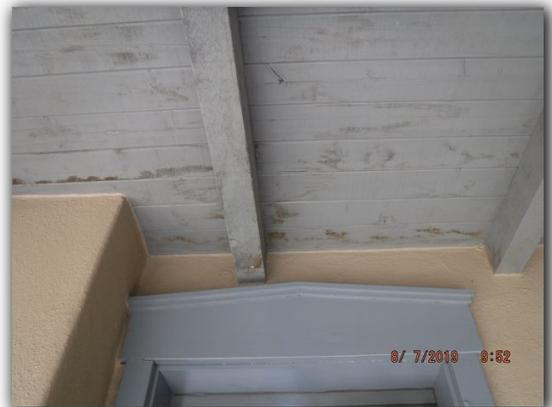
1. Some bricks are loose on the walkways around the home.
2. Uneven walking surface is creating a trip hazard in some areas.
3. Rear Patio : Evidence of moisture intrusion. Tested negative for moisture.
4. Front Entry : Bricks are separating.

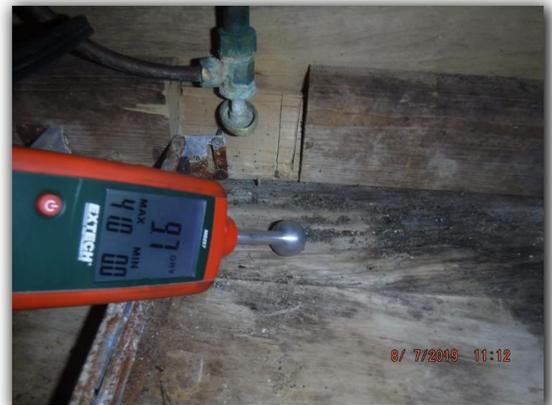
1. Kitchen And Bathrooms : Some cabinet door hinges are loose. Recommend tightening.
2. Cabinet under kitchen sink is water damaged. Tested negative for moisture.

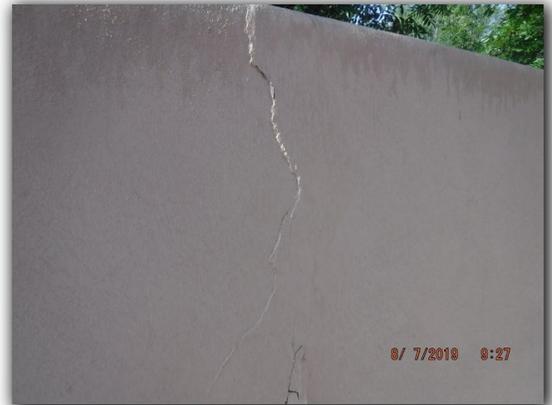
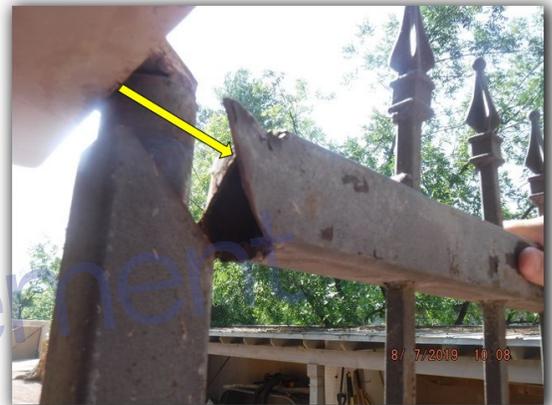
1. Wall by the pool equipment is leaning and bracing has been installed. Cracks are present in that area.
2. Right gate is damaged. Weld is broken on upper left corner.

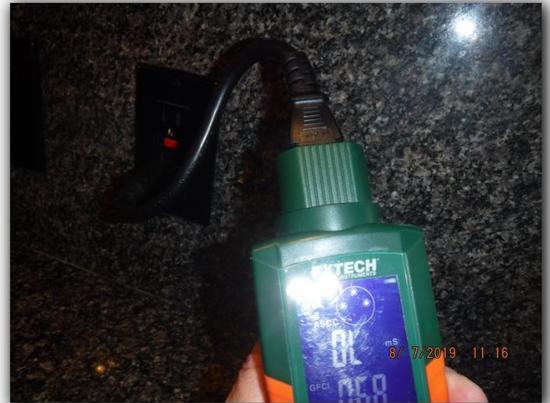
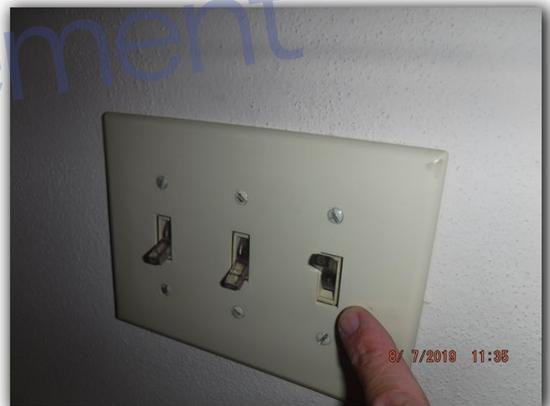
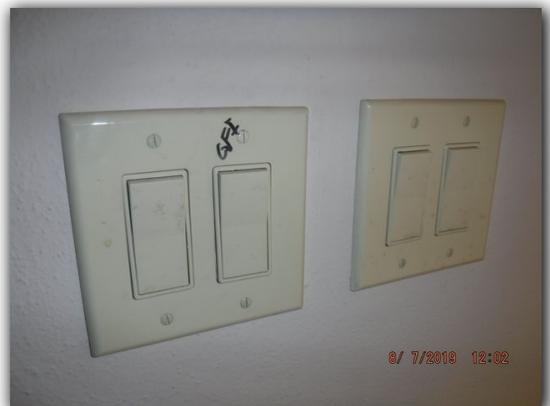
2. Exterior : No GFCI protection.
3. Laundry Room : GFCI is inoperable.
4. One or more outlets are loose.
5. Unable to determine what several switches operated.
6. Some light dimmer switches were inoperable.
7. There is an electrical line on roof above the kitchen that is enclosed in plastic sheathing. Must be enclosed in conduit.

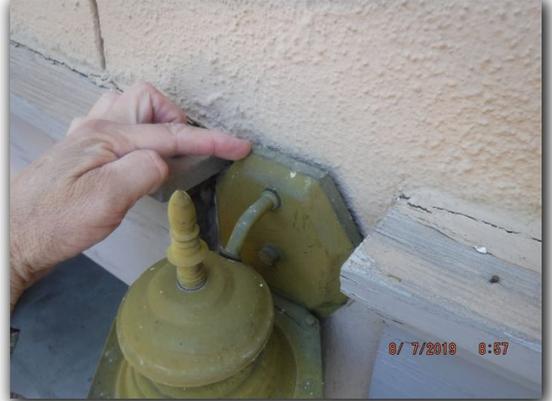
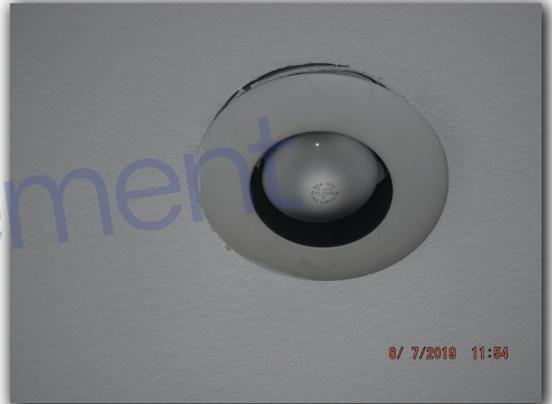
- 5. Exterior : All lighting fixtures are loose. Recommend tightening and caulking around all exterior lighting fixtures.

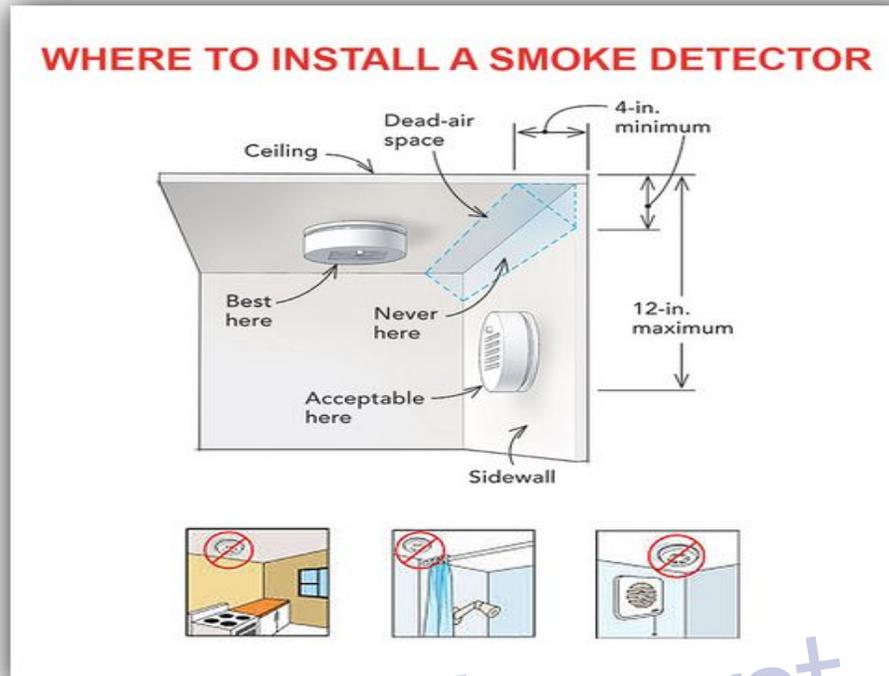
- 1. Smoke alarms are not present in each sleeping area
- 2. No smoke alarm in hallway
- 3. Carbon monoxide monitor is not present.

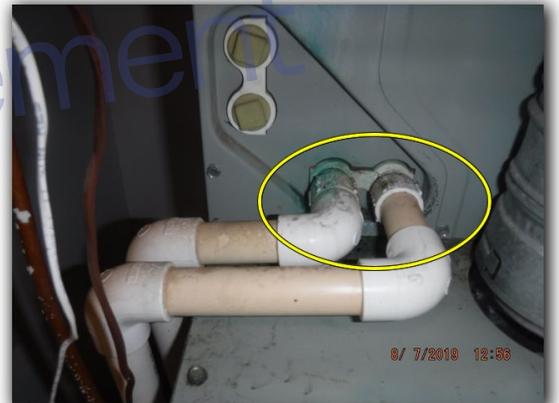
1. Main Hallway : Ice build up on refrigerant line. Recommend servicing.
2. Recommend installation of a Safe-T-Switch on the main condensate line of both split units to prevent condensate spill-over from the evaporator tray in event of blockage.
3. There is a condensate line at left side of home that is blocked by debris.

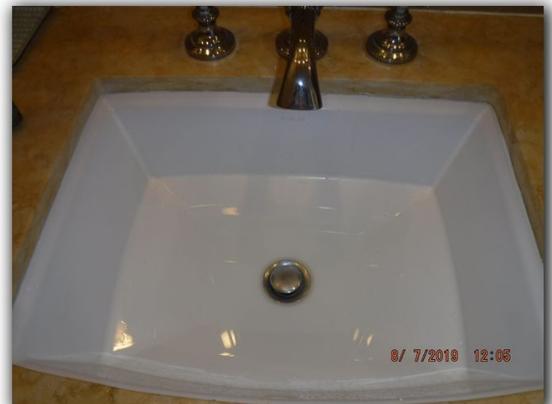
- 3. Formal Dining Room : Active leak under the wet bar sink.
- 4. Bedroom 2 and 3 Upstairs : Sink stopper is inoperable.
- 5. 1/2 Bath : Stopper linkage is disconnected.
- 6. Formal Dining Room : The wet bar drain line and trap under the sink is an incorrect corrugated plastic type that should be replaced with a smooth bore drain pipe to help prevent blockage.
- 7. Kitchen Island : Low cold and hot water output.

WET BAR SINK LEAK

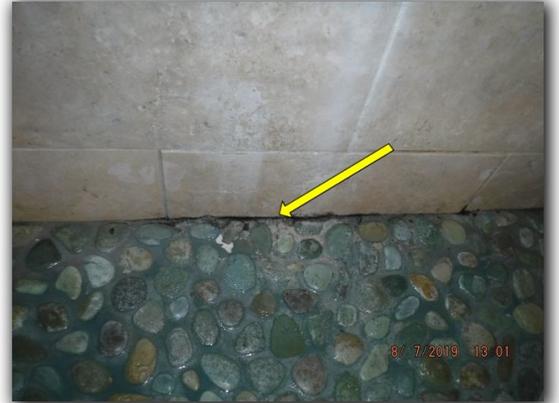
- 1. Recommend sealing around all tub and shower enclosures.
- 2. Bedroom 2 Upstairs : Tub diverter is inoperable. and stopper is missing.

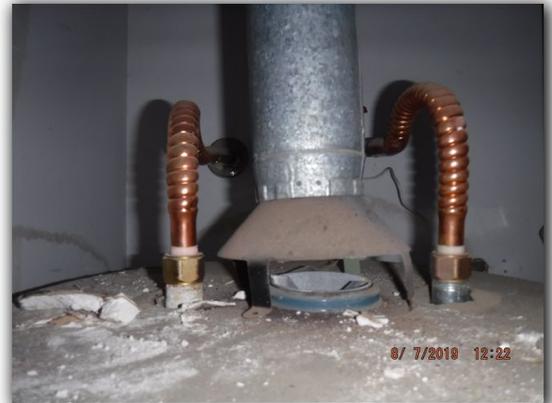
1. Main Hallway : Flue is incorrectly connected. CO risk.
2. Both Units : Pan is lacking a drain system. Recommend installing a moisture alarm available at Lowes or Home Depot.
3. Corrosion on plumbing fixtures.

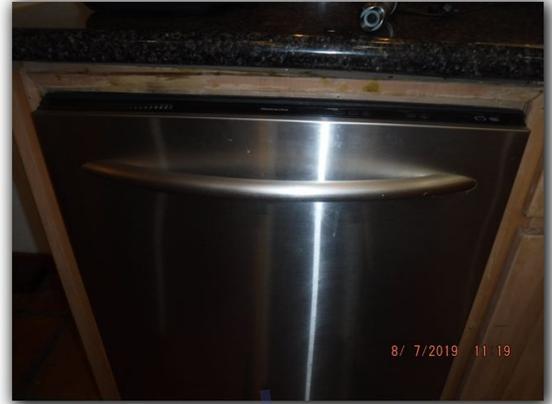
1. Unit is not properly secured to cabinet.

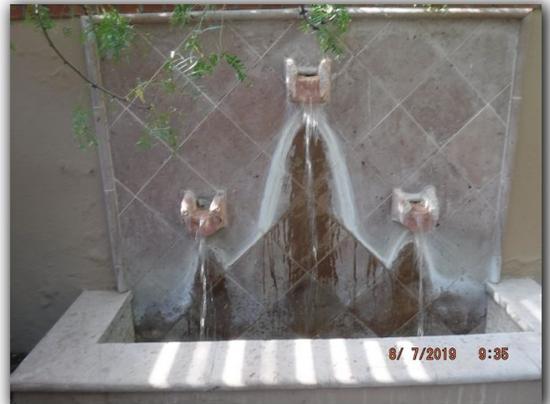
1. Active leak behind wall. Tested positive for moisture.

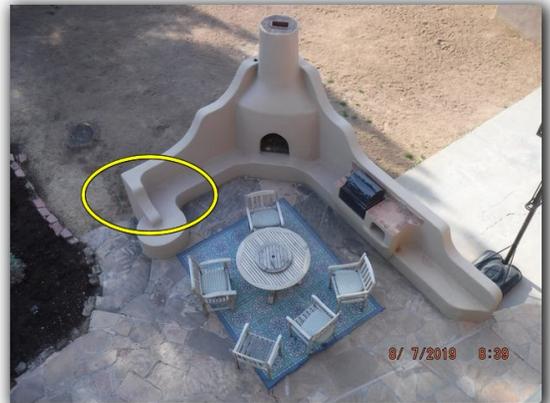
1. Evidence of moisture intrusion on structure. Tested negative for moisture.

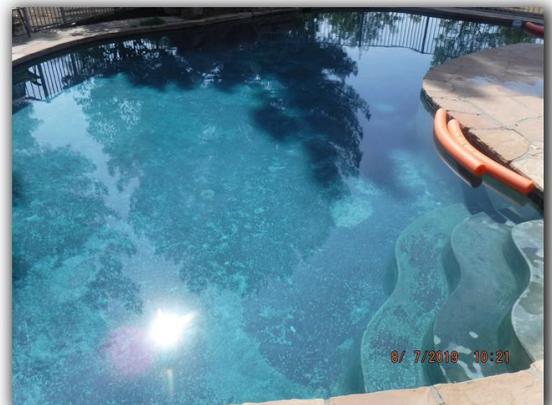
1. Decking around pool is cracked and flagstone is loose in various areas creating a trip hazard.
2. Pool surface is stained, making inspection difficult.
3. Skimmer weir(s) is missing.
4. Low flow into skimmers. Recommend cleaning DE grids to lower pump output pressure and improve flow.
5. Pump switch cover is loose.
6. Pressure gauge is weathered. Recommend replacement.

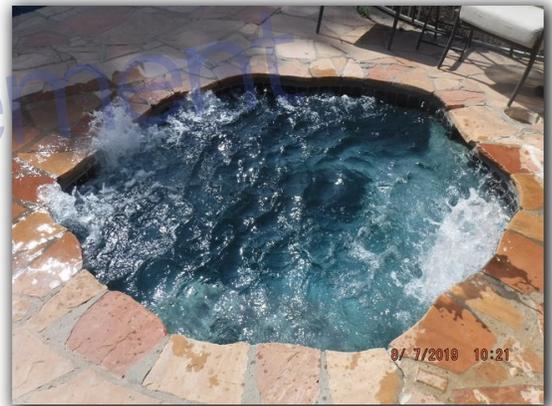
- 1. Excessive air after several minutes. Jets are not operating properly. Recommend further evaluation.
