Homequest Home Inspections PROPERTY INSPECTED

El Paso, TX 79902

D.O.M : 1955
SQ FT : 6,513
6 Bd 5 Ba

Inspector
Christopher Juarez
915-588-9399
www.homequesthomeinspections.com

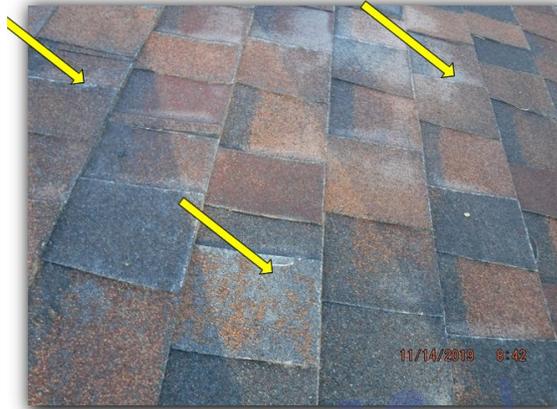
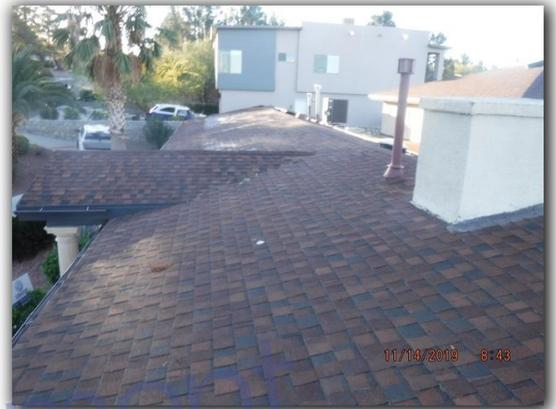
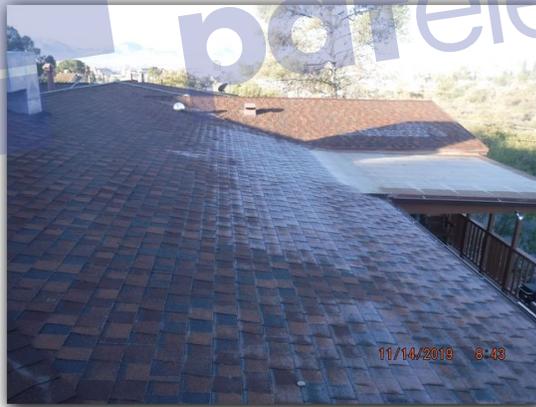
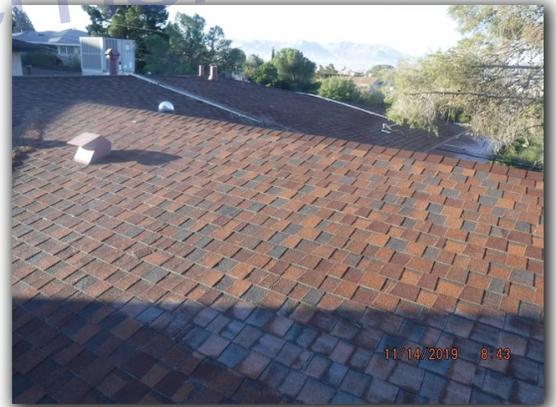
1. Granular loss throughout the shingle surface.
2. Debris in various areas. Recommend removal to prolong integrity of surface.
3. Tree branches overhang. Recommend trimming away from the roof.

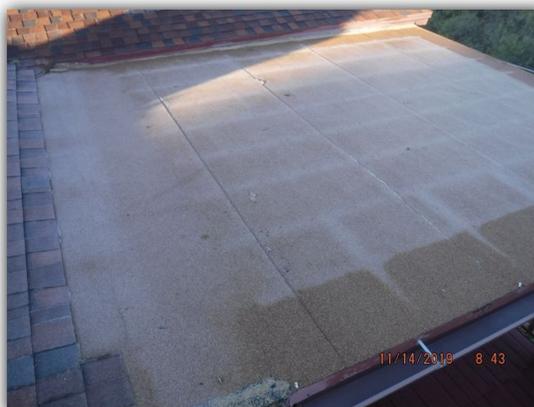
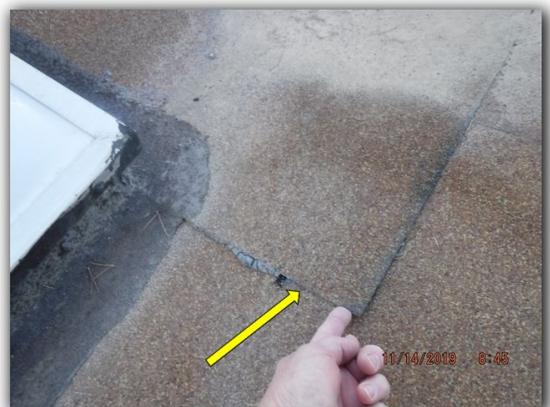
1. Rolled roofing is not overlapped properly in some areas at the down slope near the skylight.

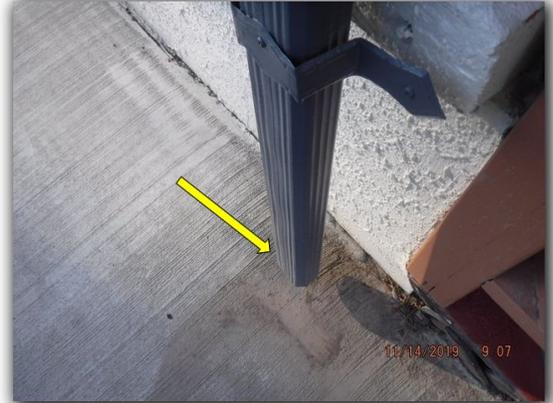
- Gutters / Downspout's at the front of home are dirty, or draining too close to foundation or roof system at the front.

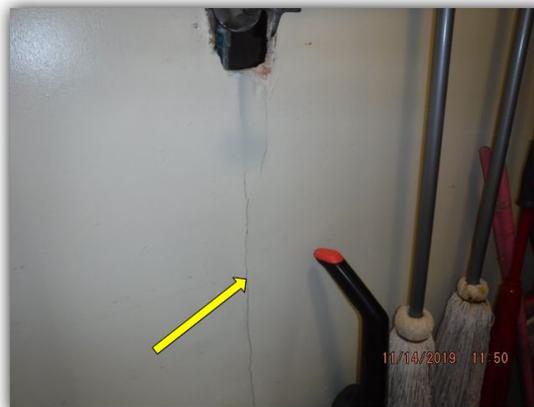
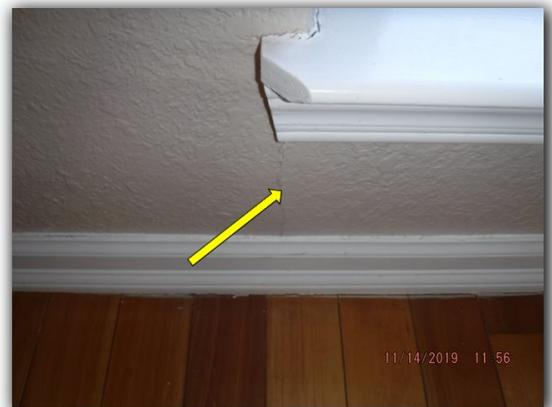
1. Dining Room : Settlement crack.
2. Master Bedroom : Step cracks on brick wall. Recommend monitoring.
3. Play Room : Crack below window.
4. Basement Utility Room : Evidence of prior moisture intrusion. Tested negative for moisture.
5. Front Furnace Room : Settlement crack.
6. There is a black substance below the stairwell, indicating prior moisture intrusion. Tested negative for moisture.

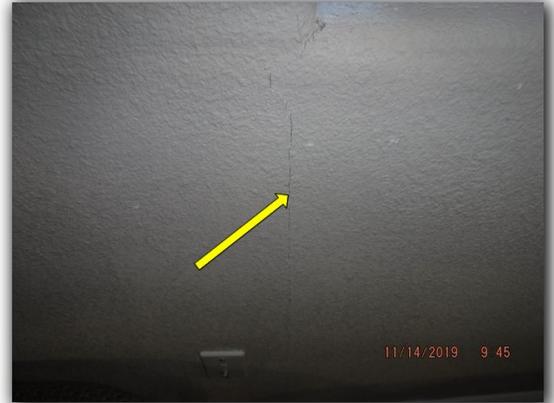
1. Settlement cracks at the rear of home in various areas. Recommend monitoring and further evaluation by a structural specialist if they widen or if more cracks develop. Please refer to statement about wall cracks above.

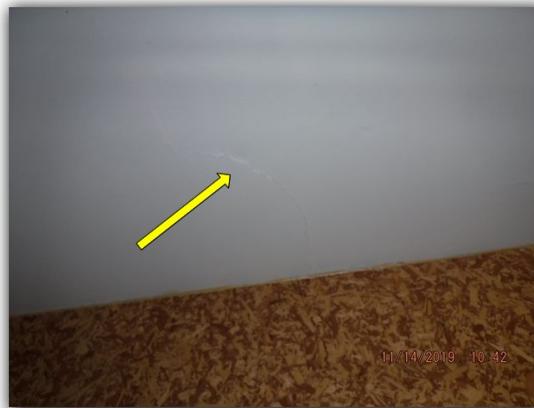
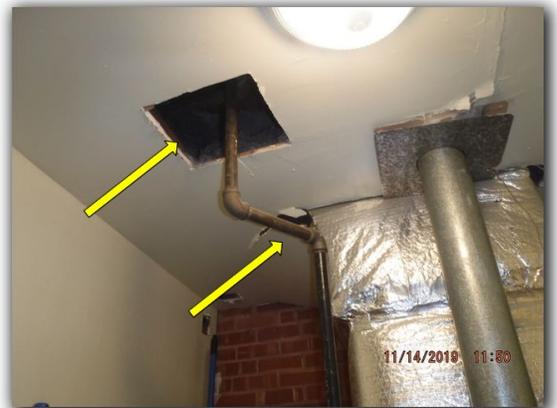
1. Basement Utility Room : Joists are water damaged. There is evidence of active moisture in that area. Guest bathroom is located above.
2. Front Foyer Closet : Ceiling crack.
3. Front HVAC Closet : Drywall by the furnace plenum is damaged and missing in some areas.

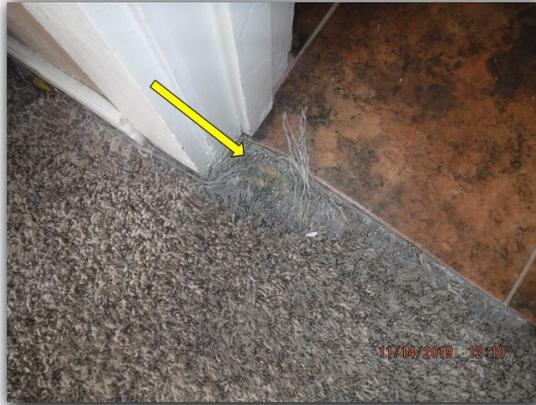
1. Play Room : Carpet is damaged by the door.

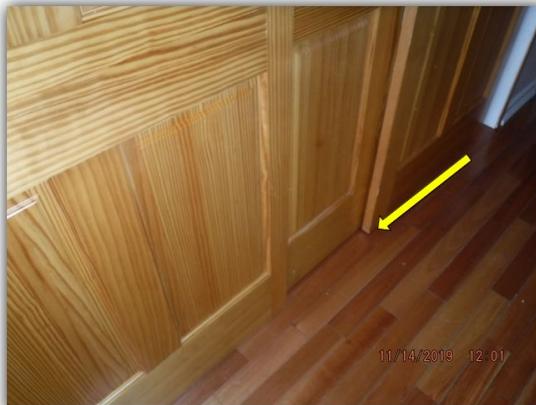
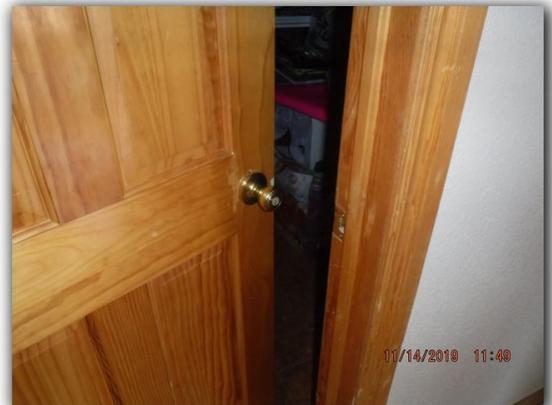
1. Foyer Closet : Does not latch.
2. Hallway : Closet floor guides are missing.

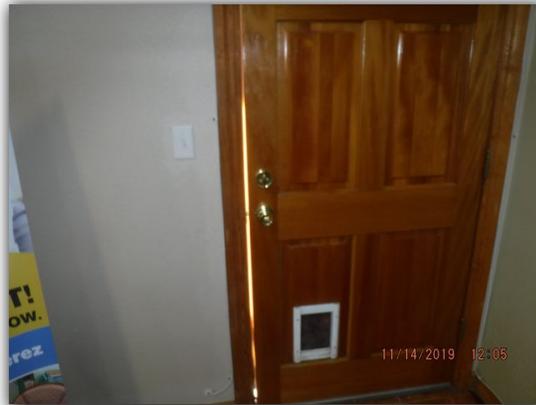
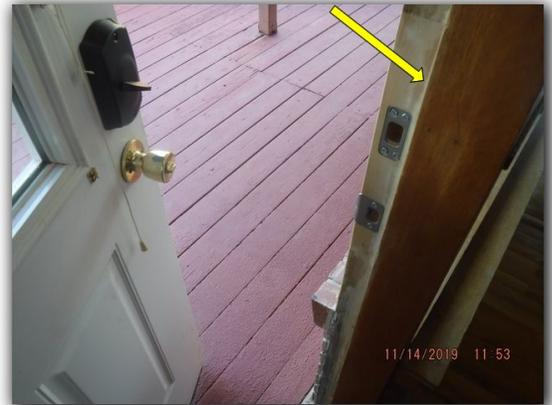
1. Side Exit : Weather stripping is missing.
2. Library : Weather stripping is missing.

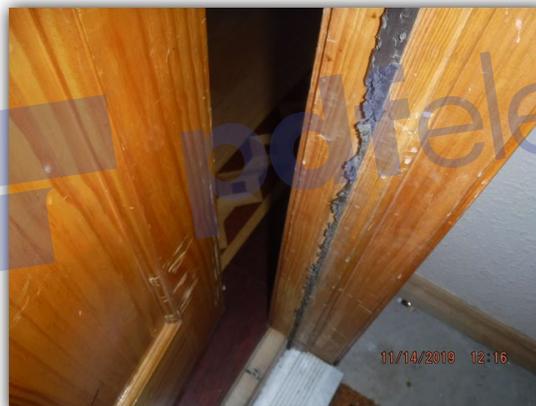
1. Weather stripping is missing or damaged.

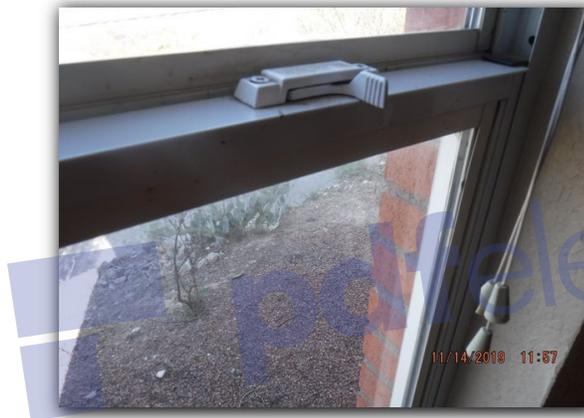
1. Some windows are difficult to open, close or latch.
2. **Basement Conversion : Some windows do not open and all burglar bars are missing internal releases. Safety and egress concern.**
3. The wood trim on some windows are water damaged on the exterior.
4. Rear Corner Bedroom : Windows do not open.
5. All windows are missing screens.
6. Maids Bedroom : Windows do not open.
7. Window sill height exceeds 44" egress in the sleeping areas.

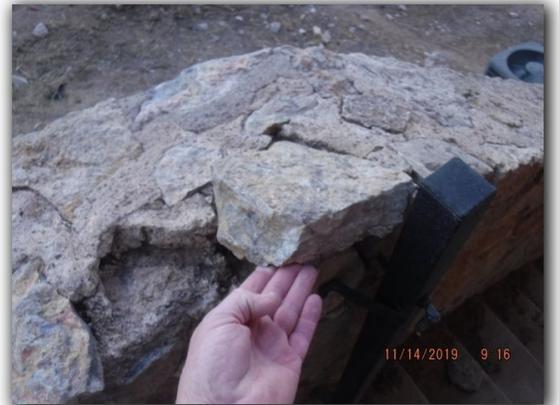
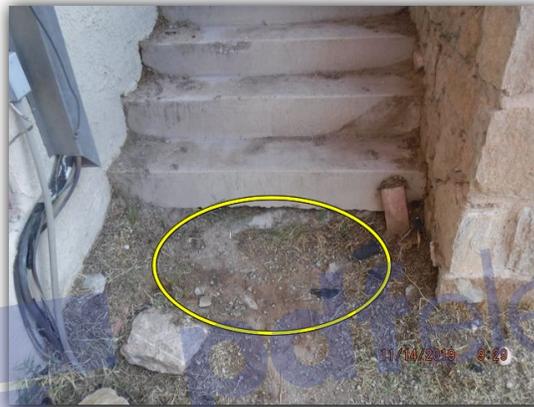
- 1.Side Exterior : Hand rail is missing.
- 2.Landing Wall : Mortar is deteriorated and some rocks are loose.
- 3.The landing at the bottom of the stairway is eroded, creating a trip hazard.

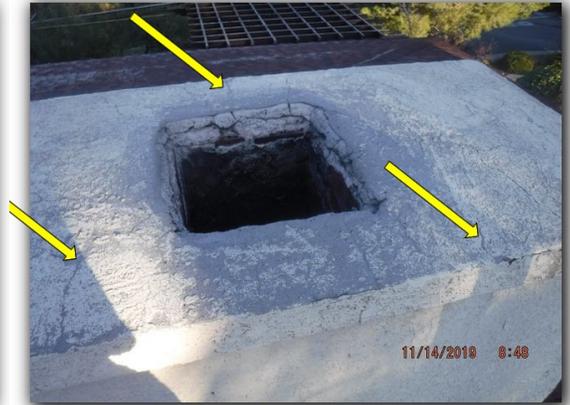
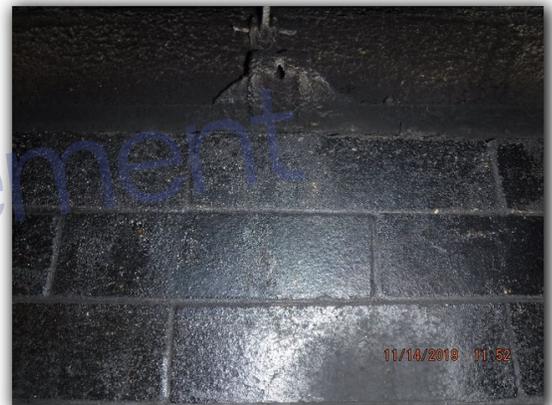
1. Creosote build up in firebox or flue.
2. Chimney crown is cracked and spark arrestor / chimney cap are missing.

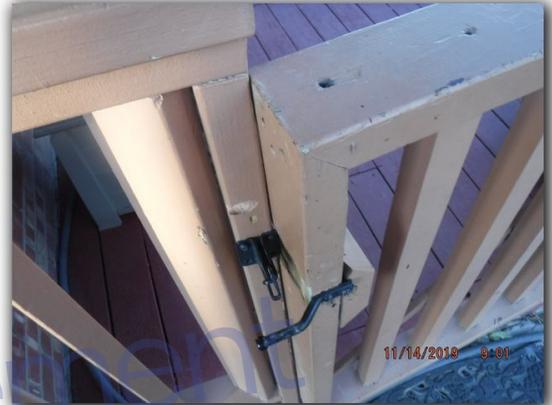
1. One balauster is missing at the front corner of the deck.
2. Gate is difficult to close. It is mis-aligned.
3. There is evidence of minor moisture intrusion on the deck joists. No evidence of rot observed.
4. The lattice around the deck is damaged in some areas.

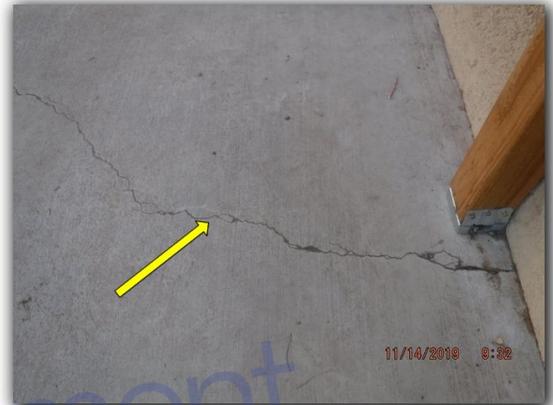
1. Minor cracking. Recommend seal and monitor.

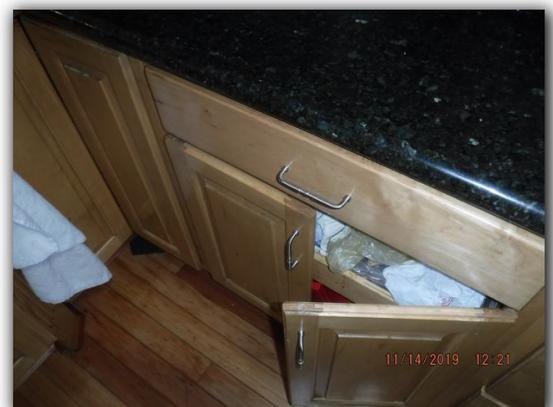
1. Guest Bath : Cabinet hinge is damaged.
2. Kitchen : Some hinges are loose.

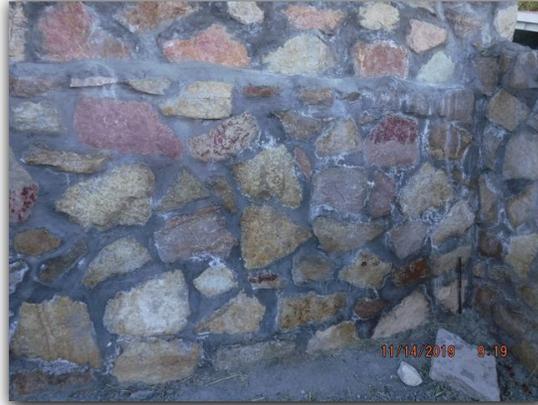
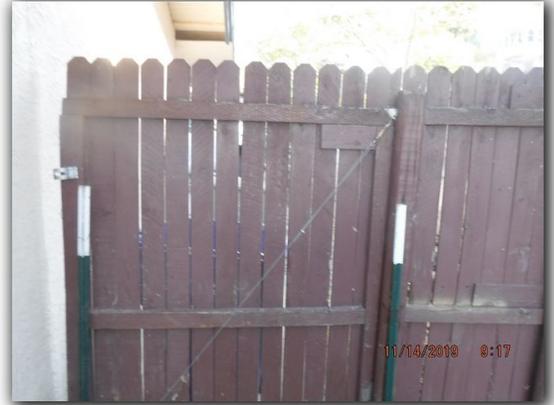
- 1. Typical cracks / voids in rock wall. Recommend seal and monitor.
- 2. Left Gate : Damaged and does not open.

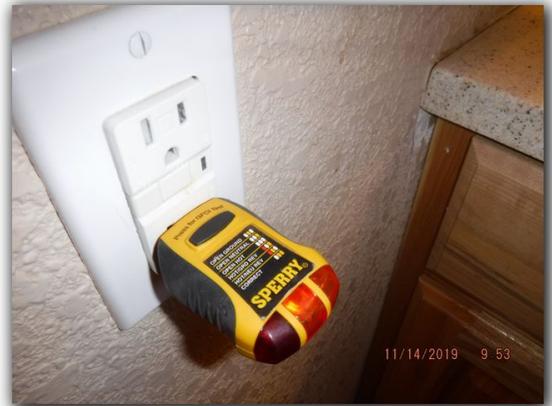
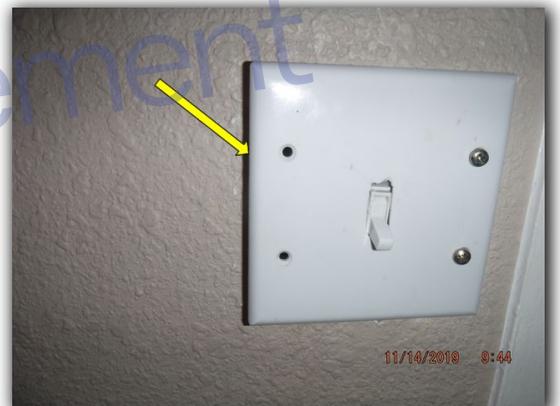
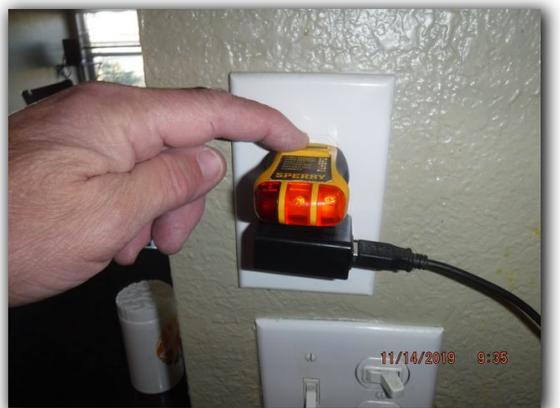
1. Master and Guest Bath : GFCI is inoperable.
2. Play Room : No power to outlets and light switch is loose.
3. Kitchen : No GFCI protection.
4. Some dimmer switches are inoperable.

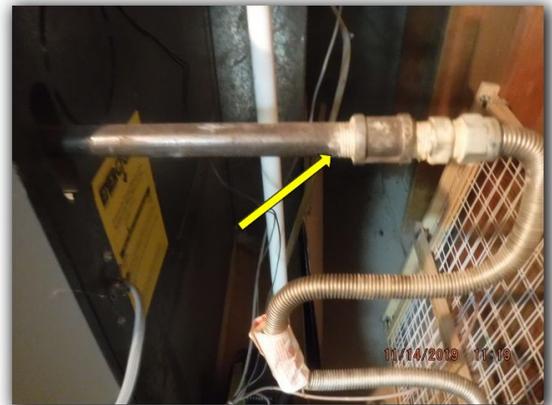
1. All Units : The heater gas supply line is not equipped with a sediment trap just before the gas appliance connector. This condition does not meet current installation requirements and should be corrected.
2. Did not locate combustion air or supply air intakes in the closet. Recommend further evaluation by a licensed technician.

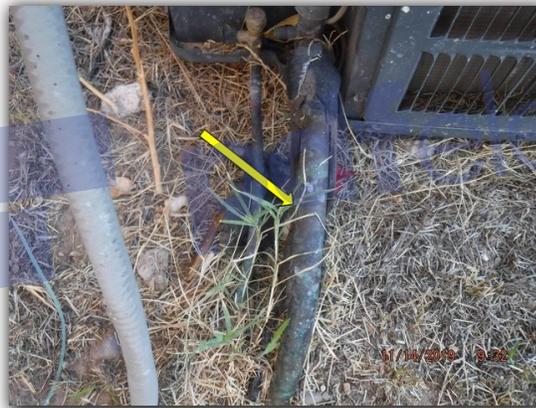
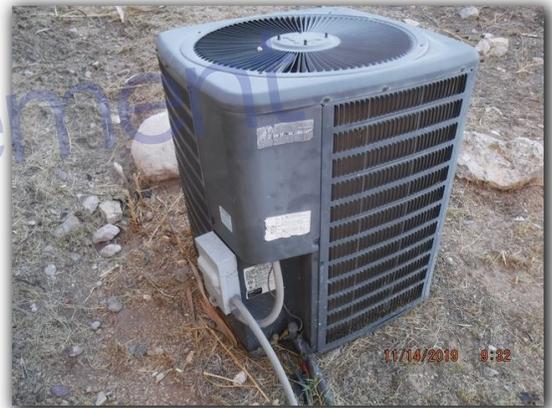
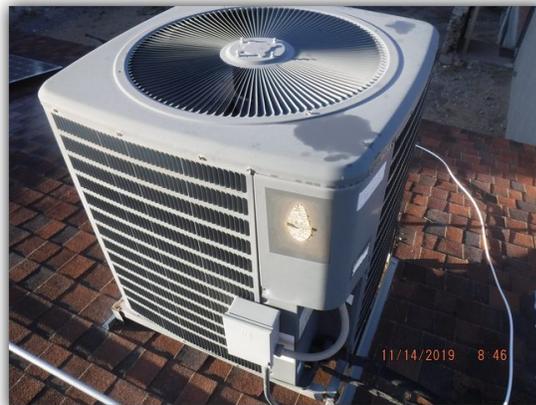
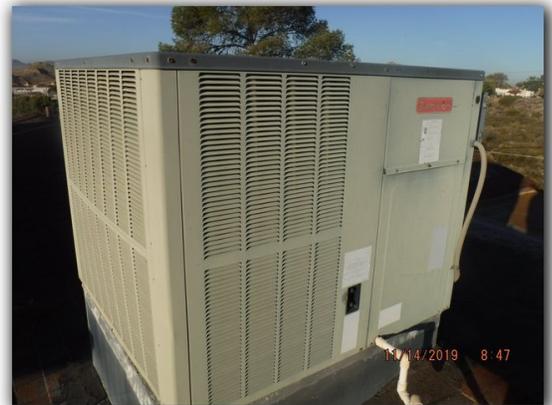
1. Garage Unit : Refrigerant lines not properly insulated at the condenser. Left exterior of home.
2. Garage Unit : Condenser is mounted on the ground. Recommend a mounting pad minimum 3"thick.
3. The condensate drain on one roof top unit is disconnected.
4. The condensate drain on one roof top unit is not terminated properly and the roof penetration needs to be re-sealed to prevent water intrusion.

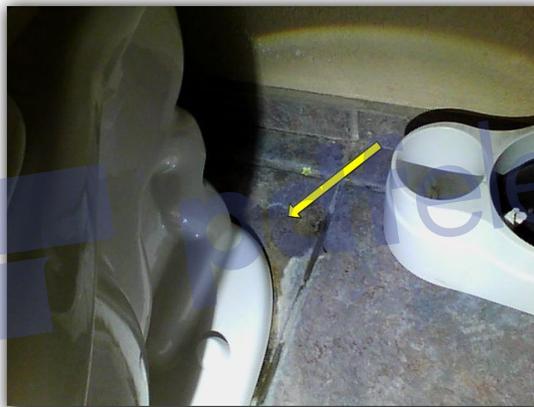
- 1. Guest Bath : Leakage around commode.

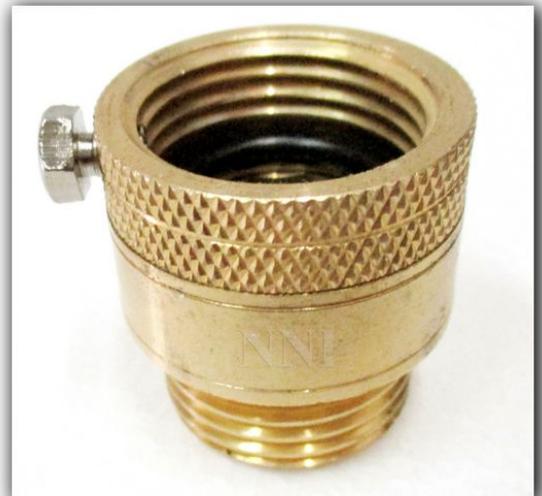
1. Some exterior hose bibs do not have back-flow prevention.

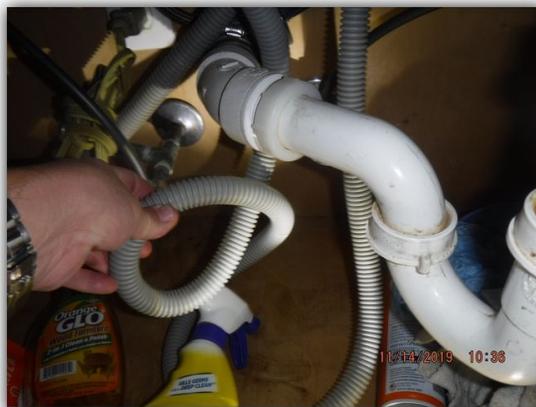
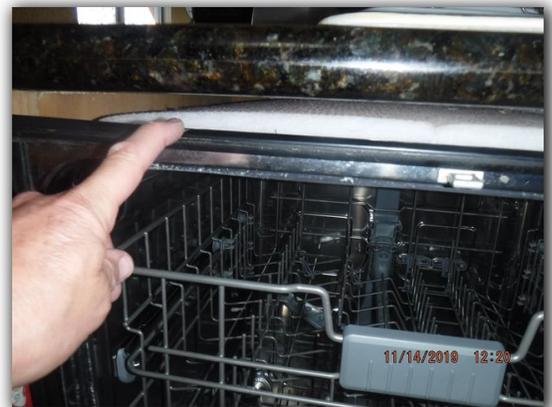
1. Recommend shortening the anti-siphon loop at the drain line to prevent blockage.
2. Unit is not properly secured to cabinet.

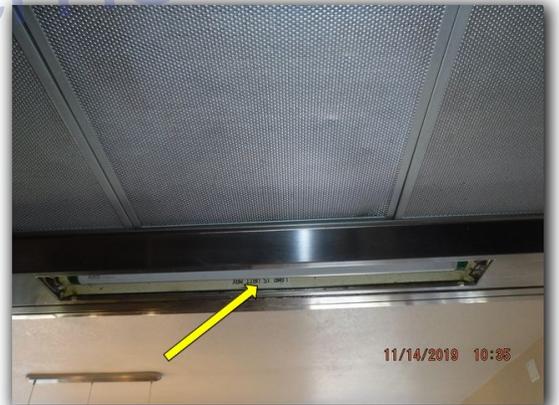
1. One lens is missing.

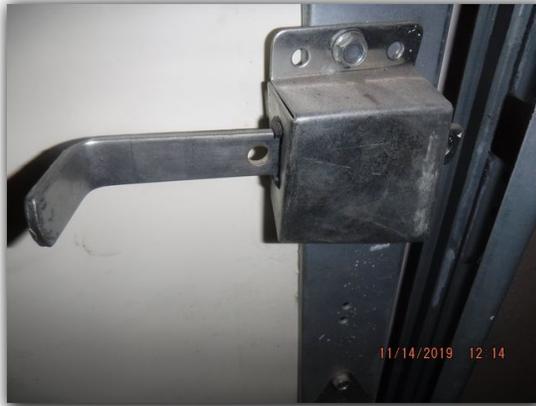
1. Door locks or side ropes have not been removed or disabled. Recommend removing or disabling to prevent door and opener damage.
