Homequest Home Inspections PROPERTY INSPECTED

PROPERTY INSPECTION REPORT

El Paso, TX 79912

12/19/2019

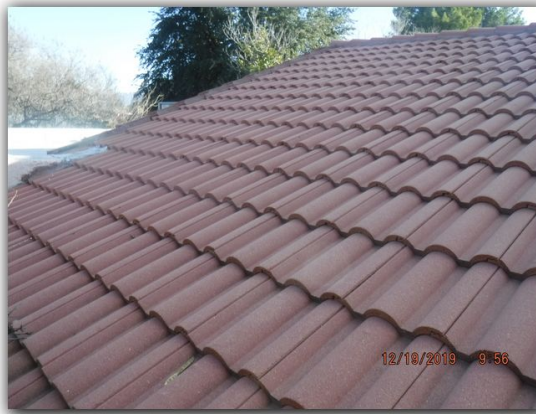
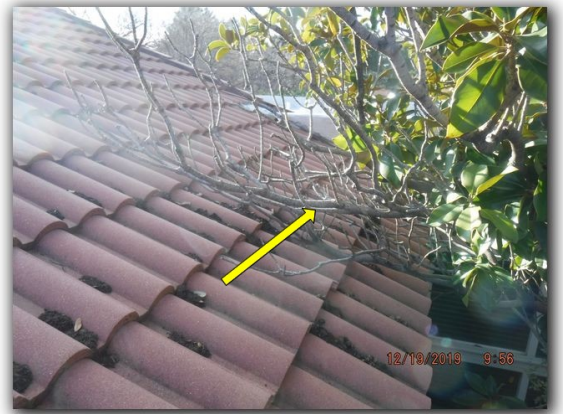
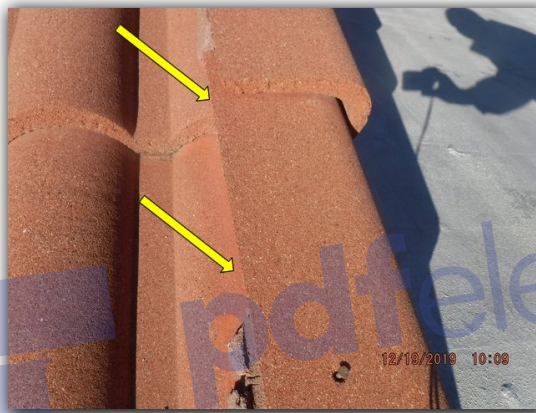
1. Mortar is deteriorated cracking or missing on some cap tiles. In need of repair. Refer to Comments above.
2. Tree branches overhang at the front. Recommend trimming back to clear roof.

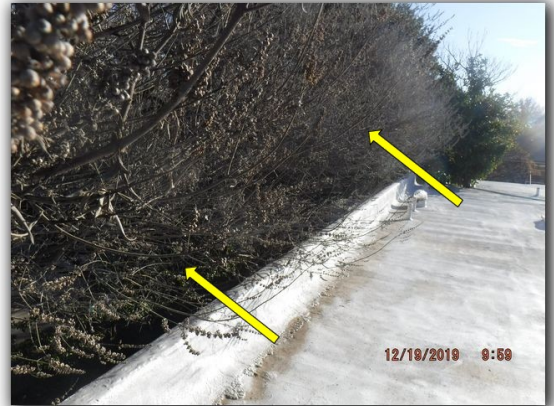
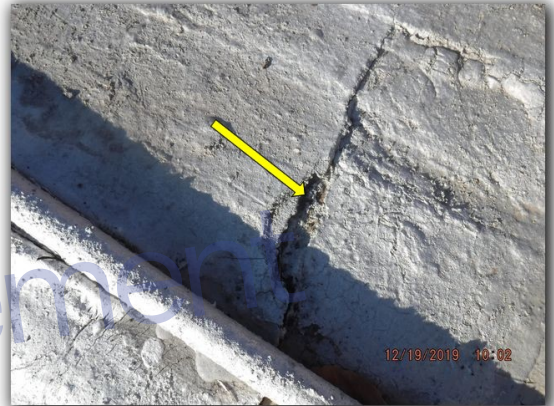
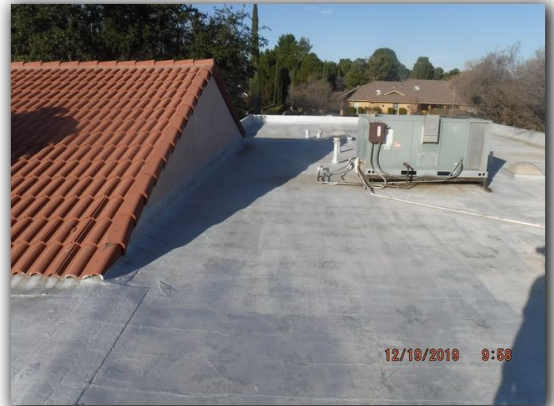
1. Cracking of roof coating in one or more areas. Refer to Comments above.
2. Indication of water ponding in various areas.. Refer to Comments above.
3. Tree branches overhang at the left and rear. Recommend trimming back to clear roof.

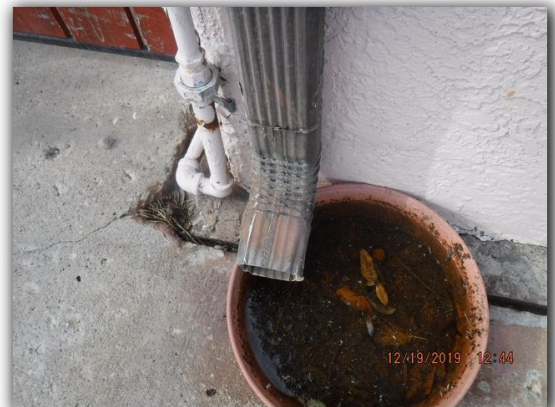
1. Gutters / Downspout's draining too close to foundation at the rear. Refer to Comments above.
2. Gutter downspout is disconnected at the left side of home.

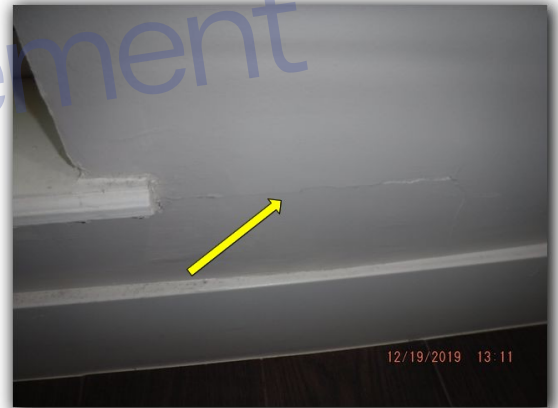
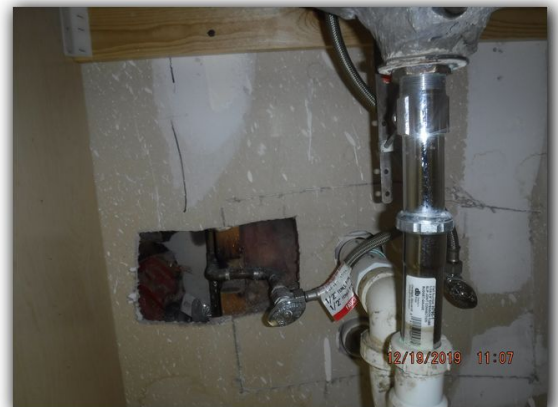
1. West Bedroom : Settlement crack by the window.
2. East Bathroom : Drywall is missing under the sinks and the access cover to tub plumbing is missing.

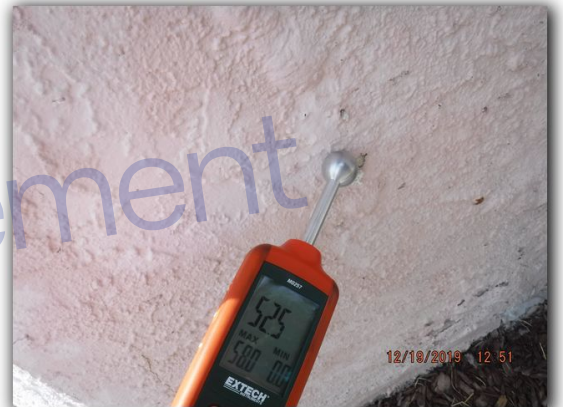
1. Some cracks on the stucco siding in various areas. Recommend sealing to prevent moisture intrusion.
2. Rear : stucco is bubbled below the bay window. Tested positive for moisture. Recommend further evaluation.

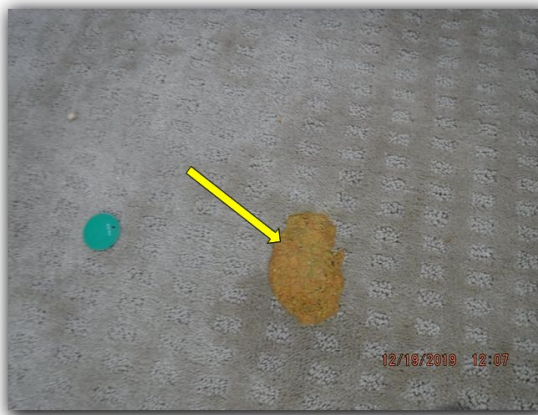
1. Office : Carpet is stained.

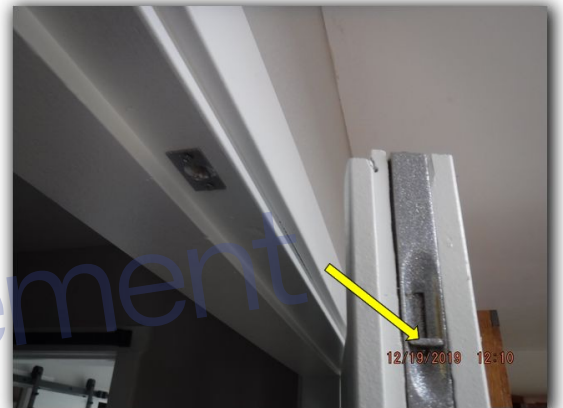
1. East Bedroom : Hits frame.
2. Master Bath : One barn door is difficult to slide and hardware is loose.
3. Office : Latch to French door is seized.

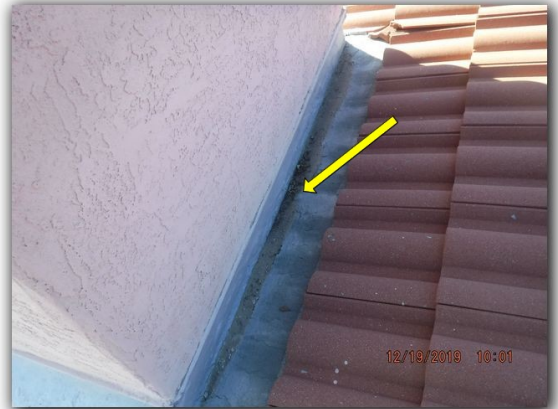
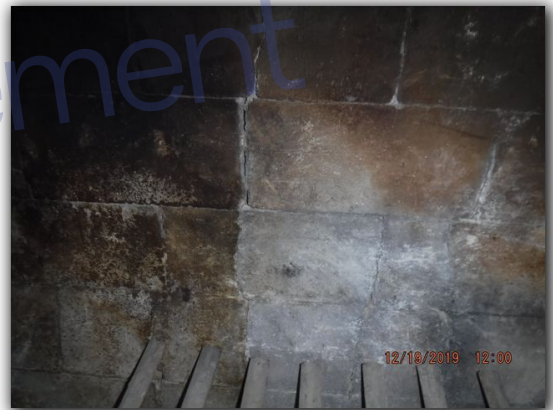
- 3. Rear hearth fire brick is cracked. Refer to Comments above.
- 4. Creosote build up in firebox or flue. Refer to Comments above.
- 5. It is recommended to install a cricket where the down slope of the roof connects to the chimney to channel water away from the chimney.
- 6. The clean out door does not close.

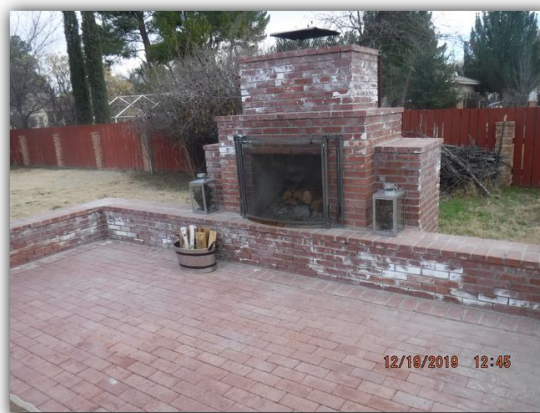
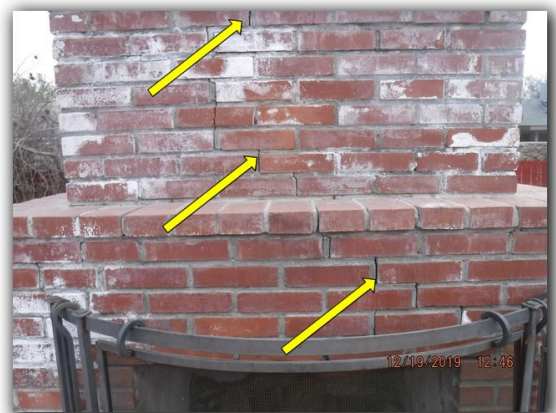
- 1. Step cracks on the chimney. Recommend sealing.

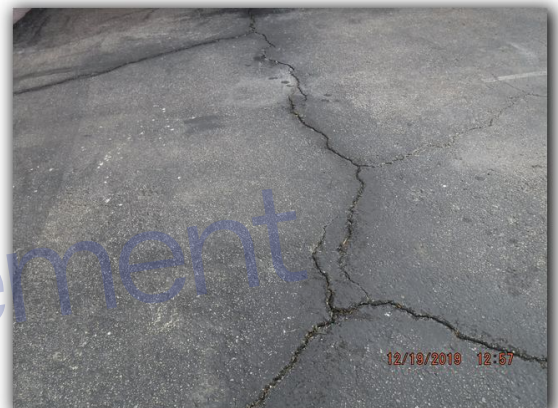
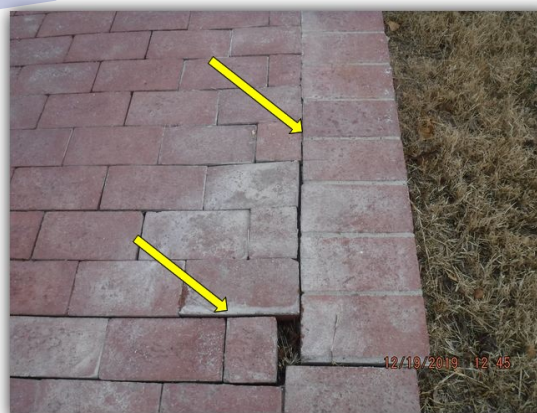
1. Minor cracking. Recommend seal and monitor.
2. Rear Patio : Some bricks are loose. Possible trip hazard.

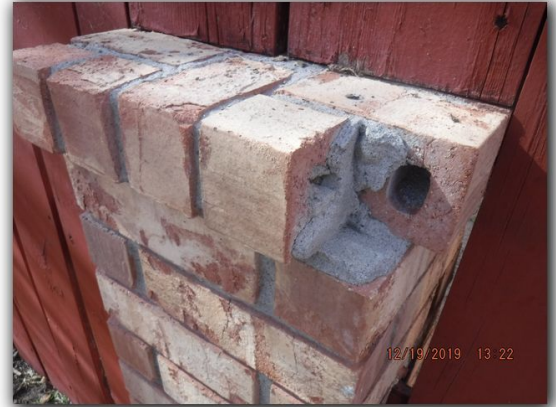
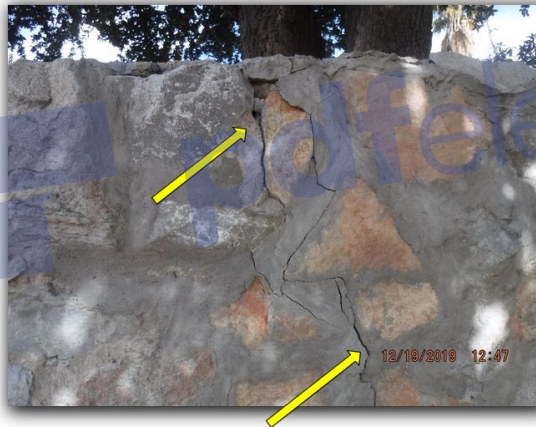
1. Typical cracks / voids in rock wall. Recommend seal and monitor.
2. Rear : Wood is damaged in various areas.
3. Bricks are missing in various areas.

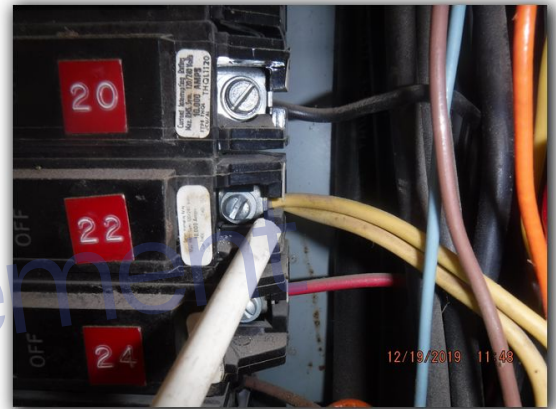
1. One doubled tapped breaker.
2. Two panel cover mounting screws are missing.

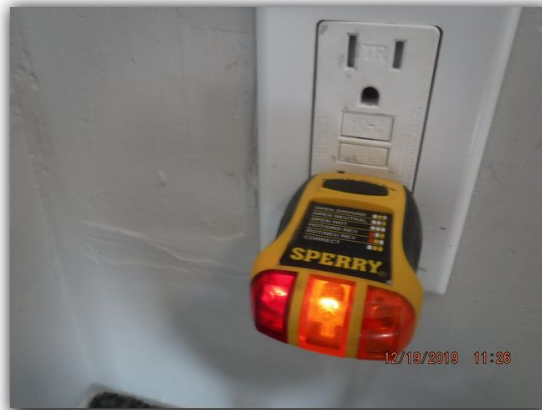
1. Wet Bar : Test indicated reverse polarity. Safety consideration. Further evaluation recommended.
2. Dining : Switch is taped. Unknown what it operates.
3. There is no GFCI protection in the garage, exterior. Safety consideration. Further evaluation recommended.
4. Family Room : One floor outlet housing is loose.
5. Dining : No power to two outlets.

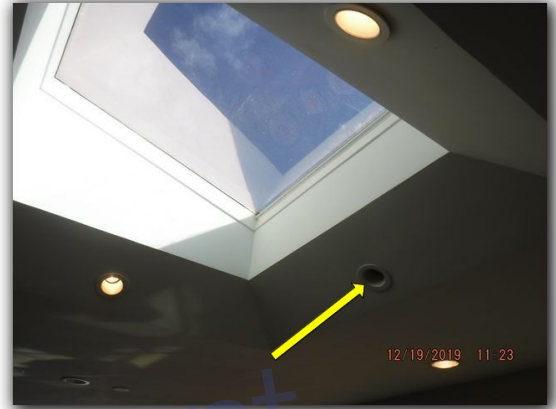
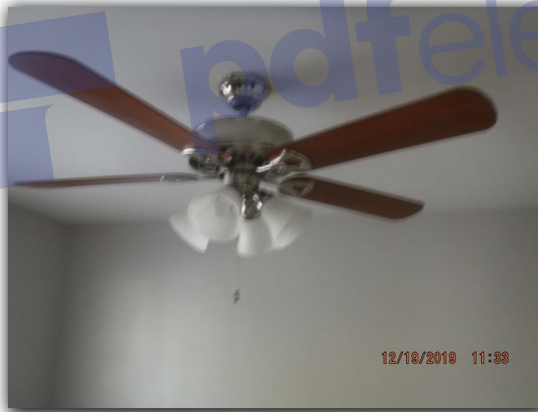
1. Front West Bedroom : Ceiling fan is not balanced.
2. West Bedroom : Light/fan does not turn on.
3. Kitchen : One recessed light did not turn on.

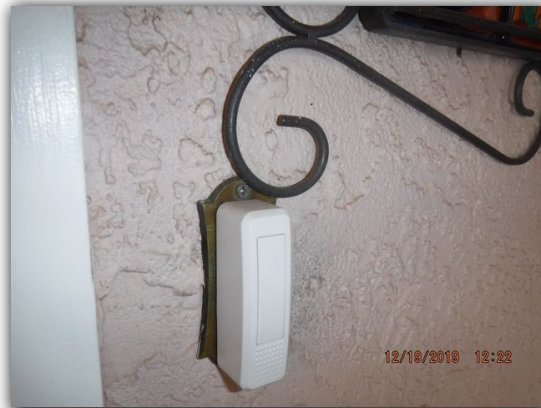
1. Chime is inoperable.

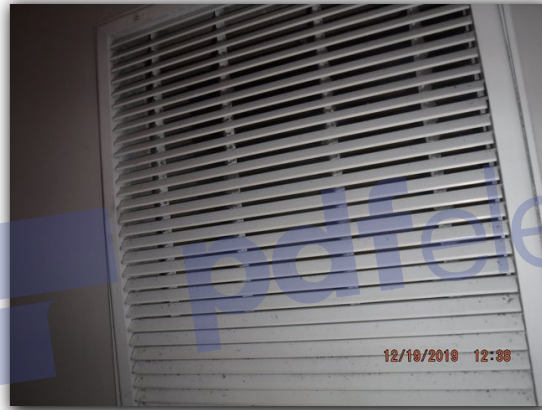
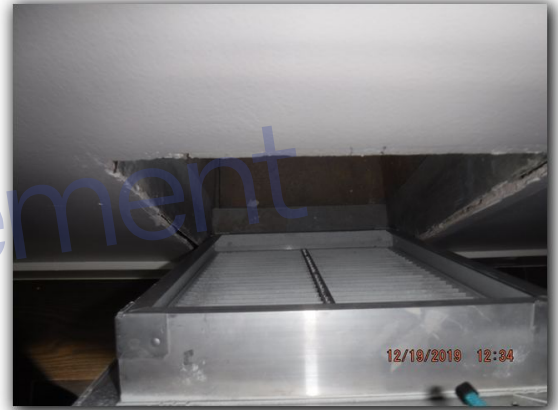
- 1. HVAC intake air filters to both units are missing.

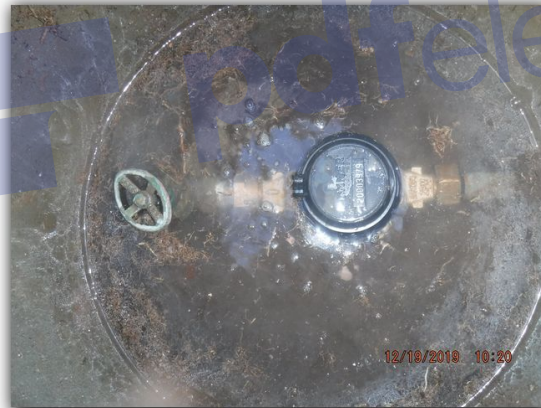
1. Active valve / pipe leak. Turned main off after plumbing inspection. Recommend further evaluation.

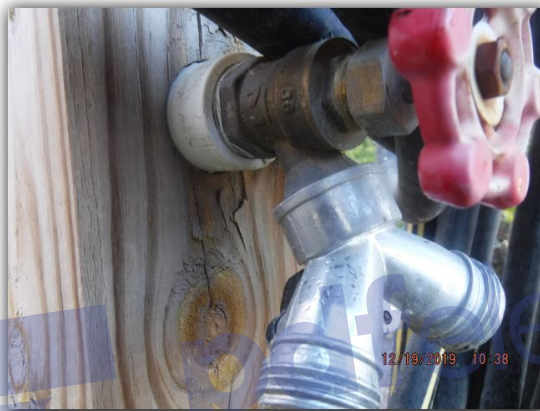
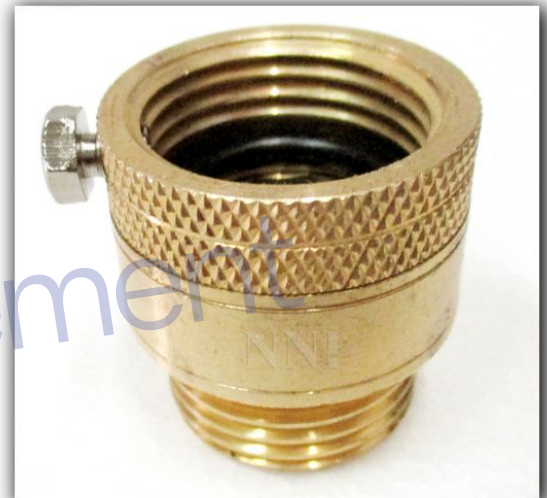
1. Front : Exterior hose bibs do not have back-flow prevention.
2. Front : No water output to one hose bib.

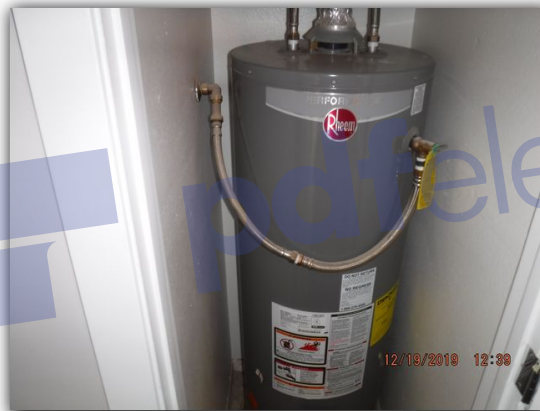
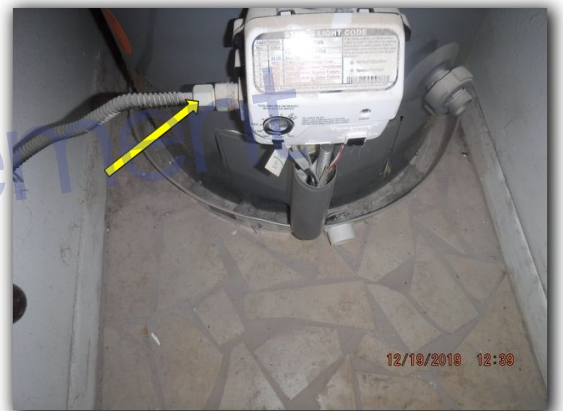
1. Vent hood mounting screws are missing.
2. The water heater gas supply line is not equipped with a sediment trap just before the gas appliance connector. This condition does not meet current installation requirements and should be corrected.
3. Pan is lacking a drain system. Recommend installing a moisture alarm available at Lowes or Home Depot.

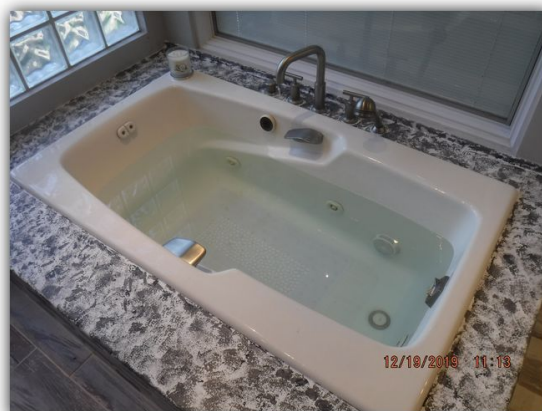
1. Inoperative unit(s) and controls. Jets did not turn on.
2. Lack of ground fault circuit interrupter. Unable to locate one. Recommend further evaluation by a licensed electrician.

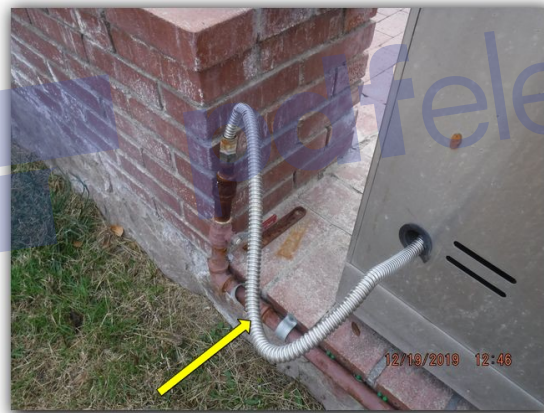
1. CSST line is in use and is prone to damage. Recommend shielding it or installing rigid black pipe.

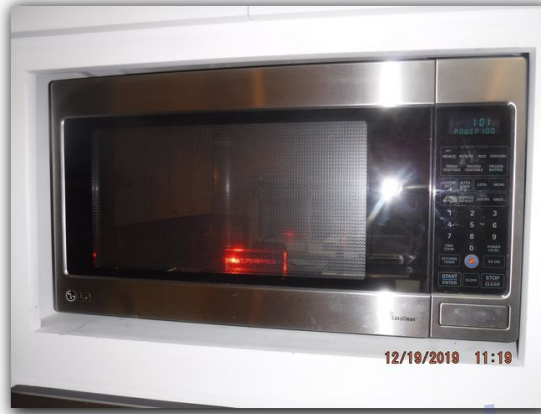
1. Unit may not be operating at full capacity after setting to 100% power. All LED's on tester did not flicker as recommended.

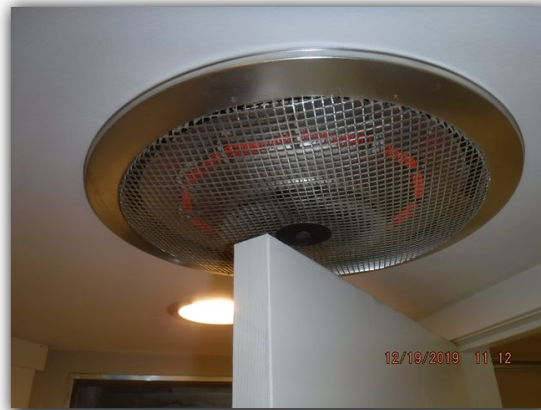
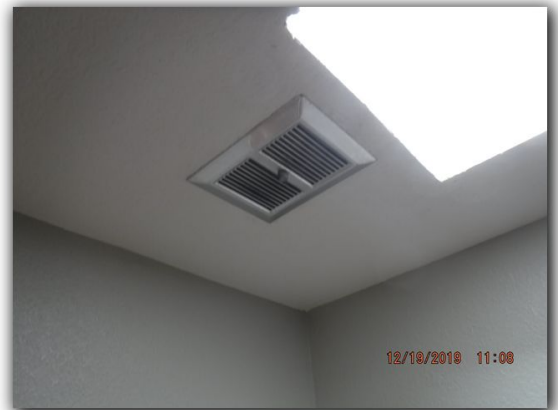
1. Master Bath : One radiant heater is directly over the entry door. Safety consideration.
2. West Guest Bath : Exhaust fan is noisy.
