Homequest Home Inspections PROPERTY INSPECTED

PROPERTY INSPECTION REPORT

El Paso TX 79936

12/26/2019

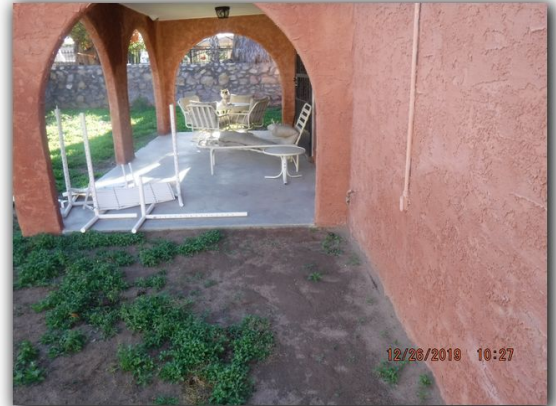
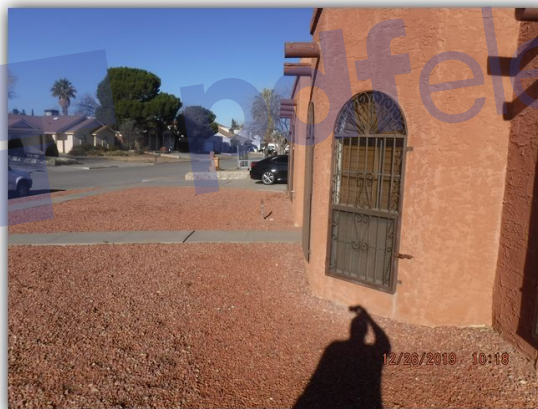
- Houses in the greater southwest area are typically built on almost flat grades, which could present problems with significant moisture buildup. This lot did not appear to have the proper slope for drainage at all points along the foundation at grade; this may lead to foundation distress. Lots should be graded to drain surface water away from the foundation walls. The grade should fall a minimum of 6" within the first 10'.

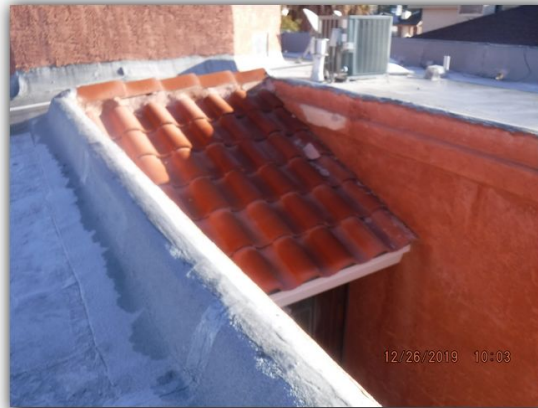
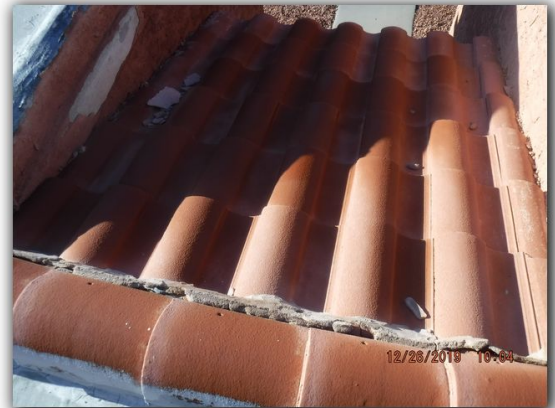
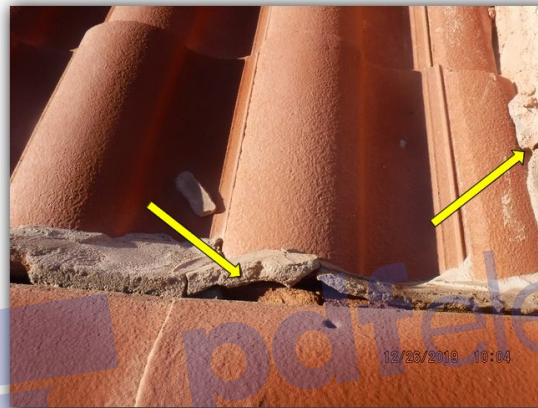
1. Mortar is deteriorated cracking or missing. In need of repair. Refer to Comments above.

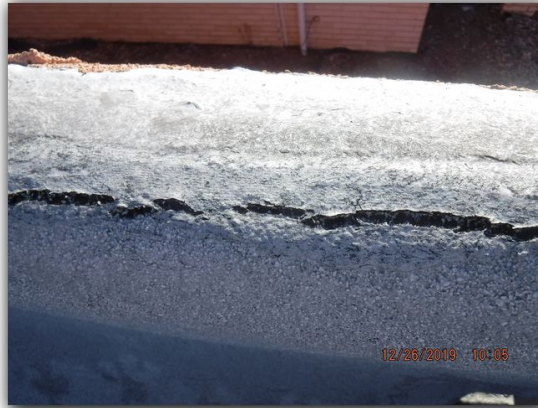
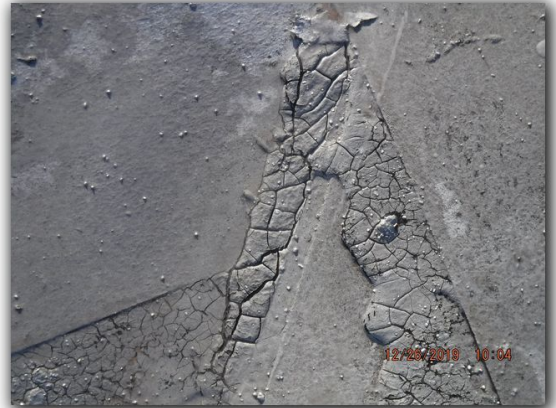
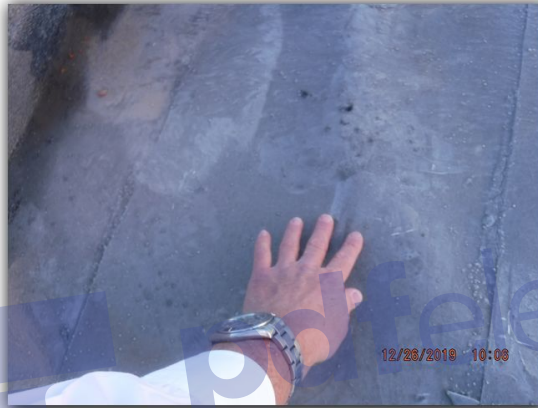
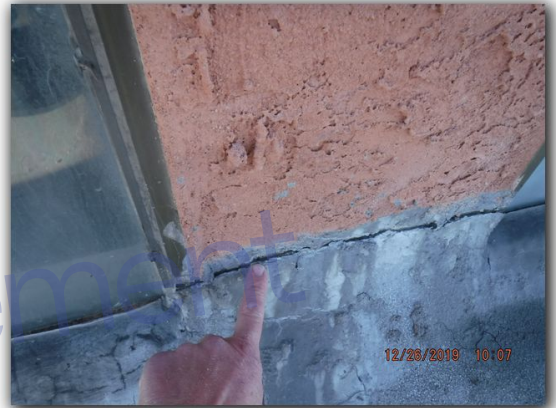
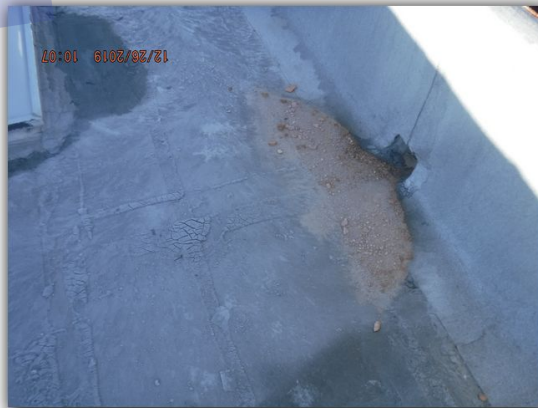
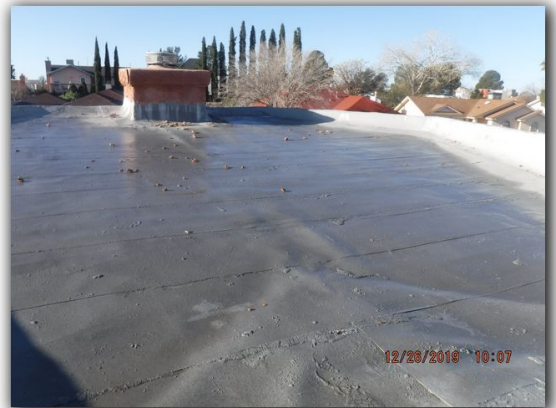
Flat Roofs

- 1. Further evaluation of the roofing system by a licensed roofing contractor is recommended.**
2. Cracking of roof coating in one or more areas. Refer to Comments above.
3. Blisters in roof coating at the right rear. While deficient inspector does not recommend repairs at this time; visual inspection periodically is recommended. If faults are noted, condition should be re-evaluated. Refer to Comments above.
4. Refer to Comments above.
5. Indication of water ponding. Refer to Comments above.
6. The vertical wall is touching the roof line above the family room and the tar seals are cracked. New home construction requires a relief clearance between the vertical wall siding and the roofing material for water to pass freely under the siding. This home was constructed prior to the new standards and is not considered a deficiency if it is properly flashed. Refer to Comments above.

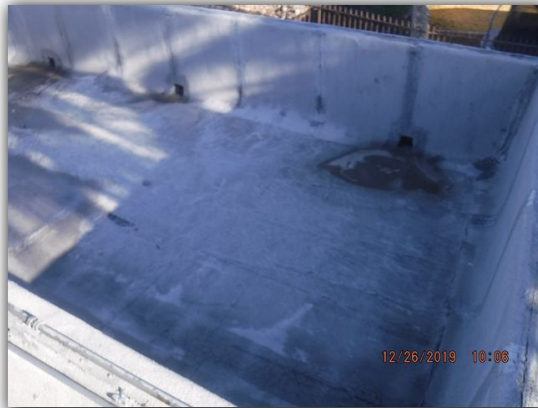
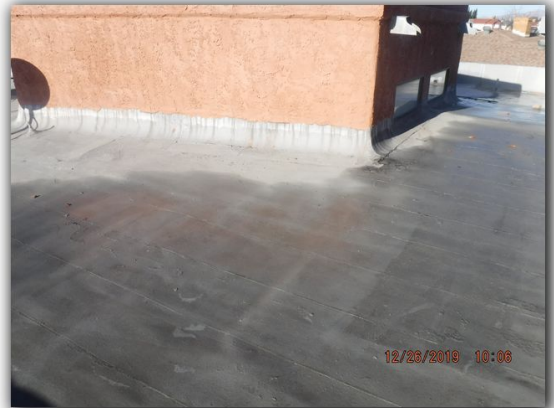
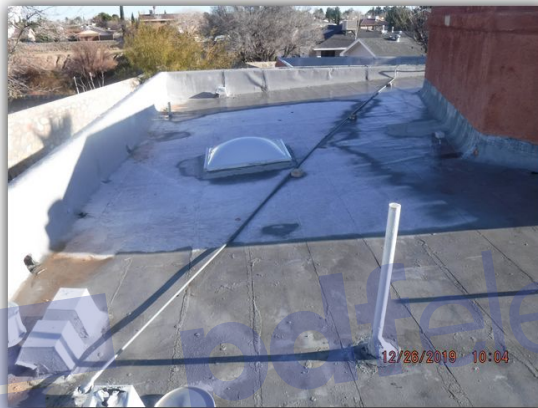
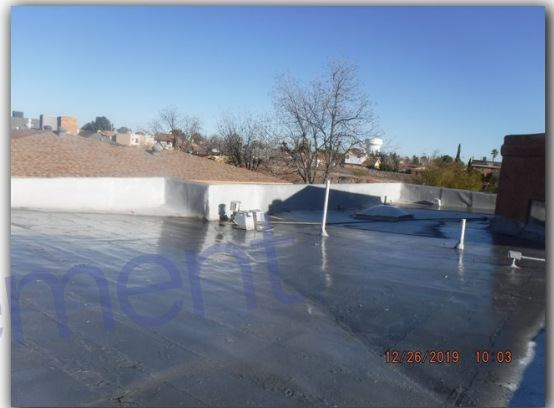
Roof Penetrations - Gutters

1. The tar seals at the roof penetrations need to be re-sealed and coated with a reflective coating or embedded with reflective granules. Refer to Comments above.

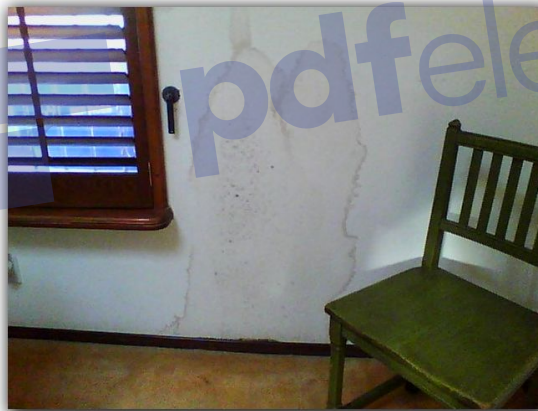
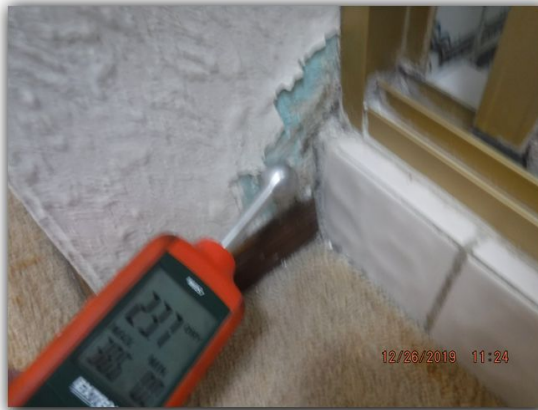
1. Water stains on wall in dining room. There is evidence of active moisture within the wall and observed a black substance. Recommend a qualified contractor to identify source of moisture and remedy.
2. Master Bath : Wall by the shower is water damaged. Tested negative for moisture.

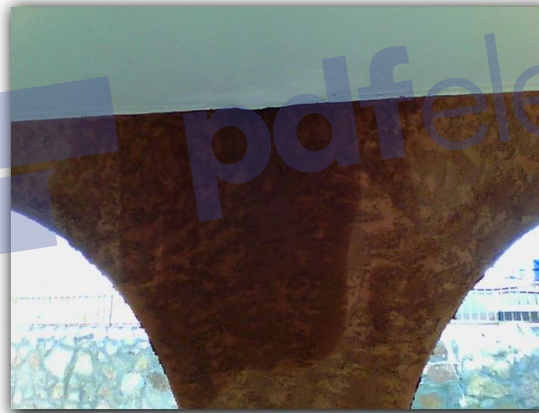
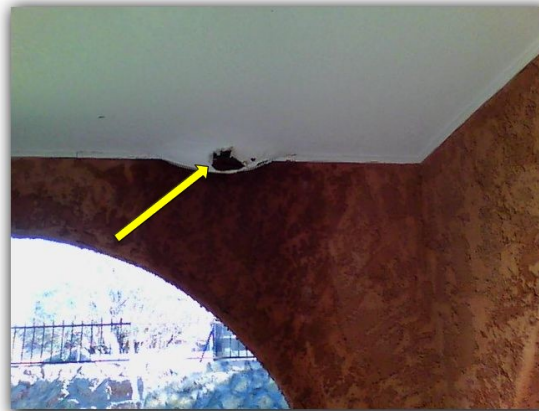
1. Water stains on wall in rear patio. There is evidence of active moisture within the wall. Recommend a qualified contractor to identify source of moisture and remedy.
2. Stucco terminating below grade. This item met building standards at the time the home was built. The building standards have changed and Per TREC standards of practice we are required to note this item as a deficiency.
3. Minor settlement crack on left side of home.
4. Wood trim is water damaged at the garage and exterior doors.

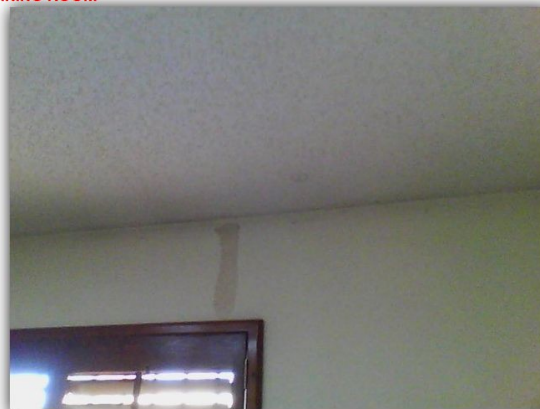
DINING ROOM

1. Ceiling structure showed signs of water intrusion, which could lead to more serious structural damage. All areas, with exception of the dining room, tested negative for moisture. Recommend a qualified contractor to identify source of moisture and remedy.
2. Ceiling drywall is sagged visibly at the time of the inspection in the hallway. This appears to be due to leakage from above. The source of moisture intrusion should be identified and corrected, and the damaged section of drywall replaced. Tested negative for moisture.
3. Dining Room : Evidence of active moisture. Recommend a qualified contractor to identify source of moisture and remedy.
4. Ceiling finish is stained or damaged in numerous areas.
5. Rear Patio : Drywall is water damaged. Tested positive for moisture.

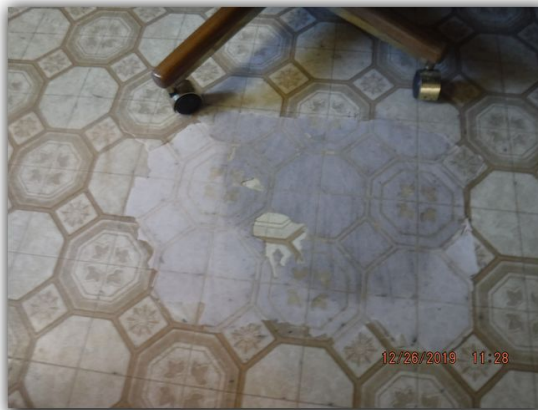
1. Kitchen : Linoleum is worn and damaged.

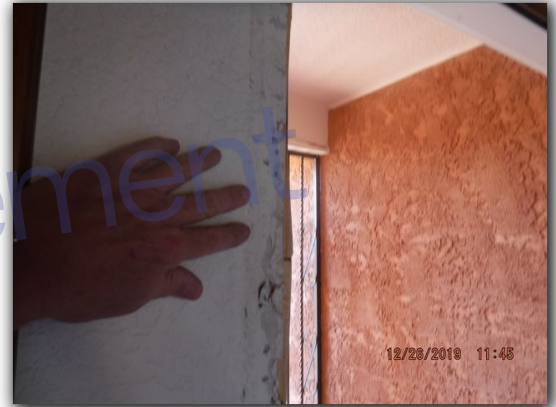
1. Front : Difficult to open, close, weather strip is missing, trim piece is missing.
2. Front Security Door : Double cylinder locks pose an egress issue in event of emergency.

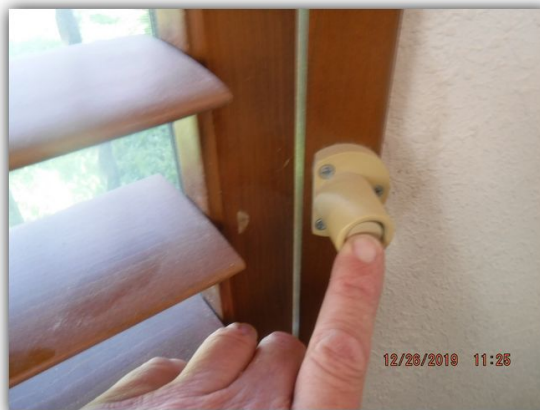
1. Some windows are difficult to open, close or latch.
2. Some windows are difficult to open or close due to dirt buildup in the tracks.
3. Some windows did not open.
4. Dining : Window does not stay open and screen is missing.
5. **Front Bedroom : Burglar bar did not release.**
6. **Master Bedroom : Burglar bar did not release.**
7. Thermal pane window seals have failed, moisture is present on kitchen and family room solar windows.
8. Security bars do not provide for adequate emergency egress. Safety consideration.
9. There is evidence of prior moisture intrusion on some sills. Recommend re-sealing around all windows on the exterior.

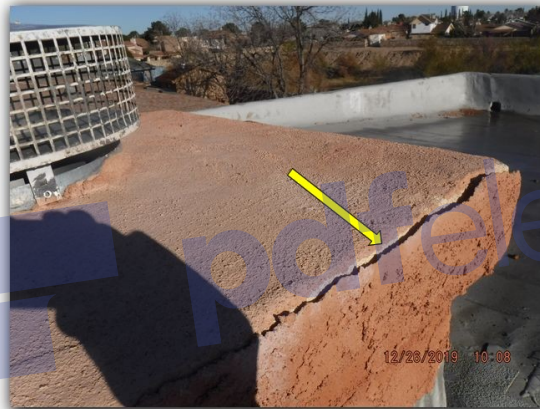
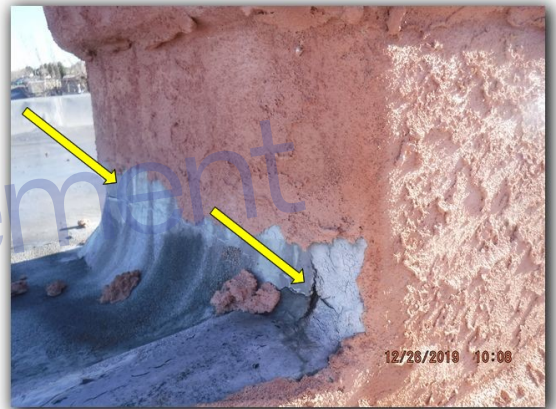
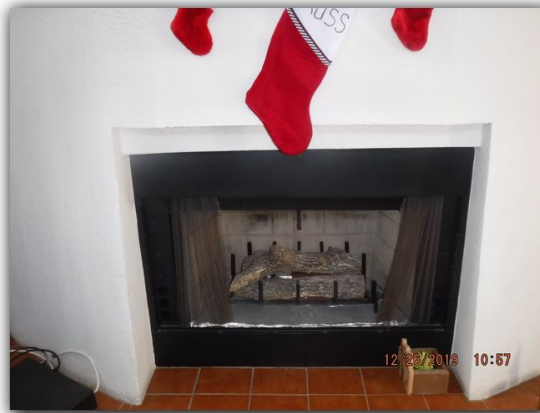
- 1. Chimney crown is cracked and missing stucco in various areas. Refer to Comments above.

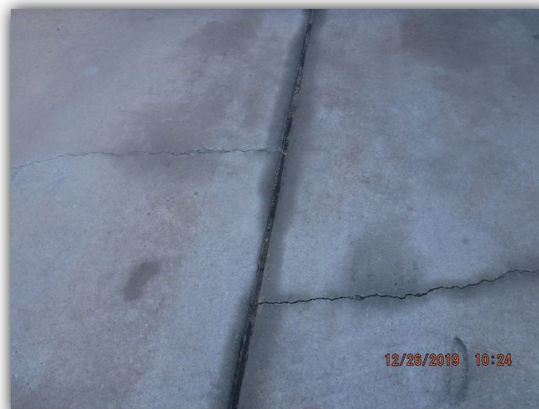
1. Minor cracking. Recommend seal and monitor.

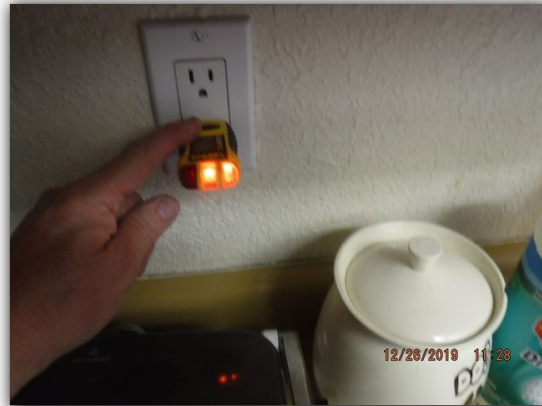
1. **There is no GFCI protection in the kitchen, wet bar, bathrooms, laundry, garage, exterior. Safety consideration. Further evaluation recommended.**

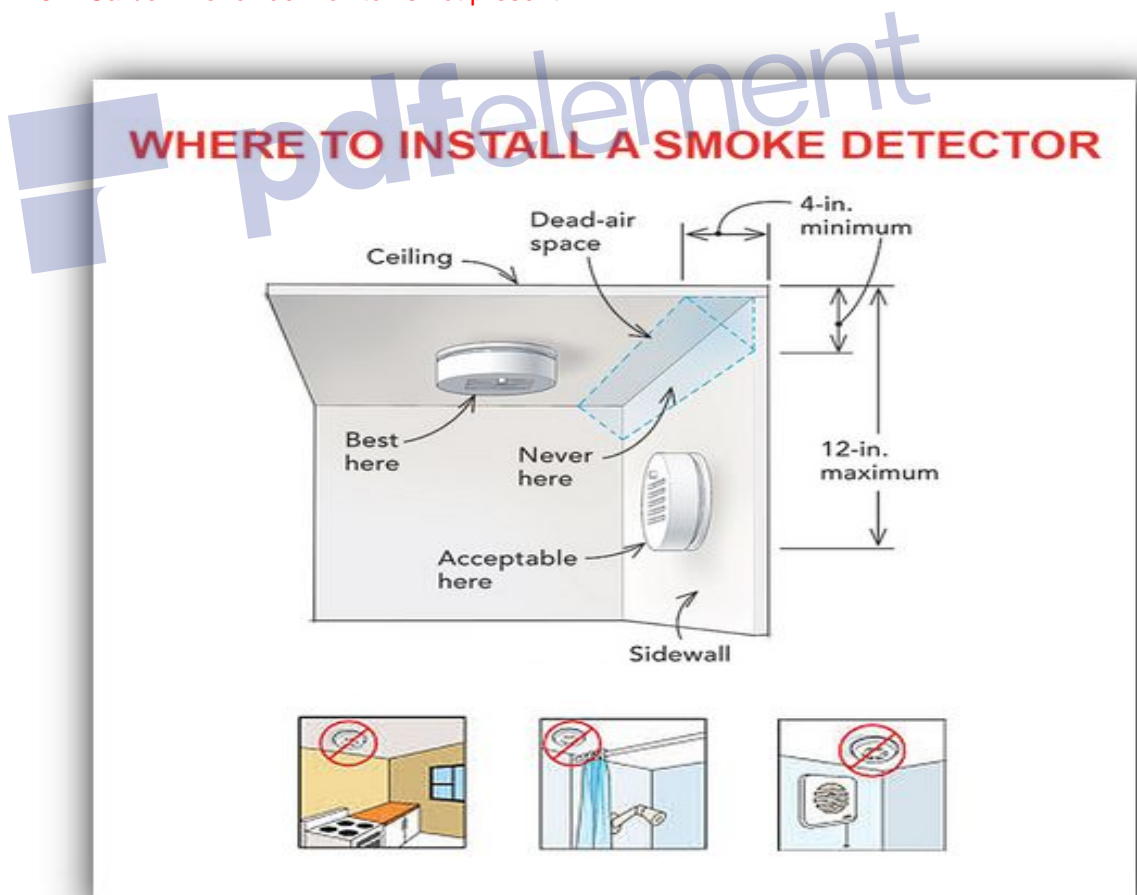
1. Smoke alarms are not present in each sleeping area.
2. No smoke alarm in hallway.
3. Carbon monoxide monitor is not present.

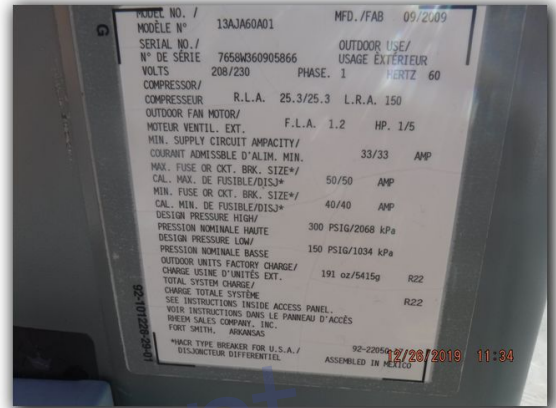
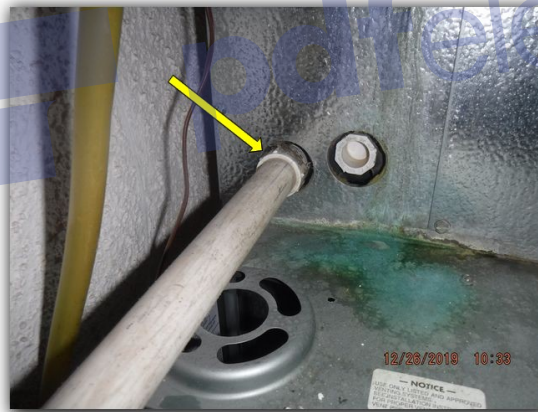
1. Condensate drain lacks a Safe-T-Switch interlock that will disable the unit in event of drain blockage from evaporator tray.

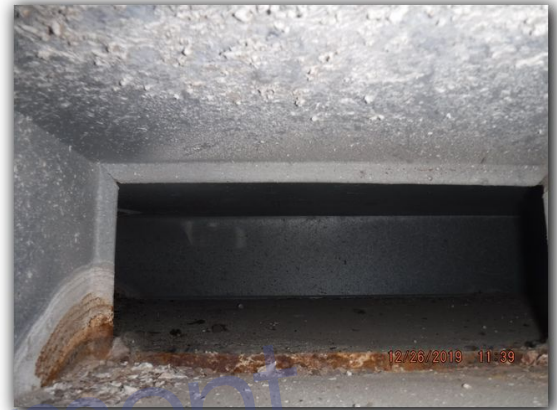
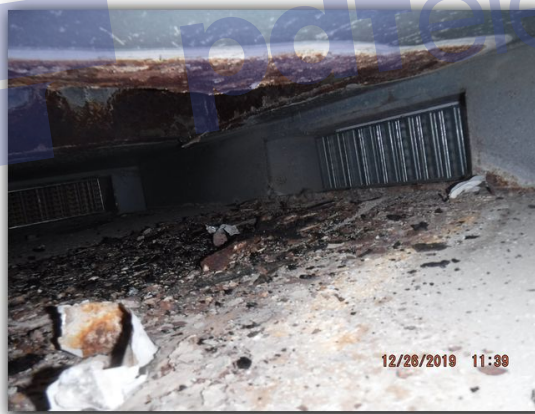
1. Ducting is dirty.
2. Ducting is corroded.

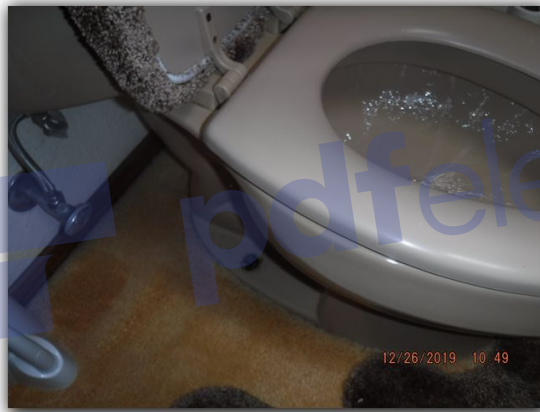
1. Guest Bath : Loose at floor mounting.

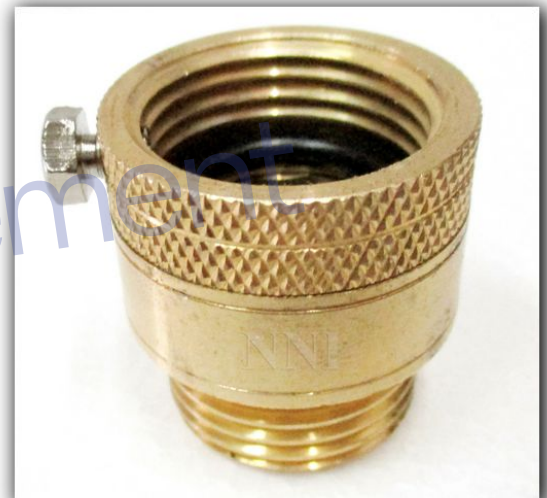
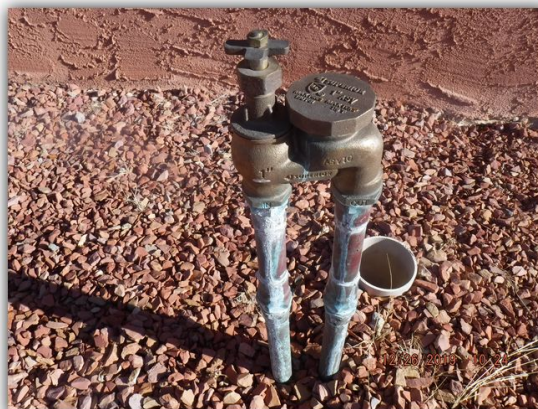
1. Exterior hose bibs do not have back-flow prevention.
2. Recommend insulating the sprinkler supply lines to prevent freeze damage.

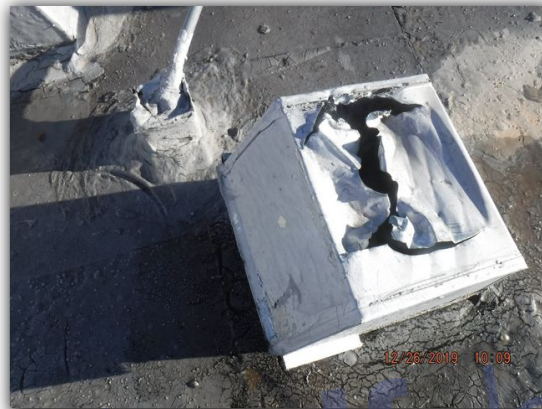
1. One roof vent above the water heater / garage is damaged.

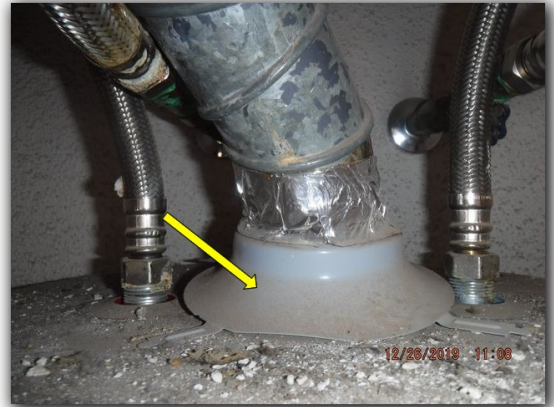
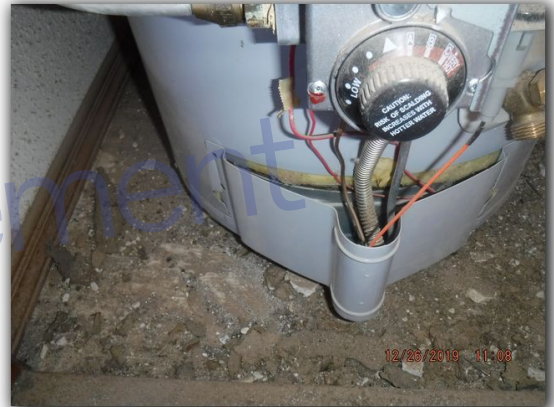
- 4. Draft hood is damaged and not connected properly.
- 5. Platform is warped and water damaged.

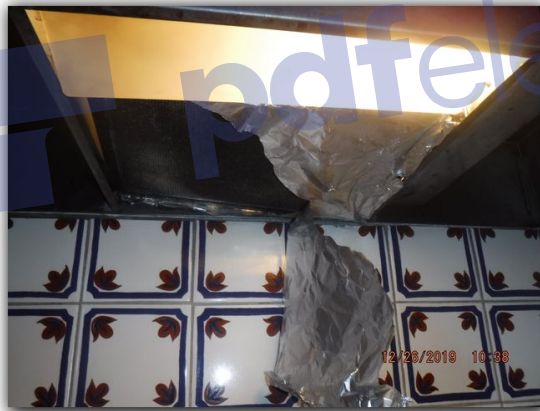
1. Filter is dirty / greasy

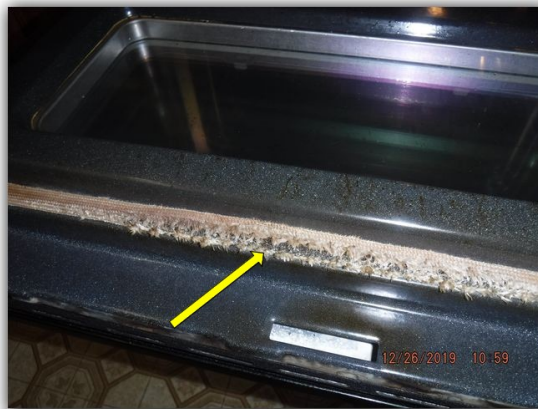
- 1. Oven door seal is worn.
