"Full" Reserve Study

**Cypress Creek Property Owners' Association,
Inc.
Boynton Beach, FL**

**Report #: 40239-0
For Period Beginning: January 1, 2021
Expires: December 31, 2021**

Date Prepared: September 25, 2020

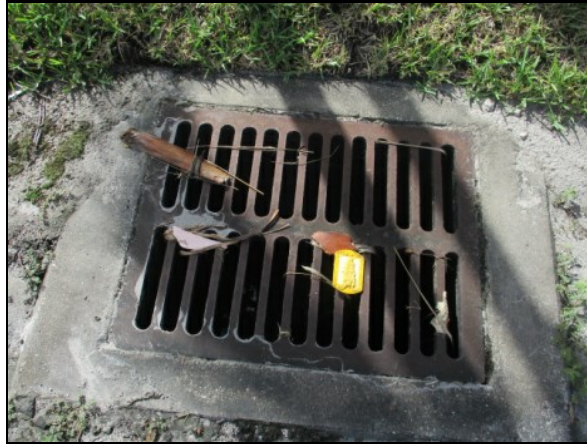
Comp #: 2113 Site Drainage System - Clean/Repair

Useful Life:
10 years

Remaining Life:
5 years

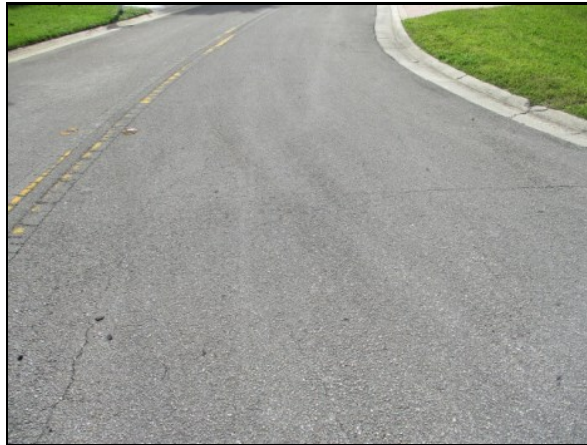
Useful Life:
4 years

Remaining Life:
0 years

Lower estimate to seal/repair

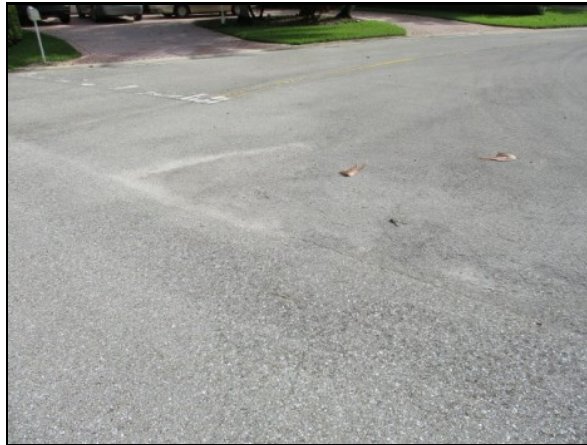
Useful Life:
20 years

Remaining Life:
12 years

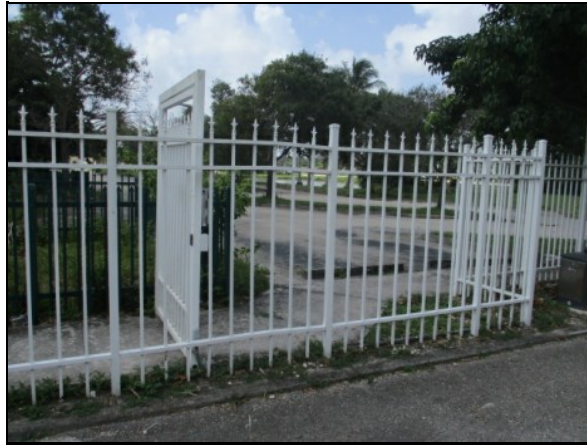
Useful Life:
25 years

Remaining Life:
10 years

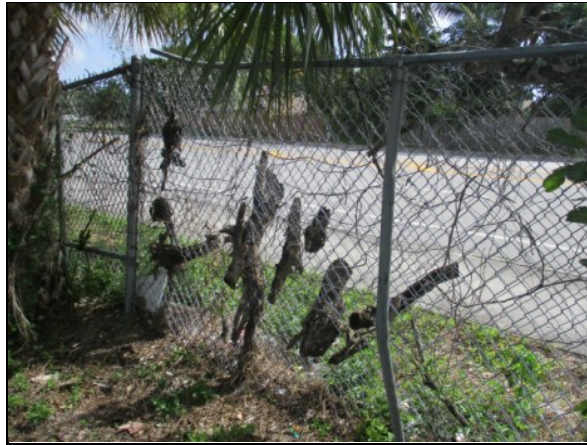
Useful Life:
30 years

Remaining Life:
5 years

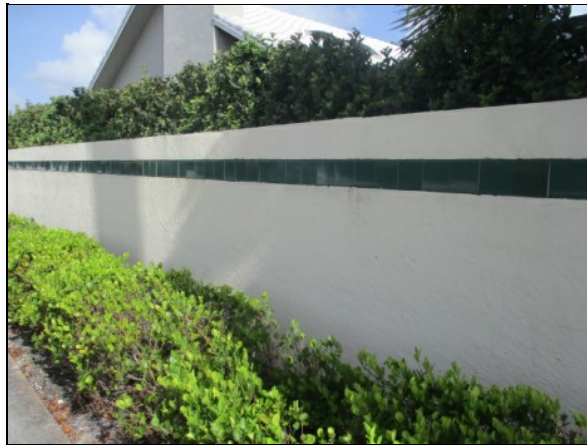
Useful Life:
7 years

Remaining Life:
5 years

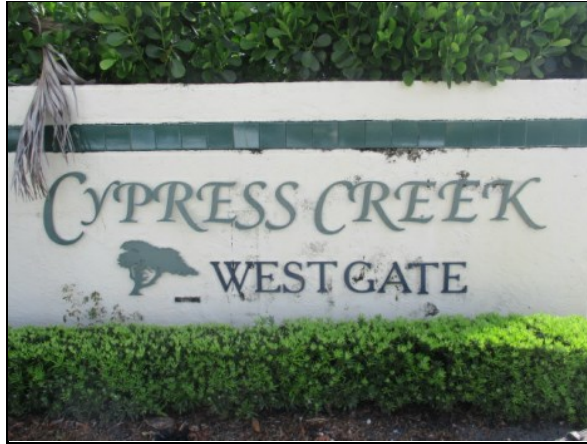
Useful Life:
20 years

Remaining Life:
5 years

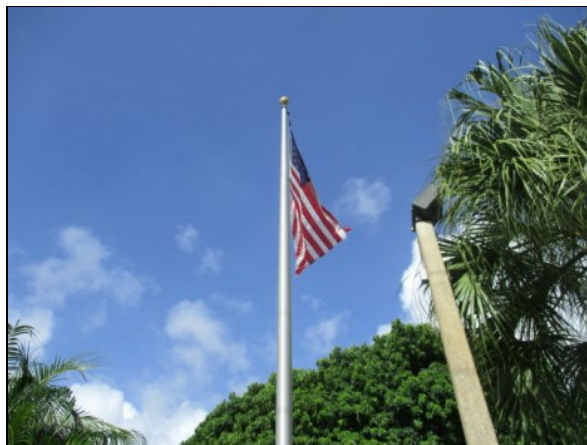
Useful Life:
30 years

Remaining Life:
10 years

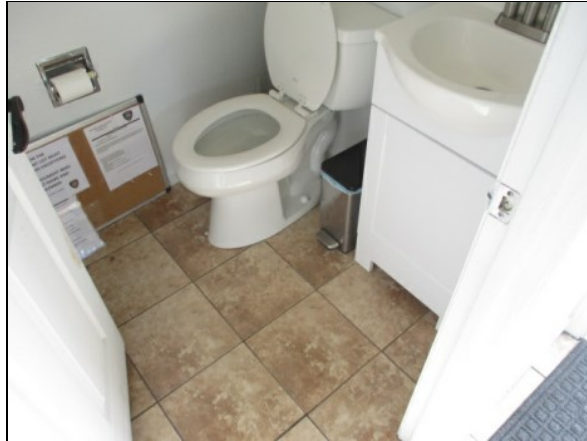
Useful Life:
10 years

Remaining Life:
5 years

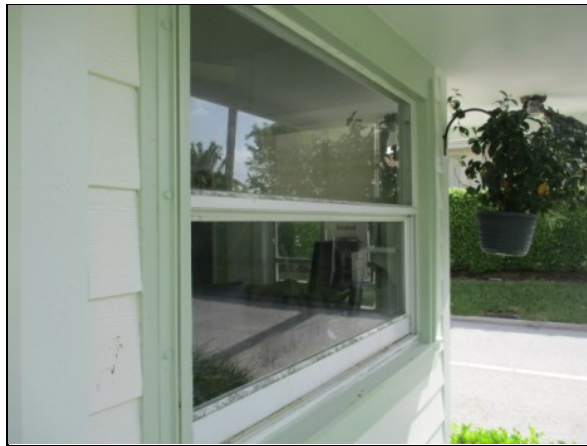
Useful Life:
40 years

Remaining Life:
39 years

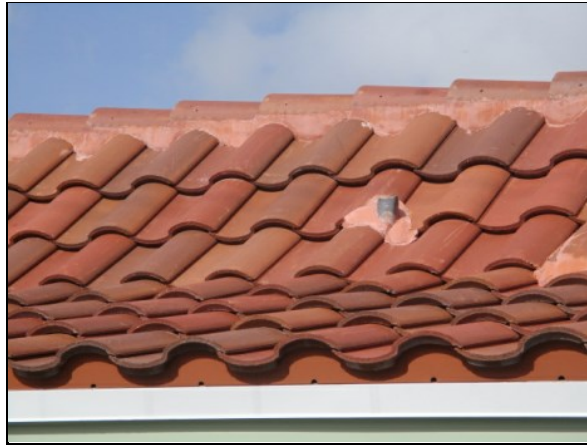
Useful Life:
25 years

Remaining Life:
24 years

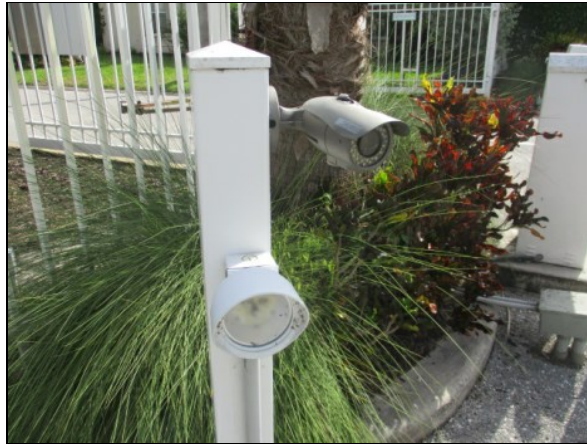
Useful Life:
10 years

Remaining Life:
10 years
