# Blue Line Home Inspections, LLC

## Home Inspection Report

Lexington, OK 73051

Inspected on Sun, Jul 12 2020 at 9:00 AM

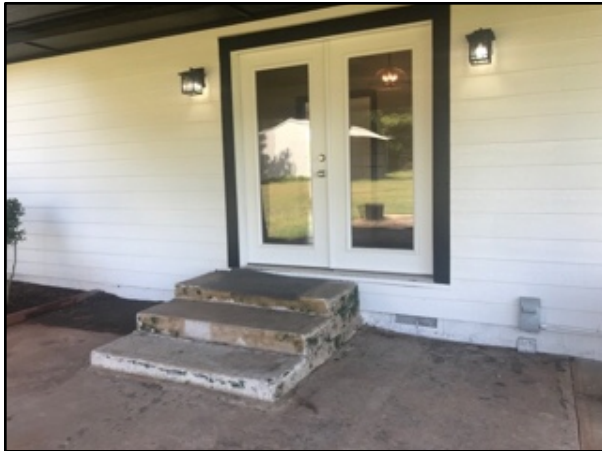
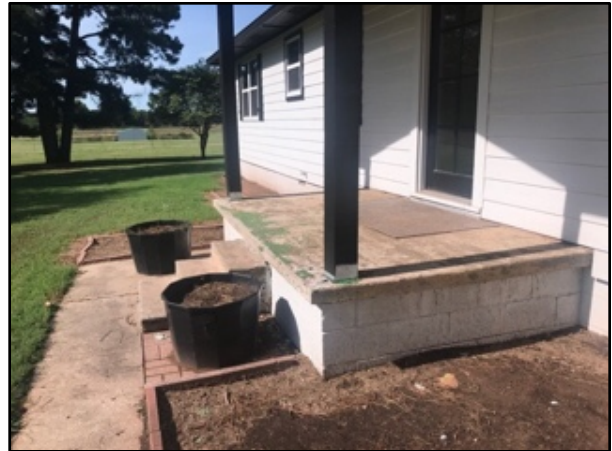
I recommend adding handrails for the entry door stairs to increase their safety.

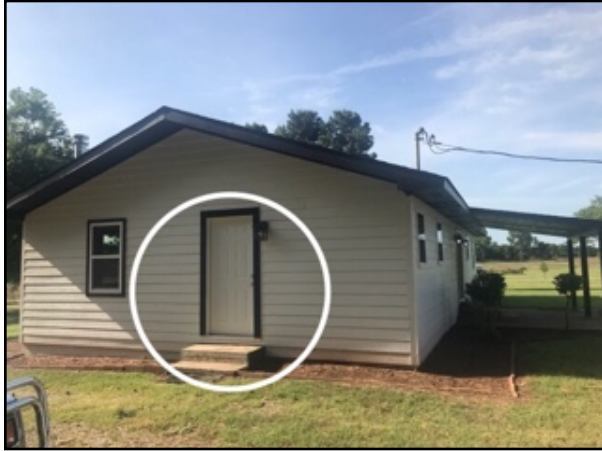
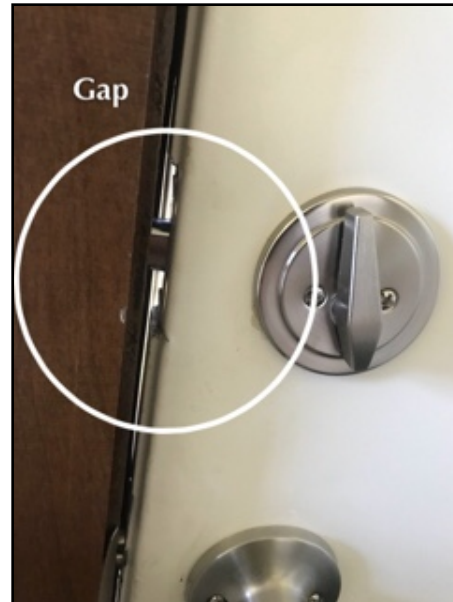
The exterior door on the south side of the home does not close properly. The deadbolt is difficult to lock, the strike plate is missing, and there is a gap between the door and frame. I recommend it be further evaluated and repaired.

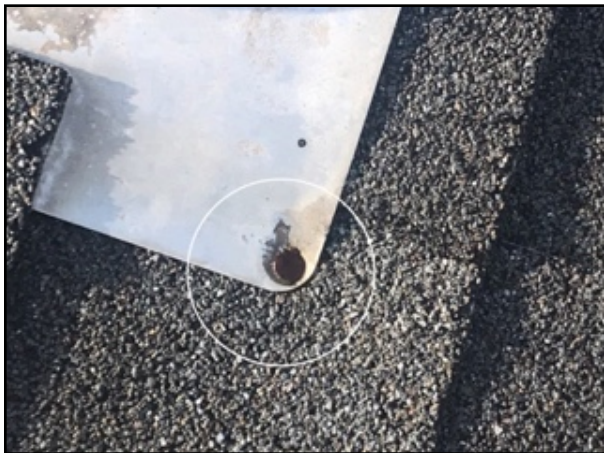
Figure 8-1

Some roof penetrations have exposed nail heads in their flashing that should be covered with a sealant to prevent them from corroding. Corroded fasteners can contribute to roof leaks.

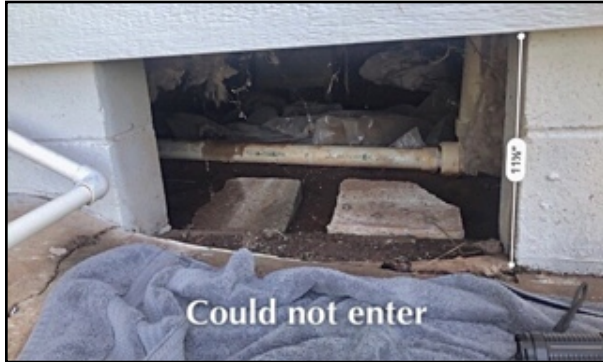
Figure 11-1

The crawl space could not be safely entered due to the low clearance, wet conditions, and plumbing lines blocking entry. This means important structural aspects of the home's foundation were inaccessible for inspection. The height of the crawl space hatch opening is 12". I recommend the hatch be increased to a minimum of 18"x24".

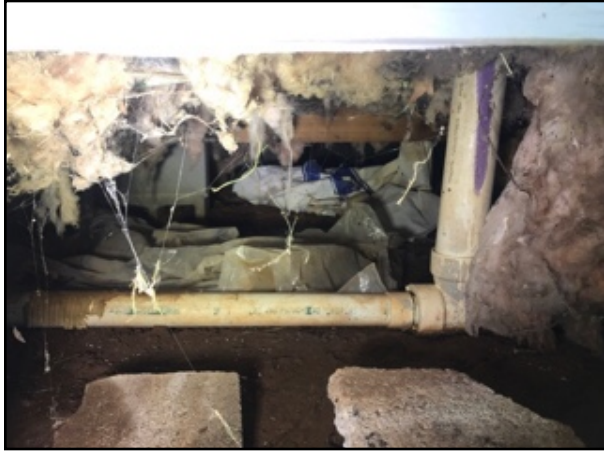
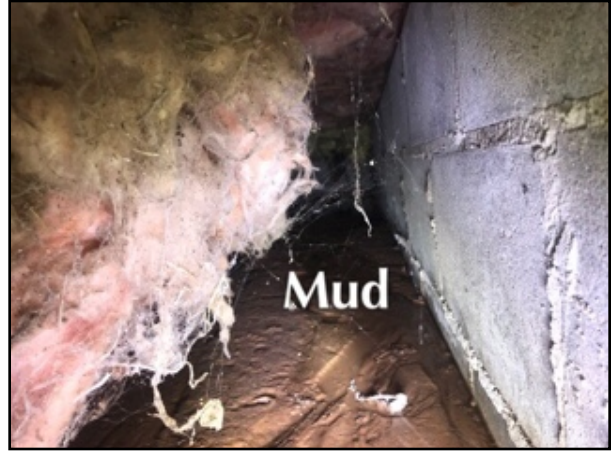
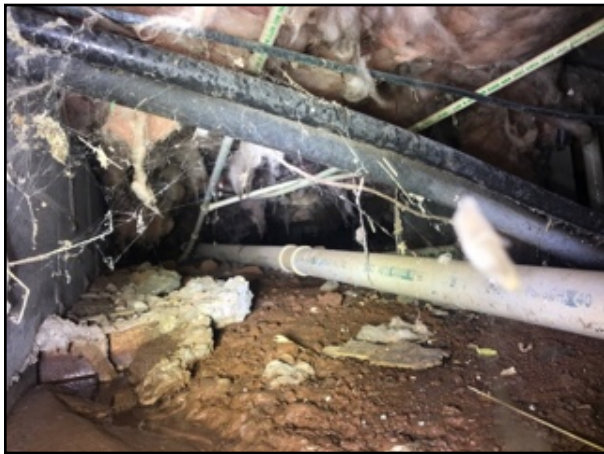
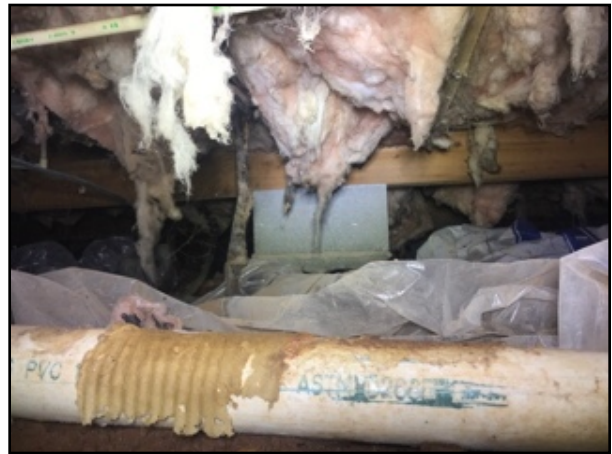
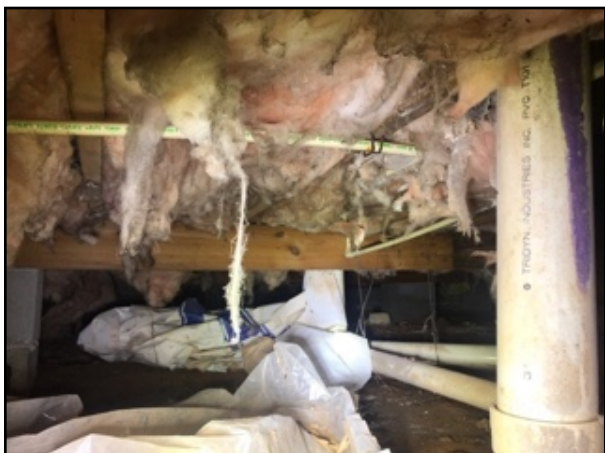
The crawl space has a severe moisture problem as evidenced by fungal stains on structural members, water-logged insulation hanging down, and a muddy crawl space floor with standing water. After the plumbing leak is corrected, I recommend a crawl space repair contractor be consulted to improve the crawl space conditions (such as installing a vapor barrier, dehumidifier etc..)

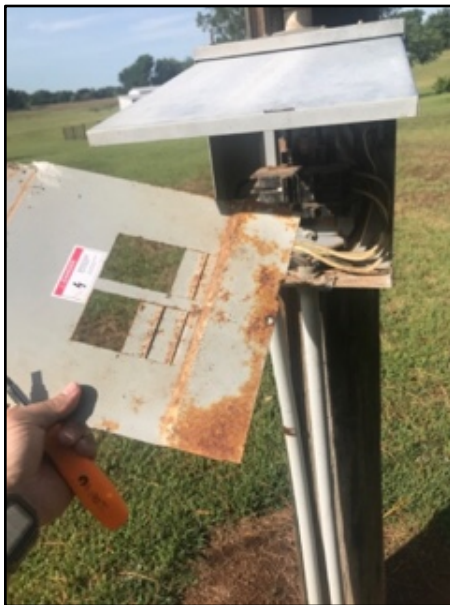
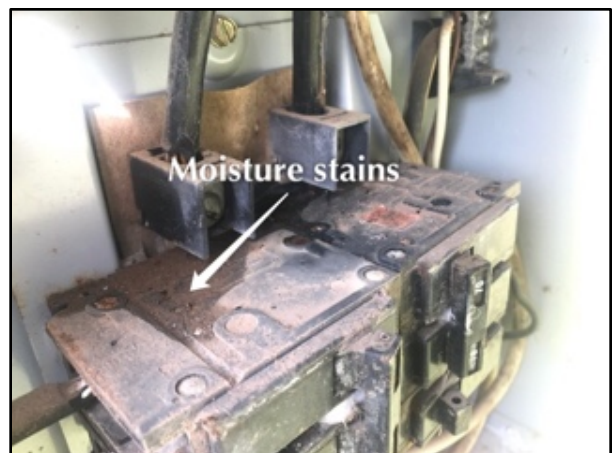
The sub panel on the pole below the meter has signs of moisture intrusion as evidenced by corrosion and water stains. I recommend the panel be evaluated for replacement by a licensed electrician.

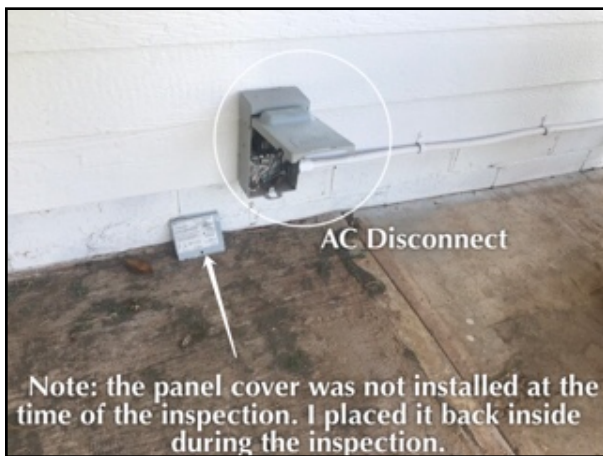
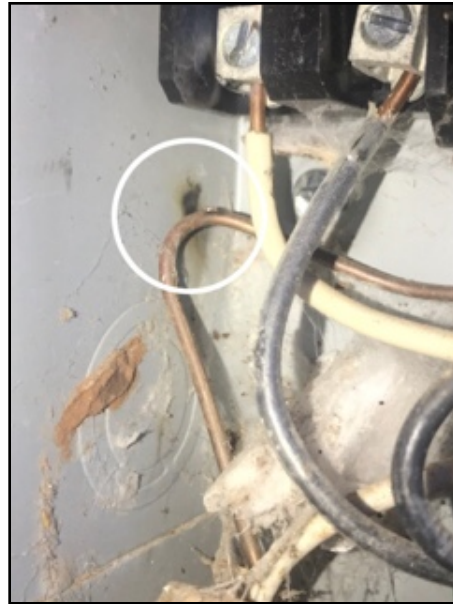
The AC disconnect panel should be evaluated by a licensed electrician. Evidence of arcing was observed inside the panel (see photo).

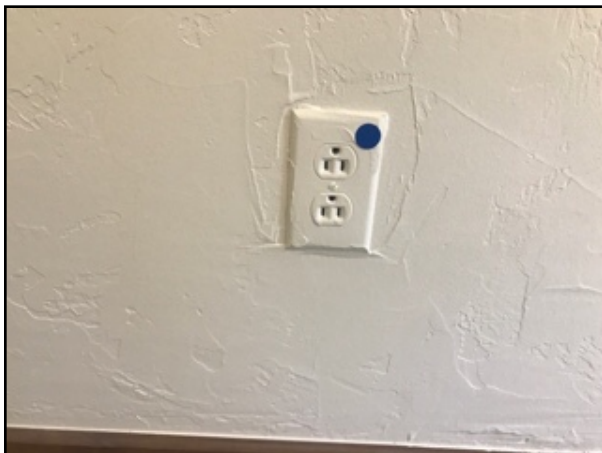
Figure 18-1

**Comment 18:**  
Several wall receptacles are wired in reverse (reverse polarity), meaning that the hot wire is connected to the neutral screw and the neutral wire is connected to the hot screw. This is a hazardous condition because anything plugged into the receptacle still allows electricity to flow even if the fixture or appliance is off. I recommend this be corrected by a licensed electrician. I placed blue stickers on the receptacles I identified with reverse polarity, however all should be rechecked.

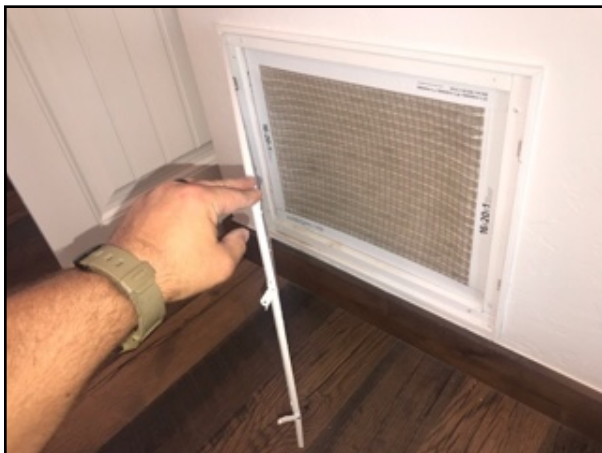
Figure 21-1

Comment 21:  
The filter(s) should be replaced prior to occupancy. This will improve HVAC efficiency, indoor air quality, and prolong equipment life. Filter size: 16x20x1

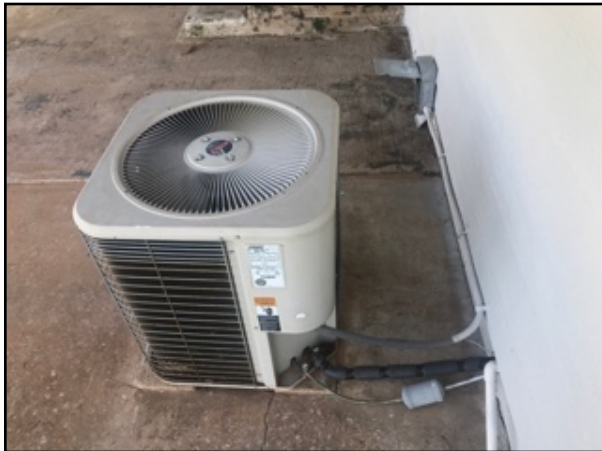
Figure 22-1

The air conditioner condenser was manufactured in 2000. Due to its age, budgeting for replacement is recommended.

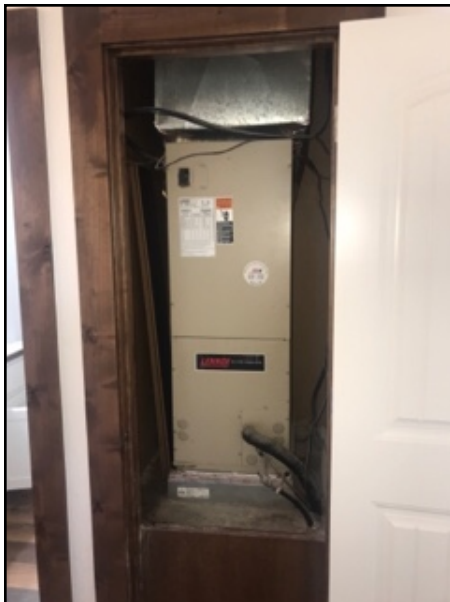
Figure 23-1

The electric heater/air handler was manufactured in 1999. Based upon its age I recommend budgeting for eventual replacement.

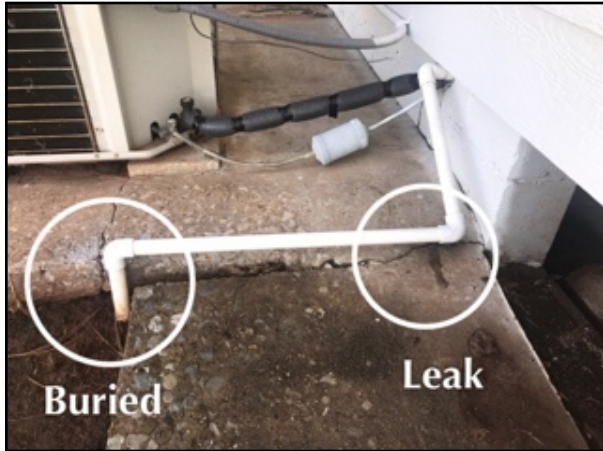
Figure 24-1

The HVAC condensate discharge tube is improperly sloped and the end is buried in mud. Also, one of the 90° elbows has a leak. I recommend a licensed HVAC technician correct this.

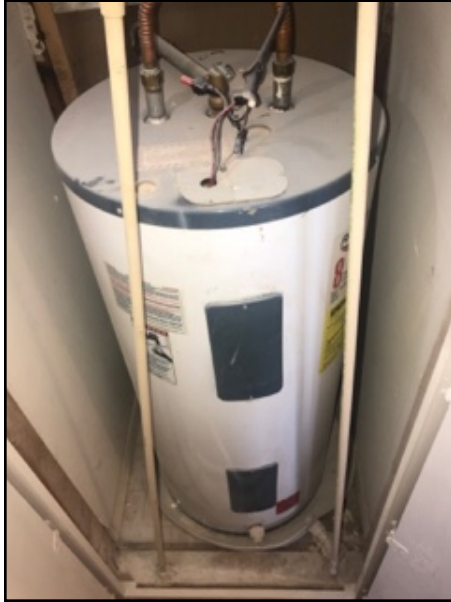
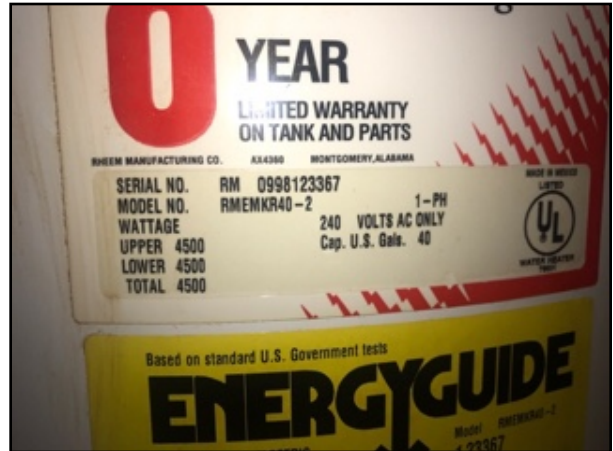
The water heater was manufactured in 1998. Based upon its age I recommend budgeting for replacement.

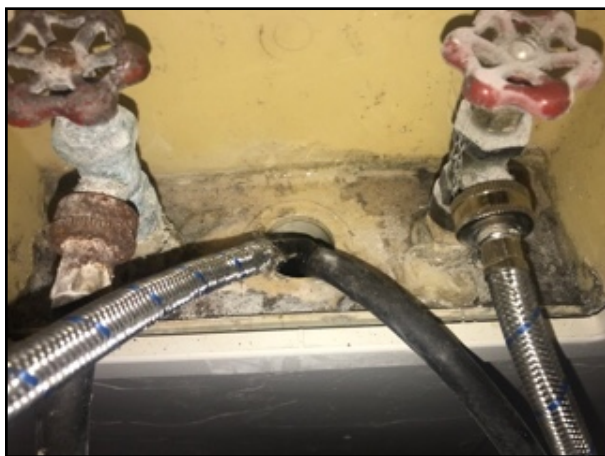
Figure 30-1

Comment 30:  
The washing machine valves produced water with no leaks observed. They are heavily corroded which could lead to leaks so I recommend they be replaced when feasible.

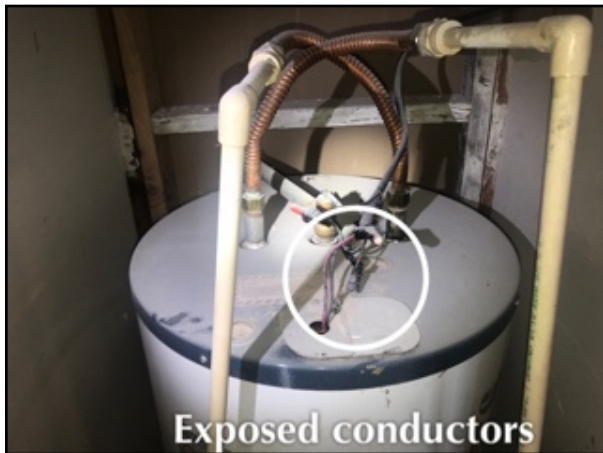
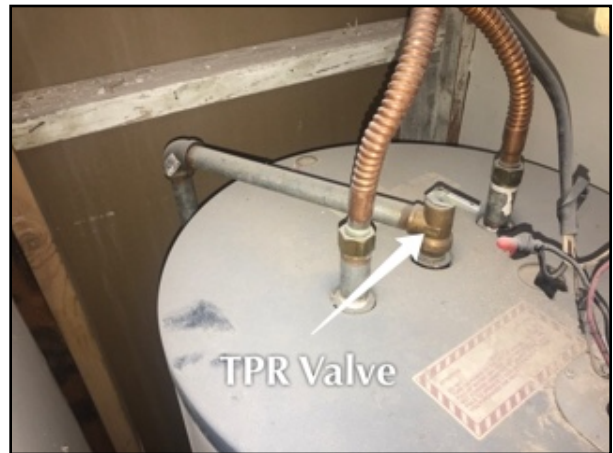
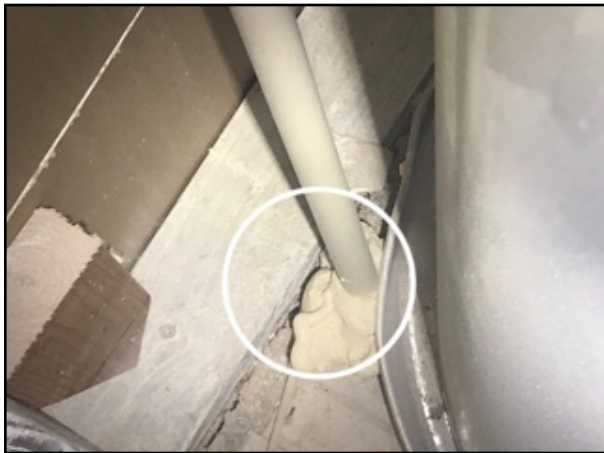
The water heater has two issues that a licensed plumber should correct: 1) the wiring at the top is exposed, unprotected. 2) the discharge tube for the TPR valve terminates below the floor under the house. This means that nobody will be able to see if water is leaking from the valve which would indicate a problem. Plumbing standards require it terminate in such a manner so occupants can see if the valve is leaking.

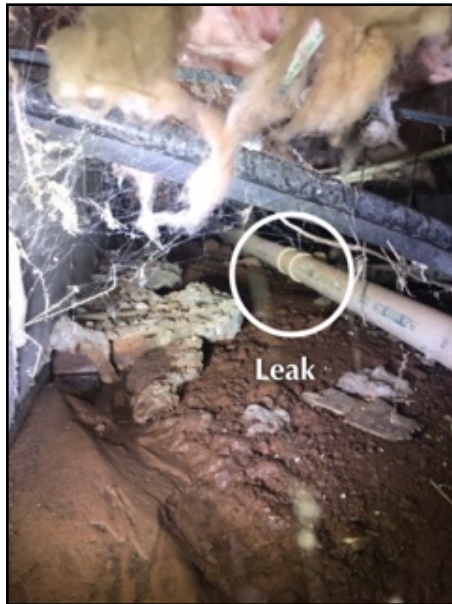
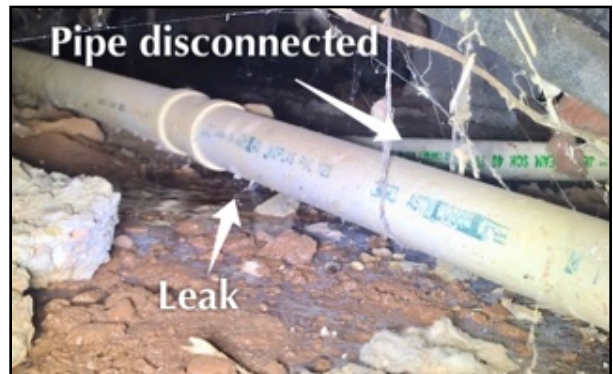
A plumbing leak was observed in the crawl space as a drain pipe under the guest bathroom appears to be disconnected. I recommend this be corrected by a licensed plumber. While making this repair, ask the plumber to evaluate the rest of the plumbing in the crawl space.

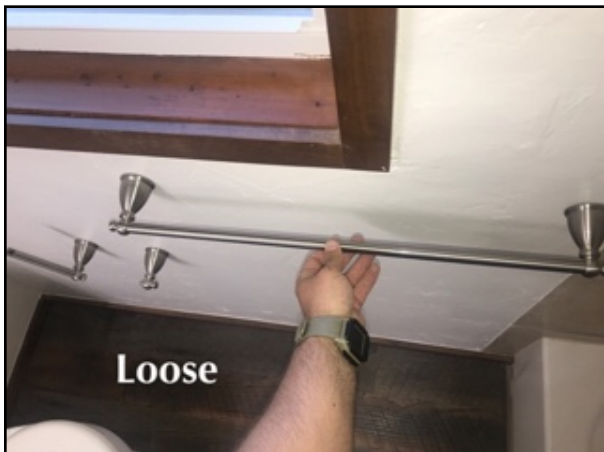
Figure 37-1

The towel rack and toilet paper holder are loose in the wall in the master bathroom.

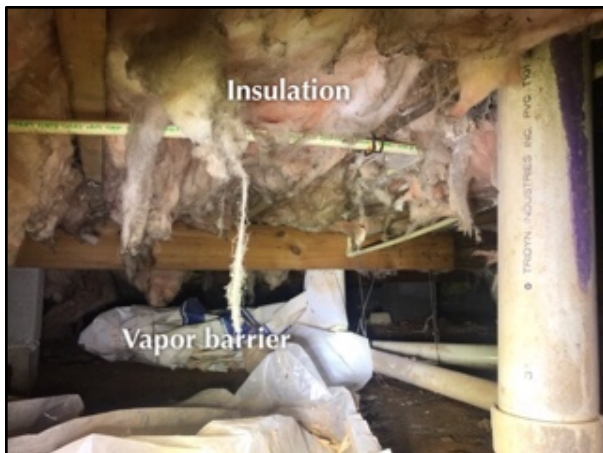
Figure 40-1

Comment 40:  
The crawl space vapor barrier is wadded up and not laying flat over the dirt ground. The fiberglass insulation between the floor joists in the crawl space should all be replaced. It has become wet and is hanging down

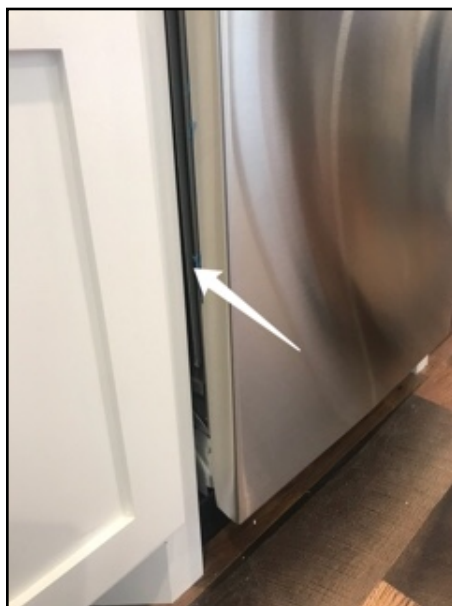
Figure 44-1

The dishwasher functioned when operated. Note: It does not quite fit the cabinet as there is a gap on the left side.

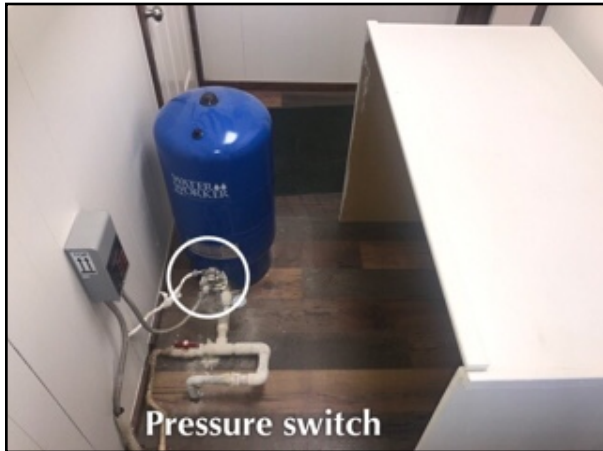
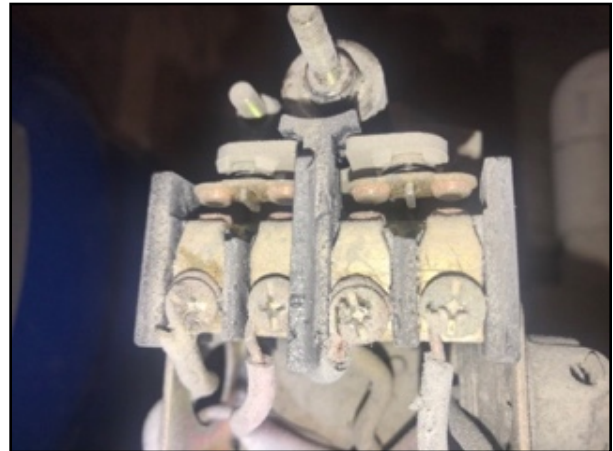
**Comment 46:**  
The pressure switch appears corroded and is missing its protective cap. I recommend the pressure switch be replaced.

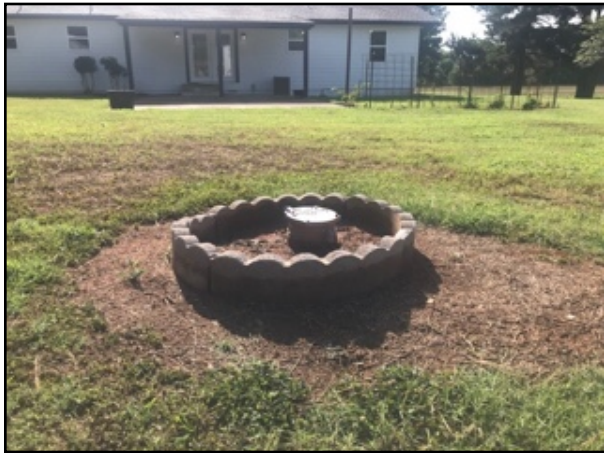
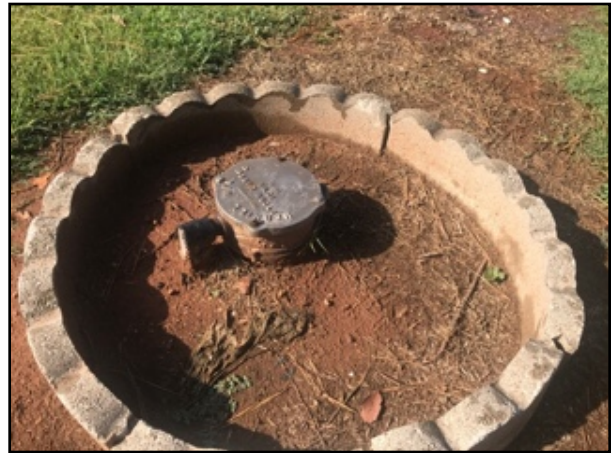
Per state well installation standards, the well head should extend at least 12" above grade and the ground around the well head sloped away. This helps prevent contamination. The well head at this property is less than 12" above flats ground. It is also surrounded by landscaping stones that can trap water. I recommend removing the stones to prevent pooling water that could bring surface contaminates into the well.

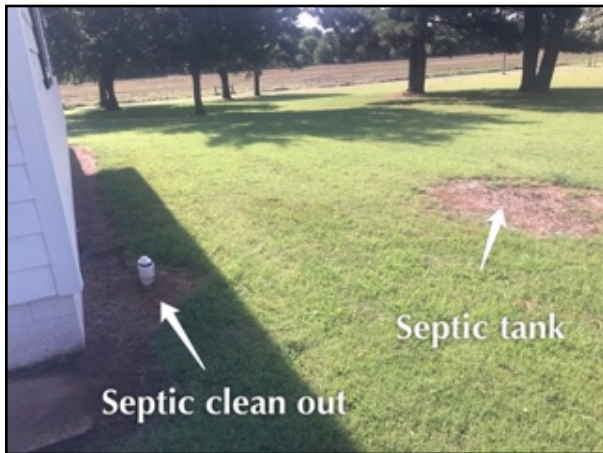
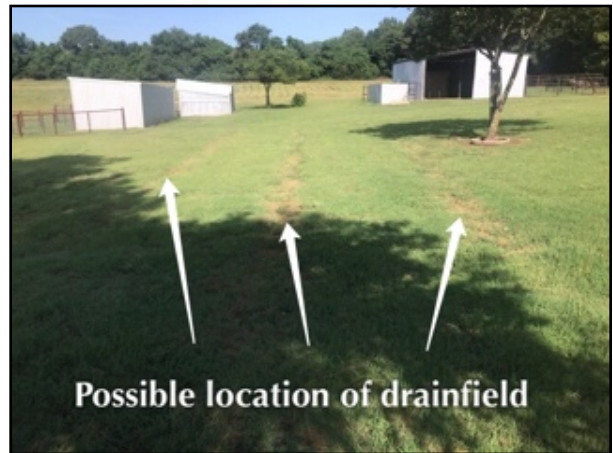
The septic system is located on the south side of the home. The tank's access covers are buried. I recommend installing access risers so that the tank can be easily inspected and pumped.

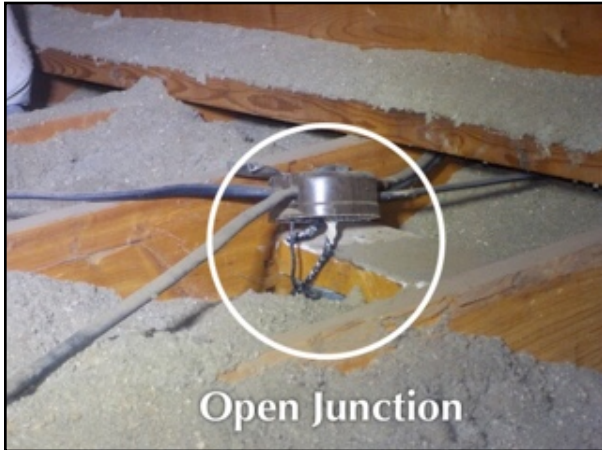
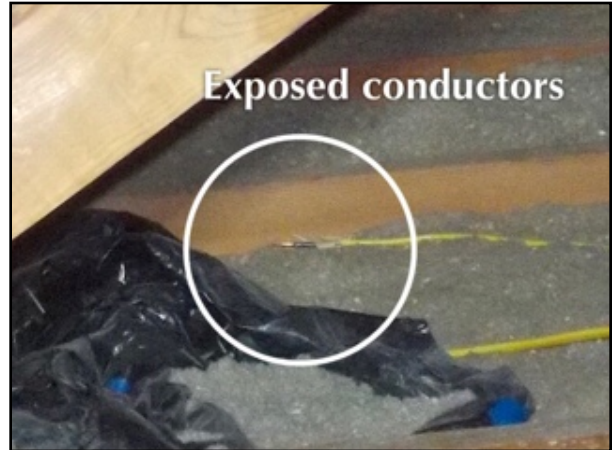
Two issues were observed that a licensed electrician should evaluate and correct: there is an open junction box meaning conductors are spliced together , partially outside of a box. Also, I observed a cable (yellow Romex) that has been cut and not connected to anything, exposing the copper conductor.

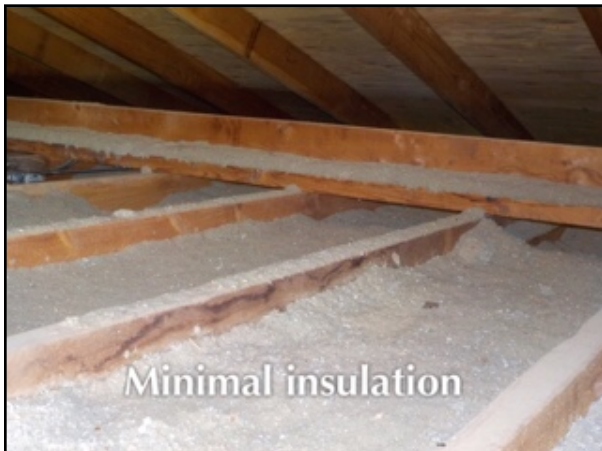
Figure 55-1

Recommended upgrade: adding additional insulation in the attic would increase HVAC efficiency and indoor comfort.
