Marling Farms
Chester, MD

Report #: 50838-0
Beginning: July 1, 2023
Expires: June 30, 2024

RESERVE STUDY
"Full"

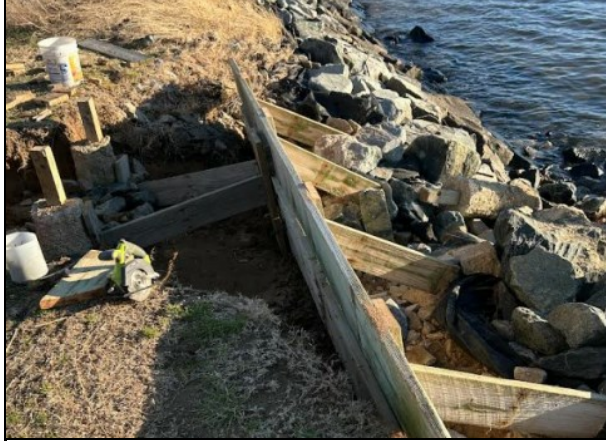
Comp #: 110 Wood Observation Pier - Replace

Comments: Association reports that this component was demolished with no intention to replace at this time.

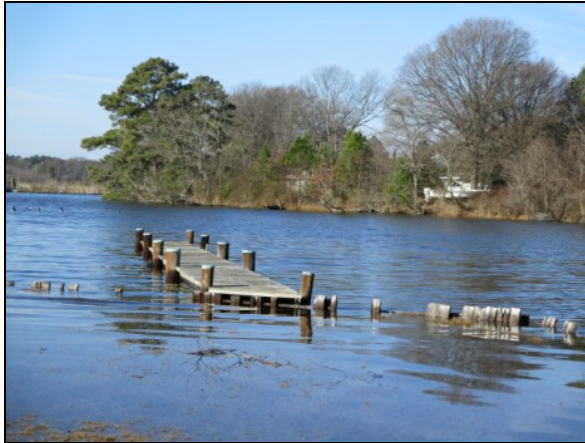
Comments: The pier at Beach 1 has been allowed to deteriorate well past its useful life and poses a serious litigation and liability risk for community. Schedule for demolition of the pier and sea wall. Any new construction or improvements after demolition can be included in the next study.

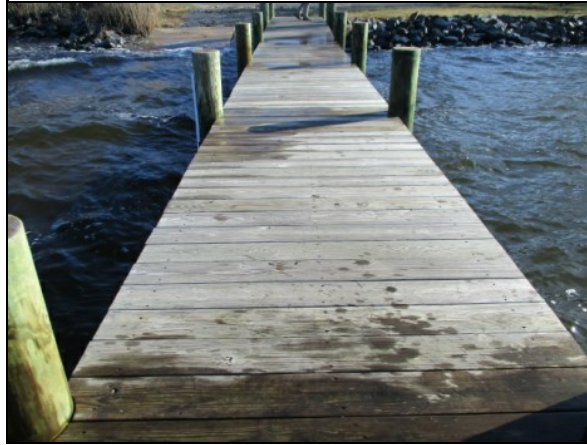
Comp #: 111 Boat Dock (Beach 3) - Replace

Comments: The pier at Beach 3 was built less than ten years ago and is in relatively good condition. Individual boards can be replaced as an operating expense with an eventual rebuild scheduled after a long useful life.

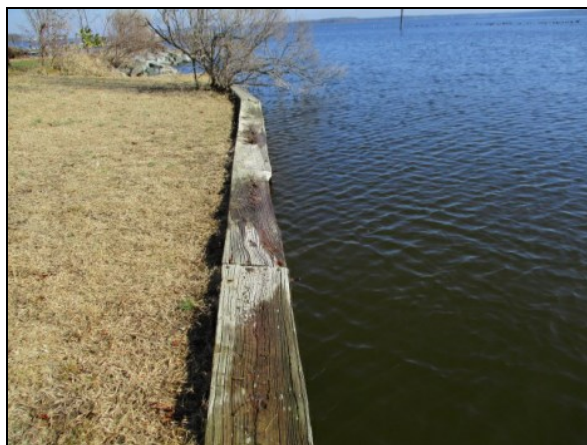
Comp #: 112 Wooden bulkhead - Replace

Comments: We are only able to inspect what is visually available and are not able to examine the subsurface level of the wooden bulkhead. It is apparent that while the structure is intact, signs of decay such as discoloration, warping of the boards and some rot indicate an advanced age. Taken in conjunction with the condition of the rest of the waterfront elements on the property it is assumed to be nearing the end of its useful life. It should be inspected immediately by a dock repair company to refine useful life estimates and costs

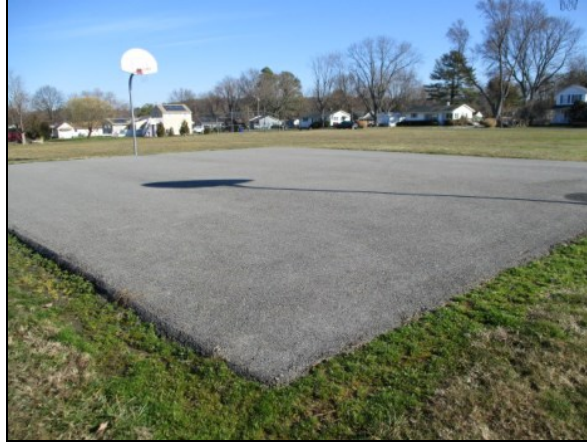
Comments: The asphalt itself looks to be in good condition however, a below average useful life has been used to reflect the lack of a rubberized seal or surface protectant that would normally be present on basketball or tennis courts. Unpainted and unsealed asphalt will deteriorate faster than sealed asphalt. Sealing every 5 years can add ten or more years of useful life. If the asphalt is sealed and painted the useful life can be extended on future studies (see #202). The replacement will eventually require milling, leveling, and reapplying the asphalt.

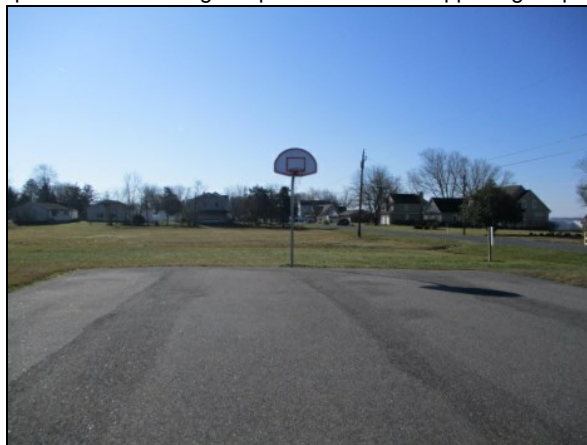
Comments: White aggregate showing through the asphalt indicates a lack of seal coat. It may be that the component was never properly sealed. Seal coating will prevent a much larger replacement from happening to quickly.

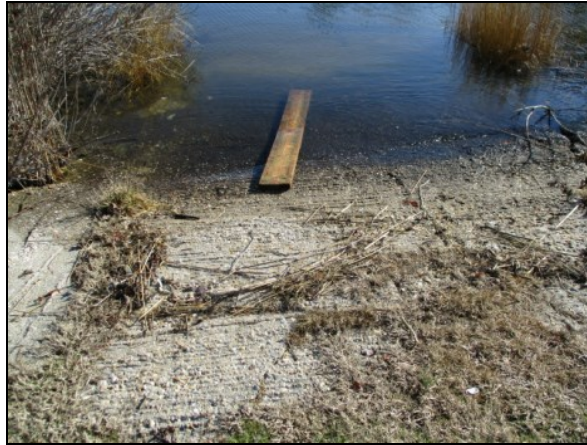
Comp #: 205 Concrete Boat Ramp - Replace

Comments: At the time of this report, large cracks and uneven surfaces indicate that the boat ramps have deteriorated past their useful life. Costs for replacements include demolition and rebuilding of the ramps all at once. The association has requested an extension on the useful life for financial planning purposes.

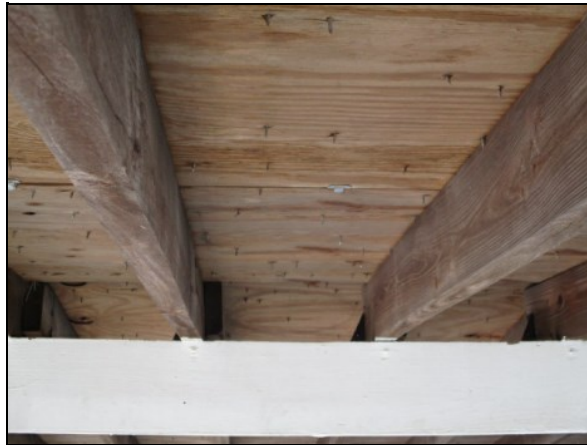
Comp #: 401 Pavillion - Replace

Comments: The pavillion is in fair to poor condition. Maintenance has been variable throughout out its lifetime. Recent repairs by association members have extended the useful life. However, the asphalt shingle roof is leaking as evidenced by rusting joist hangers and warped sub roofing plywood. Some shingles were observed to be damaged. The concrete pad exhibits some minor hairline cracking which should be repaired or water intrusion will expand the cracks and destroy a component which would otherwise remain intact for the life of the association. Funding for new roofing and concrete repairs.

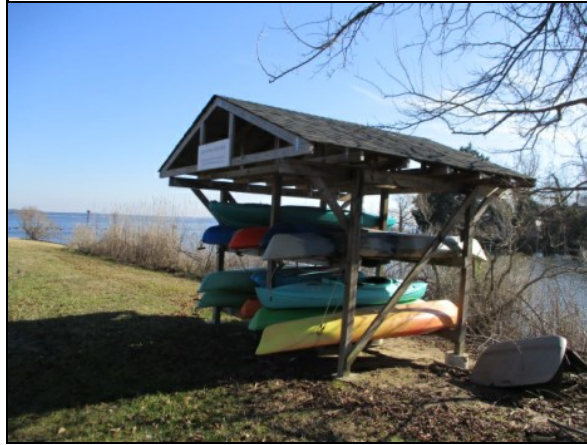
Comp #: 404 Kayak Racks - Replace

Comments: Kayak racks appear to be sturdy and intact. There is no obvious rot and the shingle roof looks even and is not missing any shingles or showing signs of leaking. Useful life reflects that the rack was not installed by a professional licensed contractor.

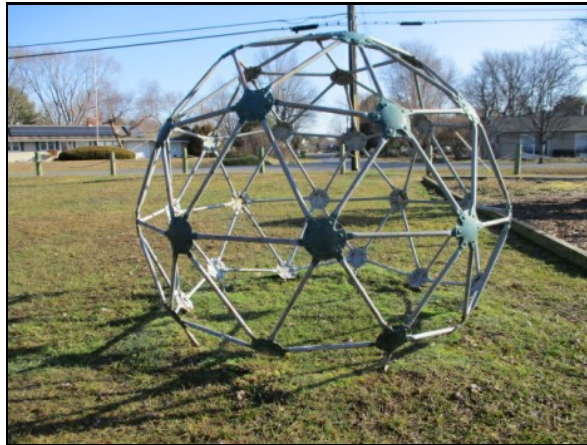
Comp #: 405 Play Equipment - 20% Replace

Comments: There is a spiderweb dome, a swing set and jungle gym structure at Beach one; and swing sets at beaches 4 and 2. The wooden swing set at beach 4 is totally decayed and presents a safety risk. This component must be demolished immediately, and can be replaced on the time line below. The funding plan represents replacing older pieces first then as the pieces that are new now begin to age they are replaced on a rotating basis.

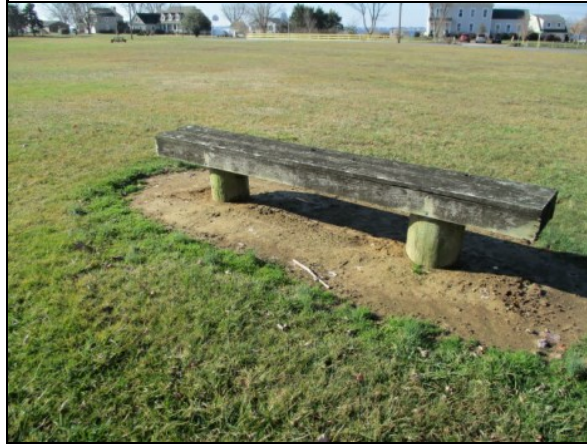
Comp #: 406 Benches - Replace

Comments: There are a wide variety of bench types all with different materials and ages. They can be replaced individually as needed.

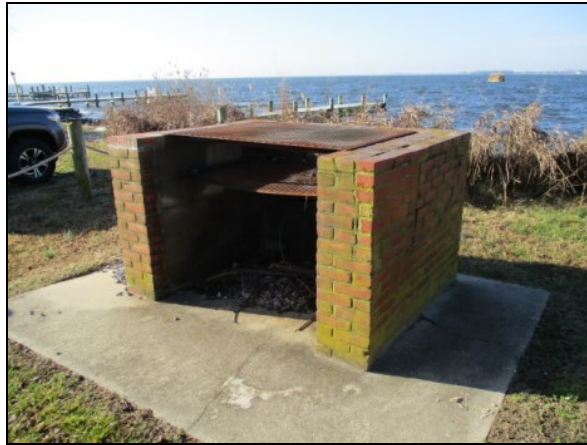
Comp #: 407 BBQ (brick) - Replace

Comments: Brick on a concrete pad shows some minor signs of deterioration. A few cracks in the concrete and organic growth on the bricks indicate the component is holding up well. Uncontrolled organic growth can accelerate deterioration and it should be power washed regularly as an operating expense. Additionally the metal grates should be updated as an operating expense. Funding provided is for brick refurbishments every 10 years to replace broken brick, update the mortar and repair cracks in the concrete.

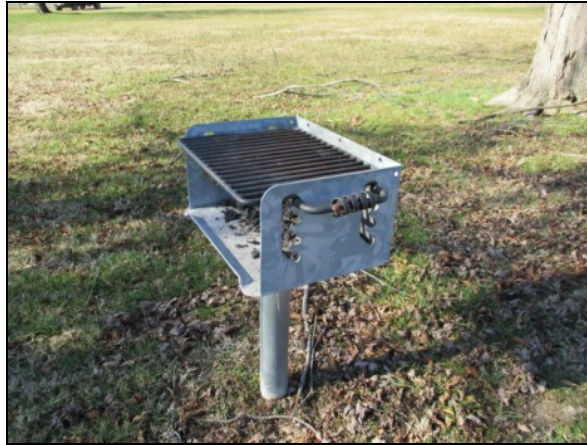
Comp #: 407 BBQ (metal) - Replace

Comments: Grills are in good condition with no signs of rust or deterioration on the grill itself. Metal grilling grates should be cleaned and replaced as an operating expense. Funding for demolition and installation of concrete bases and new grills to be installed.

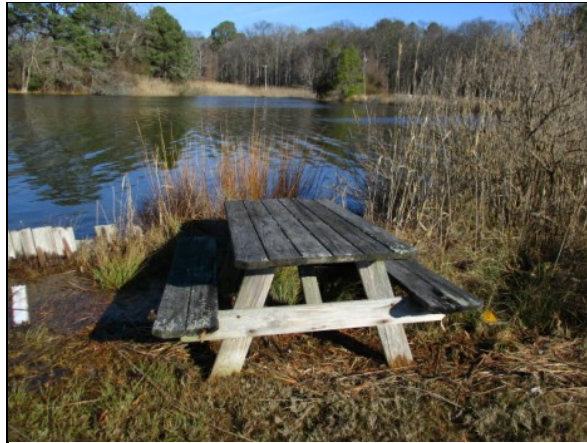
Comp #: 409 Tables/Benches - Replace

Comments: Picnic tables and benches throughout the association are in variable ages, materials, and conditions, with some appearing new and some rotting and failing. Replace individually as an operating expense.
