# Dam Safety Inspection Report

## Negaunee Lake Dam

**Dam identification Number: 2674**

June 29, 2023

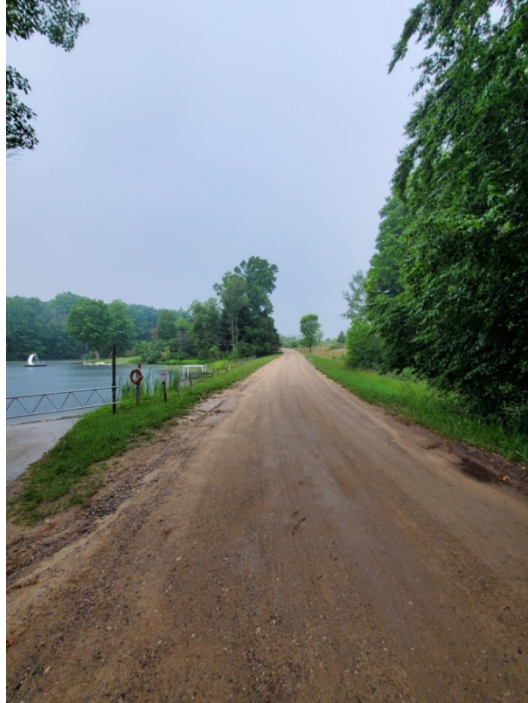
The dam crest consists primarily of a 18' wide (+/-) gravel roadway (Negaunee Lake Drive) that drops slightly more than 1' in elevation from southwest to northeast across the embankment. The low point on the dam crest is approximately 3.5' above the normal lake level and would act as the emergency spillway in the event of what would be a very extreme rainfall event. The road conveys stormwater runoff along its edges, and no degradation was noted due to moving water at the time of our inspection.

***Gravel road over the earthen embankment looking southwest from right abutment***

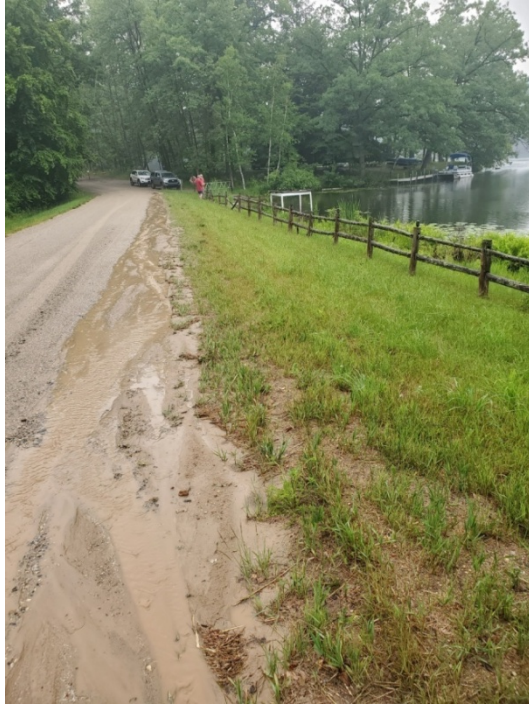
***Gravel road over the earthen embankment looking northeast from left abutment***

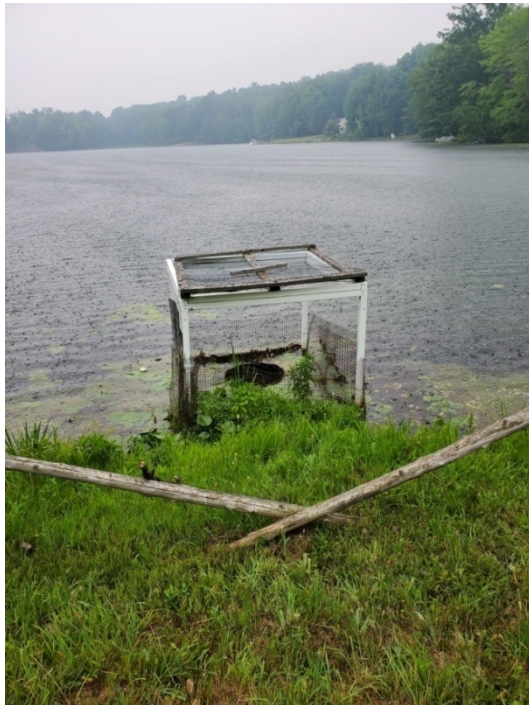
**Principal Spillway** – The principal spillway for Negaunee Lake and its dam is a standard drop-inlet structure with a horizontal outlet pipe. The hydraulic capacity of the inlet structure is relatively unimportant to the dam's safety, in that the lake can store much more than the 100-year runoff volume without overtopping the dam crest, even with zero discharges. Some degradation of the metal pipe was noticed, and this should continue to be observed closely in subsequent inspections. An unusual feature of this spillway is the presence of a slotted cone which is seated over the drop inlet. Its intended purpose is not known, but it isn't needed as a debris guard, since a larger screened cage already surrounds and protects the drop inlet. According to Mr. Charette, he plans on replacing the cone with a standard grate.

***Principal spillway with a screened trash rack over the drop inlet.***

It is worth considering a reconfiguration of the drop inlet and screened trash rack to facilitate access during an extreme rainfall event or other related emergency.

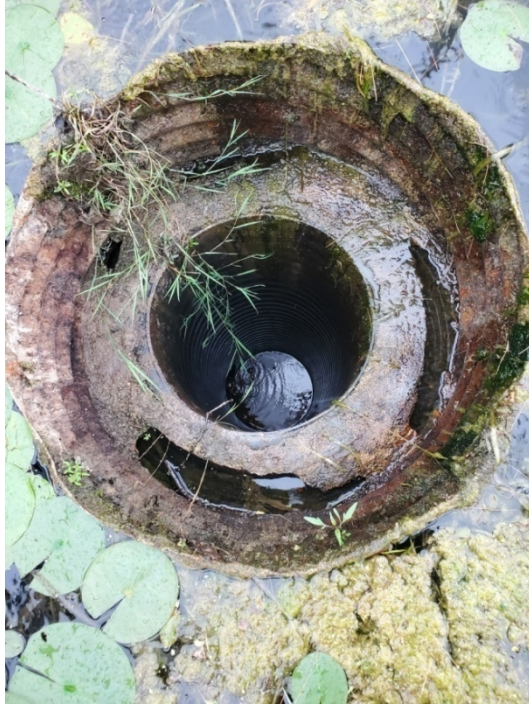
***Looking down at principal spillway drop inlet.***

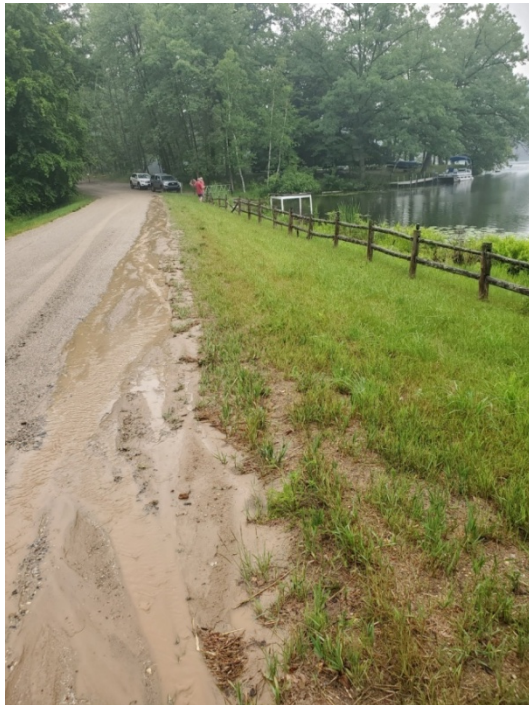
Upstream – The upstream embankment is stable, with improved vegetative conditions due the removal of trees and brush subsequent to the 2018 inspection. Two erosional areas were noted, running down the embankment from the road to the lake, along both sides of the boat launch slab. They are created from stormwater flowing off the road at local low points. These should both be stabilized by constructing a chute with a non-erosive surface.

***Upstream embankment looking north.***

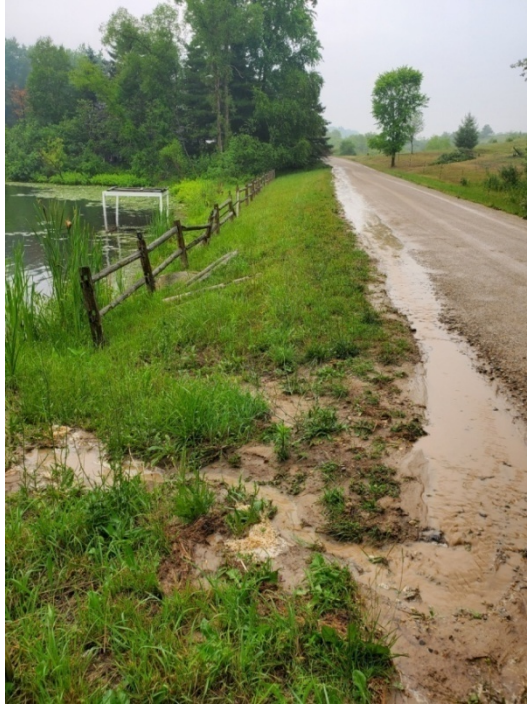
***Upstream embankment from center of dam looking southwest***

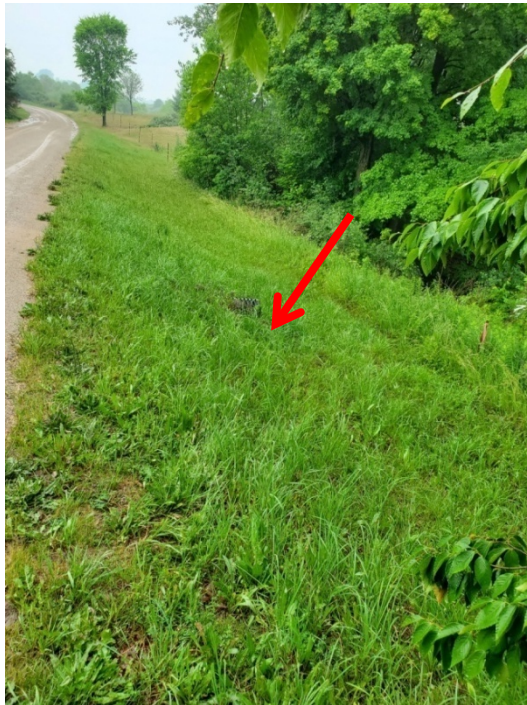
**Secondary Spillway** – A second culvert pipe penetrates the dam embankment north of the principal spillway. Its purpose is unclear, considering the excess storage and discharge capacity already present. It is our opinion that it is unnecessary, but its presence is no problem.

***Downstream embankment from north end of dam looking southwest. Note outlet end of secondary spillway shown with arrow.***

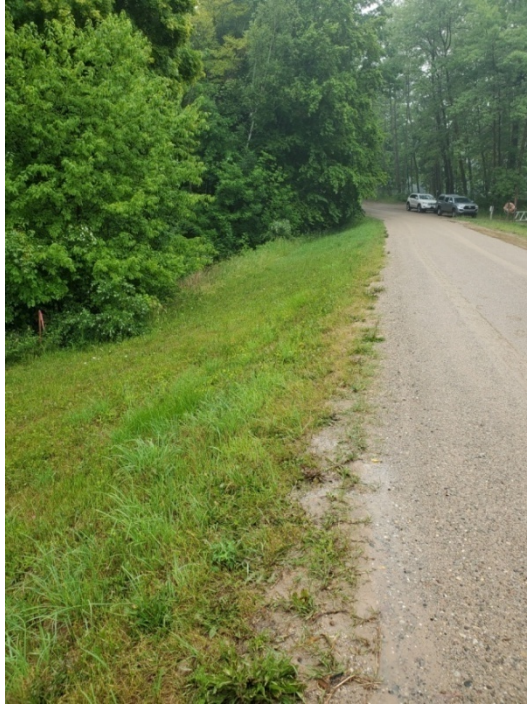
Downstream – The upper portion of the downstream embankment is being regularly mowed. However the lower portion has not yet been reclaimed from the brush that continues to dominate. Since the lowest portion of the downstream embankment is where seepage and piping will most likely occur, continued efforts to open up the lower portion and force turf grass growth are advised.

***Downstream embankment from south end of dam looking northeast.***

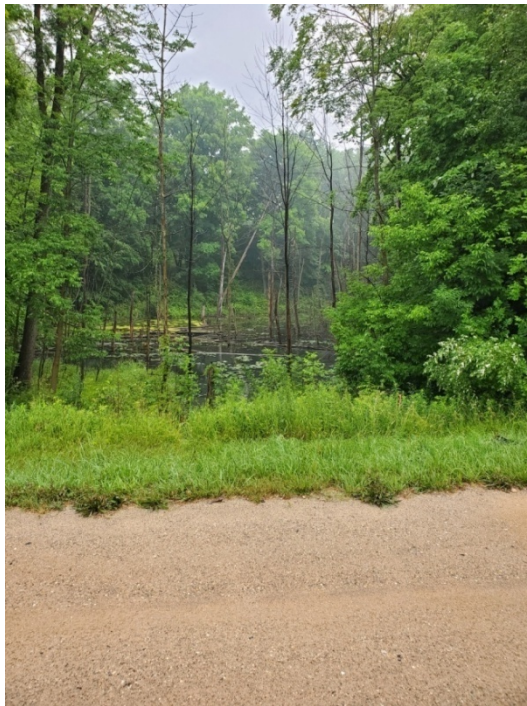
***Looking downstream from the center of the dam***

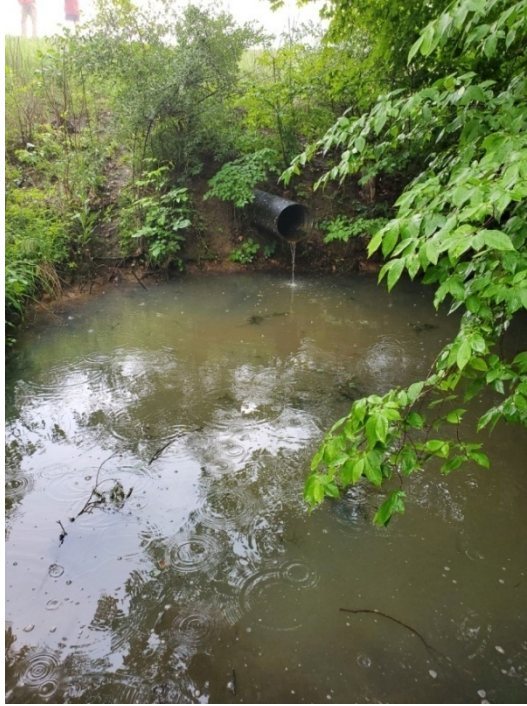
**Downstream Watercourse** – Sherlock Creek begins here, and its flow appears to be intermittent. During the inspection, no water was discharging through the principal spillway. The spillway does activate at times, as evidenced by a plunge pool located under the perched principal spillway pipe. A large undercut was noticed on an adjacent streambank downstream of the plunge pool, which may be formed by spillway discharges.

***Plunge pool area at outlet of principal spillway***

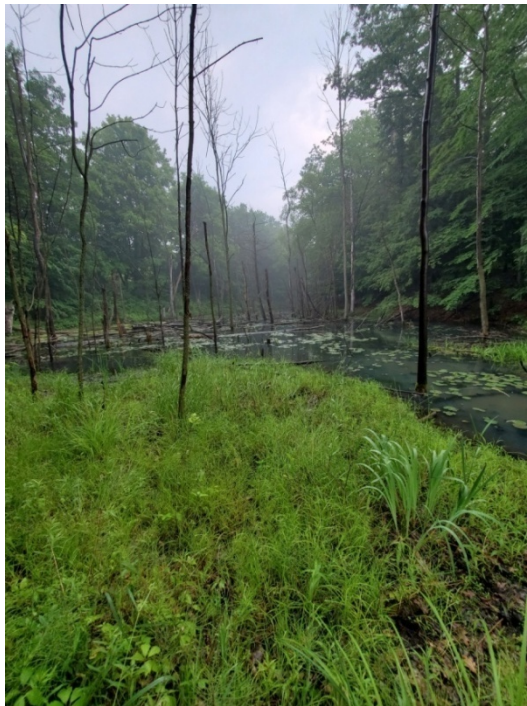
***Outlet channel downstream of principal spillway outlet***

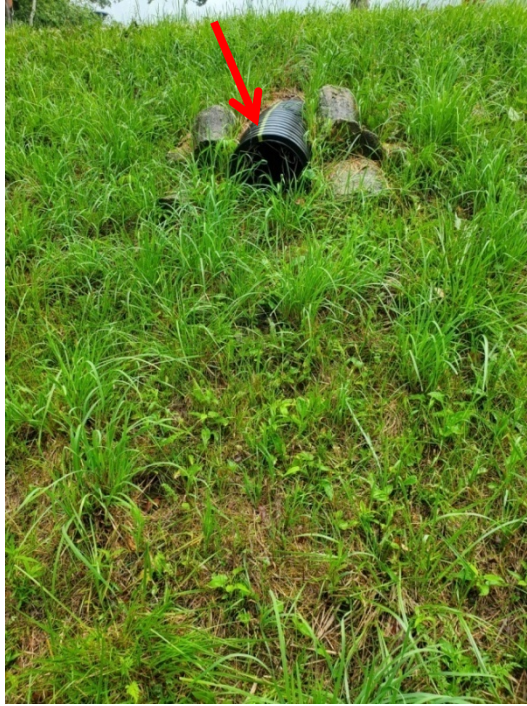
***Downstream side of earthen embankment looking east shoing secondary spillway outlet.***

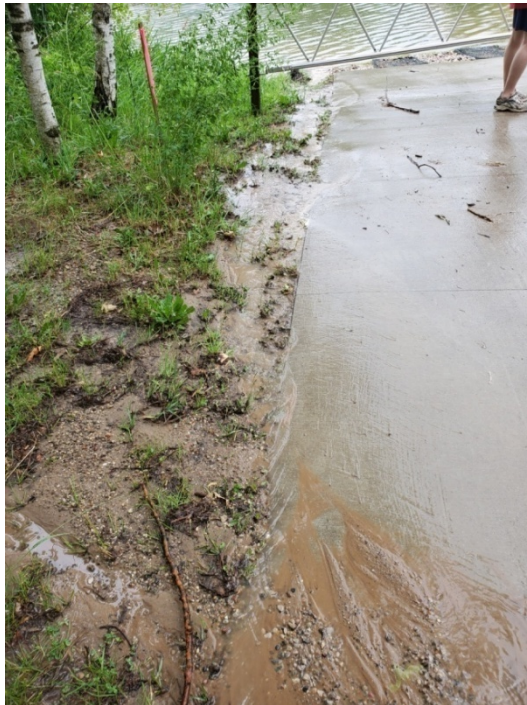
**Upstream Watercourse** – Negaunee Lake is located adjacent to the embankment and outlet works, and is in all respects normal, with no apparent issues of concern. A private boat launch ramp is located adjacent to the dam embankment, and is in good condition, with the exception of adjacent erosion from stormwater runoff.

***Channelized road runoff on northeast side of boat launch causing erosion.***

1. Construct a chute from the road edge down to the water level consisting of riprap, asphalt, or other acceptable material to convey stormwater in a non-erosive manner on both sides of the boat launch pavement.
2. Place a grate over the drop inlet at the principal spillway.
3. Continue to mow the embankment as needed to maintain a turf grass surface and deter brush intrusion.
4. Continue expanding the turf grassed embankment down the downstream embankment by removing brush where accessible.

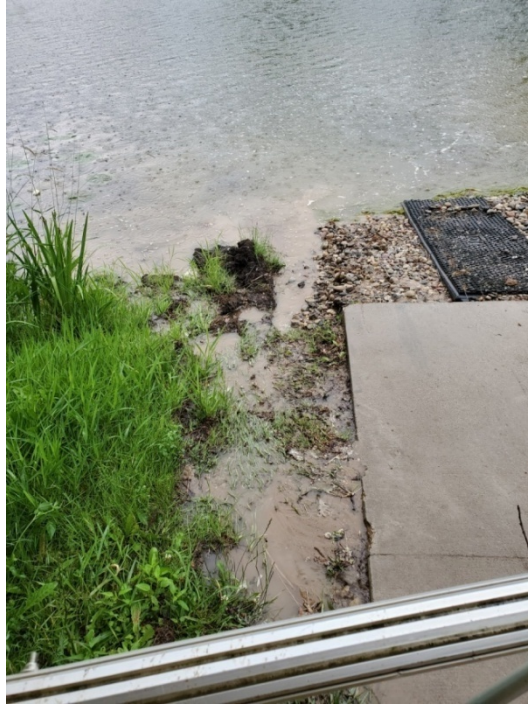
***Minor erosion on northeast side of boat launch.***

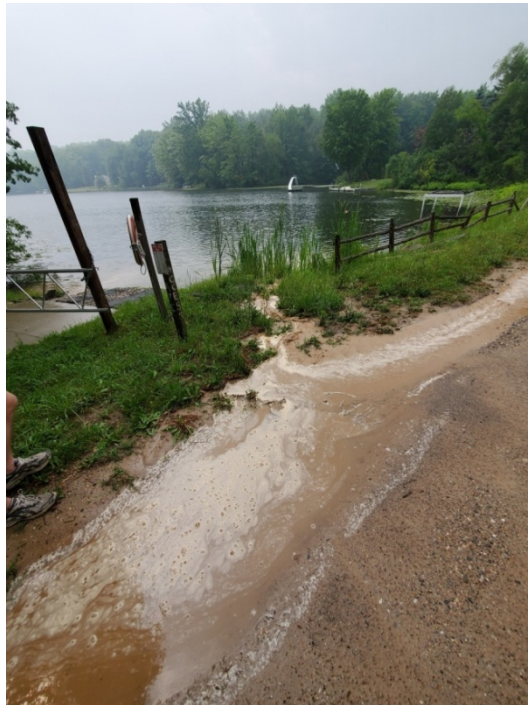
***Channelized road runoff on southwest side of boat launch causing minor erosion.***

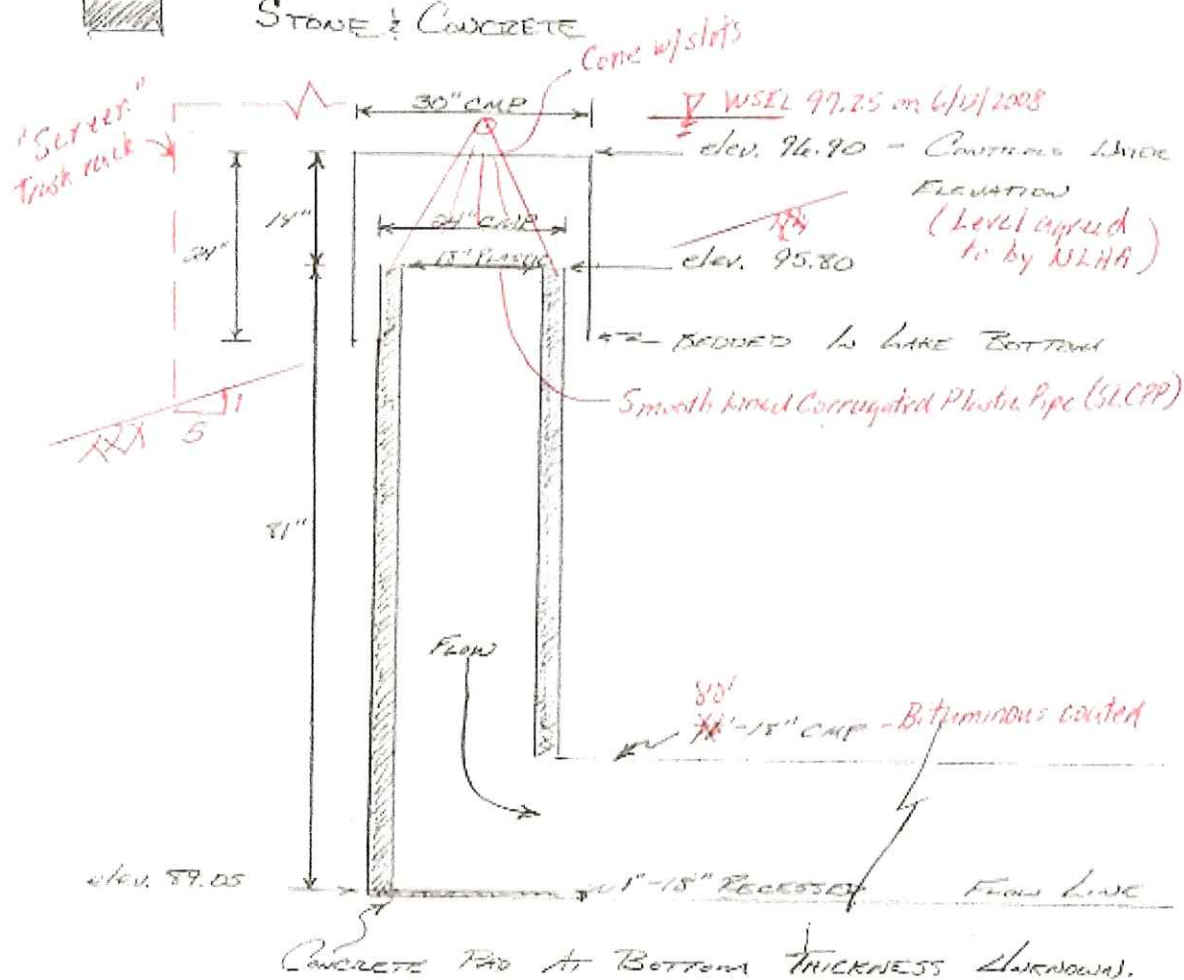
A-A

1. INNER PLASTIC TUBE SEID IN DUE TO MANY RIVOT HOLES LEAKING IN 24" CAP TUBE, 24" TUBE SHOWING SOME CORROSION.
2. ALL ELEVATIONS REFERENCE BENCH MARK SET @ 100.00 ILLUSTRATED ON PG 1 OF 3  
V Figure 2
