Response to [REDACTED], P.E. pertaining to:

- Shoal Creek waterflow
- Mechanisms that prevent overtopping
- Sediment and gravel bar removal around bridge infrastructure
- Maintenance records
- Potential West Ave bridge watermain vulnerability
- In-person inspection of creek to finalize [www.austinshoalcreek.com](http://www.austinshoalcreek.com)

05/04/2026 by [austinshoalcreek.com](http://austinshoalcreek.com)

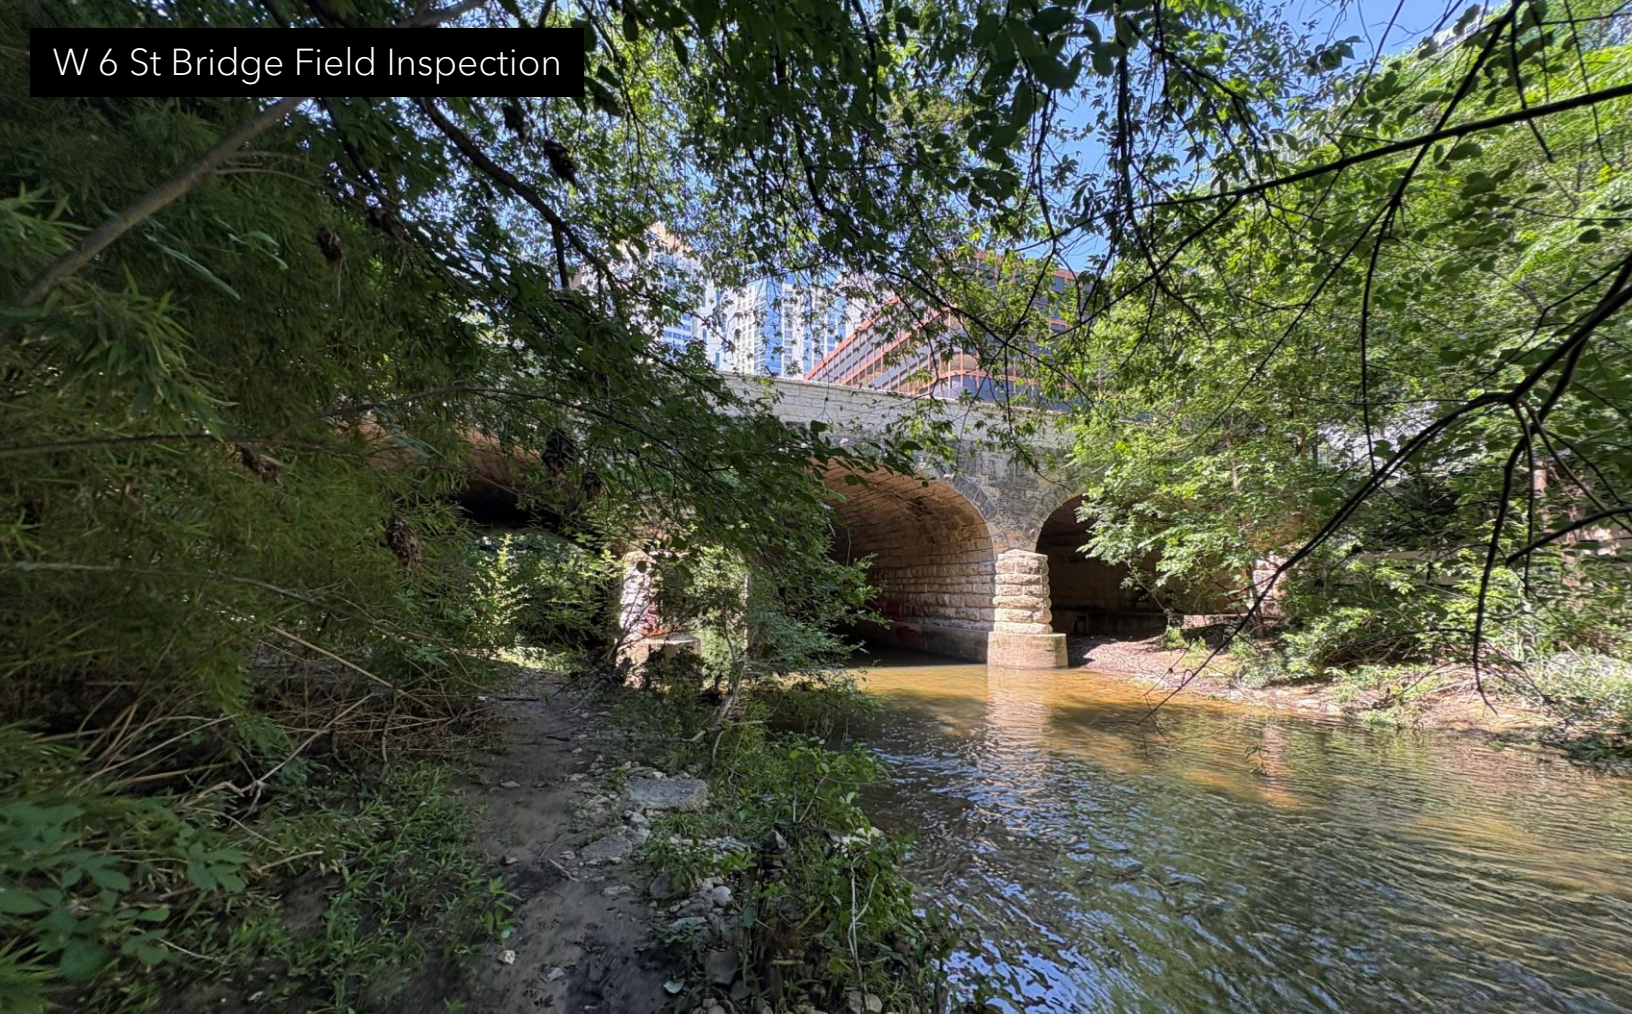
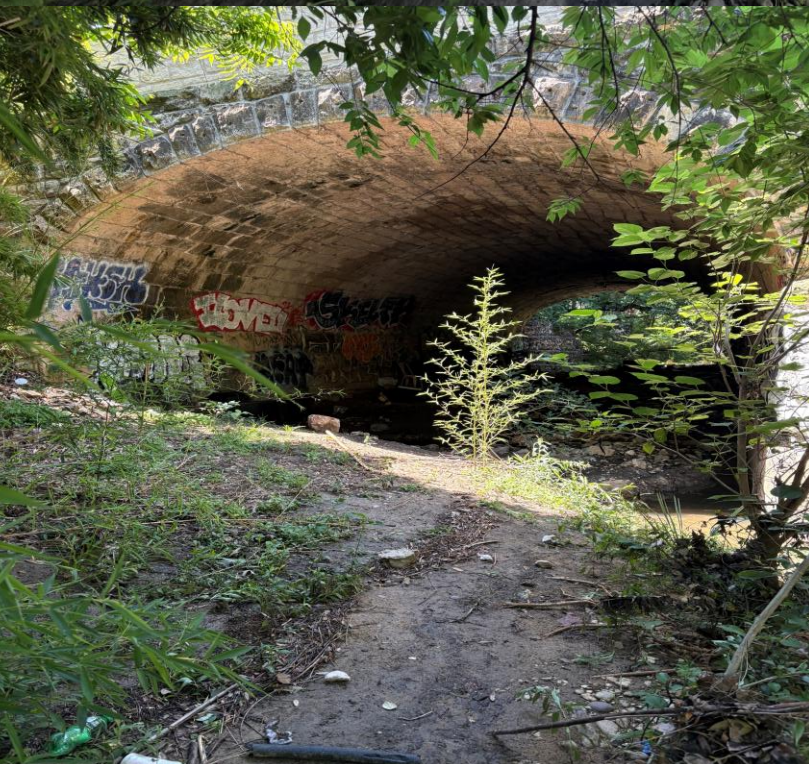
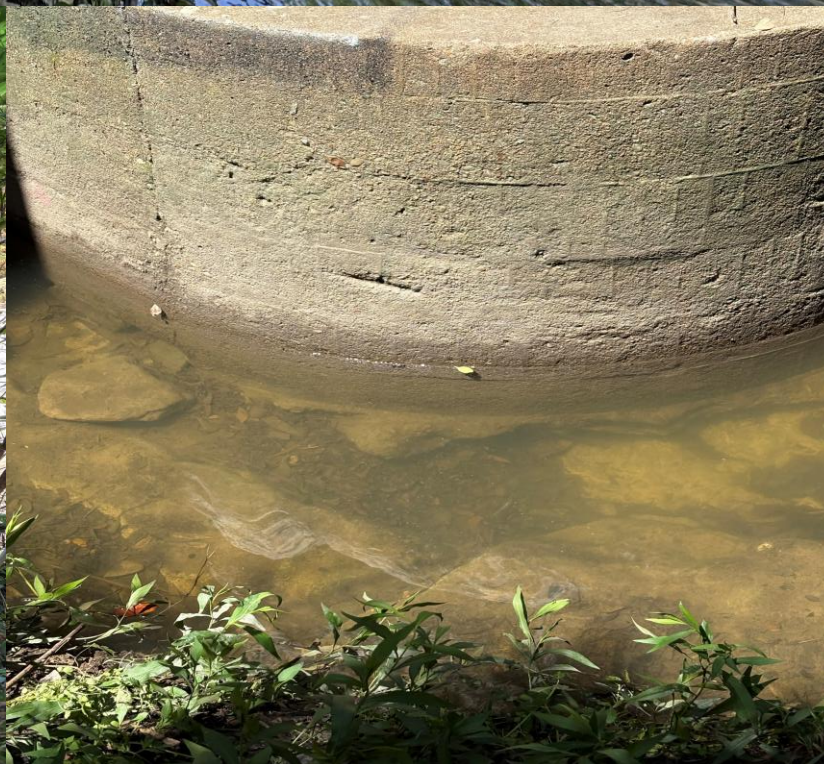
Photographed upstream are the east span and footer of the W 6 St bridge.

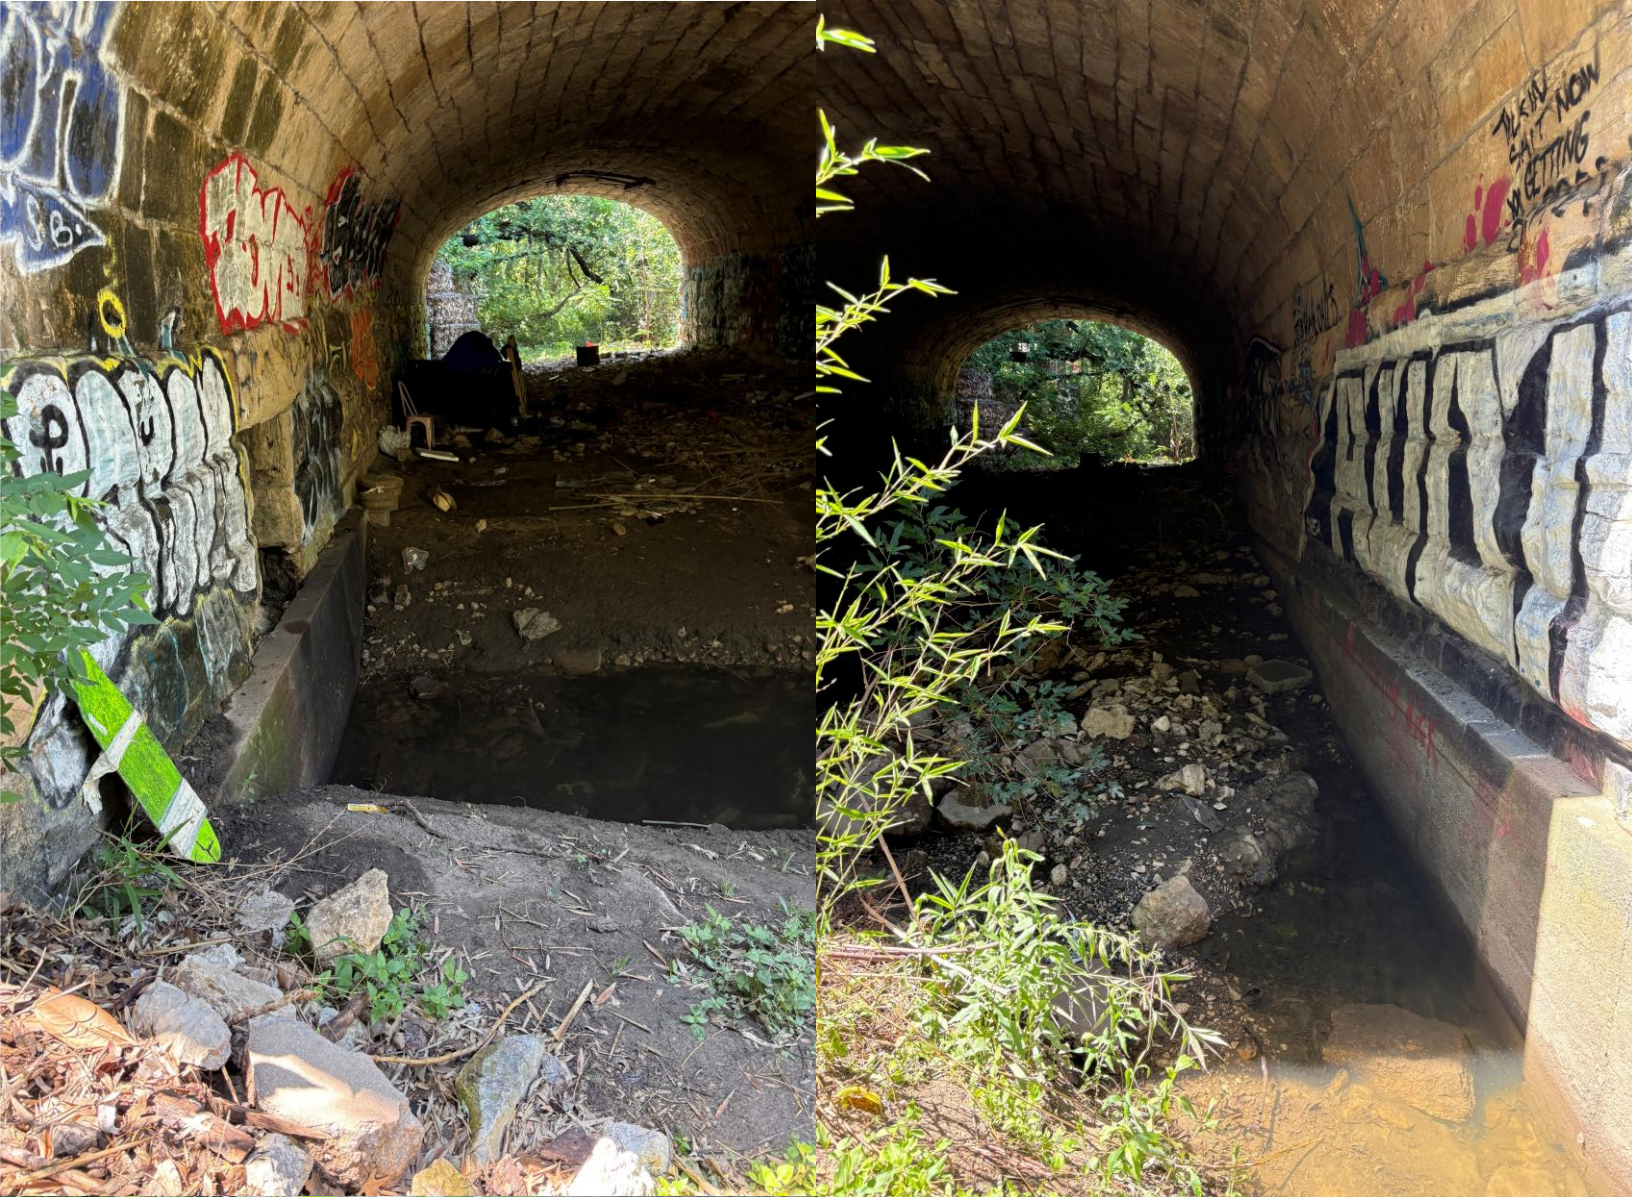
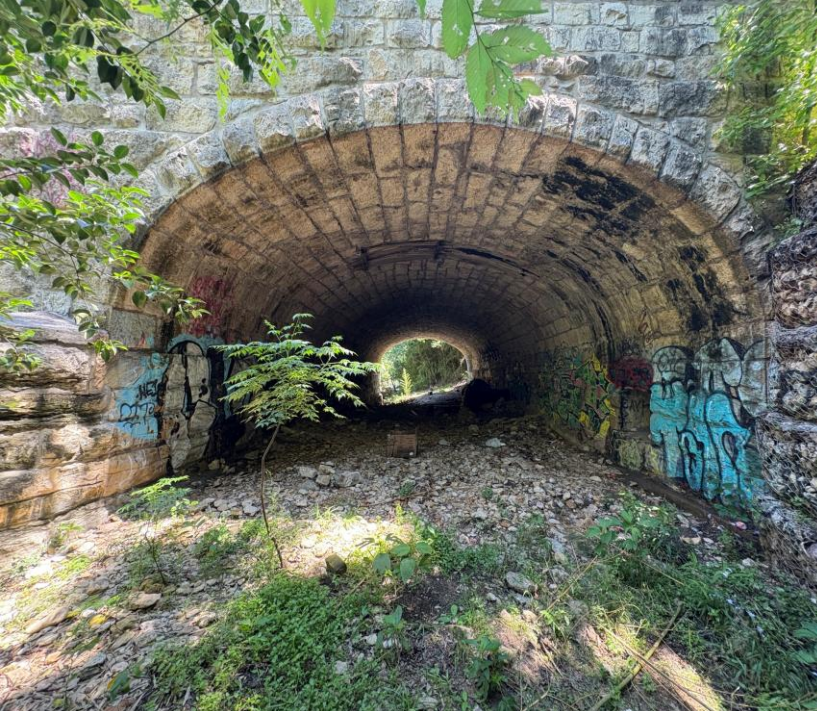
The photographs above are downstream under the east span of the W 6 St bridge. The photograph directly to the left faces upstream.

It's worthy to note that in addition to obstructing waterflow under bridges, gravel and gravel bars provide the relative level ground that encourages people to camp out and burn fires under piers using wood and propane.

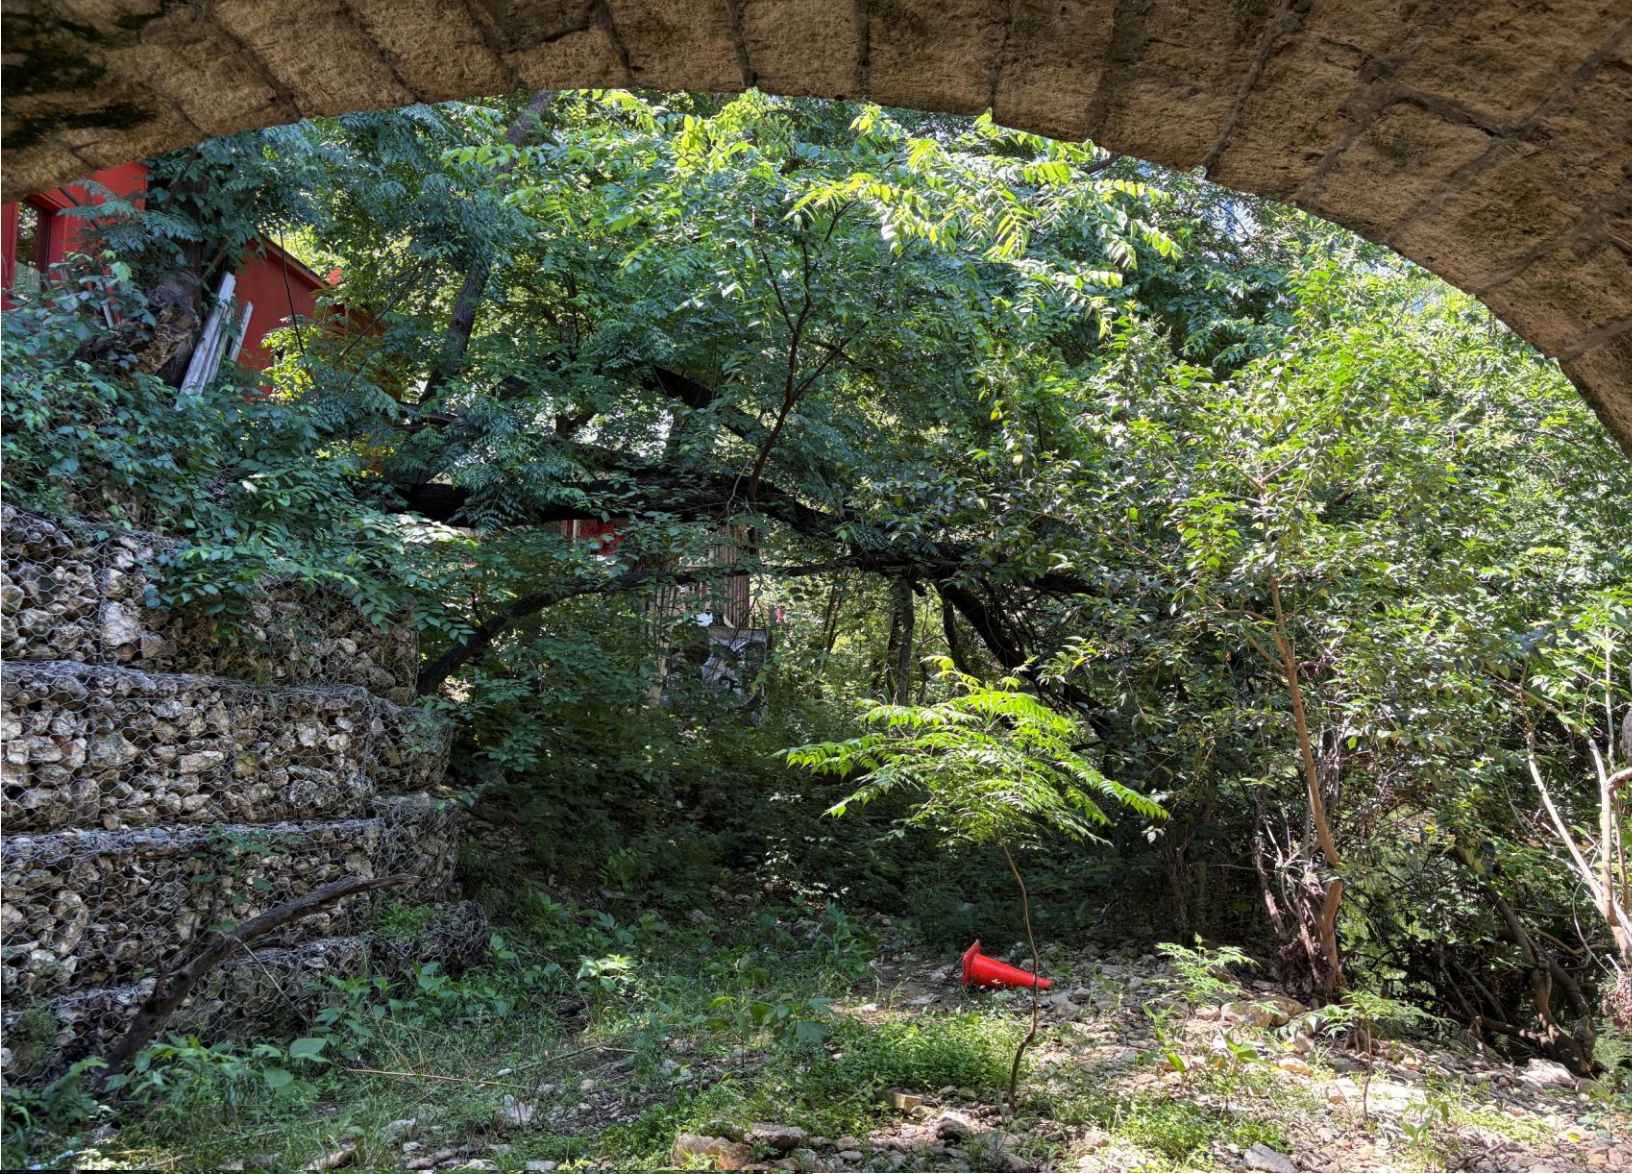
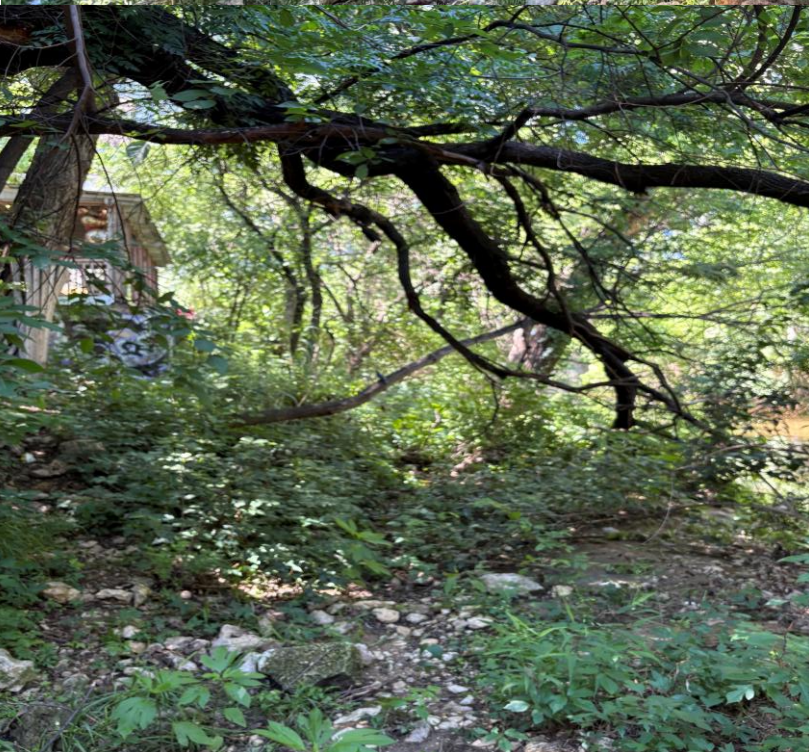
These photographs show how the east span of the W 6 St bridge feeds directly into the foundational areas of Sammie's (has partial erosion prevention measures in place) and Taquero Mucho (has no erosion prevention measures in place other than a reinforced foundation).

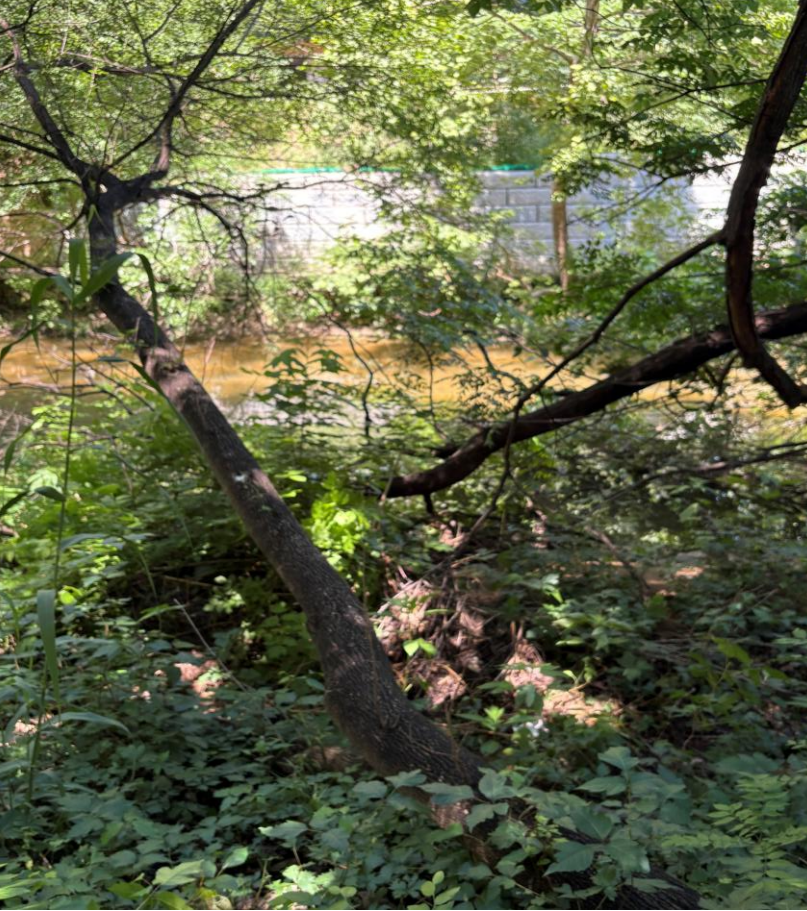
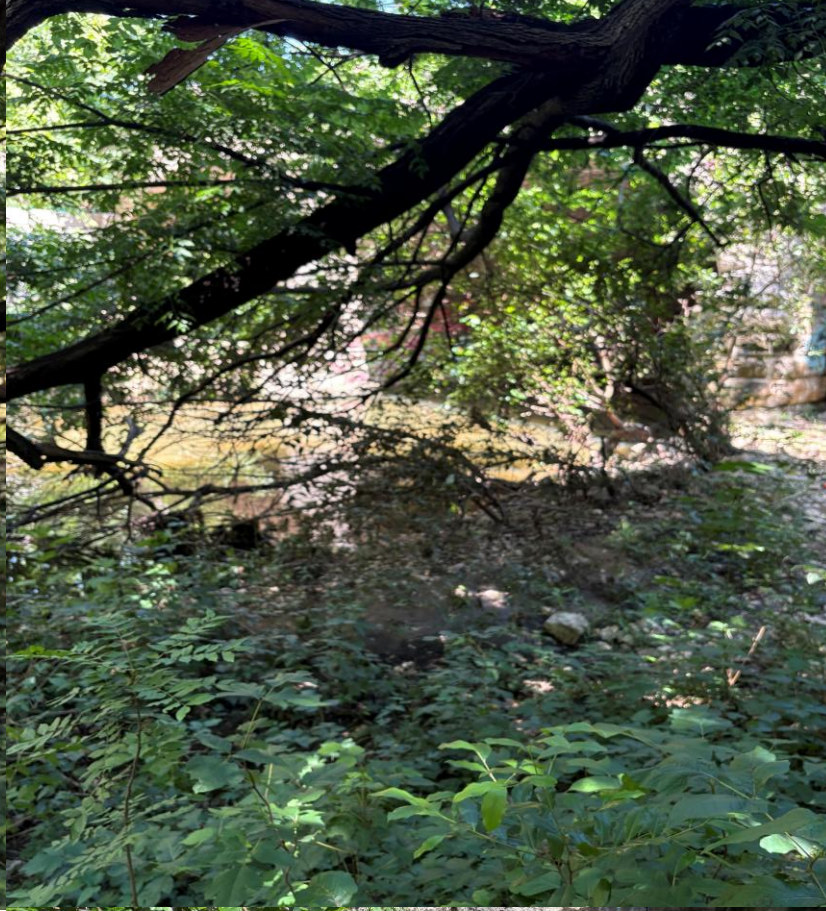
The photographs above and to the right form a pan of the creek by turning right (west) from downstream at Sammie's and returning upstream towards the east footer of the W 6 St bridge.

Erosion and obstruction may not be a concern here, despite appearing to be so. The erosion prevention measures in place across the creek on the west side (top left) look like an appropriate and needed remedy on the east side, from the layman's perspective.

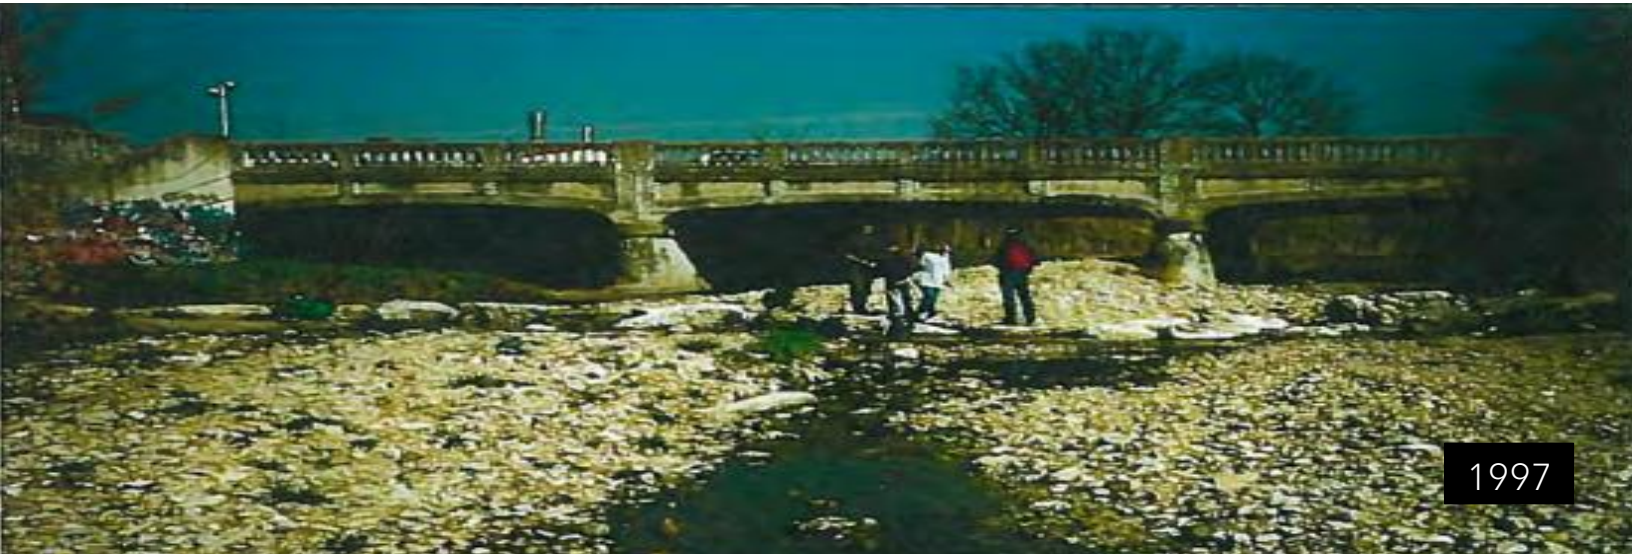
1997

Here is what the W 5 St bridge looks like facing upstream in 1997, 2016 and 2026.

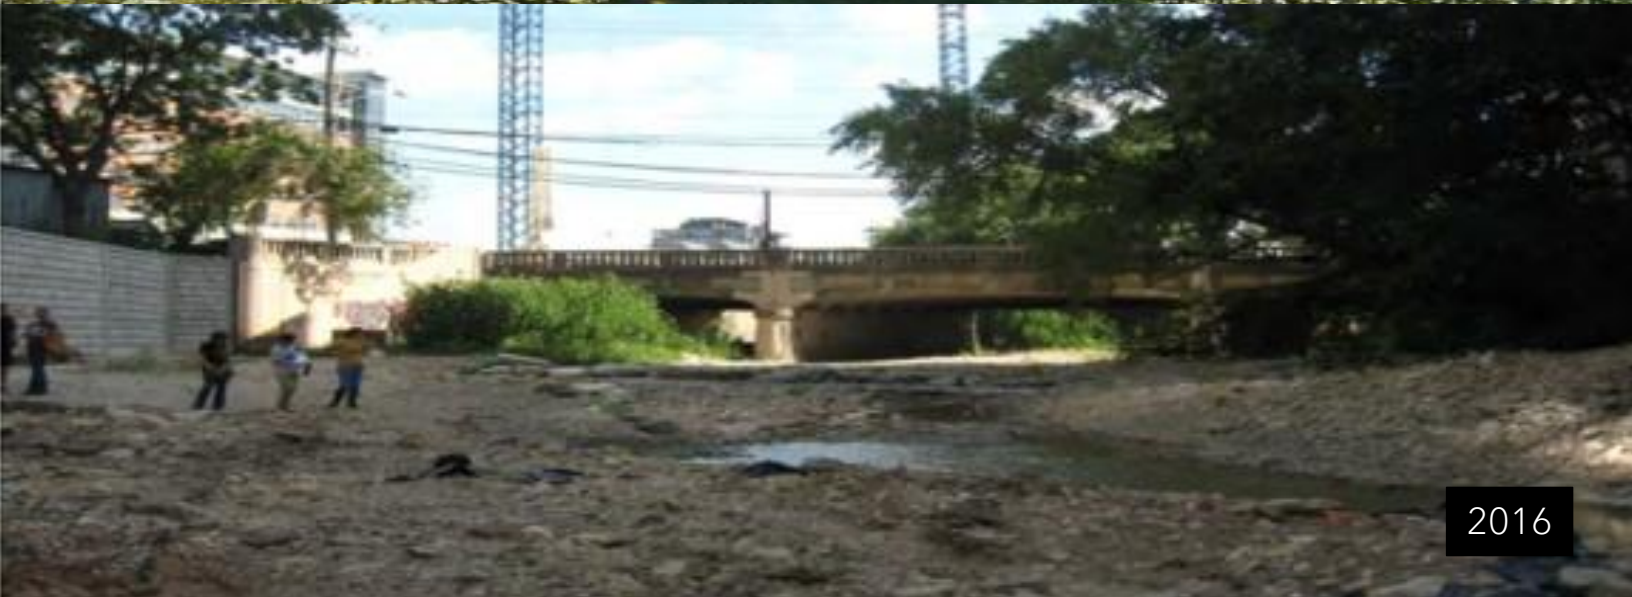
2016

Important to note is that it appears the middle span cleared out naturally between 1997-2016.

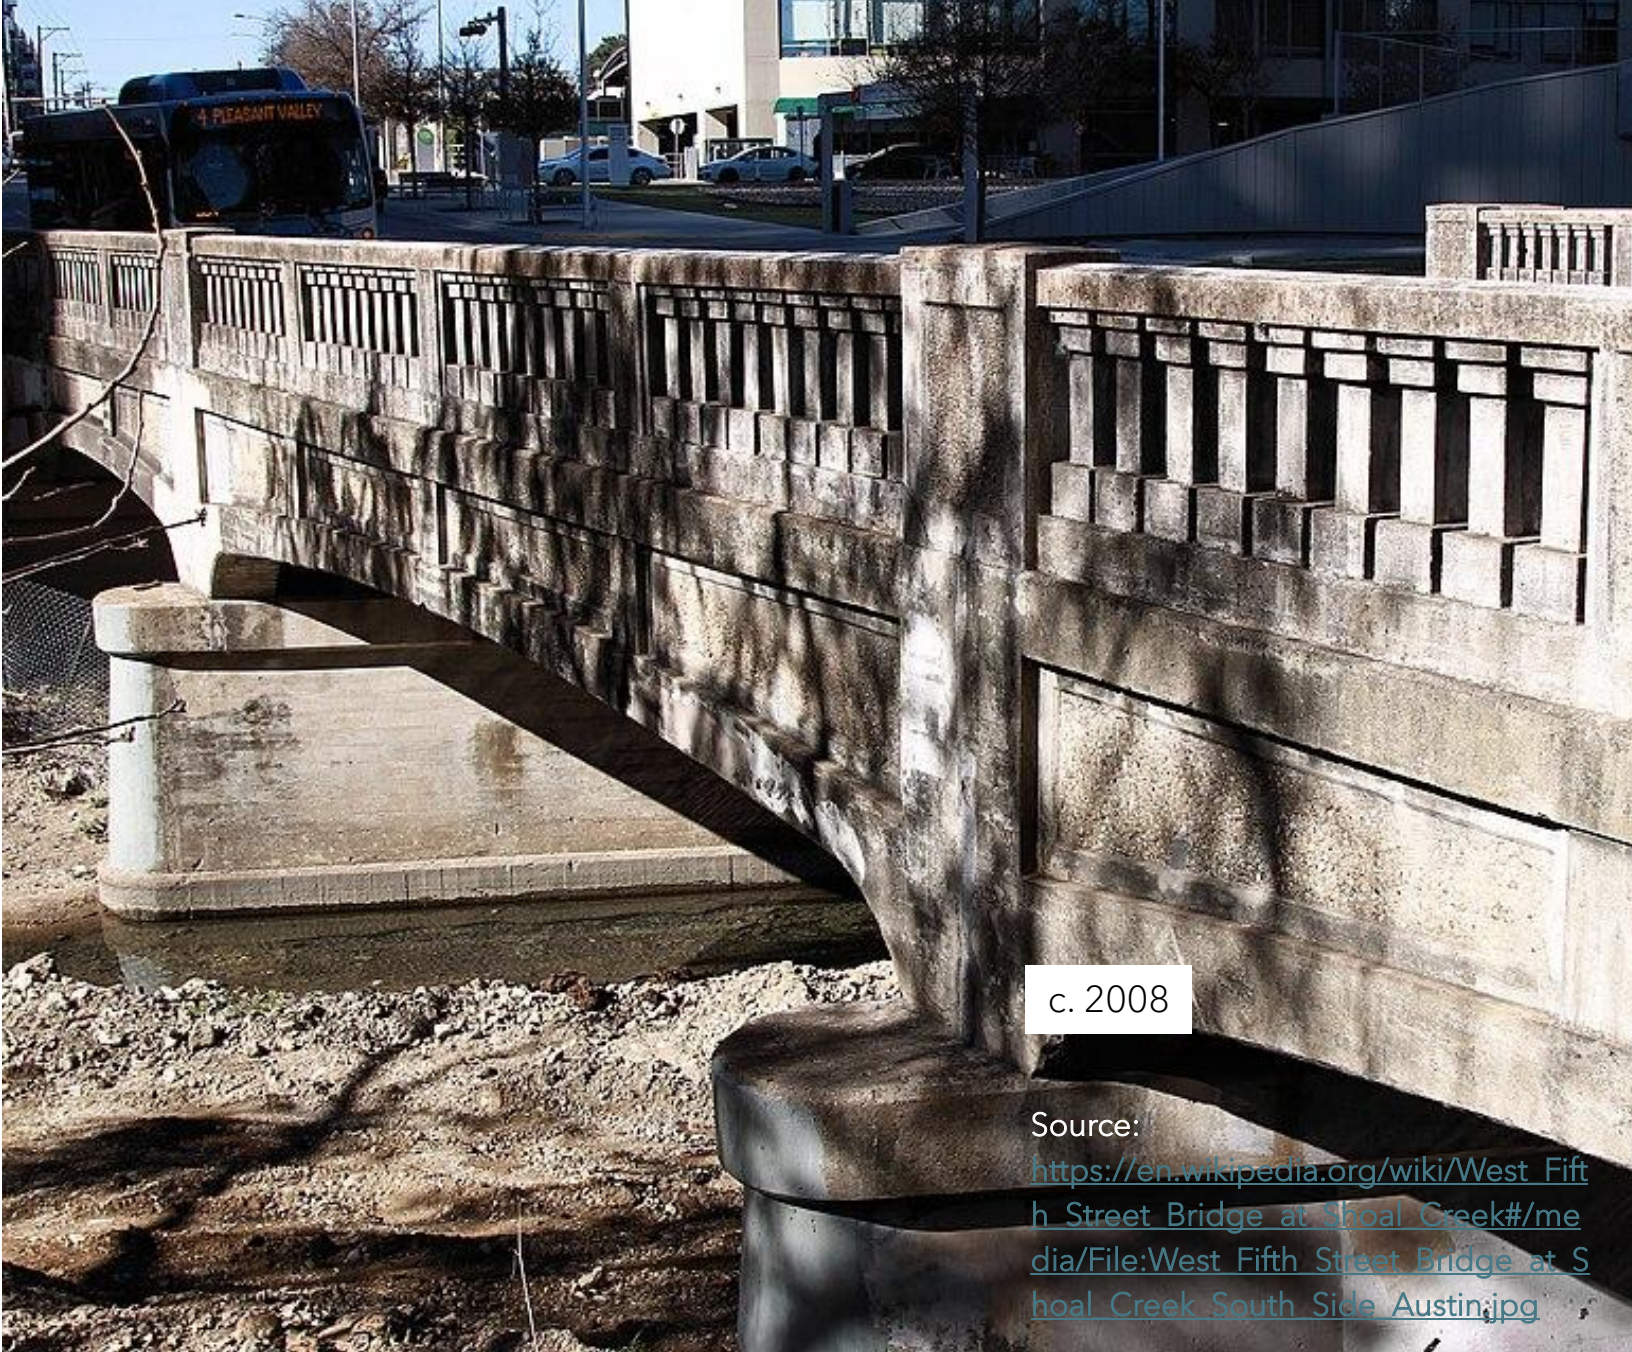
c. 2008

The east travelling 4 commuter bus confirms this is the W 5 St bridge. The temporary fencing under the west span and wheel marks under the middle span revealing uneven brown earth and finer gravel, point to construction work of some kind taking place here. What cannot be determined is if the gravel bar was removed in part or its entirety.

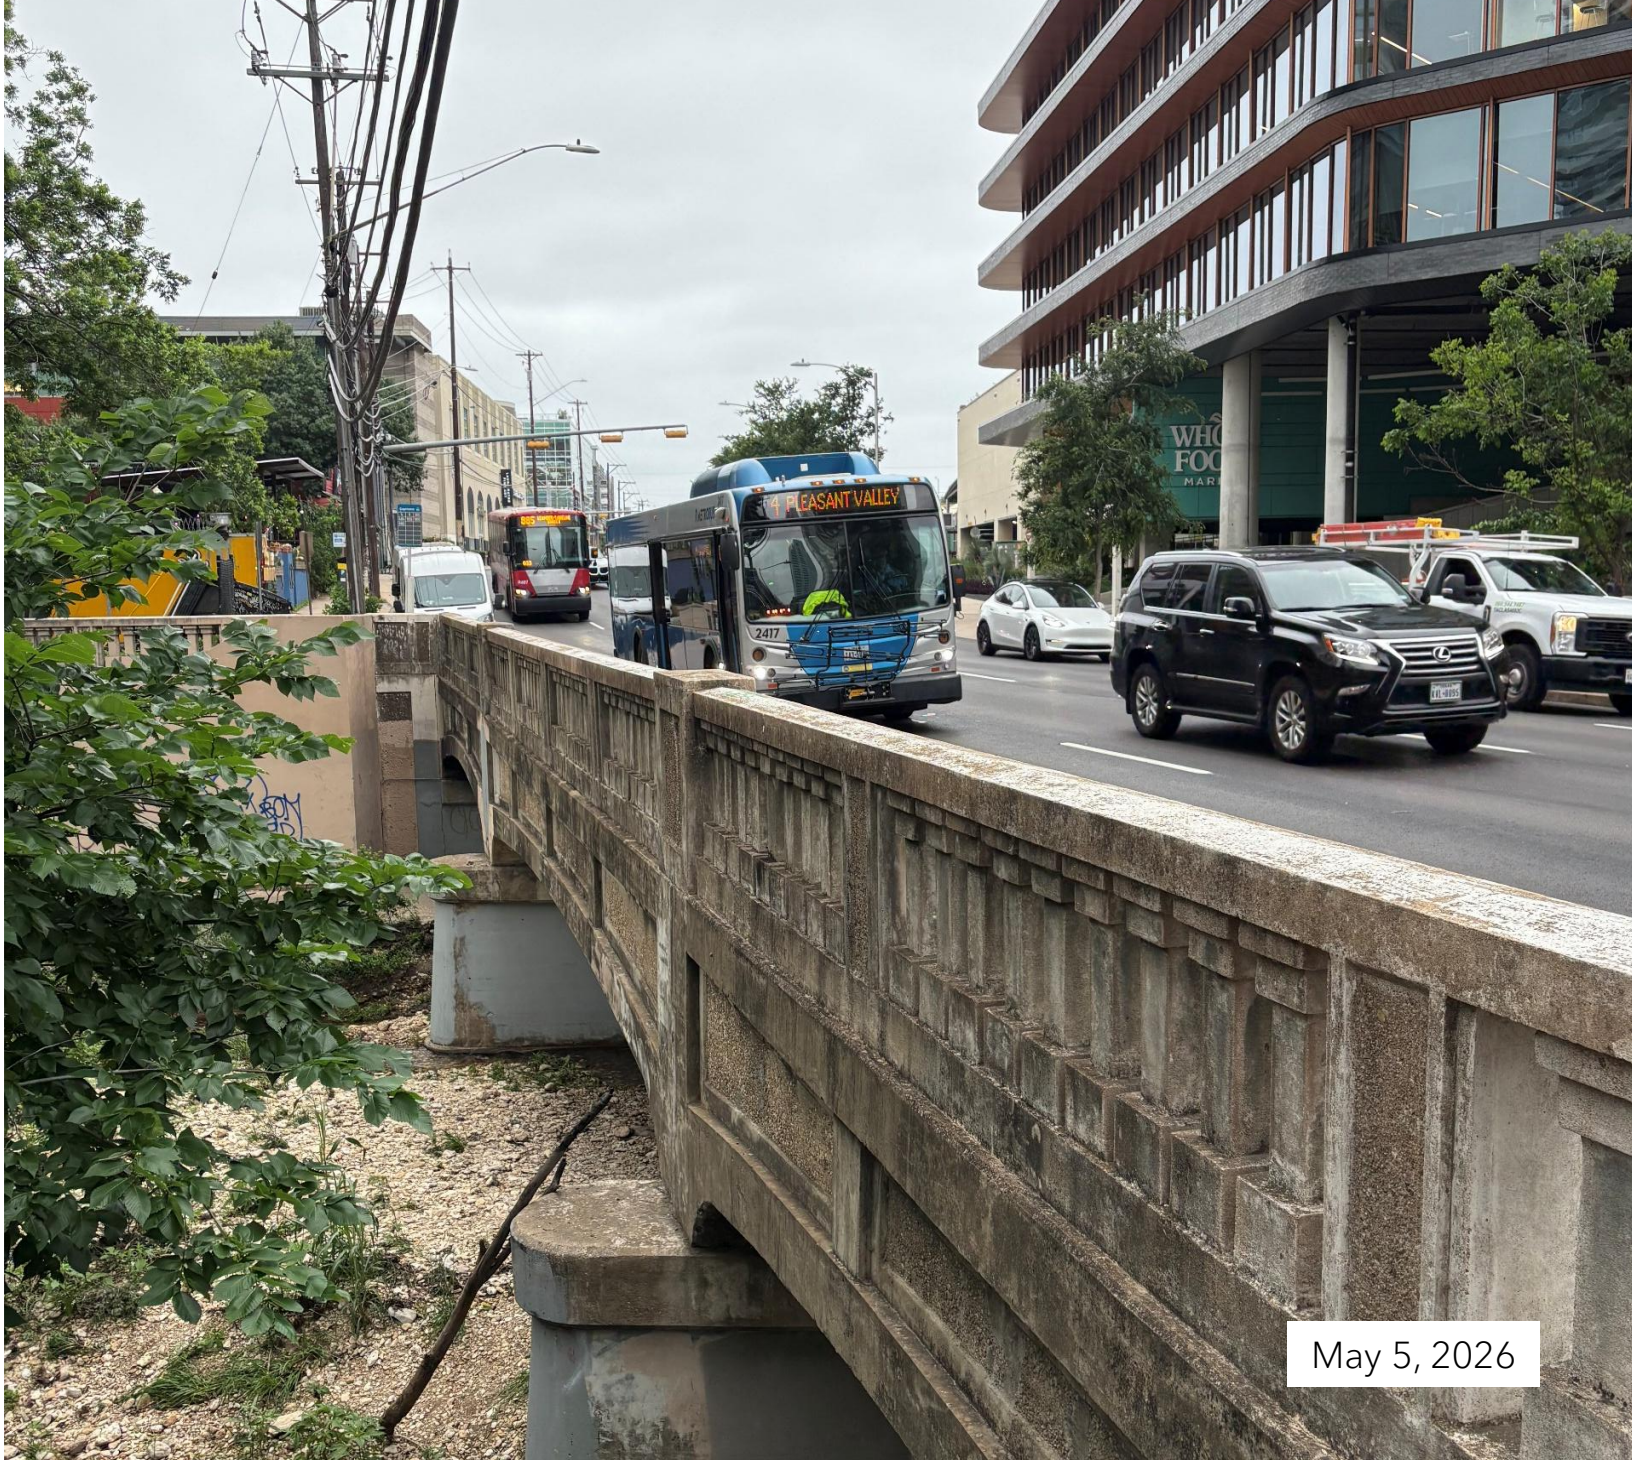
Photographed above is the W 5 St bridge on May 5, 2026. The support columns in front of the Whole Foods sign was not present in the photograph on the previous page, circa 2008.

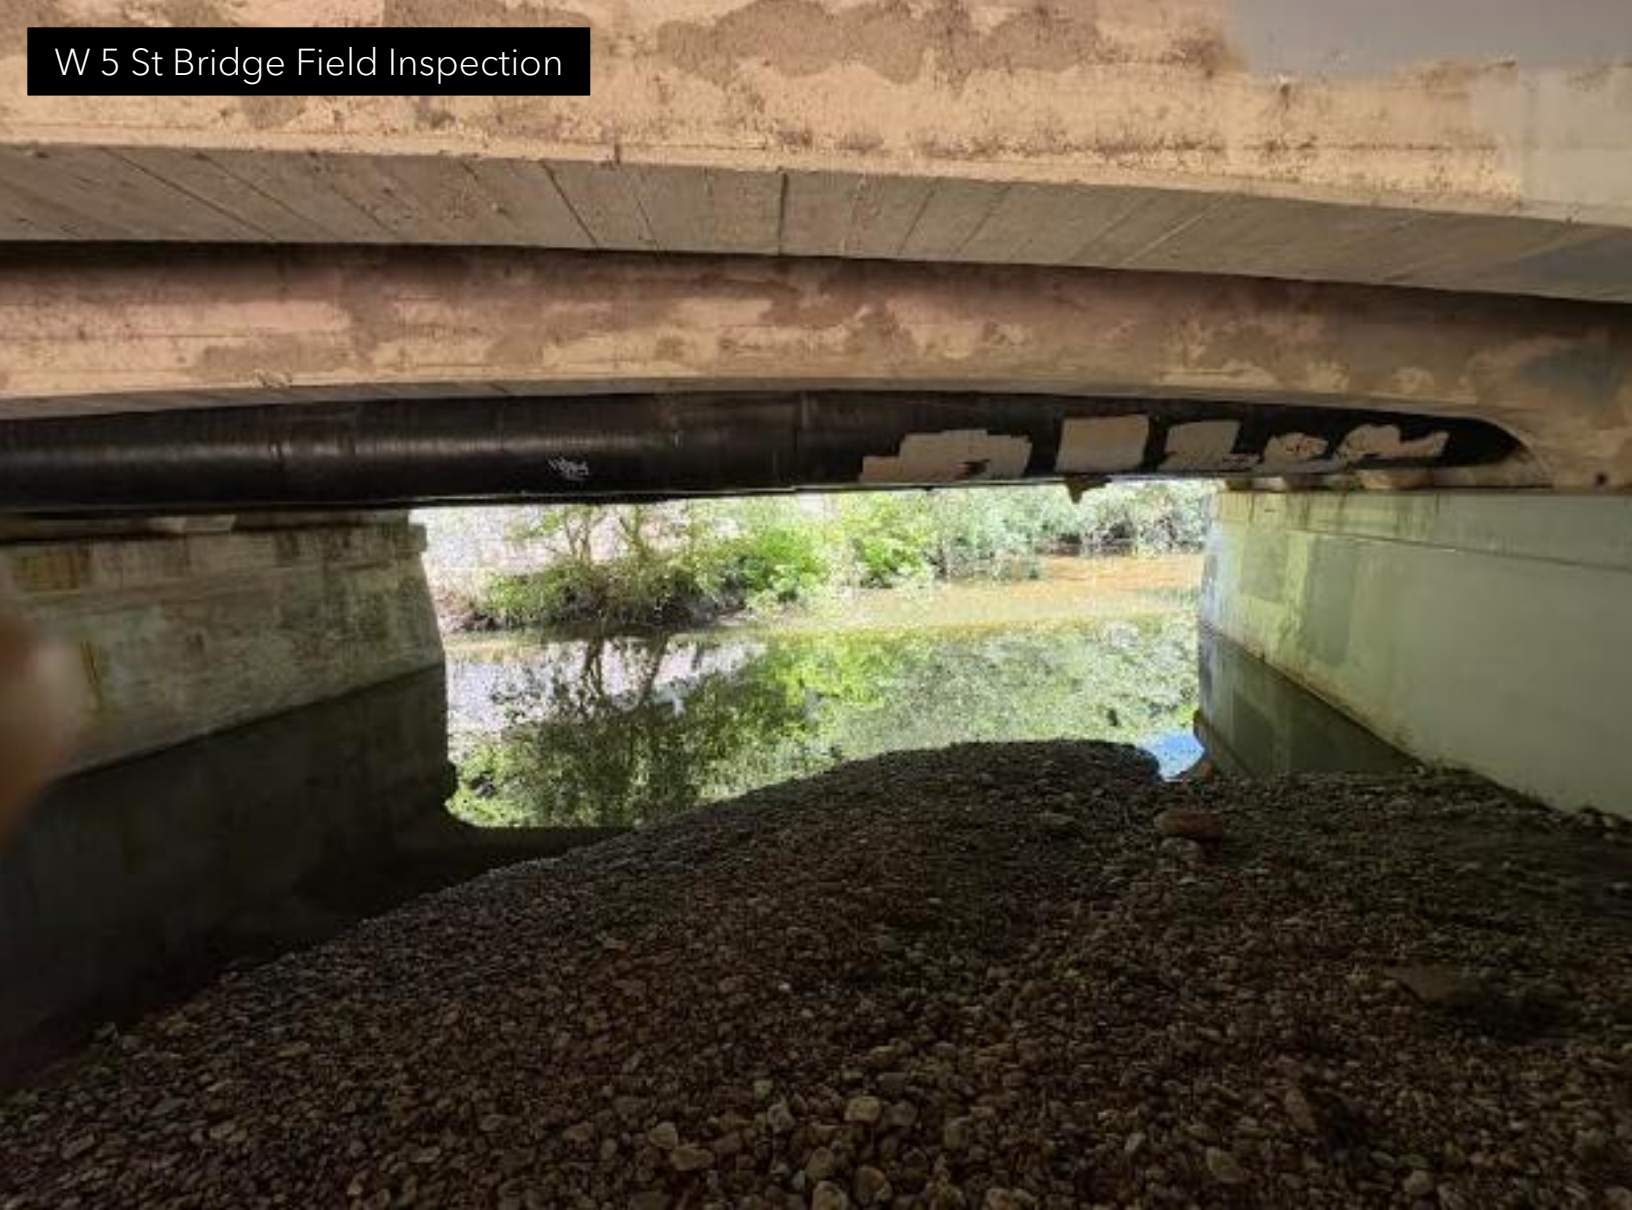
Standing in the W 5 St bridge middle span facing upstream, you can see how the sediment and gravel under this bridge blocks waterflow on a calm day after rain.

What could understandably be inferred here is that even on a good day this bridge is obstructed, and waterflow struggles to convey as a result.

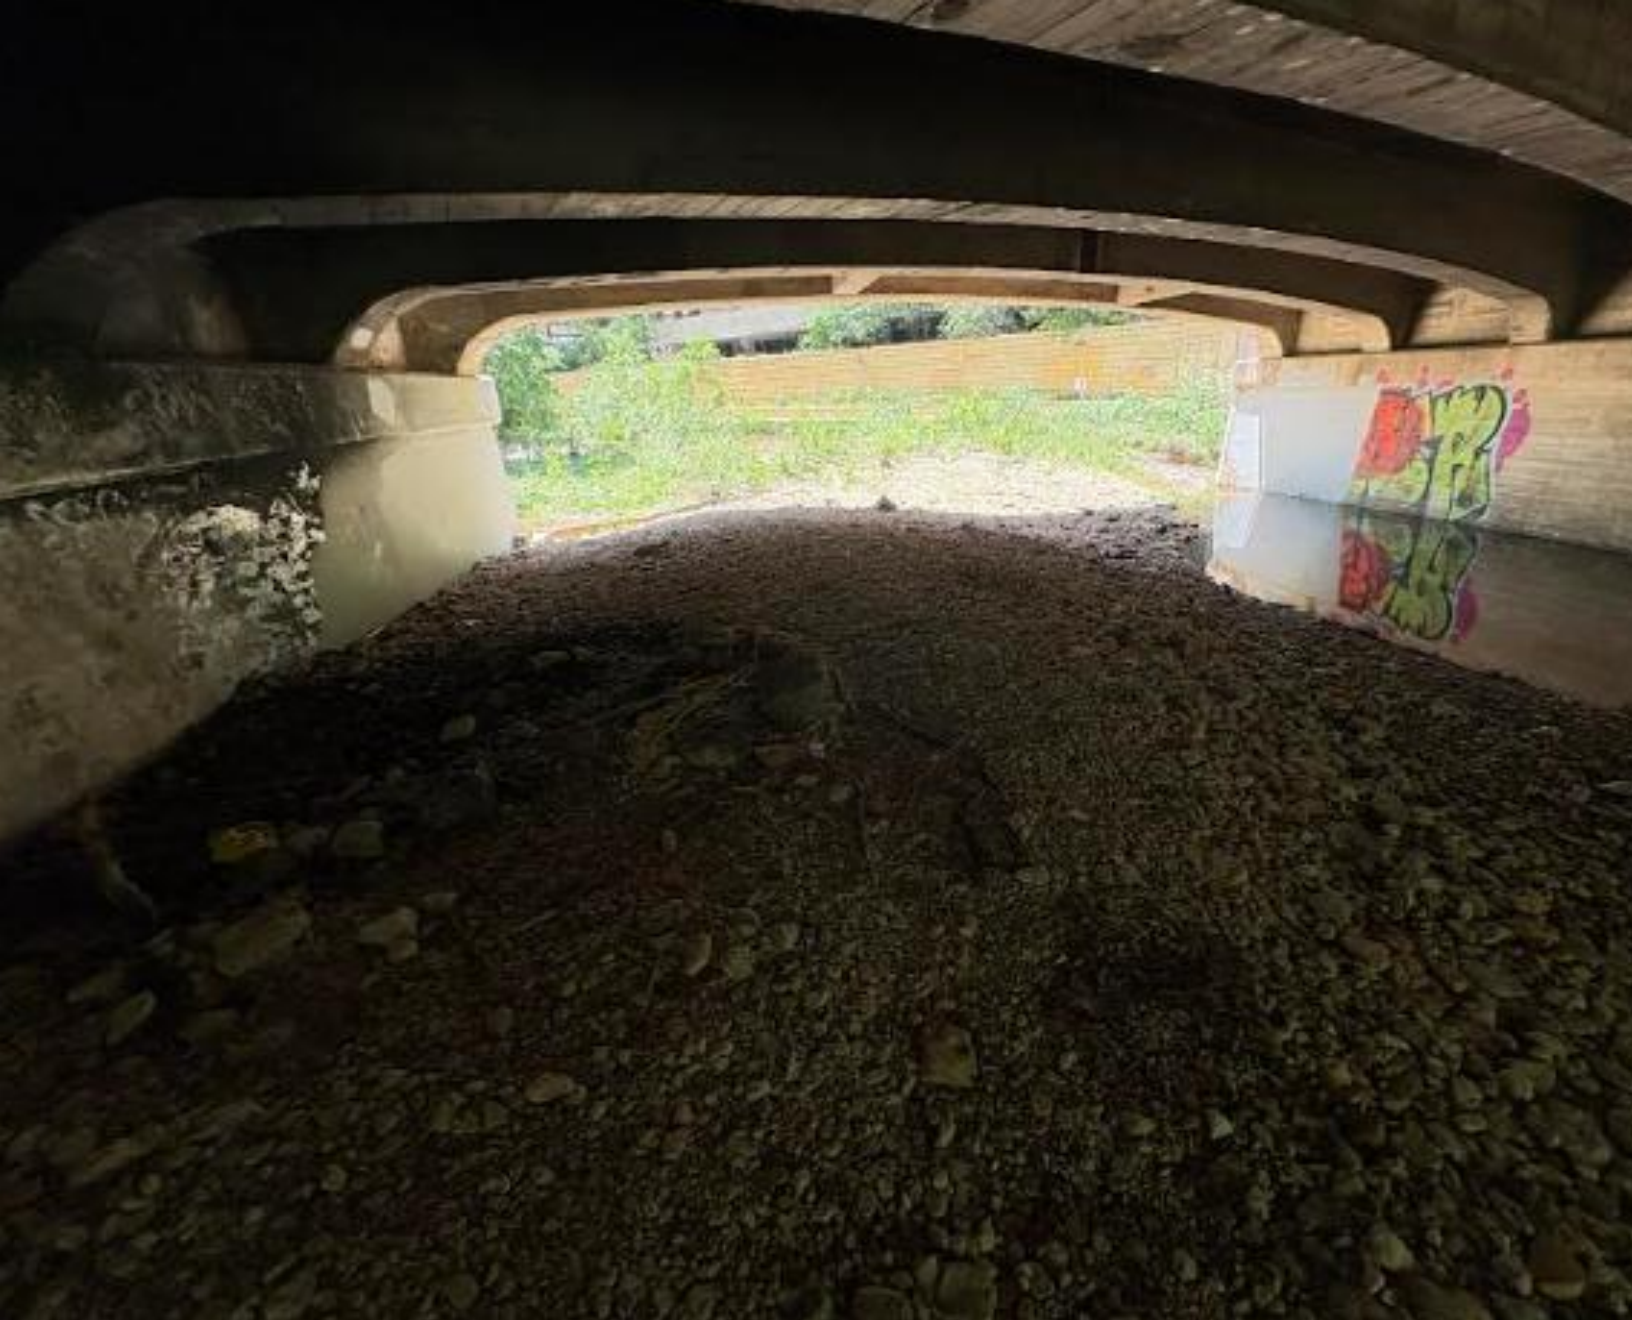
Facing downstream it's worth noting that this buildup is not natural but is the result of waterflow coming into resistance from a manmade structure.
