Response to [REDACTED], P.E. pertaining to:

- Shoal Creek waterflow
- Mechanisms that prevent overtopping
- Sediment and gravel bar removal around bridge infrastructure
- Maintenance records
- Potential West Ave bridge watermain vulnerability
- In-person inspection of creek to finalize [www.austinshoalcreek.com](http://www.austinshoalcreek.com)

05/04/2026 by [austinshoalcreek.com](http://austinshoalcreek.com)

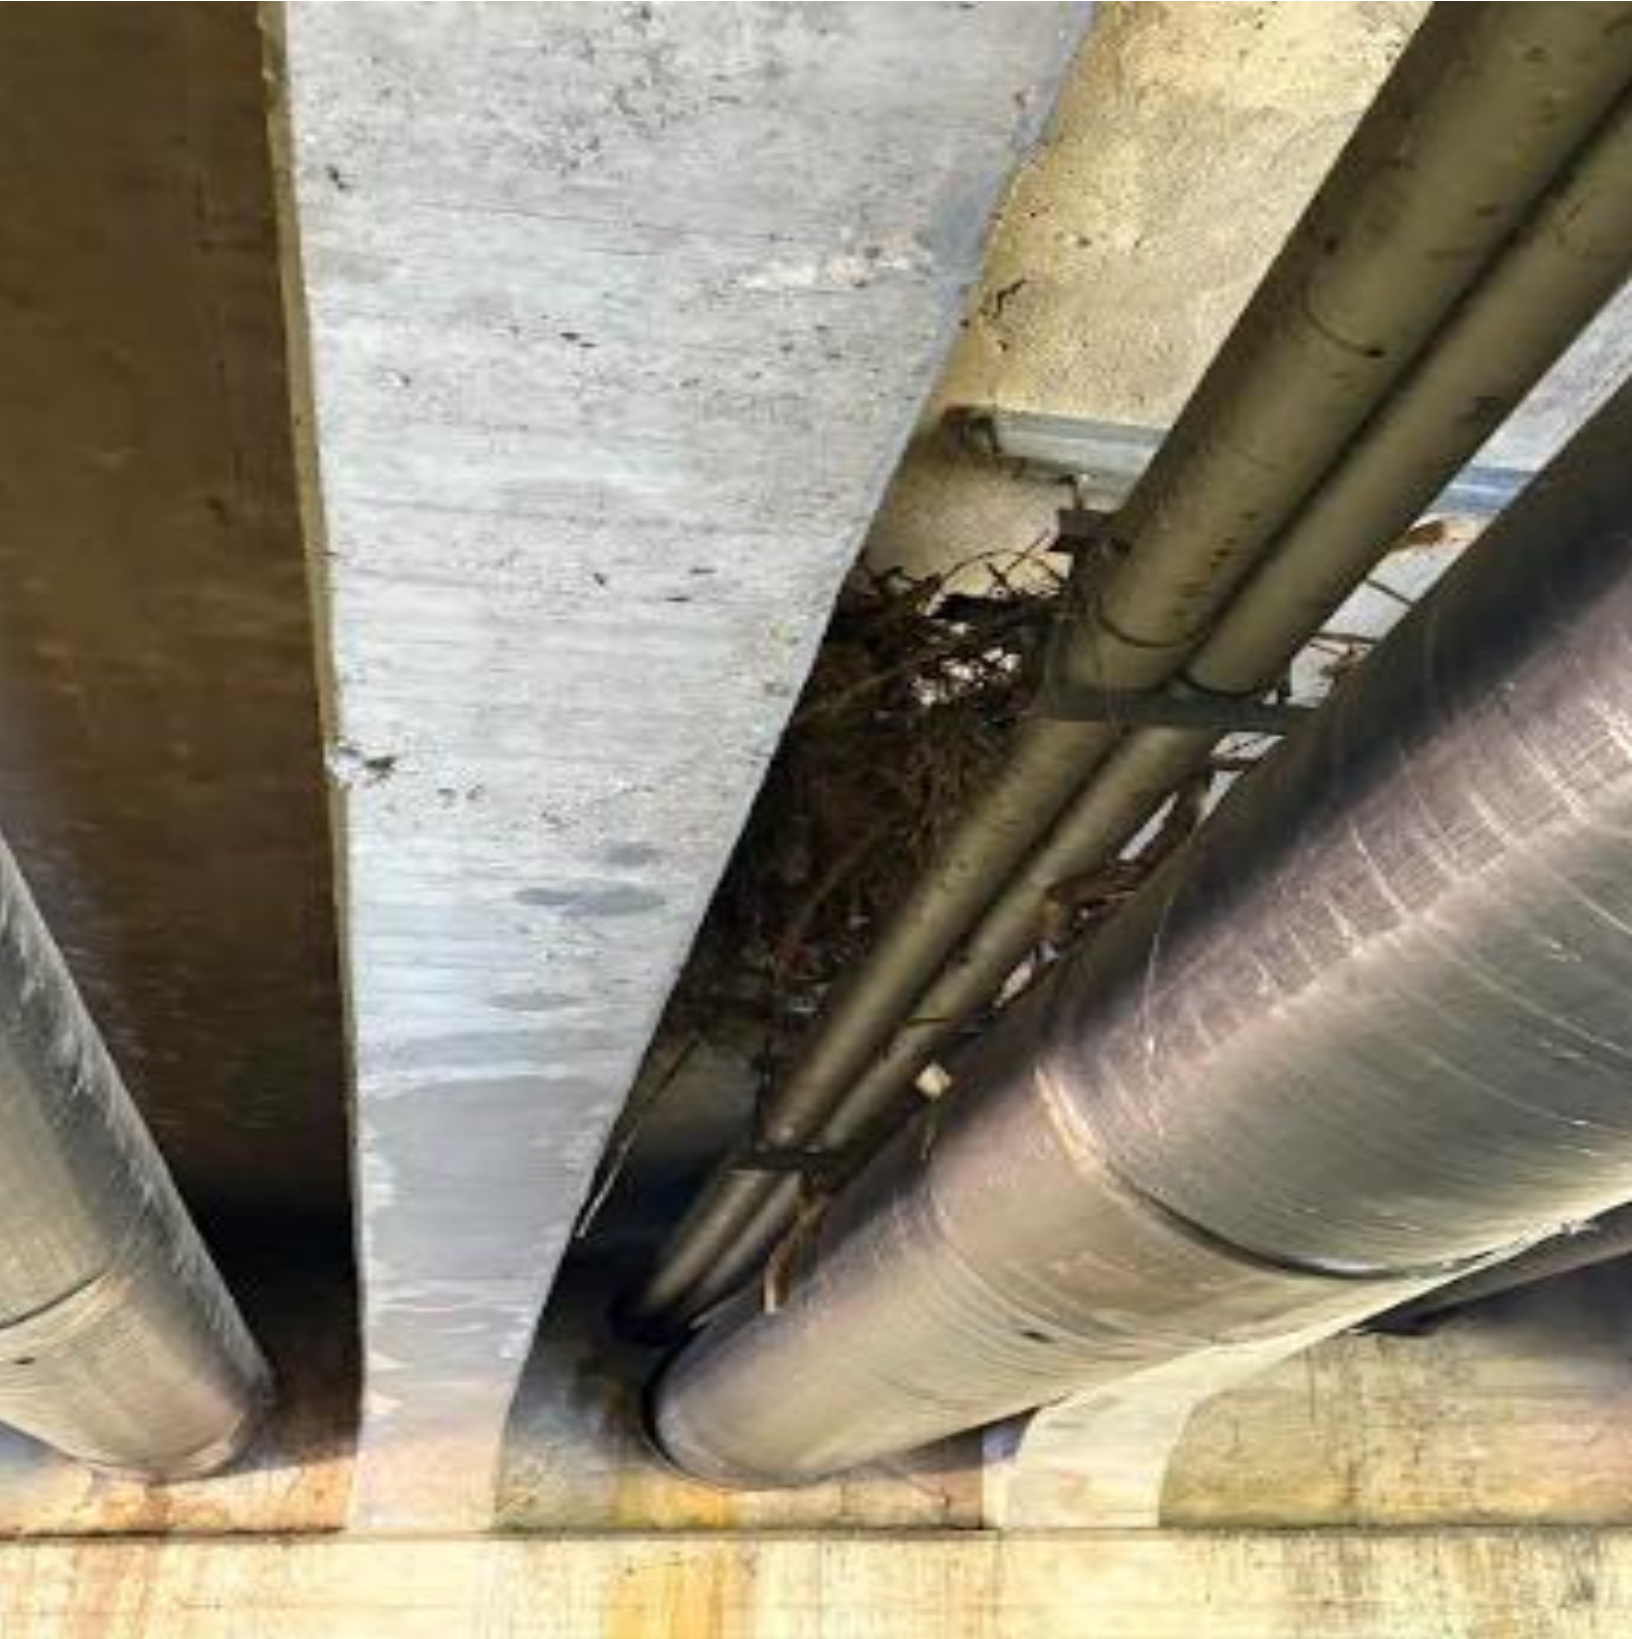
The damage to Austin Water utility pipes happens because, as indicated by snagged branches, waterflow in this area constantly reaches the height of the bridge spans, which have their designed capacity reduced by sediment and gravel.

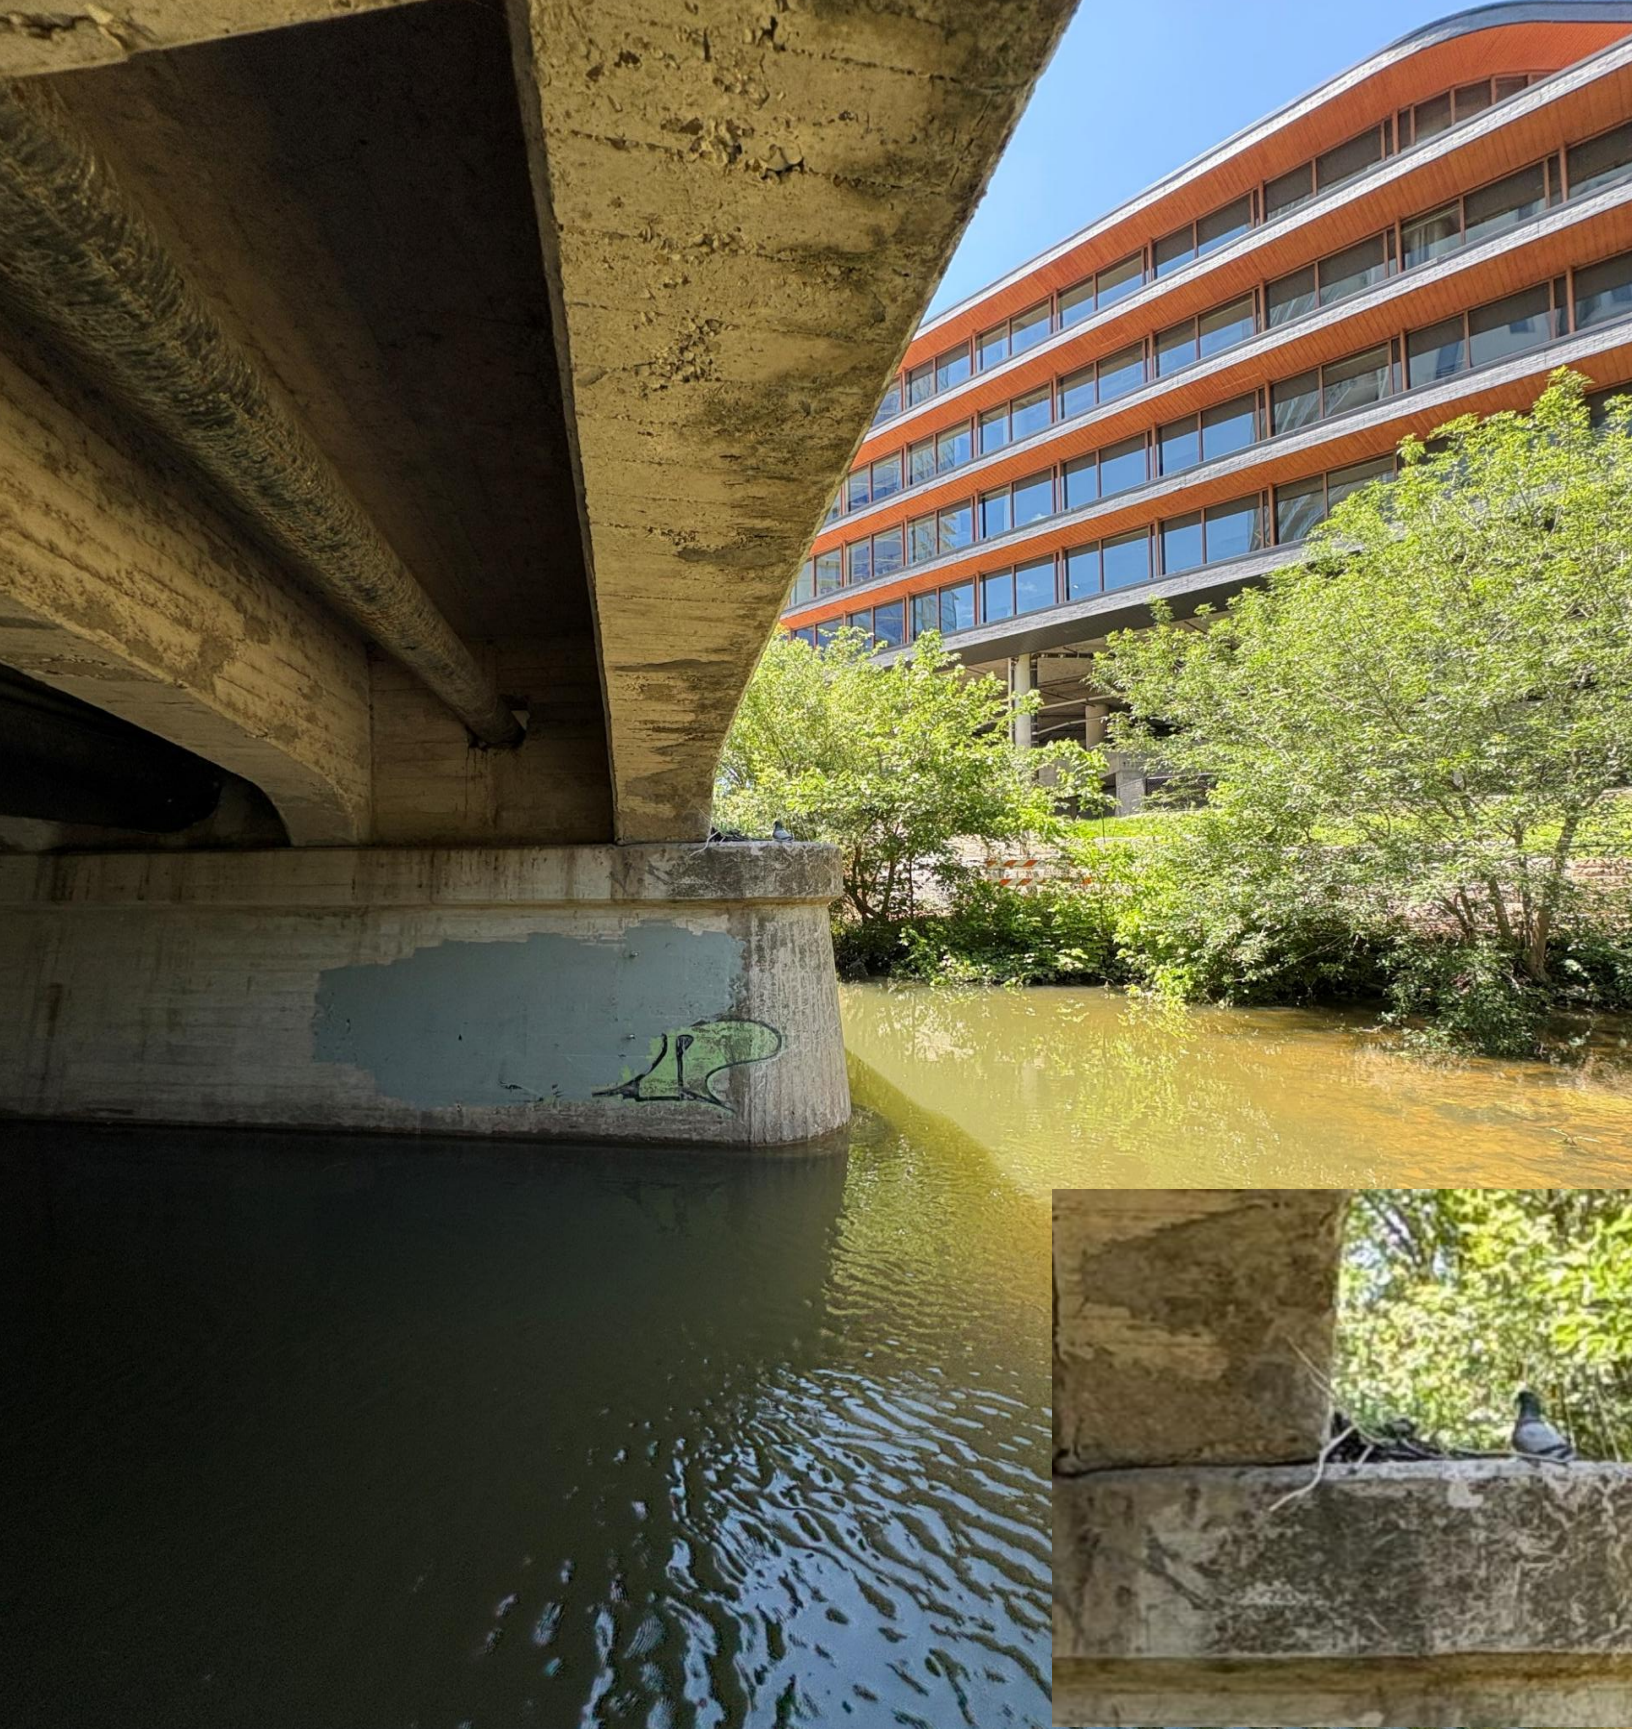
The branches stuck under the bridge could be from nesting birds, though it's doubtful.

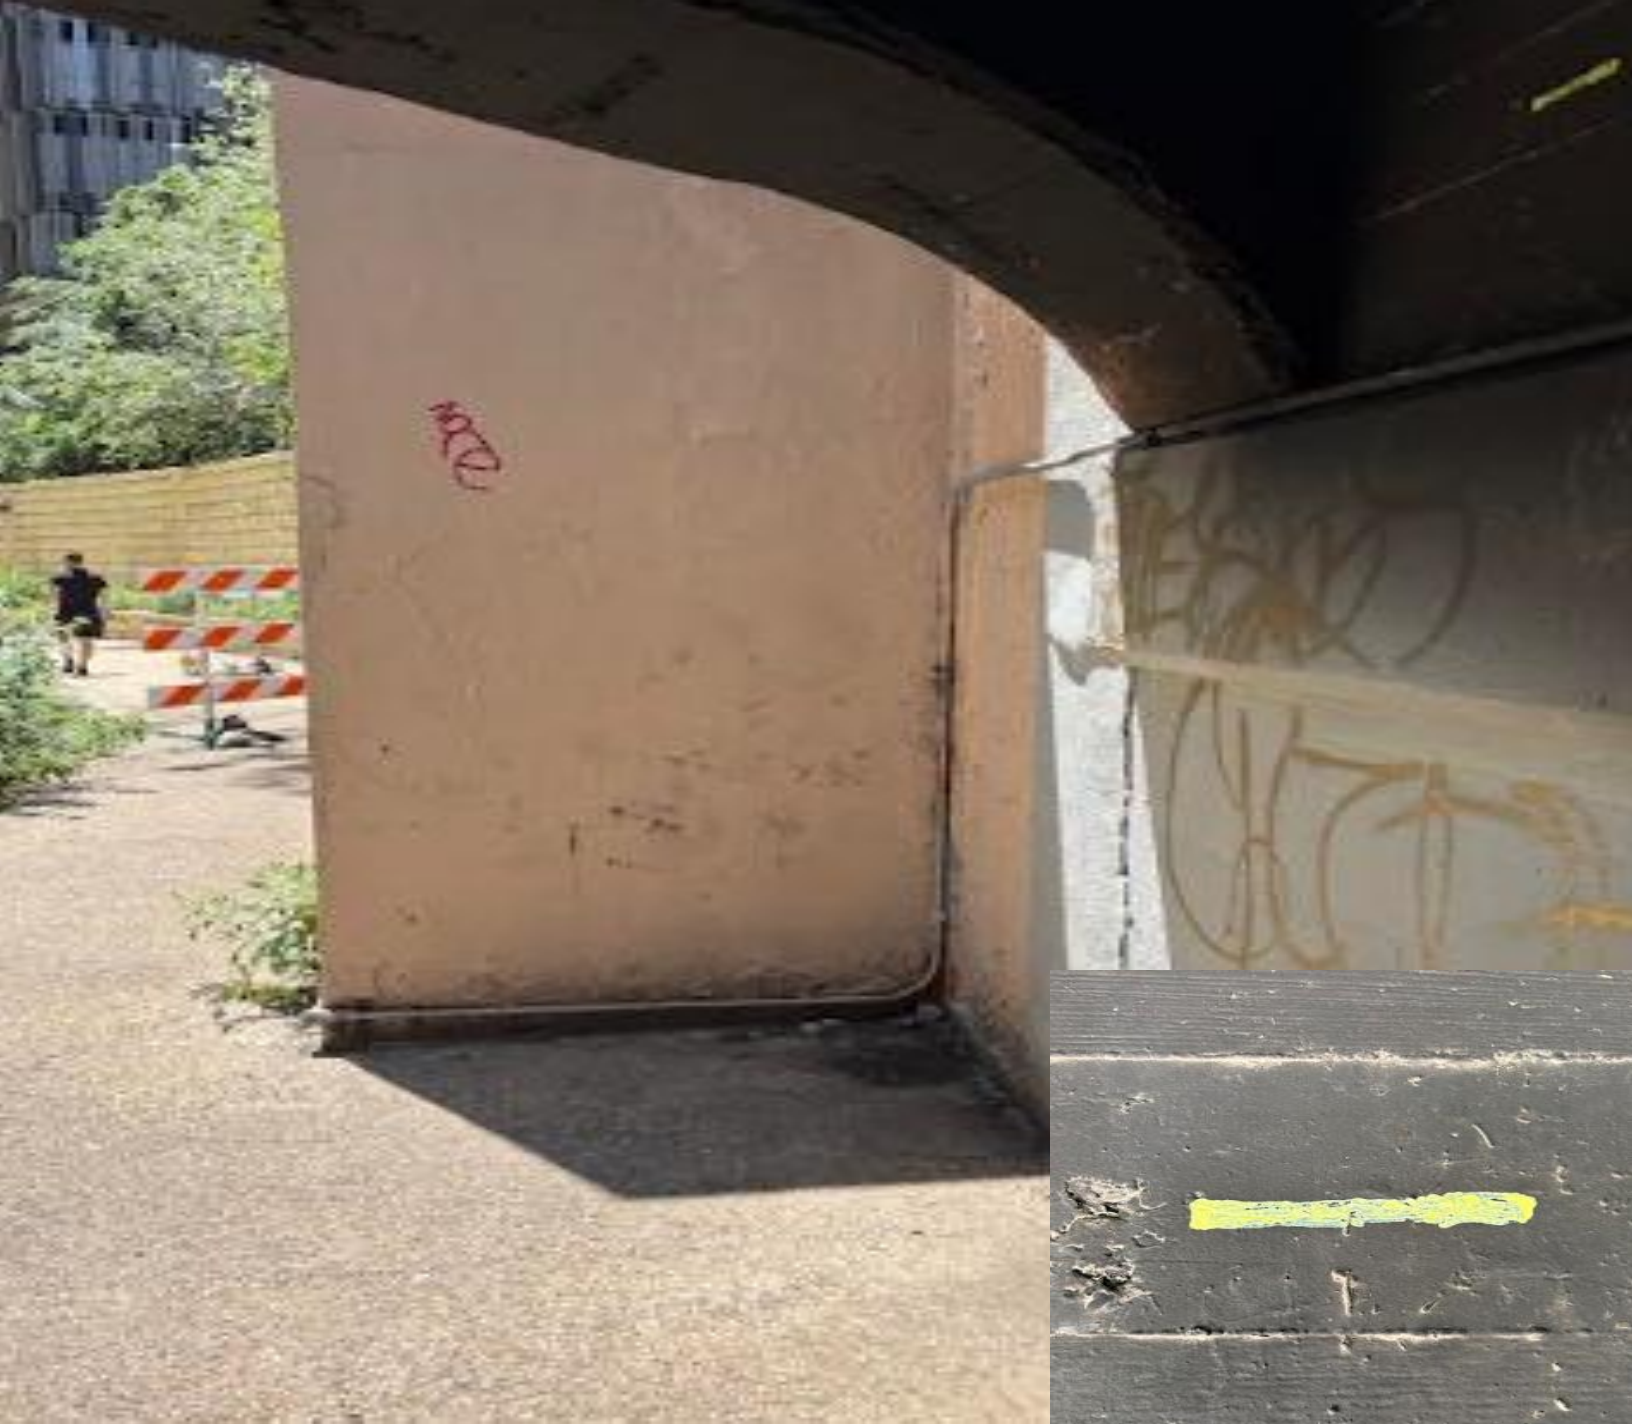
Water travelling under the west span of the W 5 St bridge has an 81 inch clearance when the height of the utility pipes is factored in; parts of the middle span have even less room.

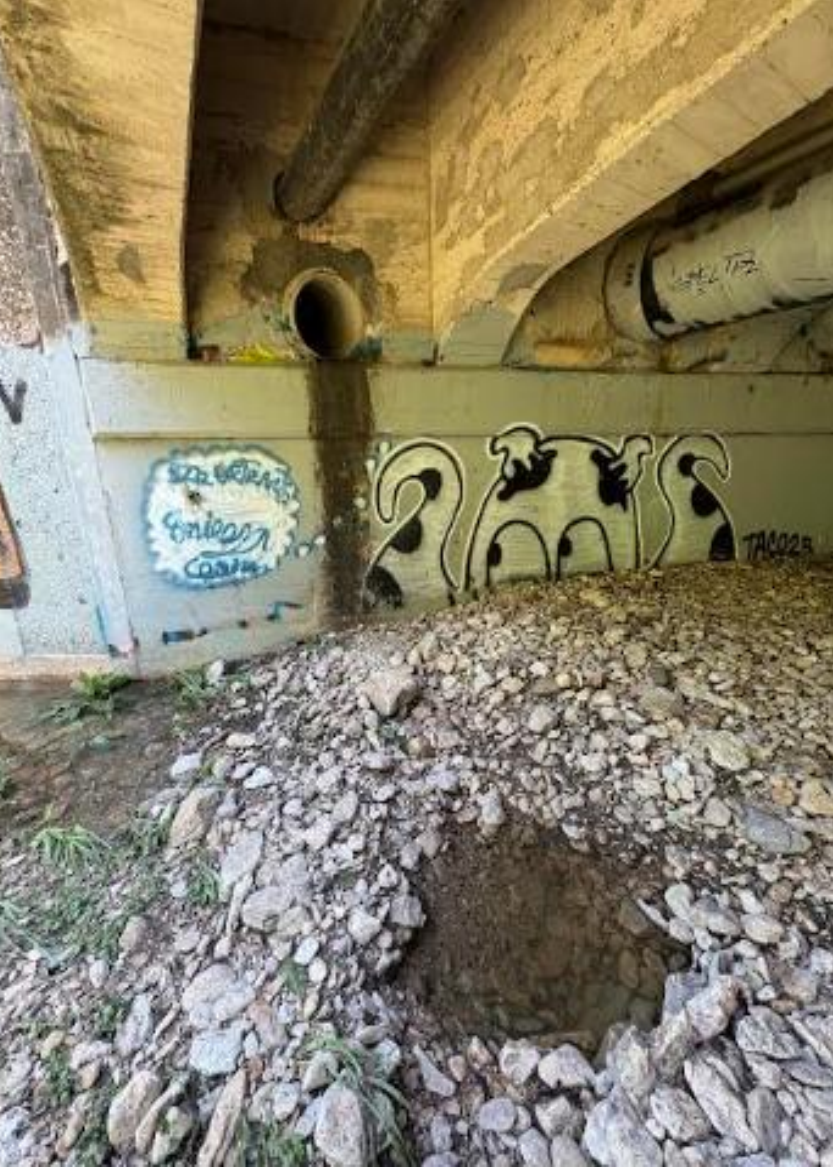
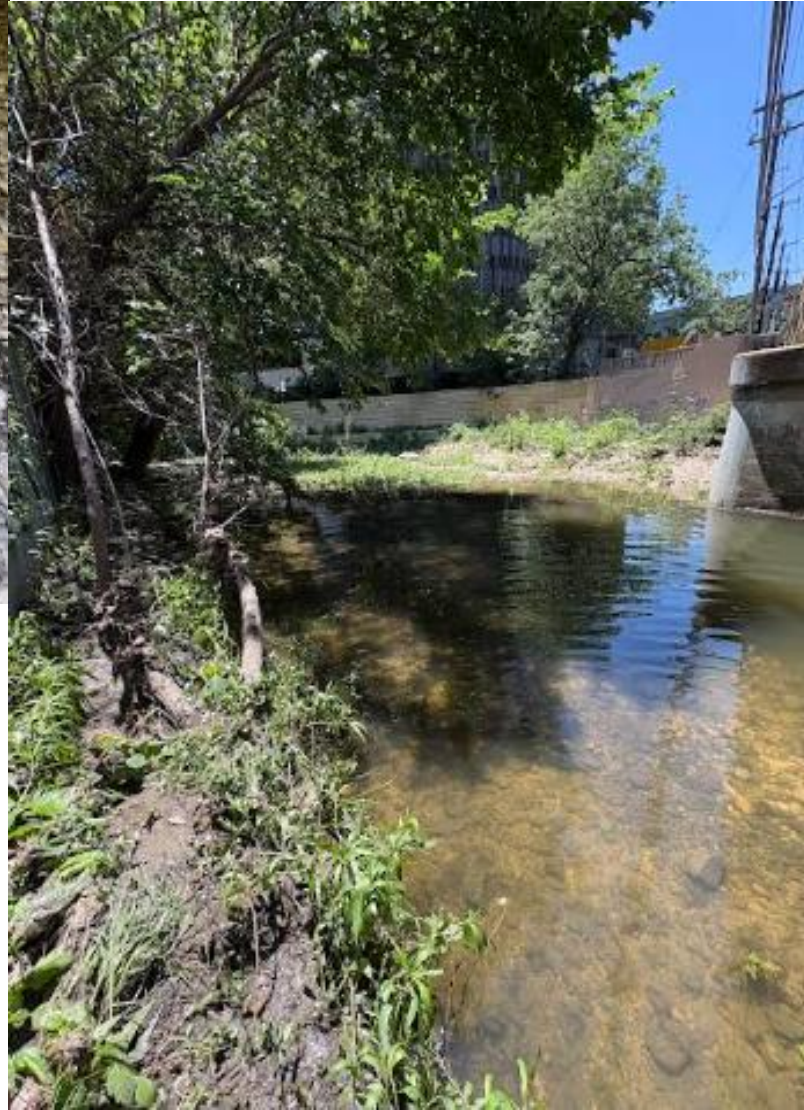
The gravel bar under the east span has grown slightly since 2016. Water is slow to drain downstream just past the span of the W 5 St bridge.

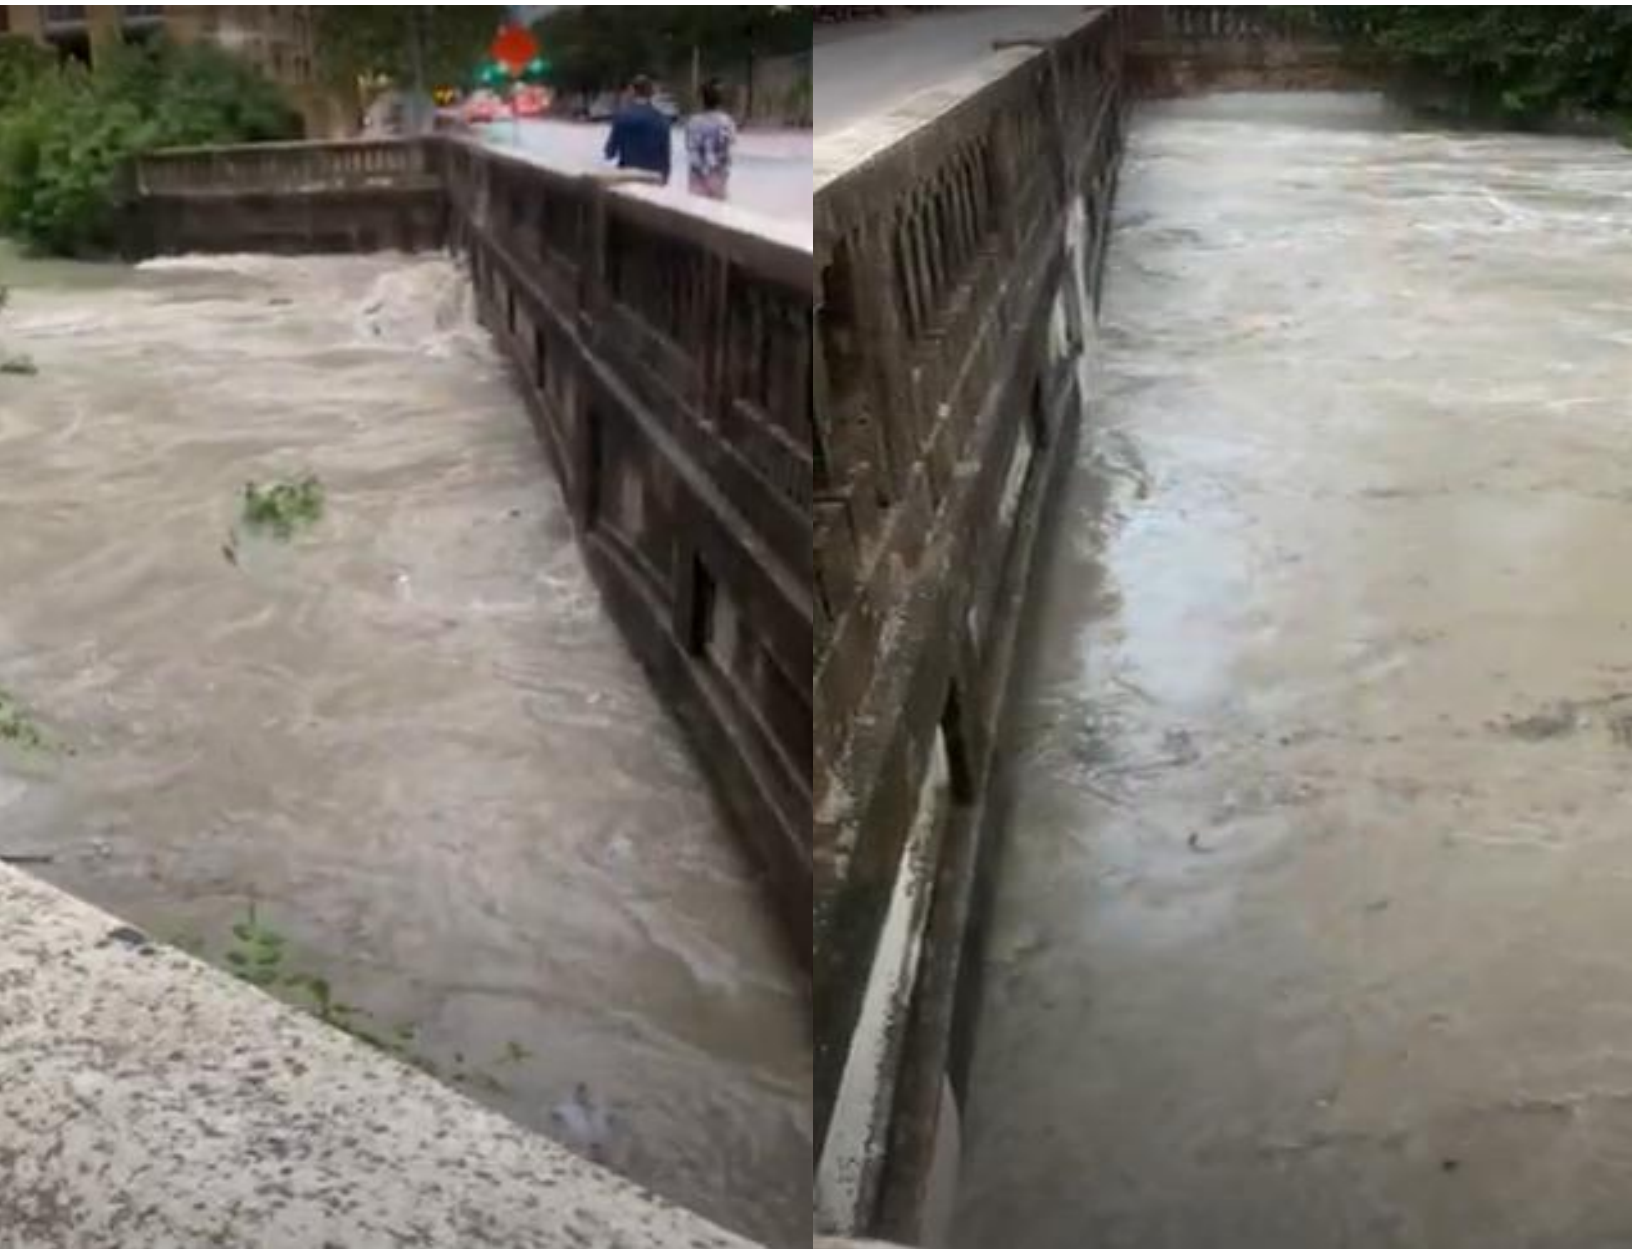
Above is what the W 5 St bridge looks like upstream (left) and downstream (right) during flooding, as documented on August 22, 2022.

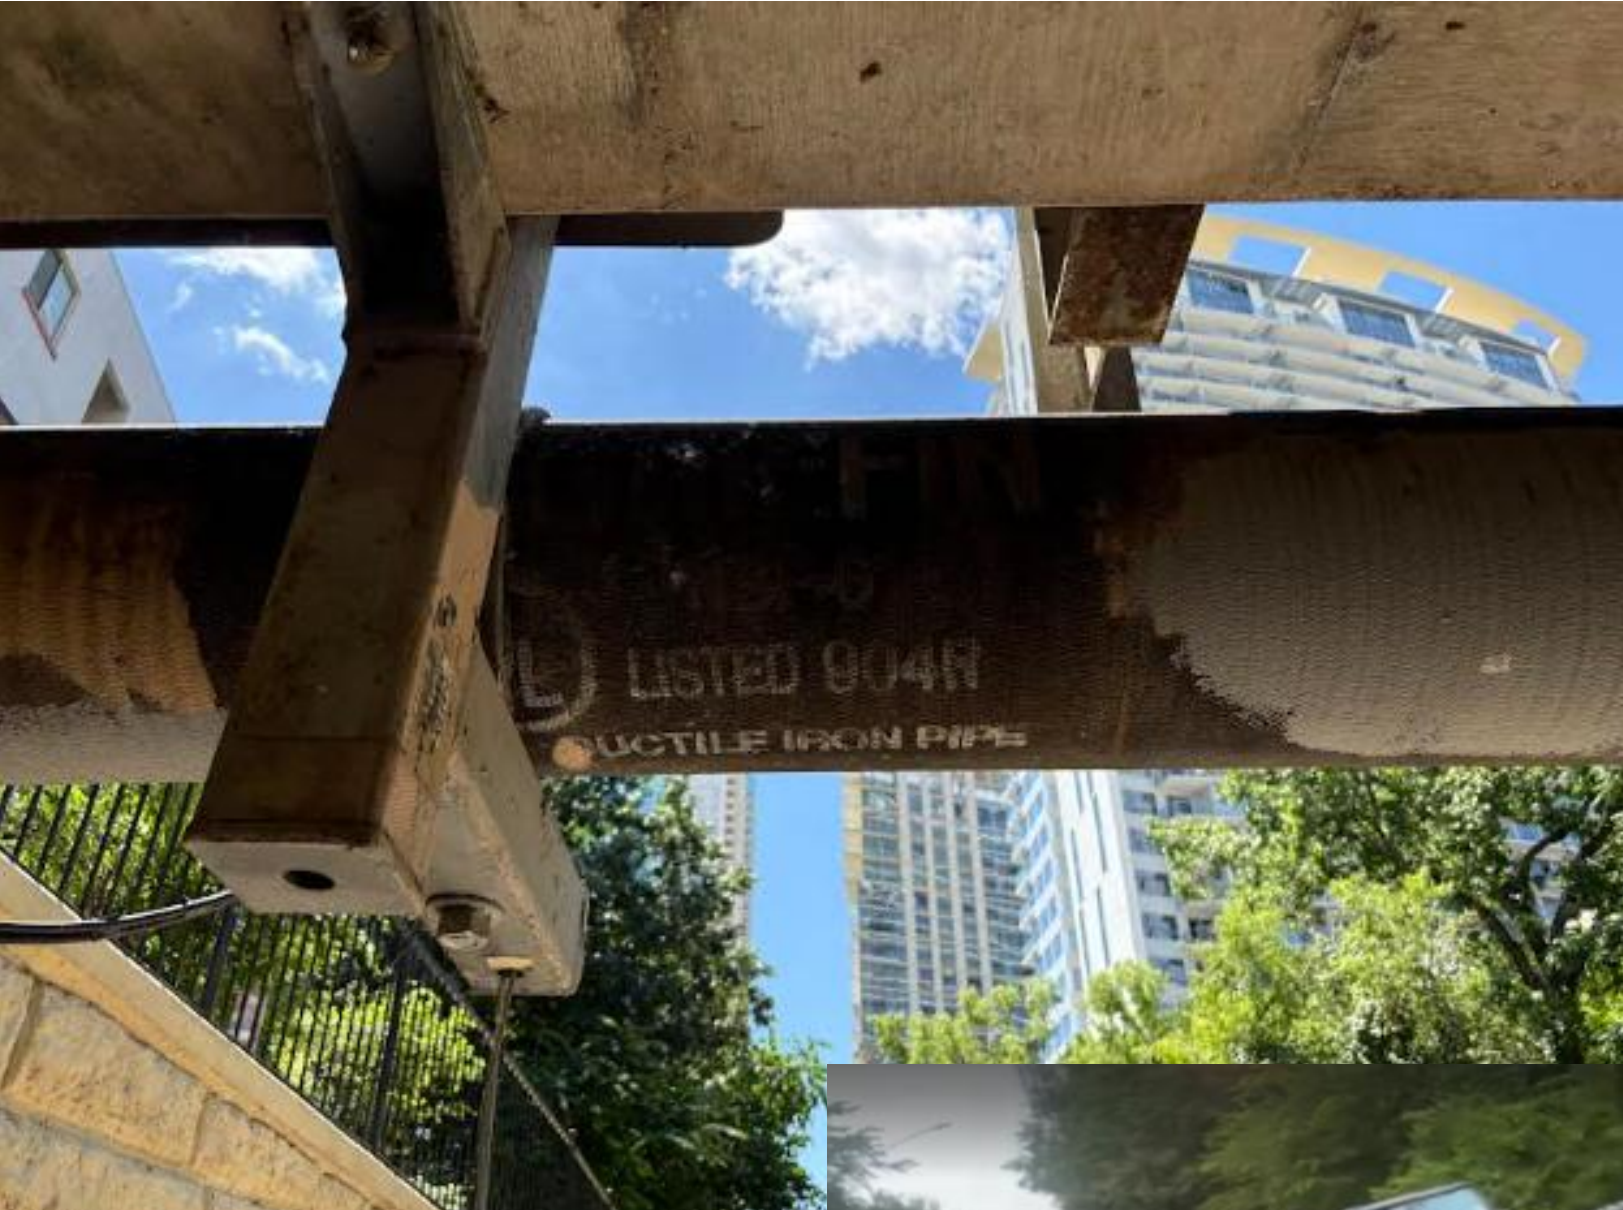
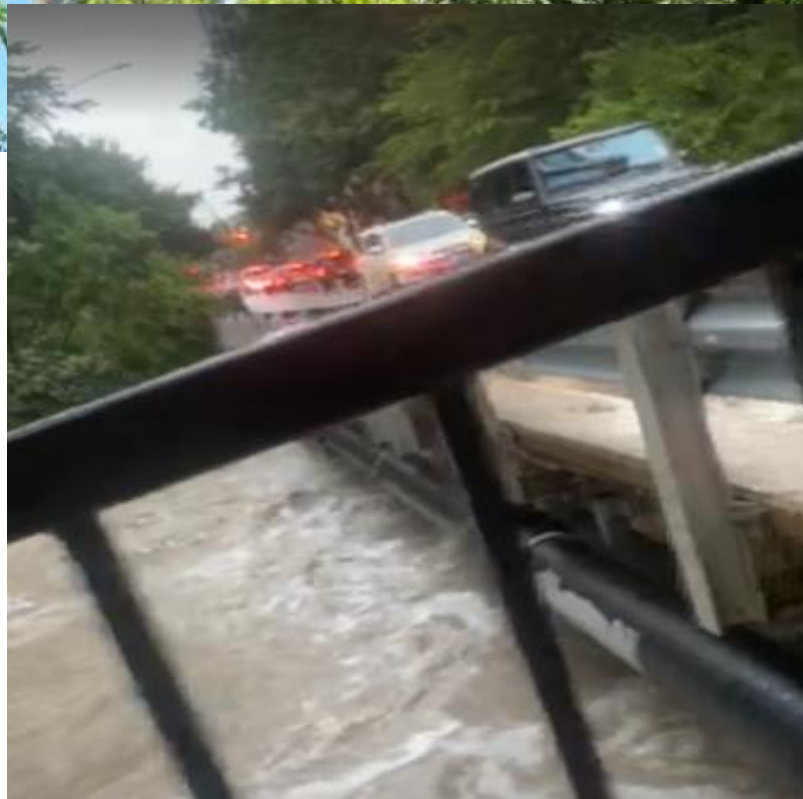
The bridge has what appears to be a pressurized utility drinking water pipe spanning directly in front of it. Based on what I've observed, the pipe could be susceptible to damage from flood debris.

Photographed right are the conditions the pipe was exposed to on August 22, 2026.

It could be supposed the pipe is designed to withstand impacts and debris collecting on it during floods. The concern here is drawn from breaches to Austin Energy utility pipe encasements at W 5 St from debris strikes. If this was a confirmed risk, an economical solution could be welding something akin to a steel shield in front of the pipe. Such a measure may also make sense for utility pipes at low lying bridges like the W 5 St bridge.

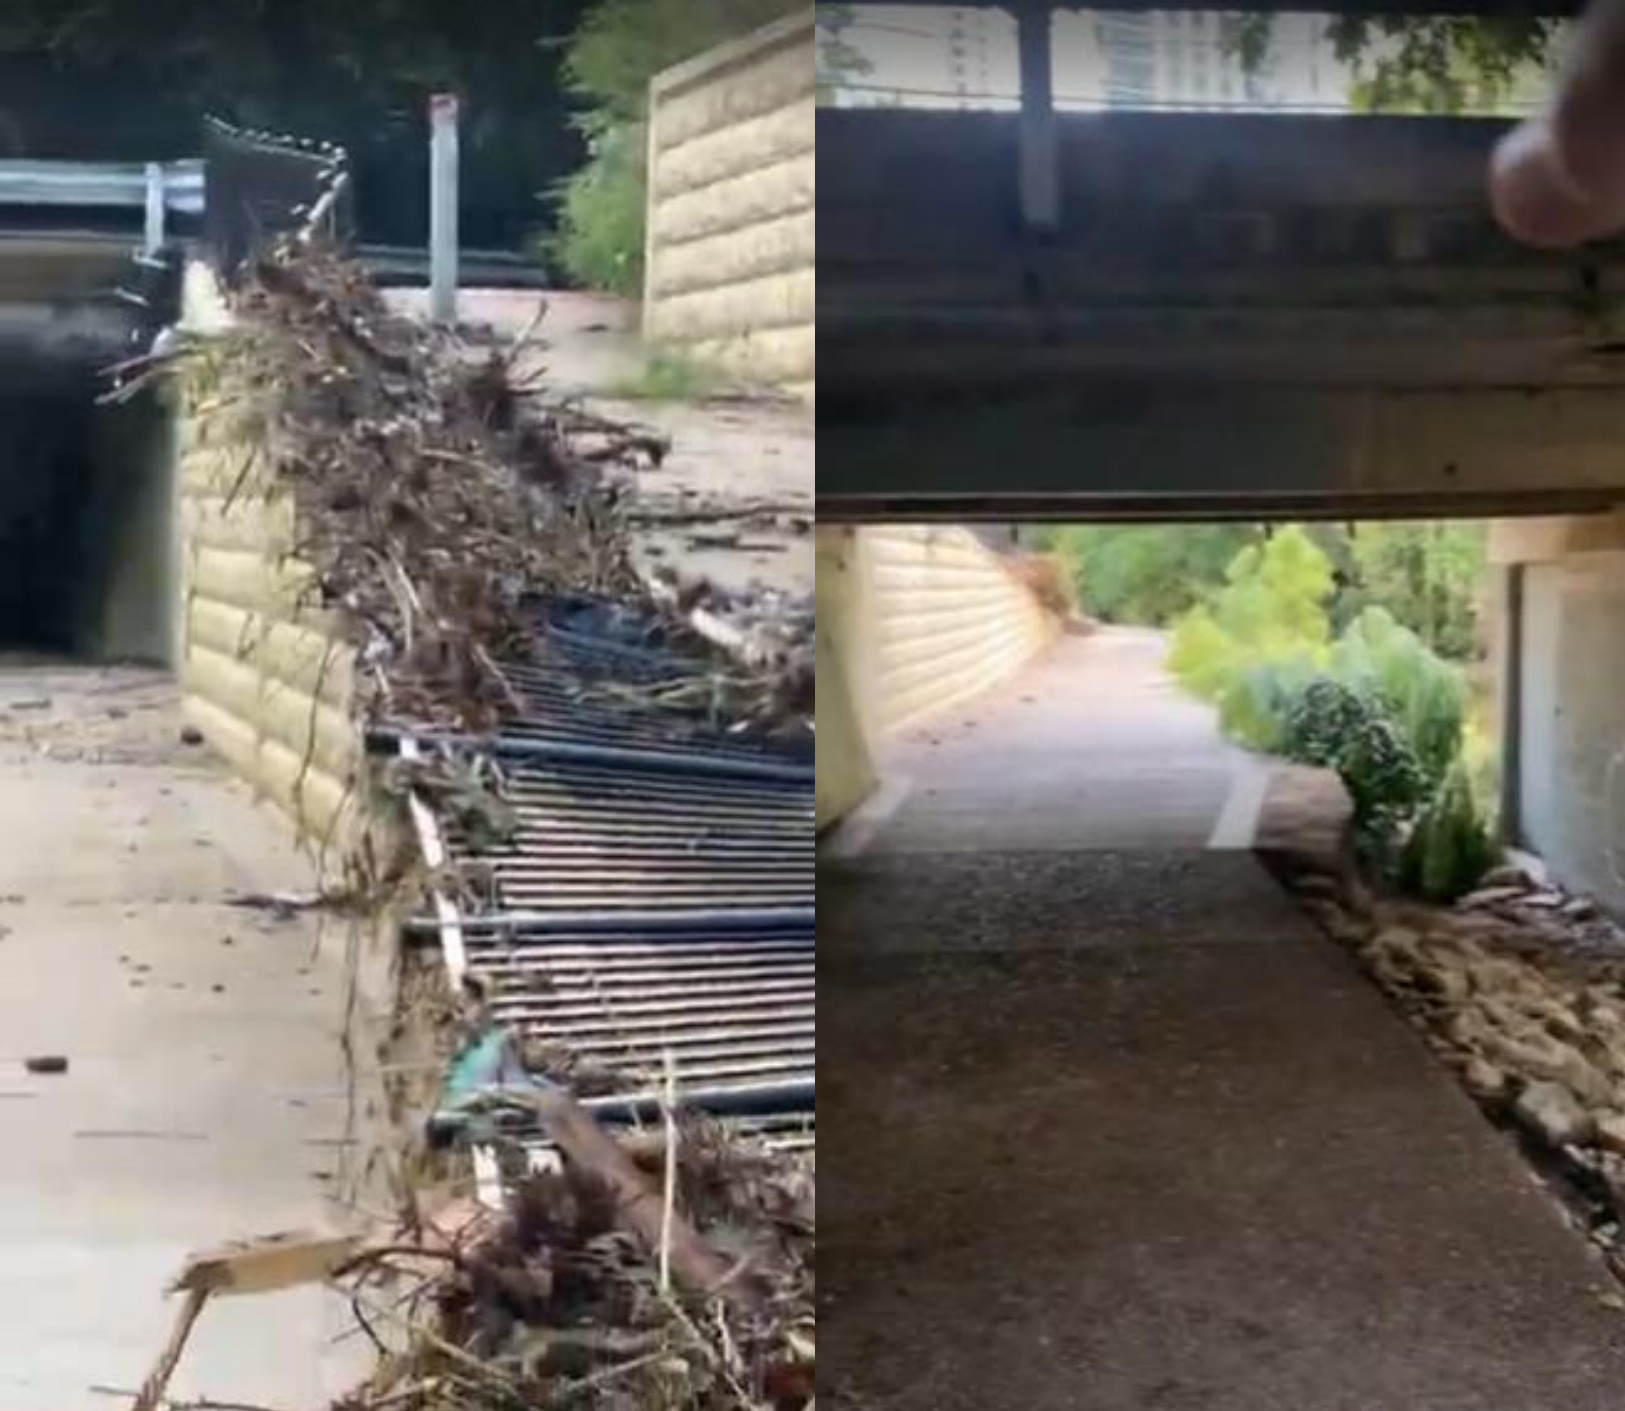
The flooding damaged the railing along the pathway ramp.

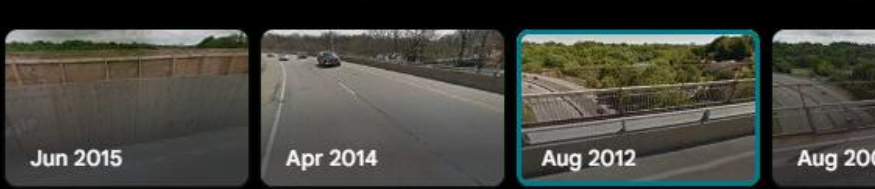
What is significant here, beyond my curiosity, is that had a bicyclist, drunk pedestrian or child fallen off the W 6 St bridge, a strong liability claim against the City of Austin and/or State could have been devised by a talented attorney. The approximately 28-inch guardrail could not have reasonably prevented children from easily climbing under or over it, and its short height could not have reasonably prevented people from toppling over it if they moved into it without balance. The guardrail was not to height code (generally 42 inches), especially given the hazard next to it. The matter could be seen as moot now given the bridge was restored in 2024, *if not for the principle*.

The screen capture of the two men walking along the W 6 St bridge in 2024 shows how the guardrail was below their pocket and could not reasonably prevent them from falling over the guardrail if they moved towards it without balance.

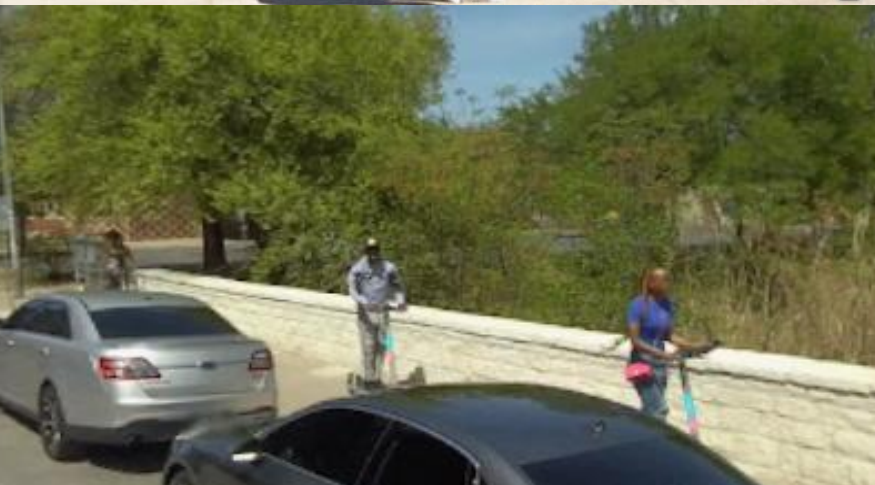
The bottom screen capture shows the height disparity between the north and south W 6 St bridge pedestrian safety measures.

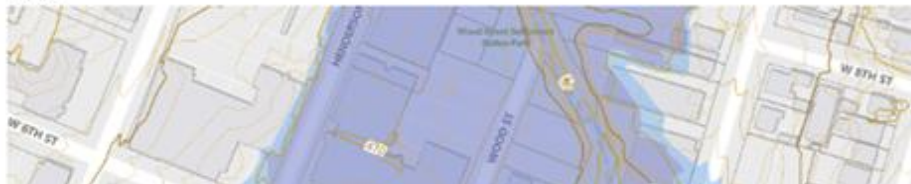
For instance, here is a screenshot of one of your areas of interest around 6<sup>th</sup> Street. This shows that the bridge is expected to overtop and the floodplain is about 400' wide.
