**AIRCRAFT  
ACCIDENT  
REPORT**  
**Trans World Airlines Flight 800**  
**Part I**  
**Consideration of Reasonable Probable Causes**

**Report on the accident to  
Trans World Airlines Flight 800  
Boeing 747-131, N93119  
Near East Moriches, New York  
July 17, 1996  
by John Barry Smith,  
Independent Aircraft Accident Investigator**

## **Part I: Consideration of Reasonable Probable Causes**

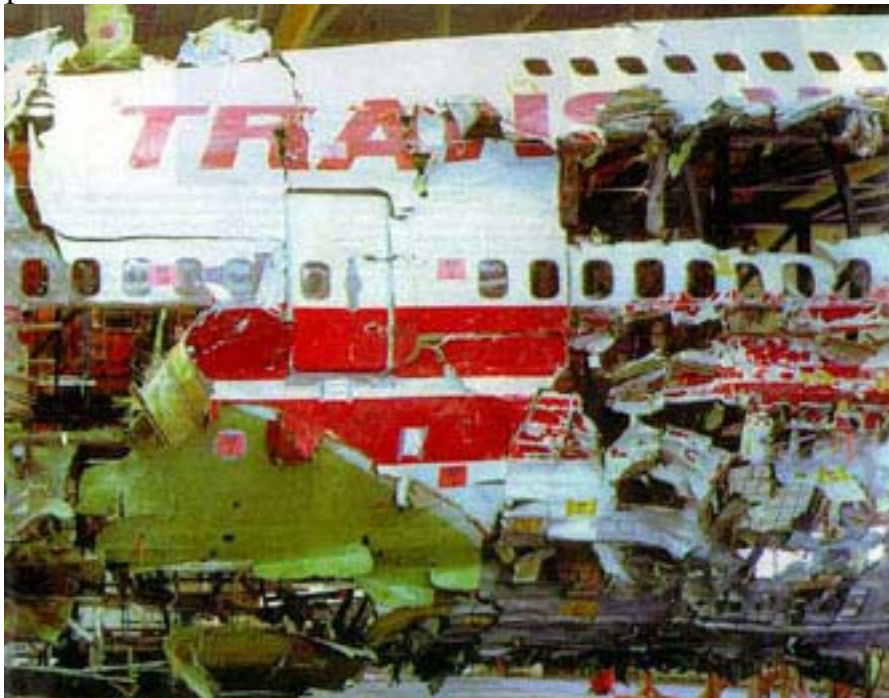
Above/previous page is a NTSB photograph of the wreckage reconstruction of Trans World Airlines Flight 800 starboard side over and forward of the wing. Fuselage station 600 is to the right extending to fuselage station 960 to the left in the photograph. A little over half of the forward cargo door is the shattered area in the lower right hand section. An outward opening petal shaped rupture can be seen at the aft midspan latch of the forward cargo door. The mildly damaged right hand, number two passenger door is in the middle left of the photograph.

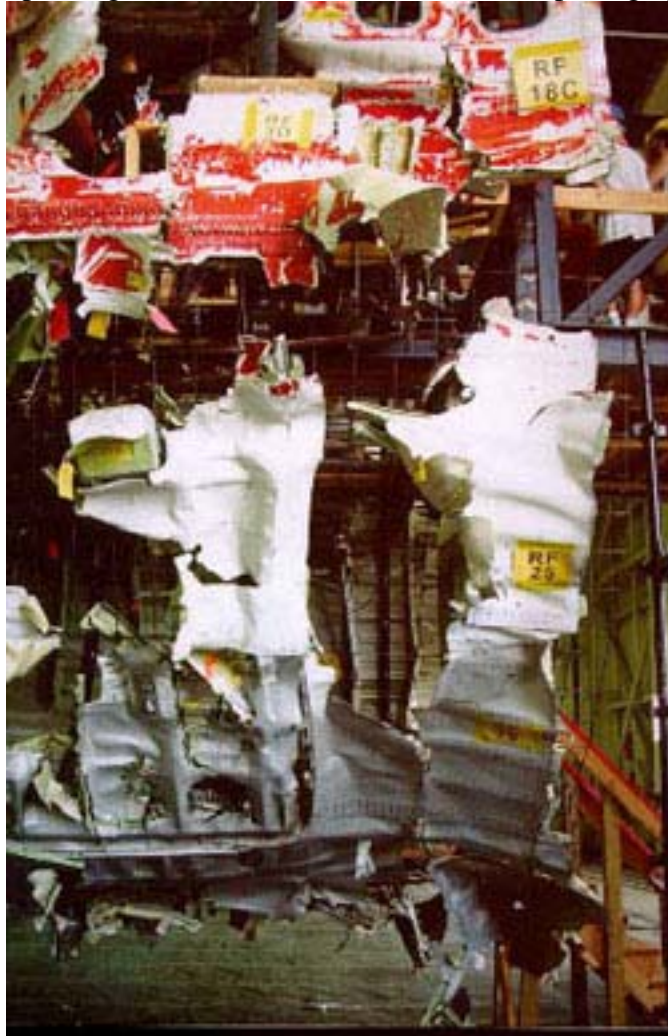
Above is a closeup photograph of about a half of the Trans World Airlines Flight 800 forward cargo door extending from fuselage station 520 on the right to fuselage station 620 to the left in the photograph. The cargo door hinge is in red near the top of the photograph. The outward opening petal shaped oval rupture is located at the forward midspan latch of the forward cargo door.

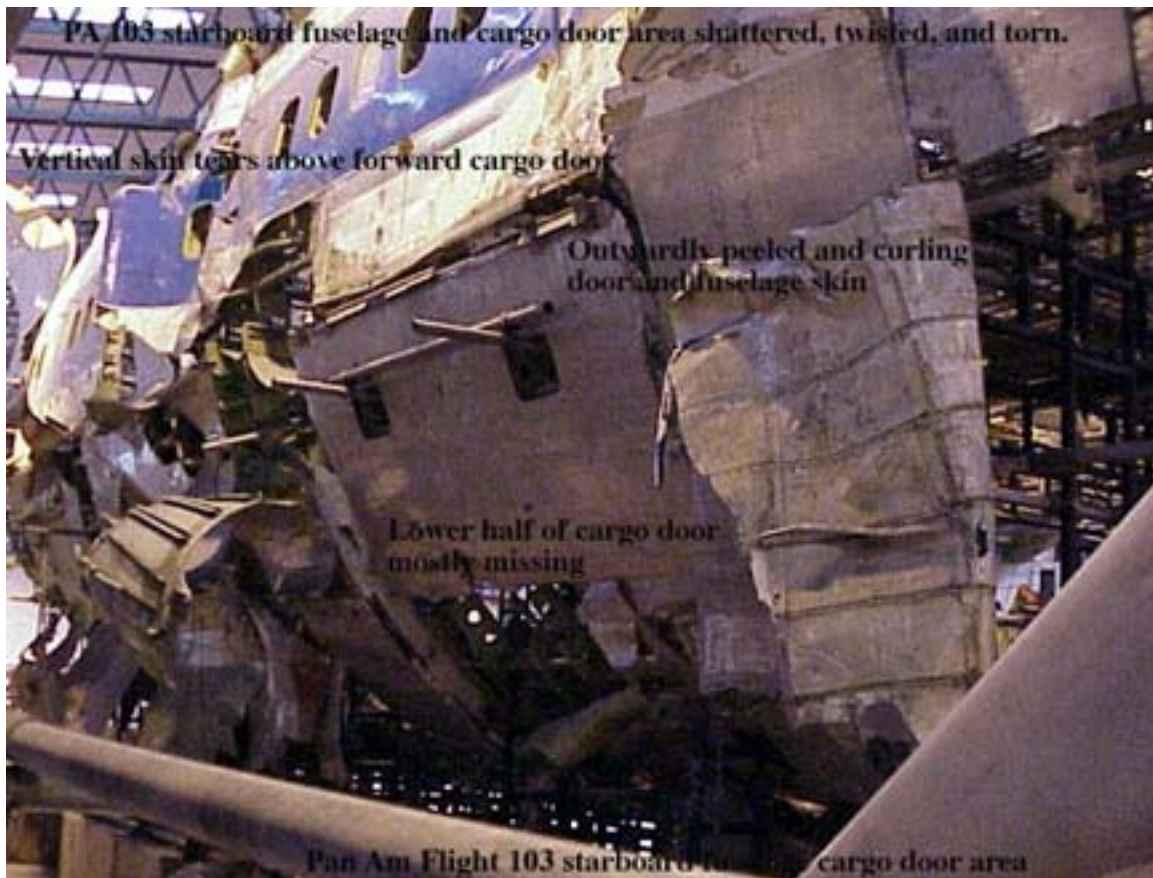
Above AAIB photograph of forward cargo door area of Pan Am Flight 103 shows the peeled back skin, vertical tear lines, and general shattered appearance.

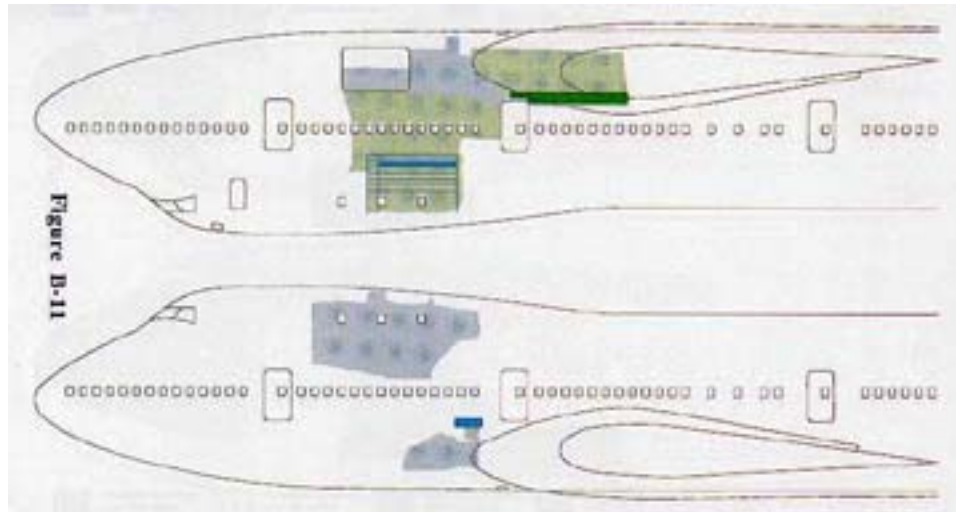
Above drawing from Figure B-11 of the AAIB report shows the large amounts of fuselage skin around the forward cargo door (top drawing) torn away at initial event time while on the port side (bottom drawing) at the same time, only a few pieces are torn off. The dark blue rectangle is the very small 'bomb explosion' shatter zone which is purported to have caused the aircraft to break in two.

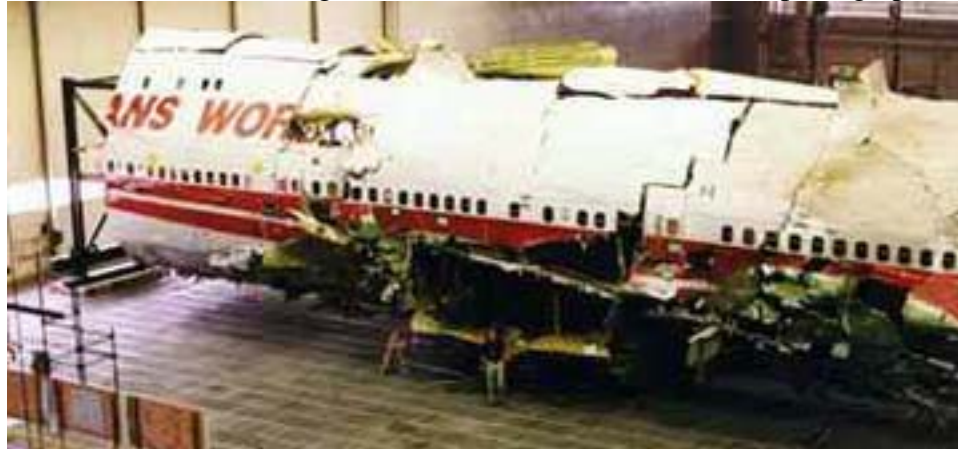
Above photograph shows the smooth port side forward of the wing (nose to left in photograph), while directly opposite the starboard side is shattered and torn. There was no inflight damage to engines Nos. 1 or 2, both on the port side of the aircraft.

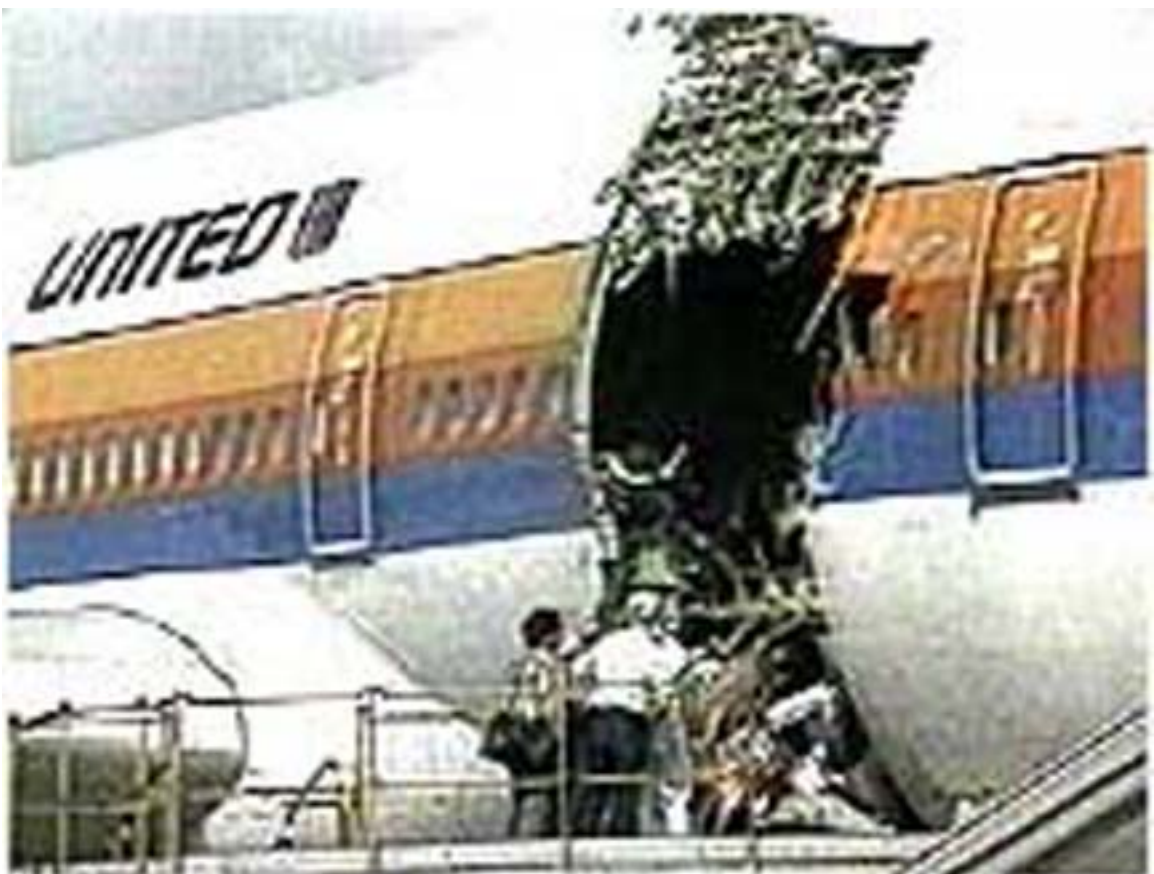
Photo of hole in United Airlines Flight 811 made by inadvertent opening of forward cargo door in flight.

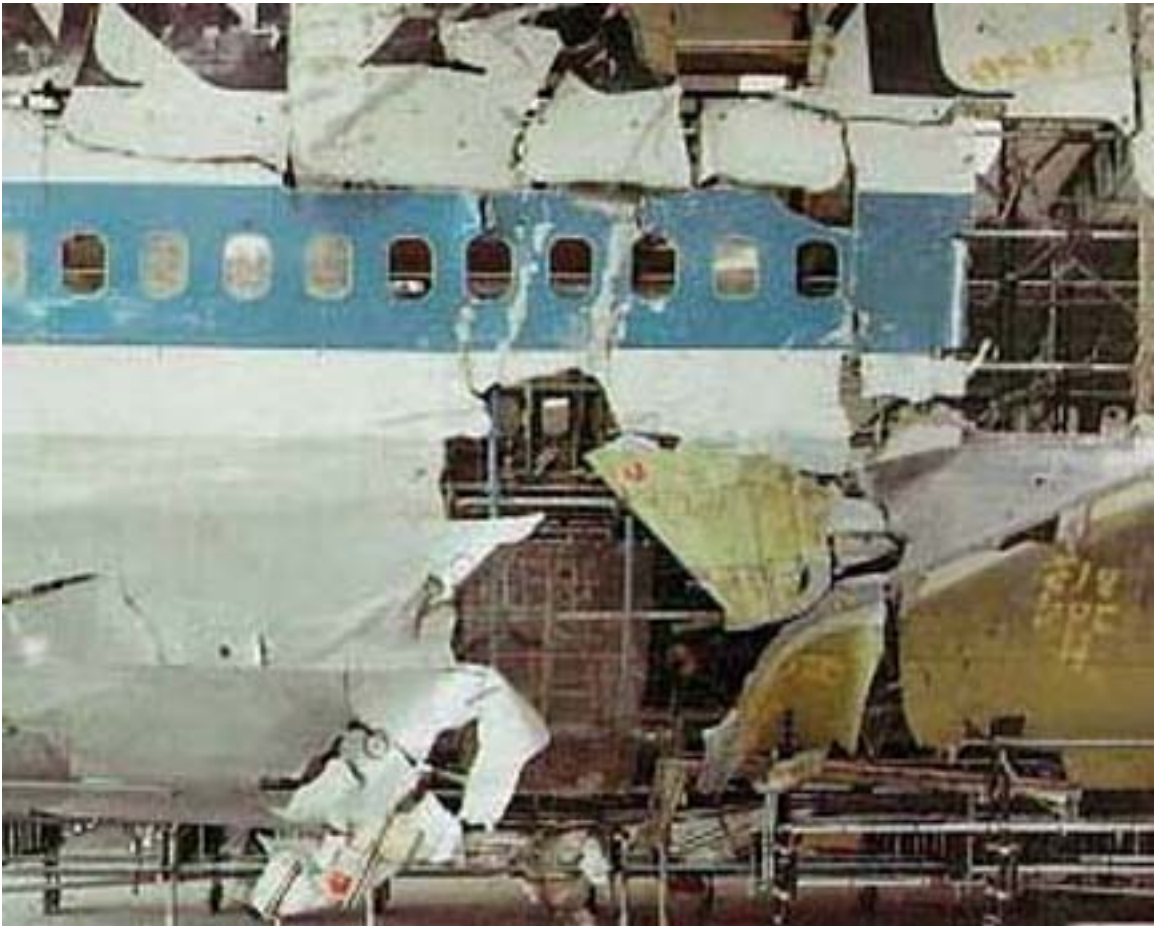
Port side of Pan Am Flight 103 forward of the wing showing the small 'bomb' hole and relatively smooth and intact fuselage skin around it.

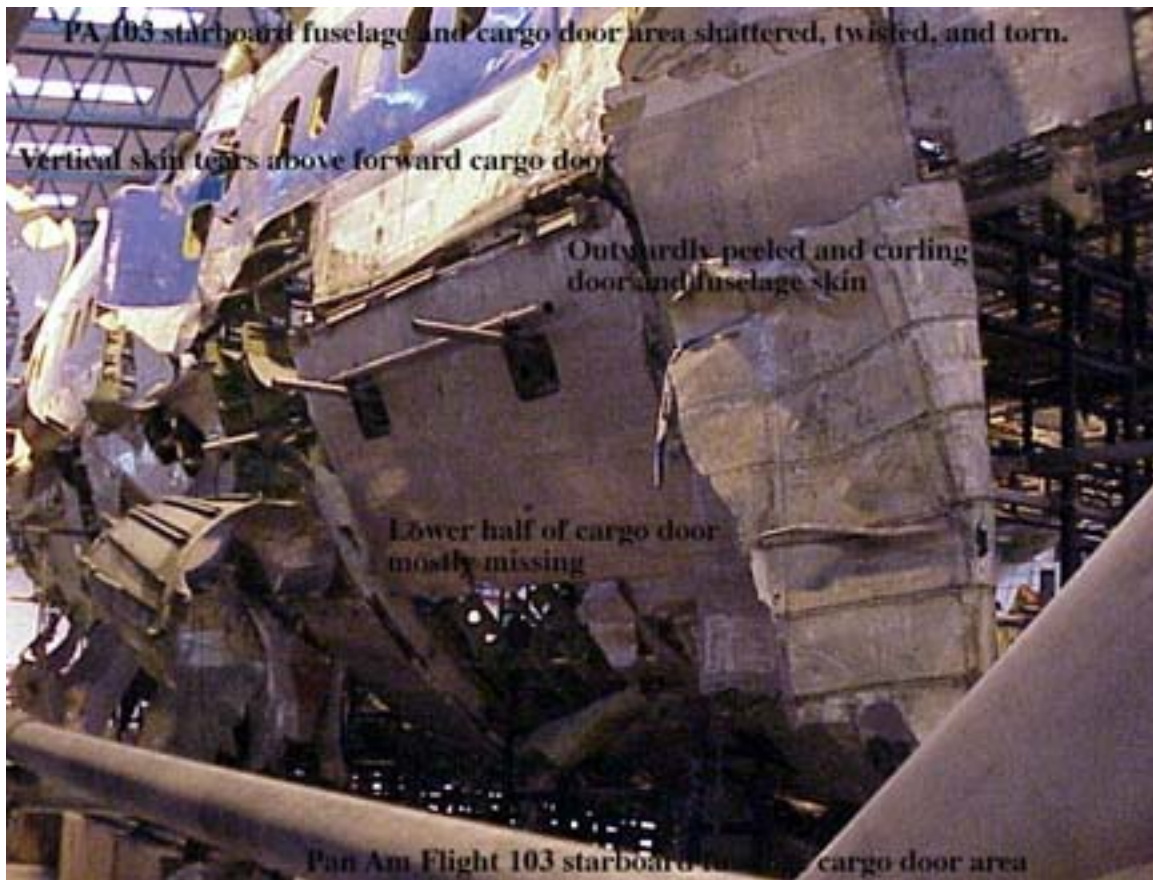
Photograph from AAIB showing Pan Am Flight 103 forward cargo door area revealing the vertical torn skin above door, peeled back and down skin from the aft midspan latch, generally shattered area, and mostly missing lower half of door which includes the manual locking handle and the eight bottom latches.

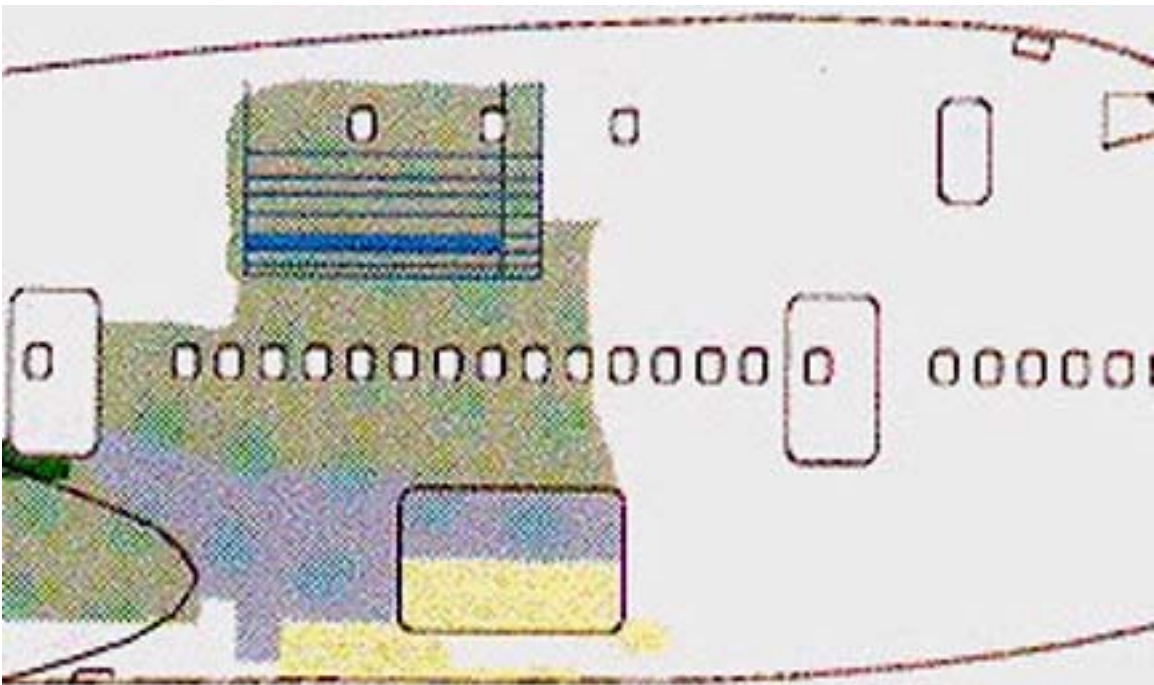
Reconstruction drawing from the AAIB 2/90 report on Pan Am Flight 103 showing the large area of torn off skin around the forward cargo door, the longitudinal split of the door, and the vertical tearing of the skin above the door.

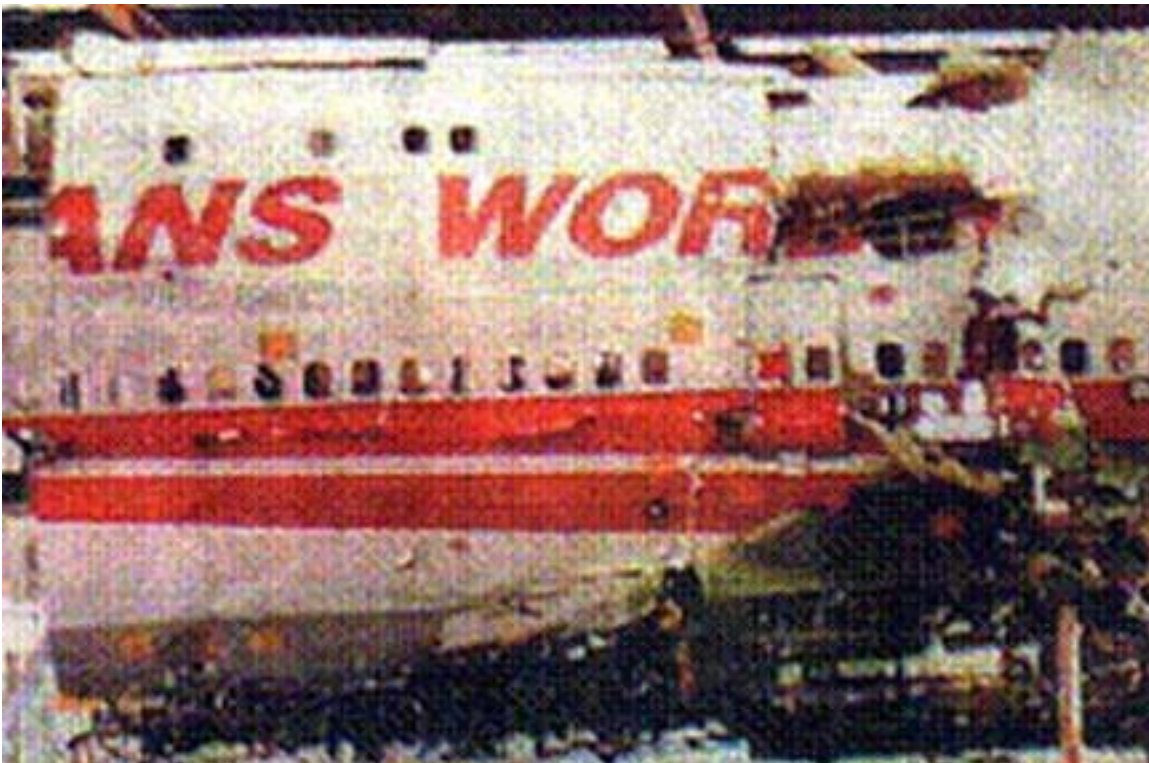
Photograph of the port side of Trans World Airlines Flight 800 showing the relatively undamaged skin forward of the wing, nose to left.

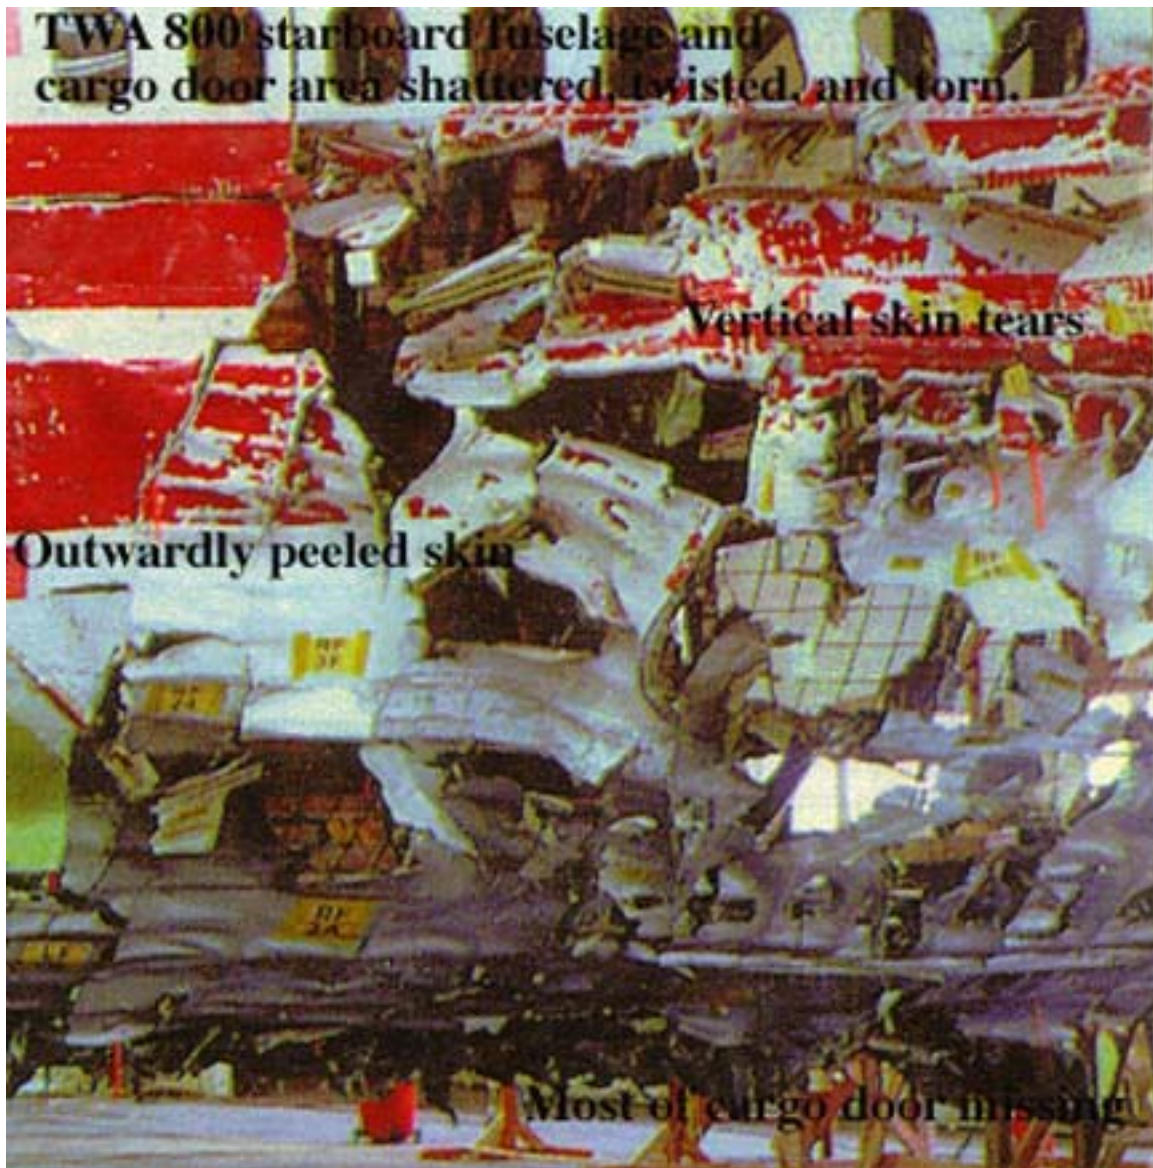
Shattered starboard side around forward cargo door of Trans World Airlines Flight 800 revealing outwardly and petaled shaped skin around aft midspan latch.

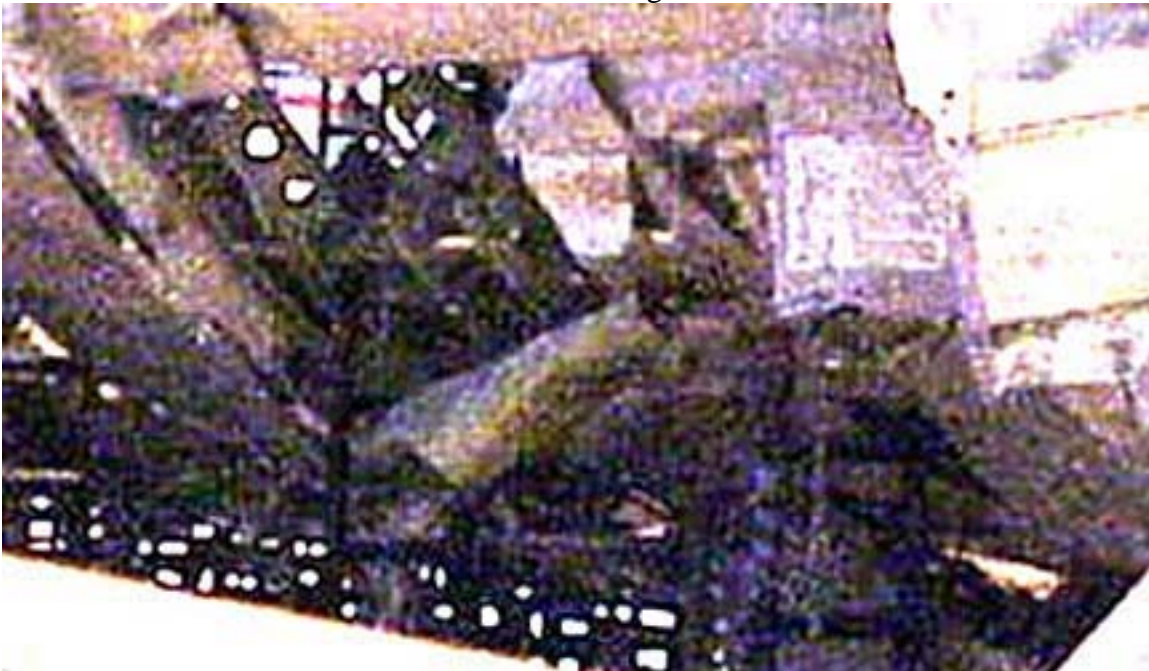
Closeup of the peeled back and down skin from the aft midspan latch of PA 103 forward cargo door.

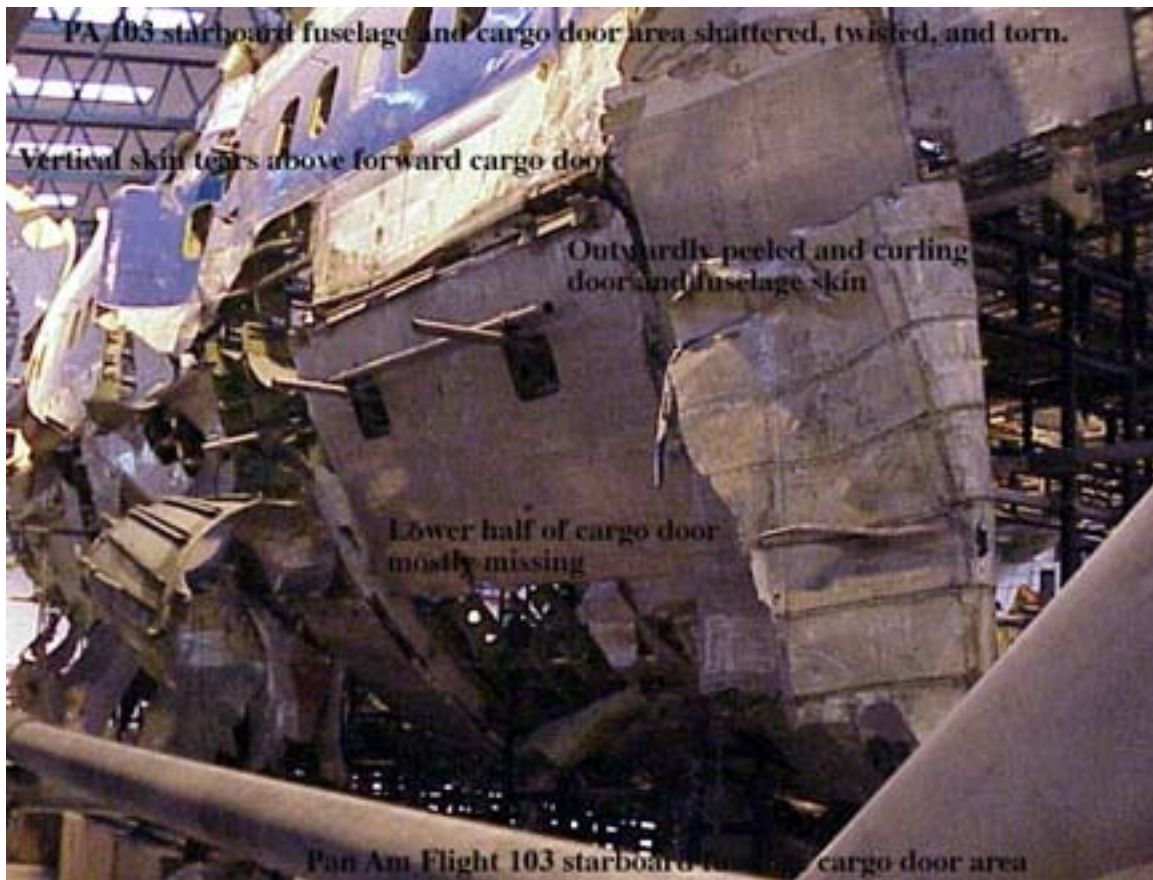
Photograph from AAIB showing Pan Am Flight 103 forward cargo door area revealing the vertical torn skin above door, peeled back and down skin from the aft midspan latch, generally shattered area, and mostly missing lower half of door which includes the manual locking handle and the eight bottom latches.

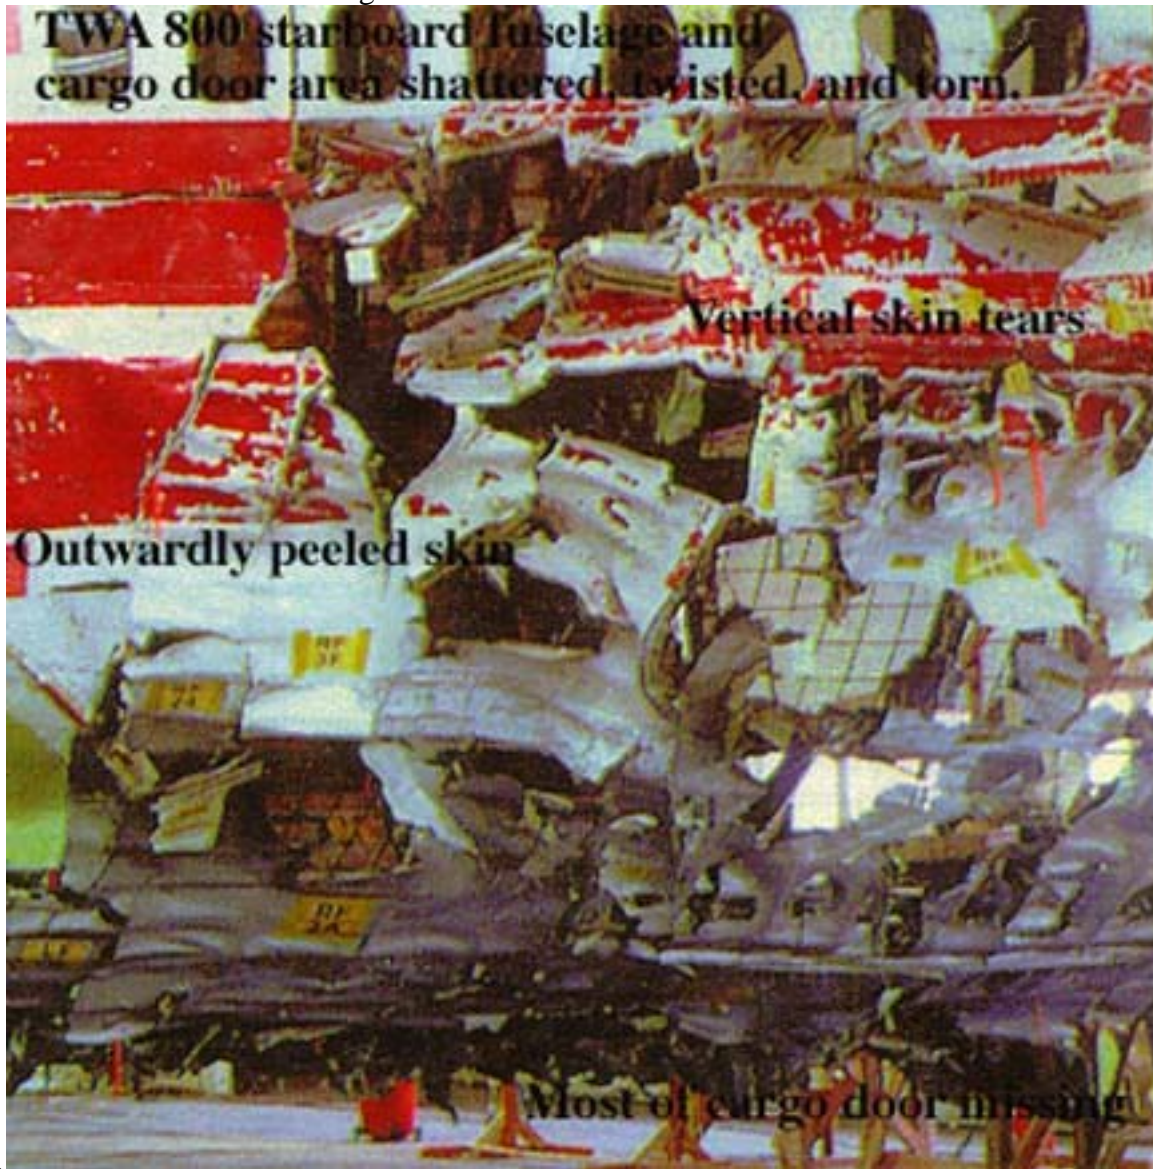
Shattered starboard side around forward cargo door of Trans World Airlines Flight 800 revealing outwardly and petaled shaped skin around aft midspan latch.

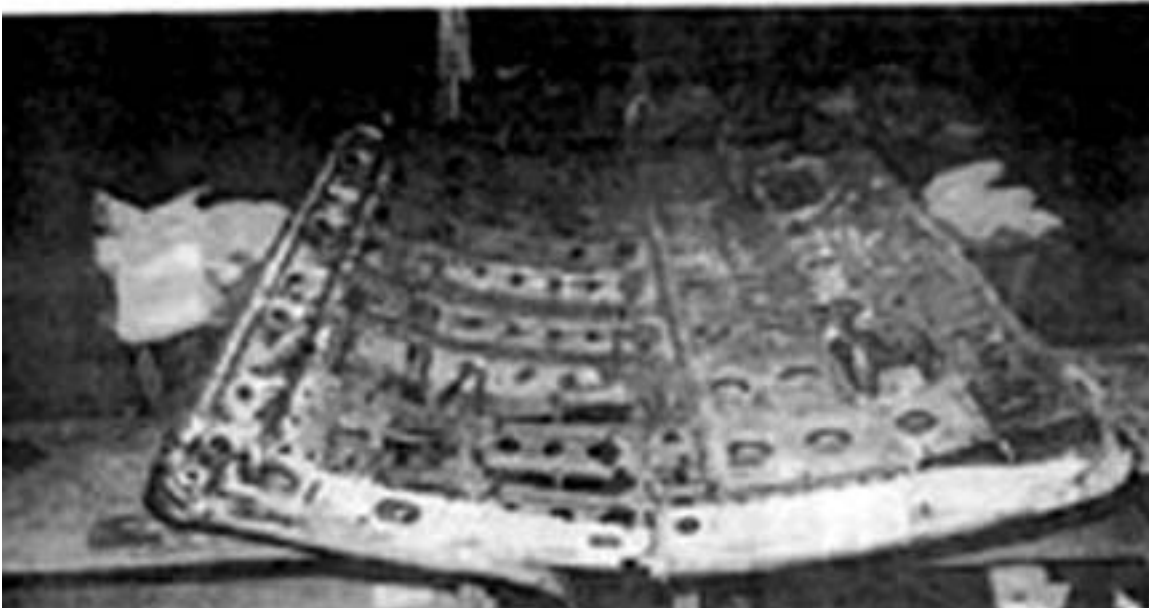
United Airlines Flight 811 forward cargo door showing missing aft pressure relief door and jammed open status of forward pressure relief door according to NTSB AAR 92/02.

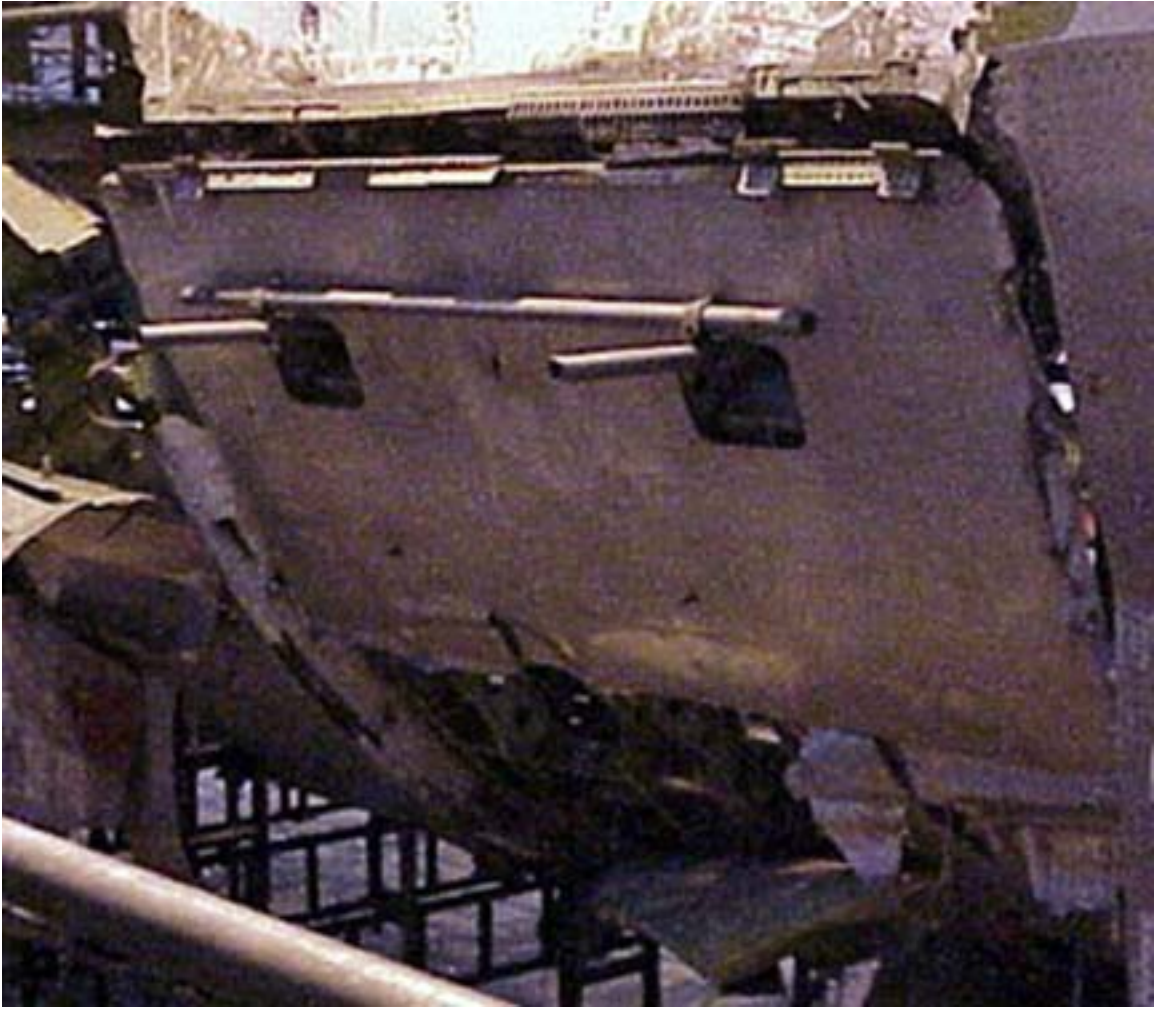
Pan Am Flight 103 Forward cargo door showing missing aft and forward pressure relief doors.

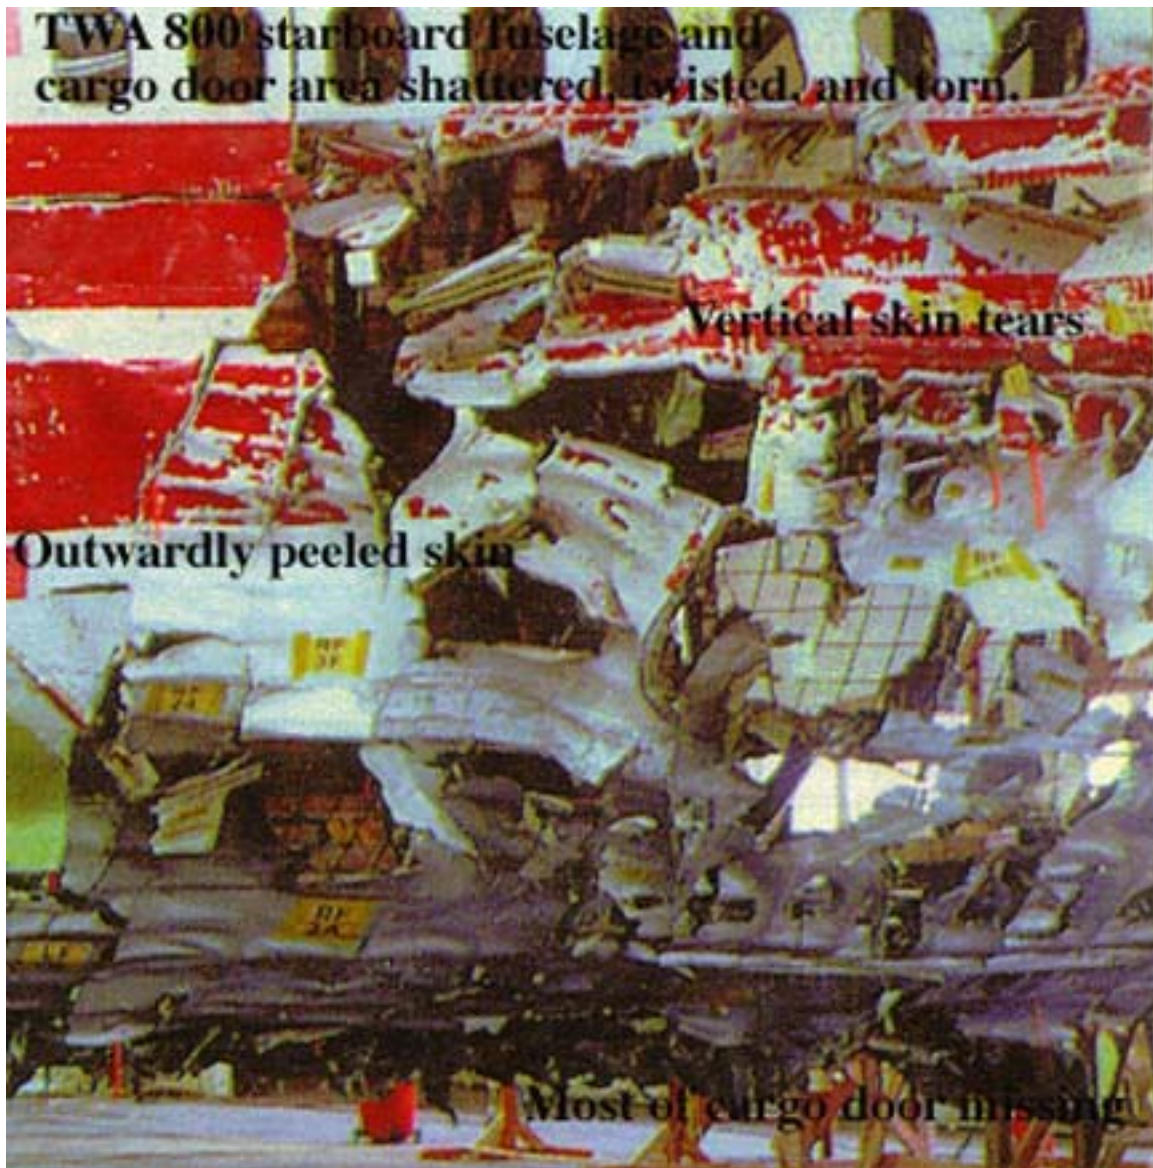
Trans World Airlines Flight 800 Forward cargo door showing missing aft pressure relief door.
