**MILESTONE INSPECTION –
PHASE I REPORT**

MiraVista Condominium – Building A
441 Quail Forest Boulevard
Naples, Collier County, Florida

SOCOTEC Project Number 6521-003.01

April 2023

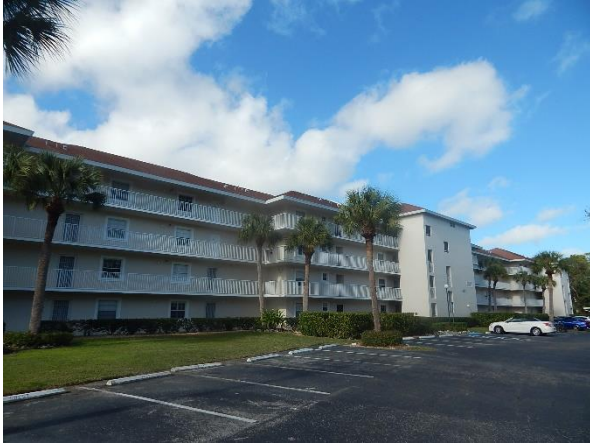
View of front of building.

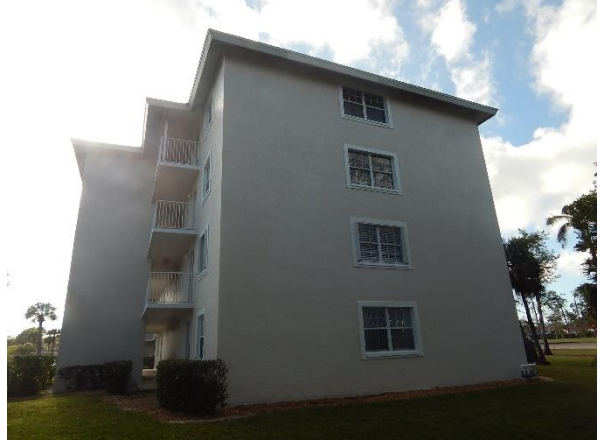
View of north elevation.

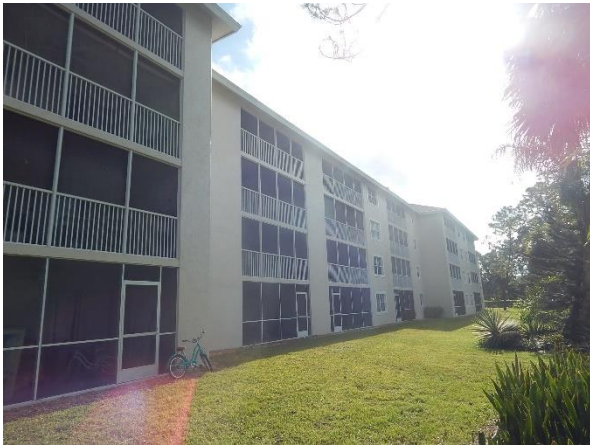
View of rear of building.

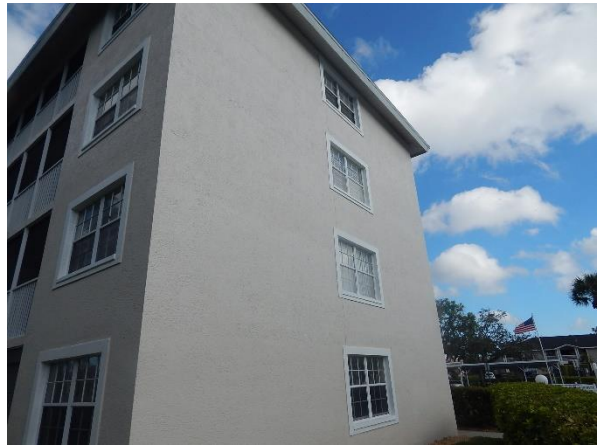
View of south elevation.

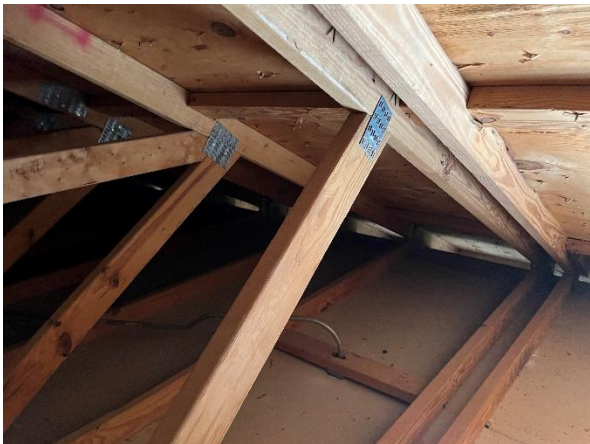
View of roof trusses and decking.

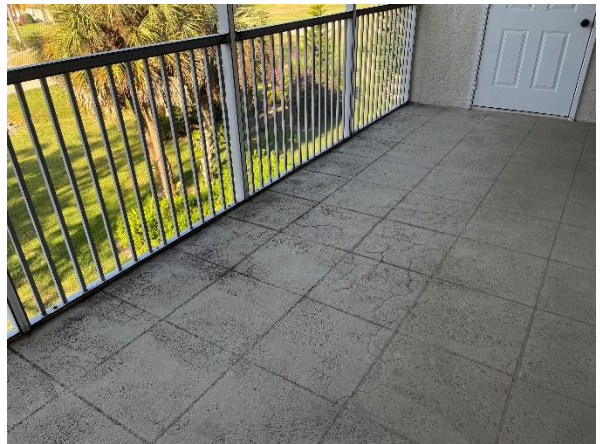
View of typical balcony.
