## County Home Inspection

**123 Sample Street**

Demo City, ST 12345

**1/15/2024 10:00AM**

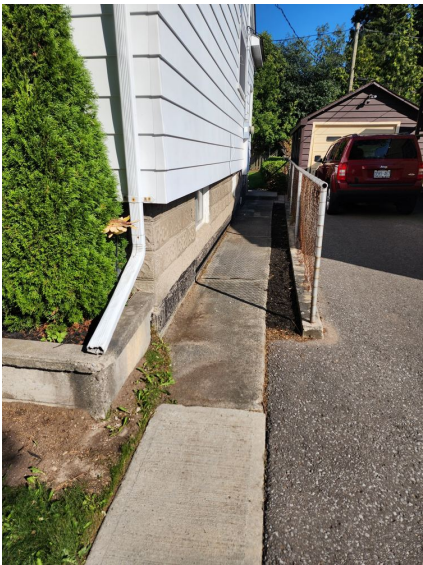
| <div>3.18 Landscaping</div> <div>Walkway: Improper slope or drainage</div> <div>Service: Improve</div> <div>Implication: Chance of water damage to structure, finishes and contents</div> <div>Location: Right elevation</div> <div>Estimated Cost: Minor</div> <div>Estimated Timeline: Discretionary</div> |

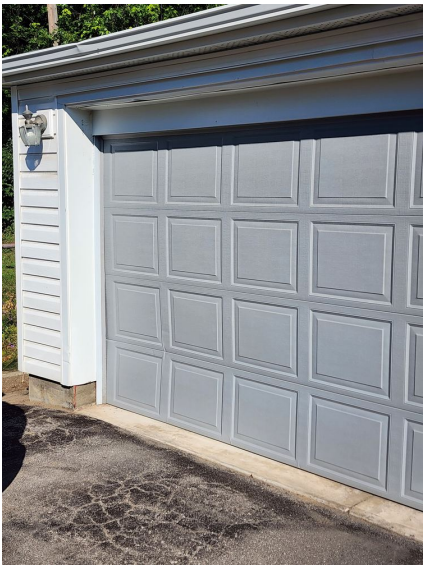
3.19 Garage

Vehicle doors: Dented

**Implication:** Damage to equipment

**Location:** Exterior

**Service:** Repair

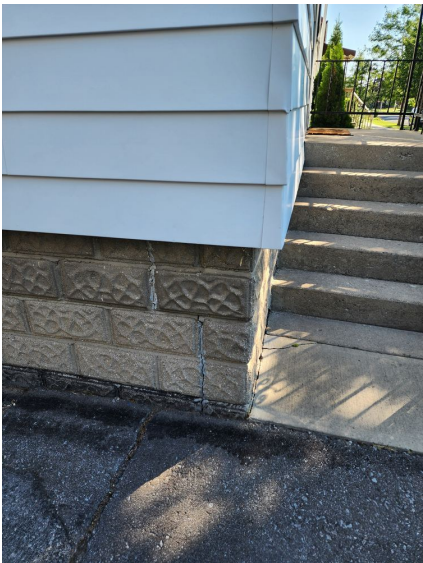
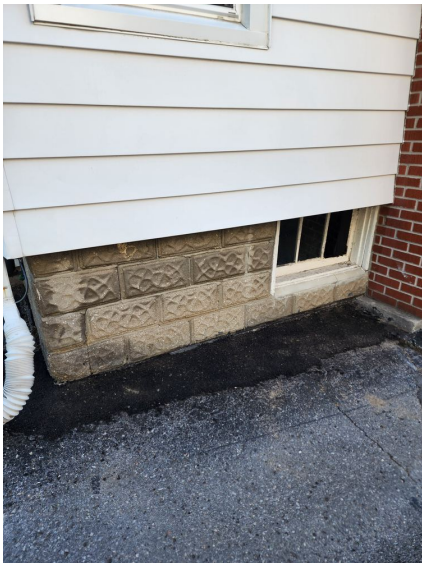
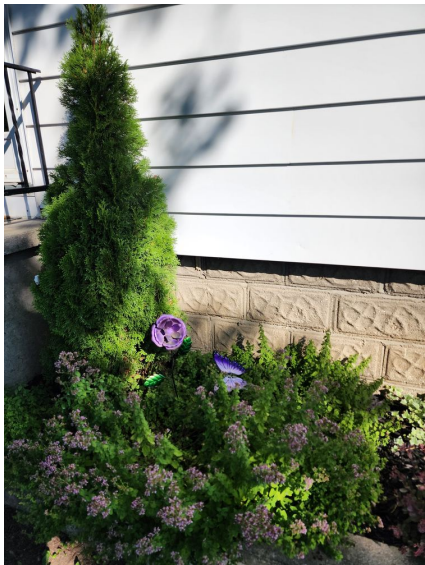
| <div>4.9 Foundations</div> <div>Typical minor cracks</div> <div>Implication: Material deterioration</div> <div>Location: Various Locations</div> <div>Estimated Cost: Minor</div> <div>Estimated Timeline: Discretionary</div> |

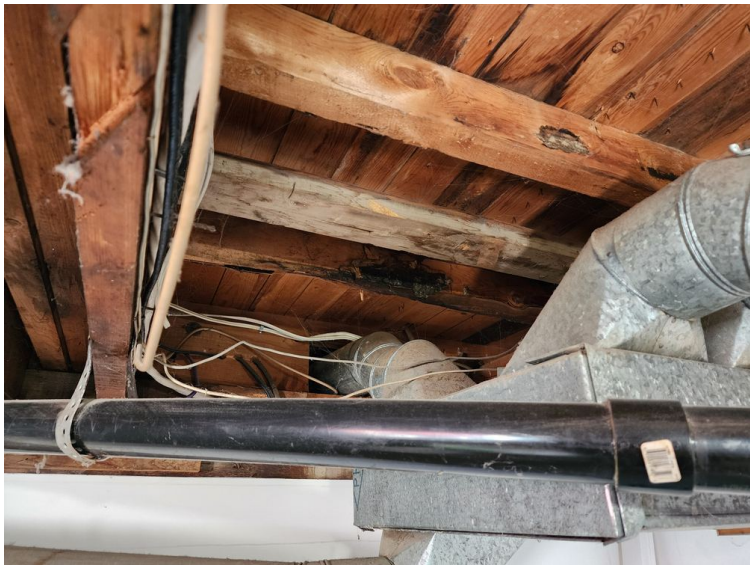
4.10 Floors

Joists: Split, cracked or damaged

**Implication:** Weakened structure | Chance of structural movement

**Location:** Utility room

**Service:** Repair or Replace

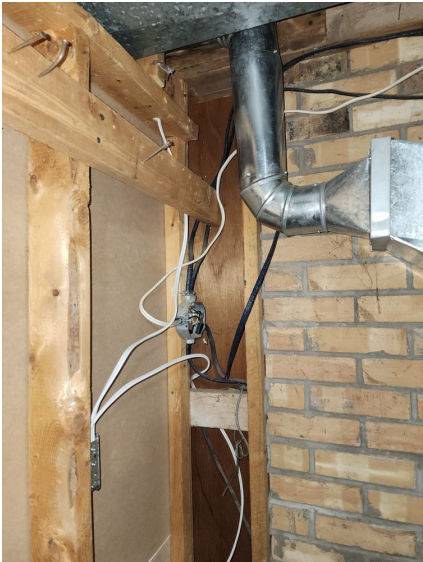
5.19 Distribution system

Junction boxes: Cover missing

**Implication:** Electric shock | Fire hazard

**Location:** Utility room

**Service:** Replace

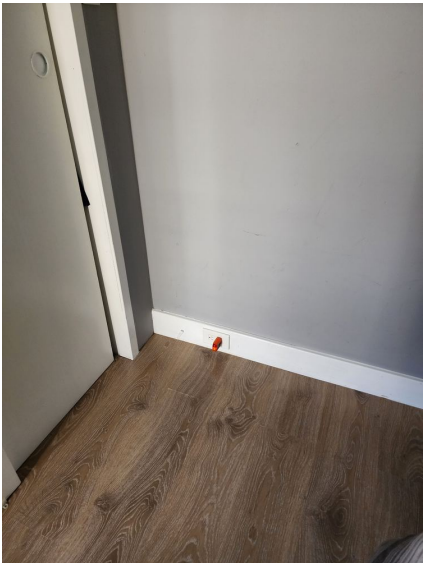
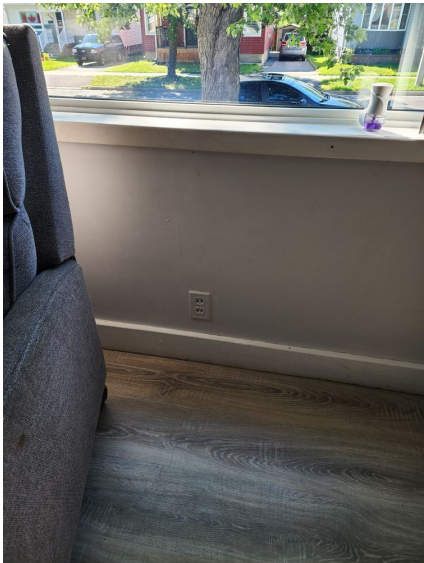
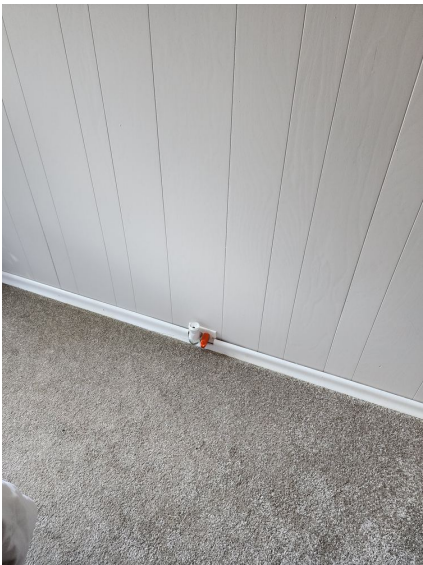
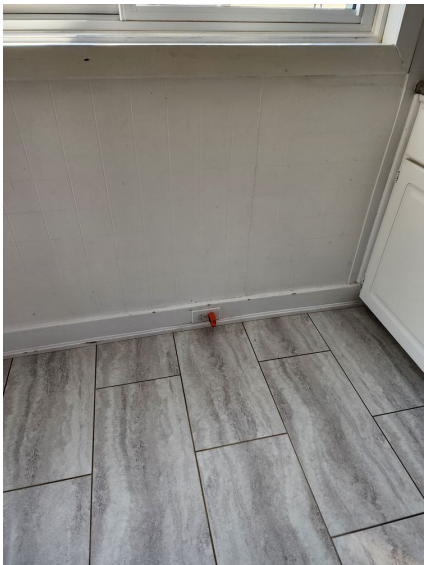
5.20 Distribution system

Outlets (receptacles): Ungrounded

**Implication:** Electric shock

Although ungrounded service maybe typical in a home of this age, safety may be improved by upgrading this receptacle.

**Service:** Upgrade

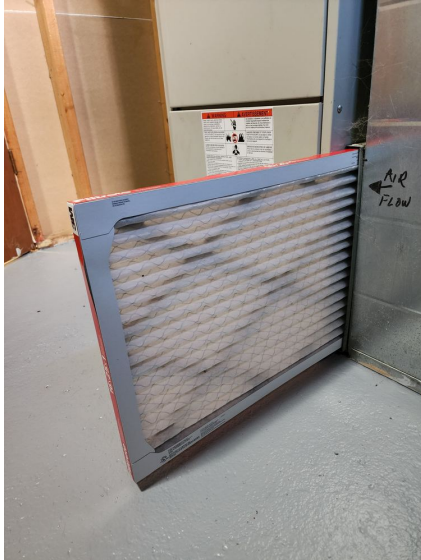
## 7.26 Gas furnace

**Mechanical air filter: Dirty**

Recommendations**Service:** Replace - Regular Maintenance**Implication:** Increased heating costs**Location:** Cold air return**Estimated Cost:** Minor**Estimated Timeline:** Regular maintenance

Replace - regular maintenance

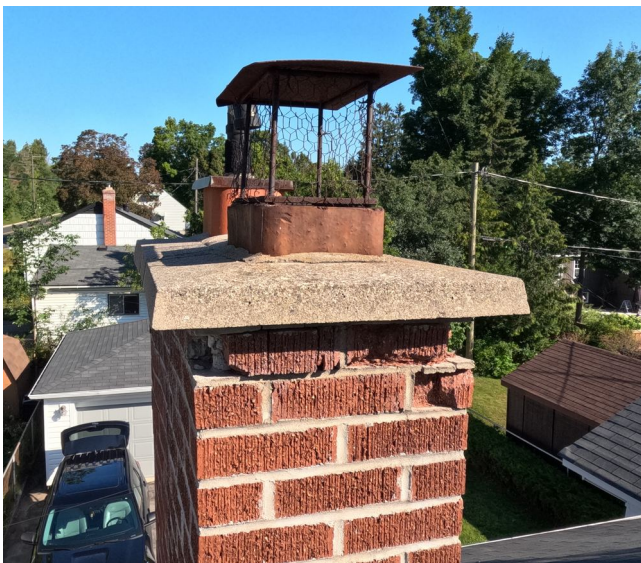
## 7.27 Chimney and vent

**Masonry chimney: Loose, missing or deteriorated masonry**

Recommendations**Service:** Repair**Implication:** Material deterioration**Location:** Exterior**Estimated Cost:** Minor**Estimated Timeline:** Discretionary

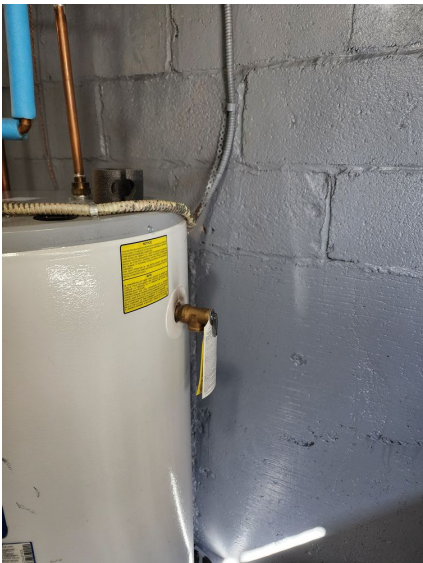
10.20 Water heater  
Temperature/pressure relief (TPR) valve: Discharge tube missing

Implication: Scalding. Possible water damage to finishes, storage and structure

Service: Replace

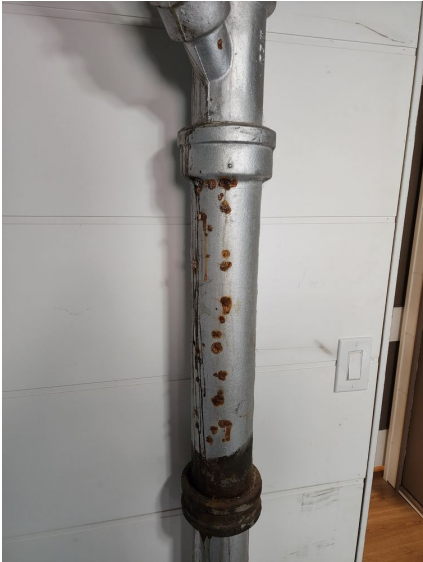
10.21 Waste plumbing

Drain piping - performance: Leak

Implication: Chance of water damage to structure, finishes and contents

Service: Repair or Replace

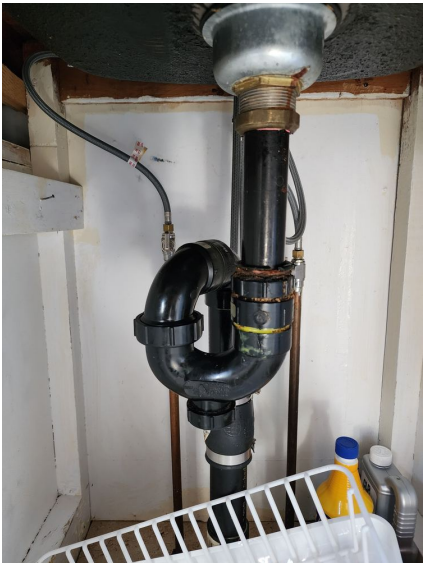
10.22 Waste plumbing

Traps - installation: Wrong type

Implication: Sewer gases entering the building

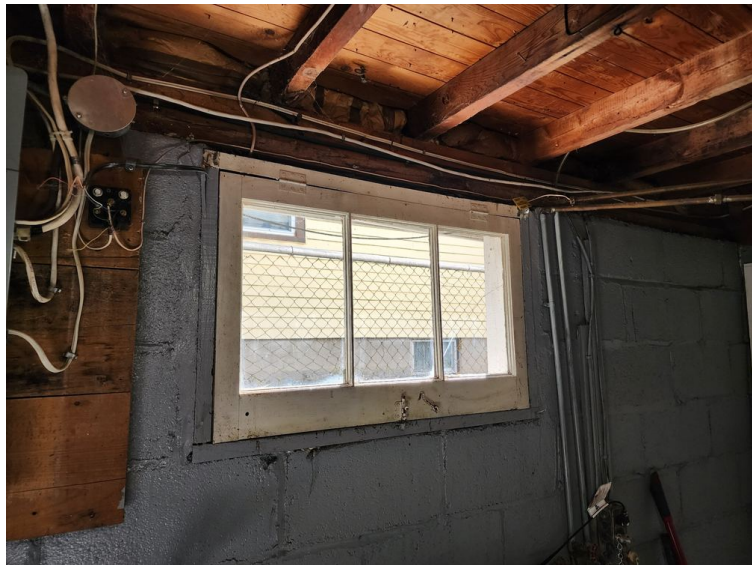
**Glass (glazing): Cracked**

**Service:** Replace

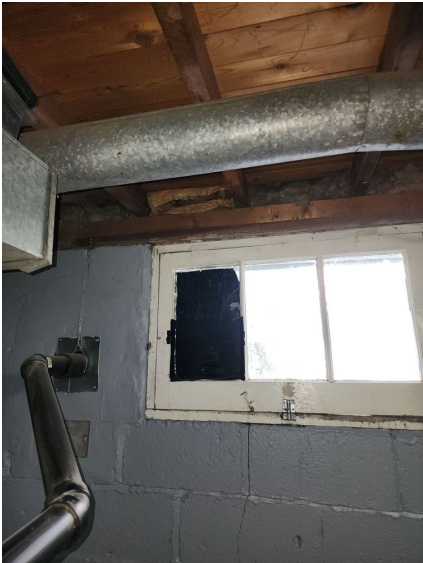
11.27 Windows

**Glass (glazing): Missing**

**Service:** Replace

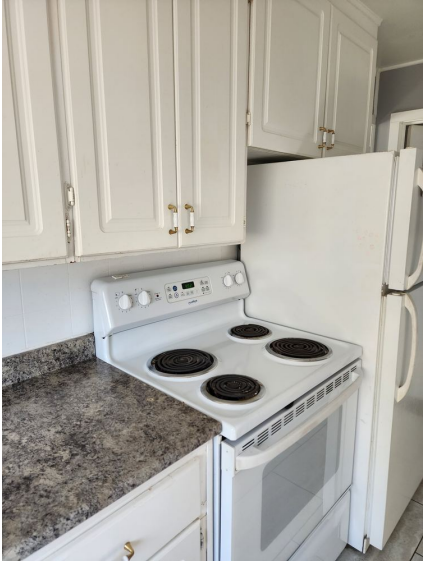
11.28 Appliances

Range: Combustible clearances inadequate

Implication: Fire hazard
