INSPECTION REPORT

123 Leafy Lane
HASTINGS, ON

Inspection Date: Monday, 5th January 2026

RE: Report No. 1366
123 Leafy Lane
Hastings, ON

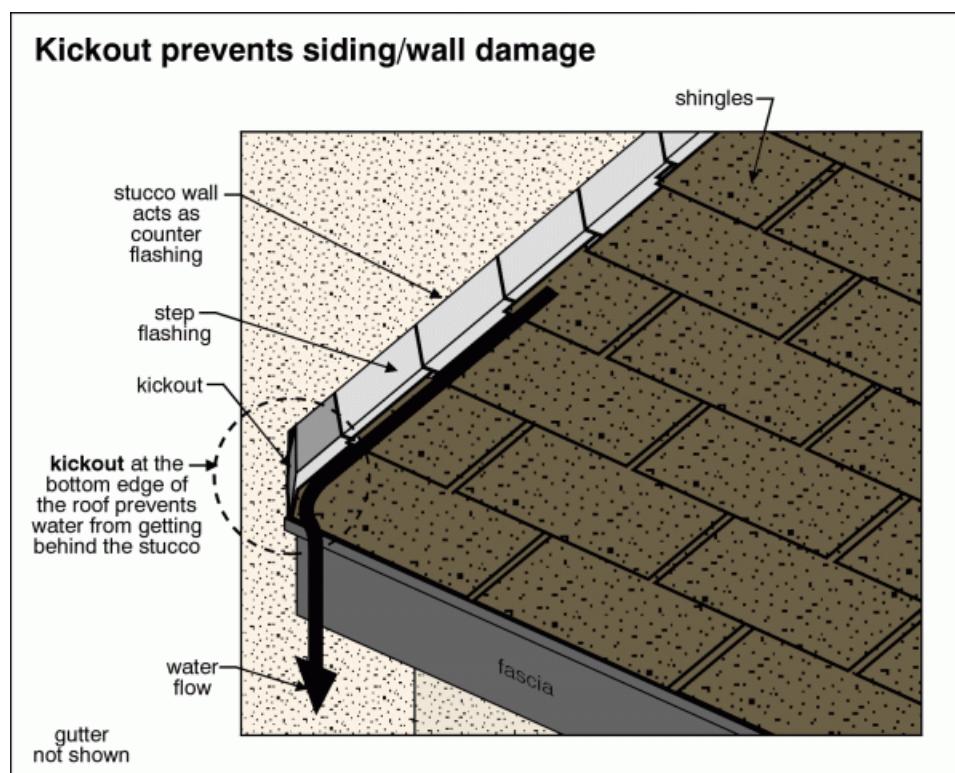
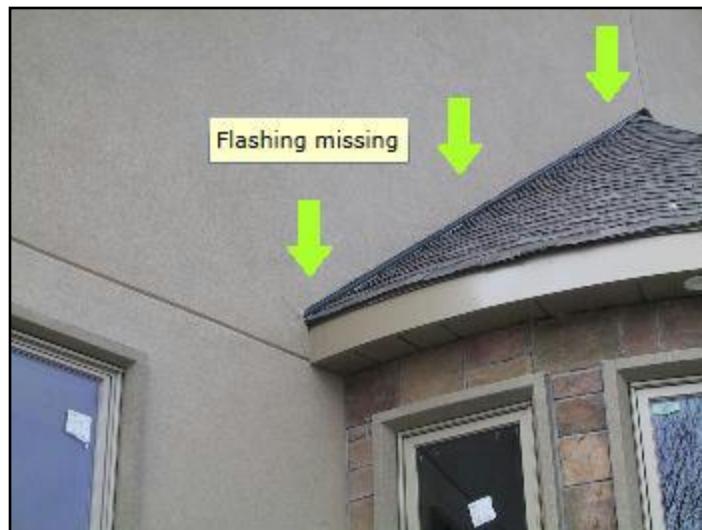
2. **Condition:** • [No kickout flashing](#)

Implication(s): Chance of water damage to contents, finishes and/or structure

Location: North First floor

1. No kickout flashing at roof/sidewall junction

Task: Improve

Time: Less than 1 year

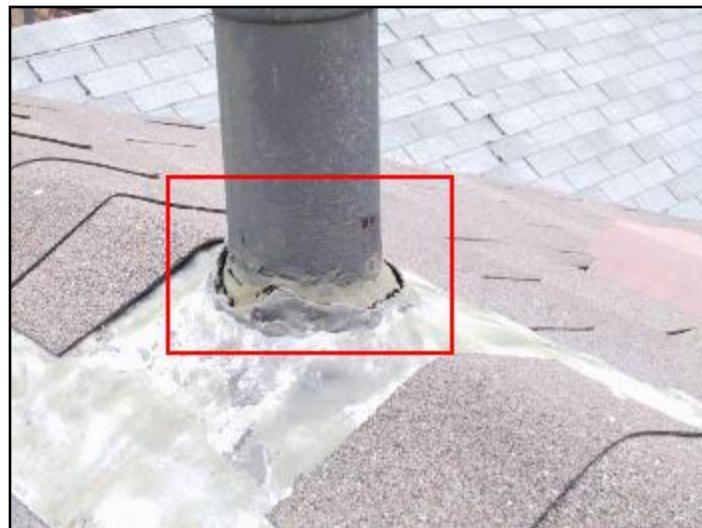
3. Condition: • Leak

Implication(s): Chance of water damage to contents, finishes and/or structure

Location: North

2. Leak

Task: Repair, immediate

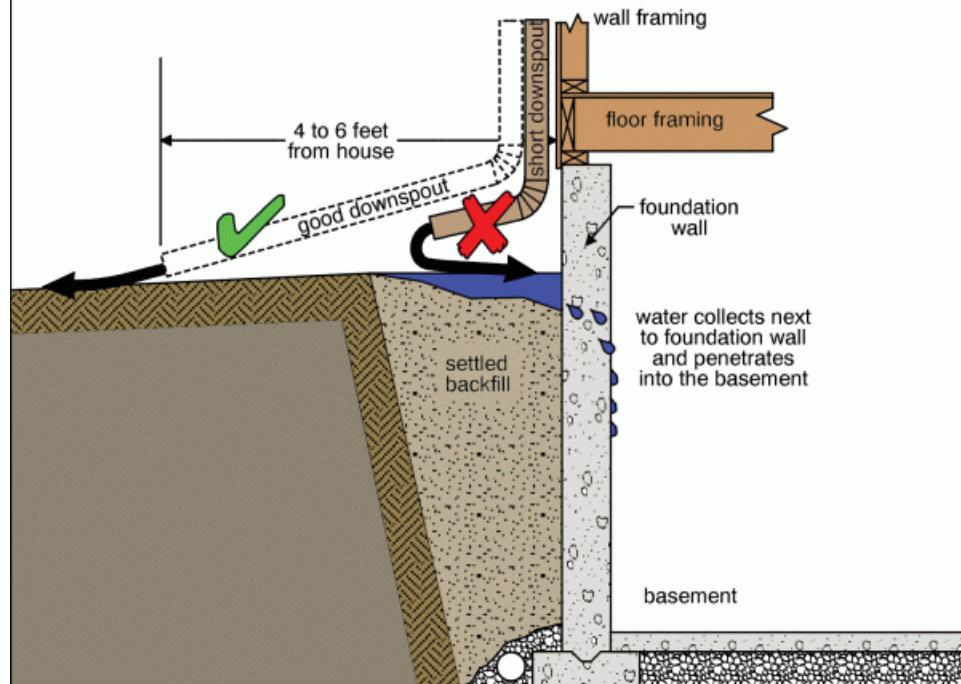
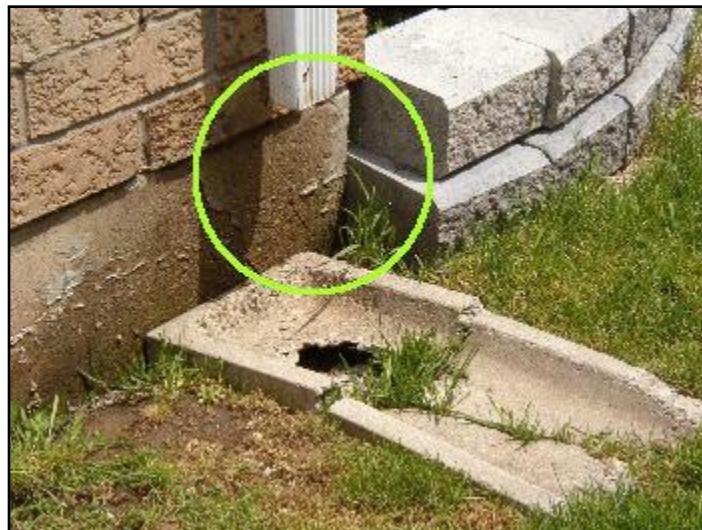
4. Condition: • [Downspouts end too close to building](#)

Implication(s): Chance of water damage to contents, finishes and/or structure

Location: East Exterior wall

Downspout extension too short

3. Downspout ends too close to building

The downspout should be extended to discharge at least 6 feet from the home. The splash block can be discarded.

Task: Improve

Time: Immediate

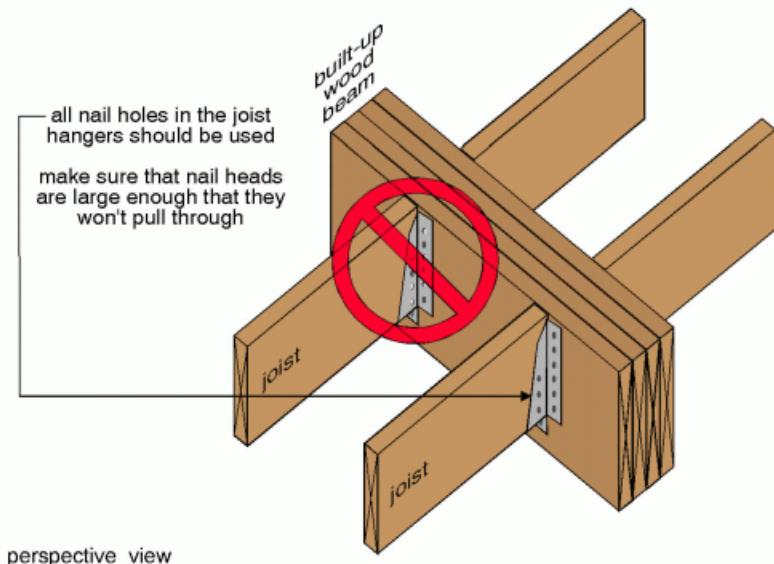
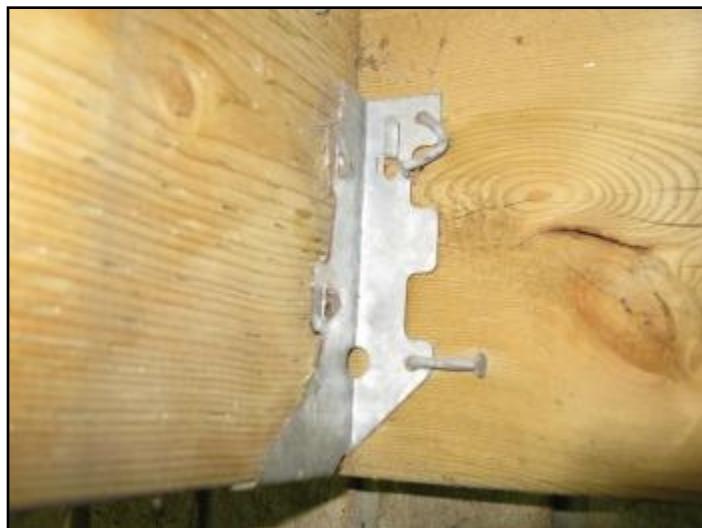
PORCHES, DECKS, STEPS, PATIOS AND BALCONIES \ Joists**5. Condition:** • Fastener problems

Joist hangers for wood deck are not properly nailed.

Implication(s): Weakened structure | Chance of movement

Location: North Exterior Wall

Watch for insufficient nails in joist hangers

4. Poor end bearing, joist hanger connections

Task: Improve

Time: Immediately

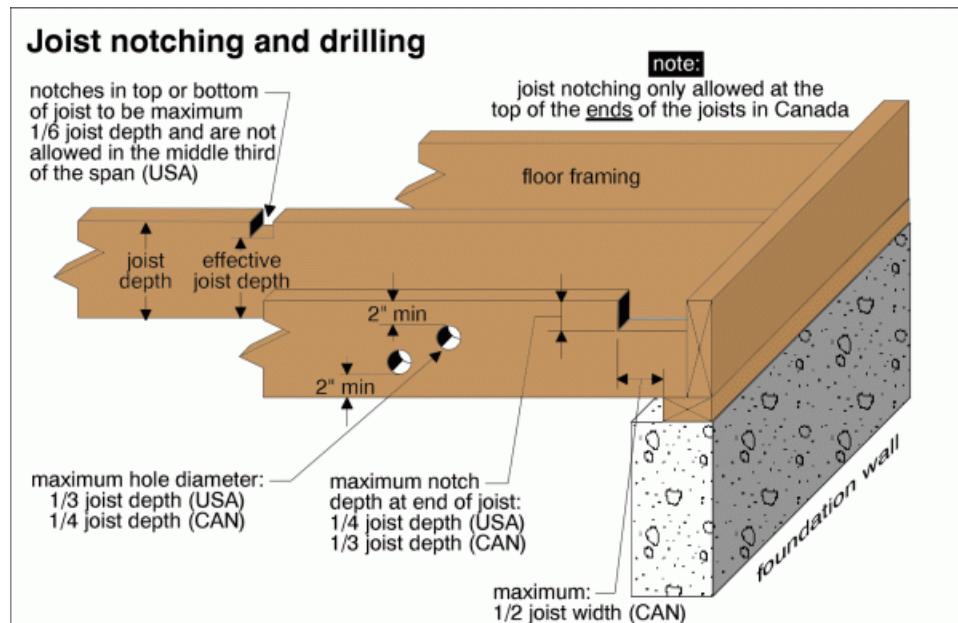
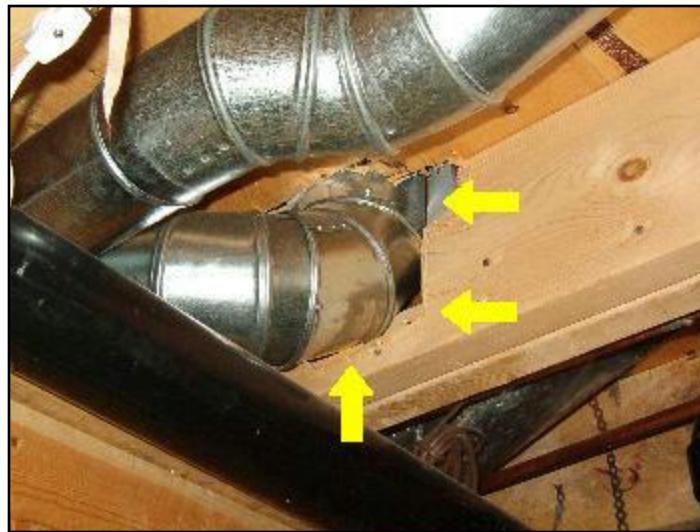
Condition: • [Notches or holes](#)

Implication(s): Weakened structure

6. Condition: • [Notches or holes](#)

Location: West

5. Joists are notched and weakened

Task: Repair

Time: Immediate

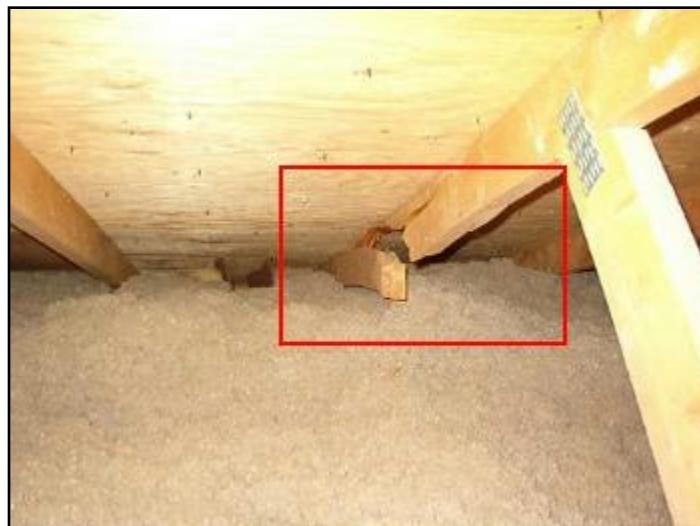
7. Condition: • Top chord of truss is broken

Location: North Attic

6. Top chord of truss is broken

Task: Replace

Time: Immediately

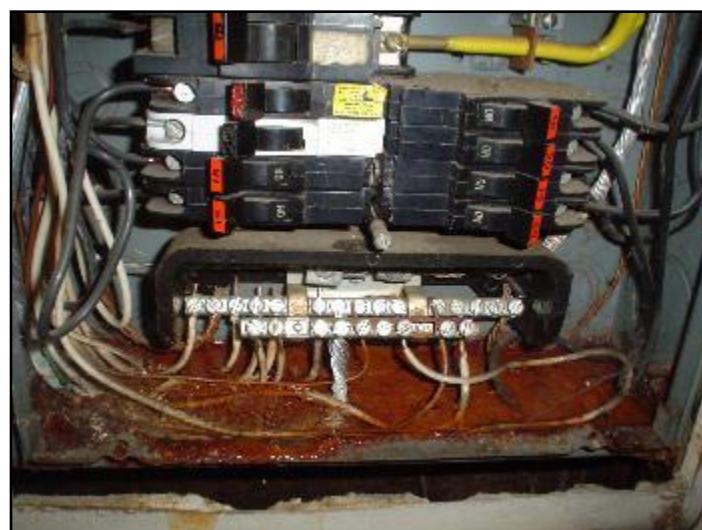
Condition: • [Rust or water in panel](#)

Implication(s): Electric shock | Fire hazard

9. Condition: • [Rust or water in panel](#)

Location: North Basement

7. Water and rust in bottom of panel

Task: Replace

Time: Immediate

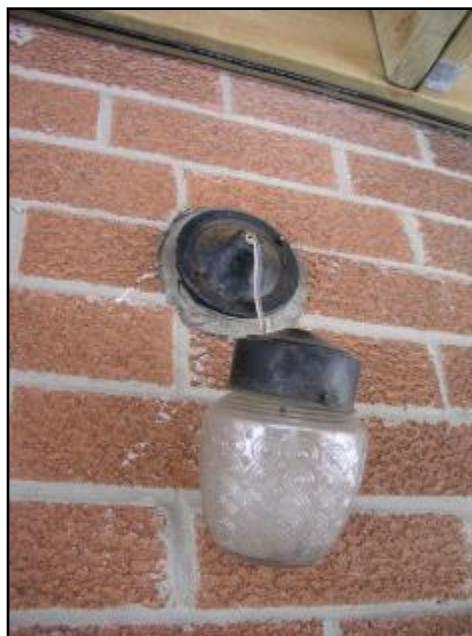
12. Condition: • [Loose](#)

Location: East Exterior wall

8. Light fixture is not well secured

Task: Repair or replace

Time: Immediate

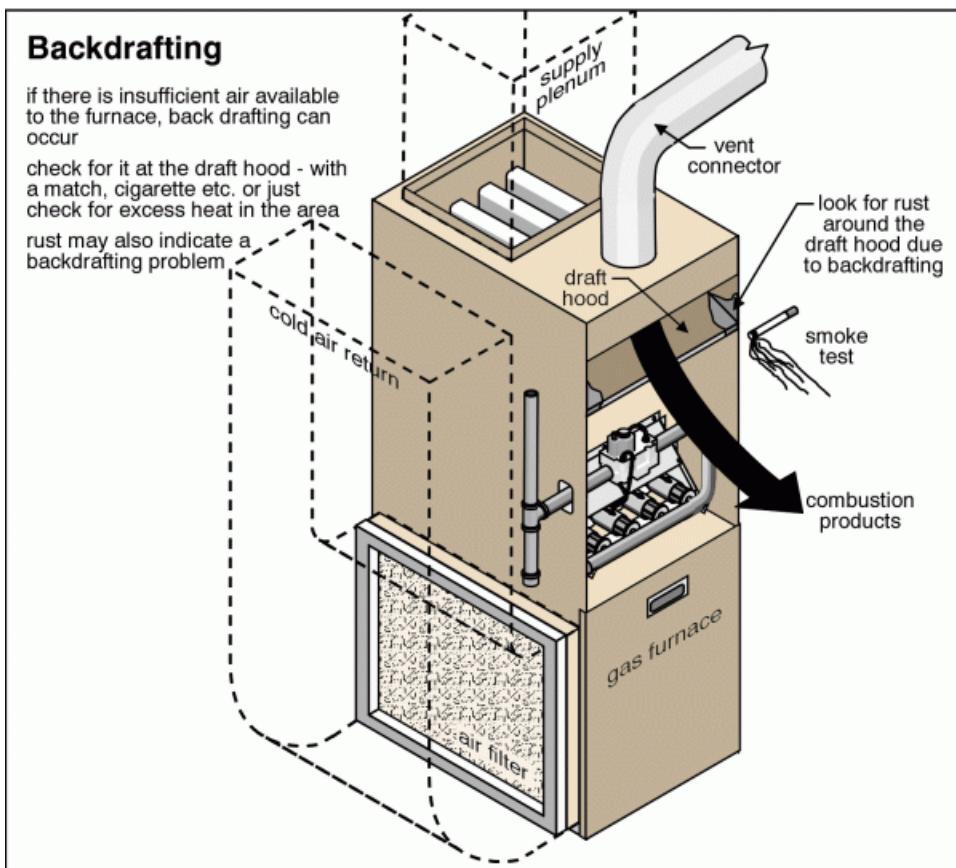
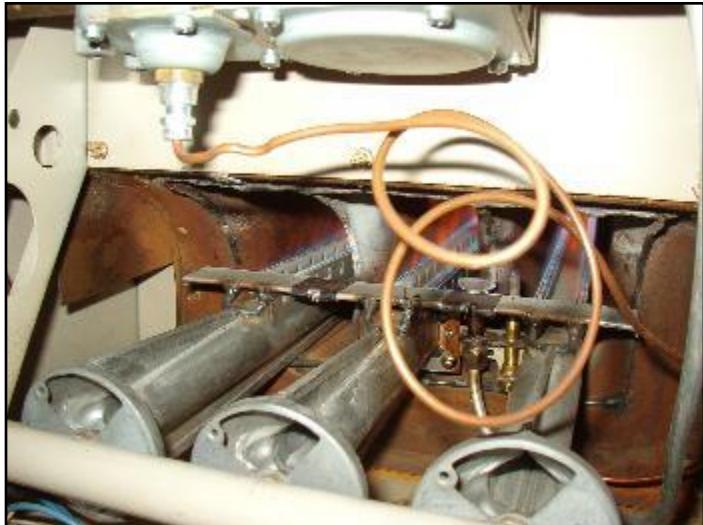
14. **Condition:** • [Draft hood spillage or backdraft](#)

A considerable amount of rust was noted on the front of the furnace.

This suggests a back-drafting problem, with combustion products entering the home.

This is a safety issue that should be addressed without delay.

Implication(s): Equipment not operating properly | Hazardous combustion products entering home

Location: Basement Furnace room

9. Rust at bottom of heat exchanger

Task: Correct

Time: Immediate

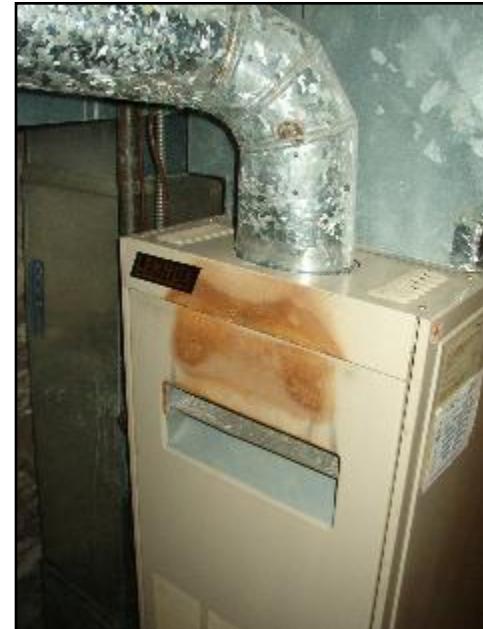
Backdrafting

if there is insufficient air available to the furnace, back drafting can occur

10. Evidence of furnace backdrafting

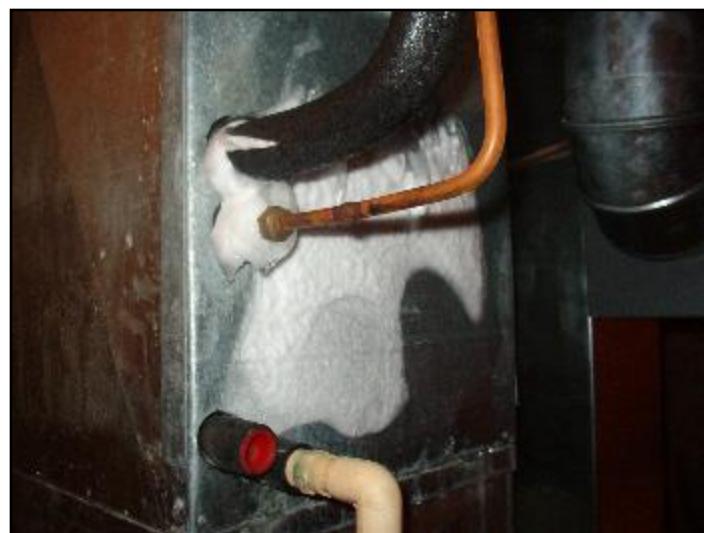
15. Condition: • [Frost](#)

Implication(s): Increased cooling costs | Reduced comfort

Location: West Basement

11. Frost visible on ductwork at AC coil

Task: Repair

Time: Immediate

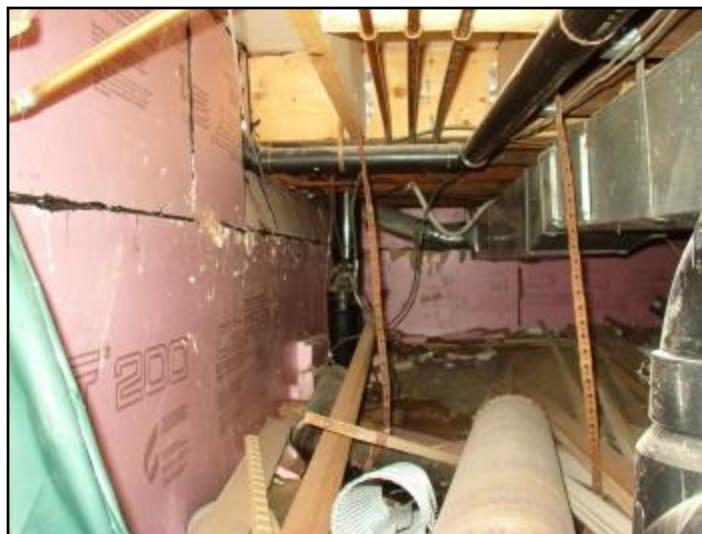
16. Condition: • [Exposed combustible insulation](#)

Implication(s): Fire hazard

Location: West Crawl space

12. Exposed polystyrene insulation is fire hazard

Task: Remove or cover with drywall

Time: Less than 1 year

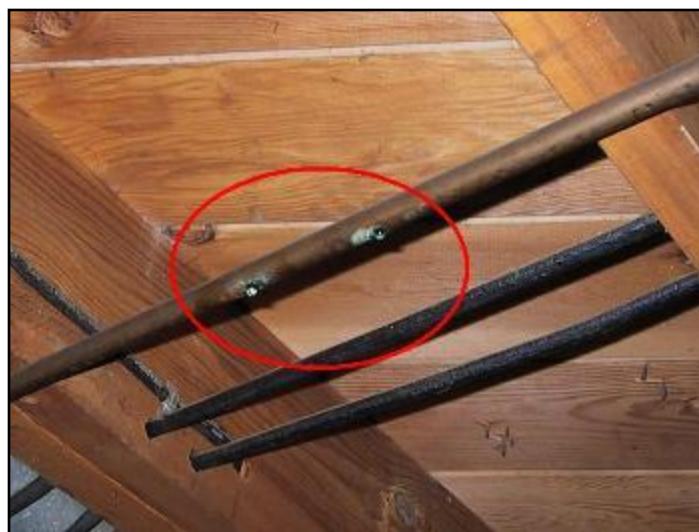
17. Condition: • [Leak](#)

Implication(s): Chance of water damage to contents, finishes and/or structure | System inoperative

Location: Northeast Basement

13. Leaking copper supply pipe

Task: Replace

Time: Immediate

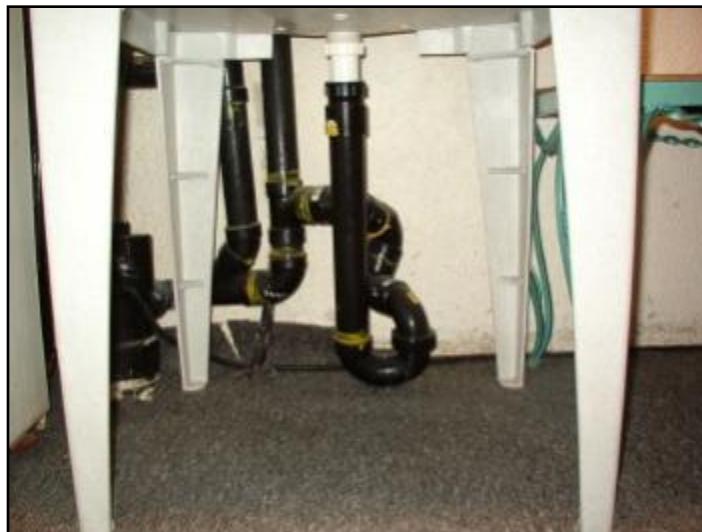
18. Condition: • [Nonstandard shape or material](#)

Implication(s): Reduced operability | Fixtures slow to drain

Location: Basement Laundry area

14. Poor trap arrangement

Task: Improve

Time: Immediate

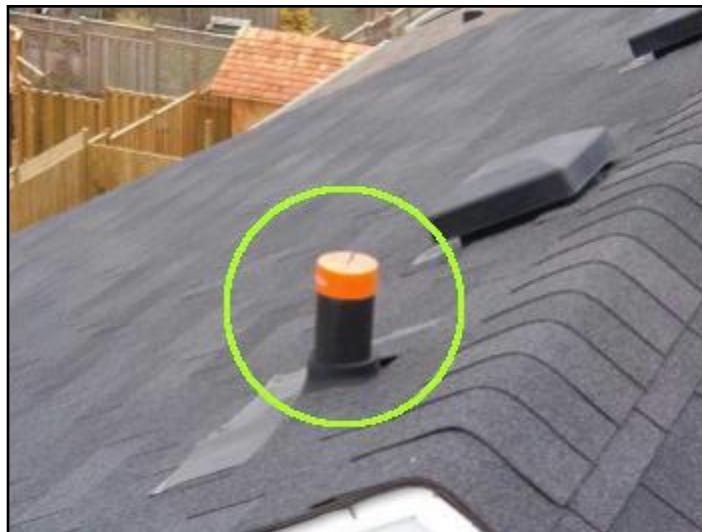
19. Condition: • [Vent termination problems](#)

Implication(s): Reduced operability | Sewer gases entering the building

Location: West central part of roof

15. Plumbing stack is capped

Task: Remove cap

Time: Immediate

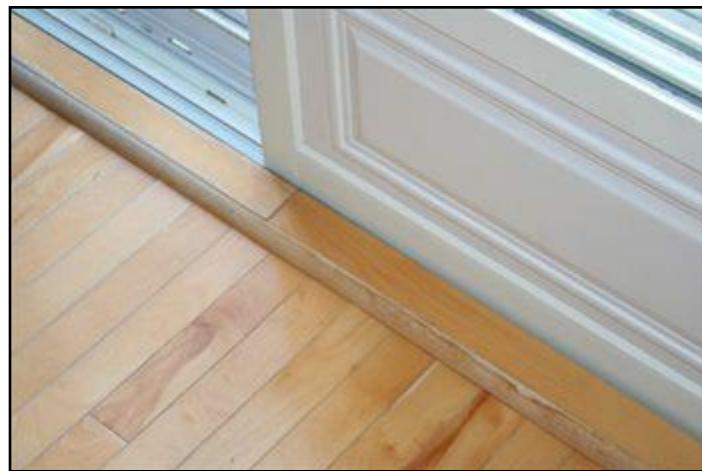
20. Condition: • [Stained](#)

Implication(s): Cosmetic defects

Location: North First Floor Family Room

16. Stained

Task: Repair

Time: Less than 1 year

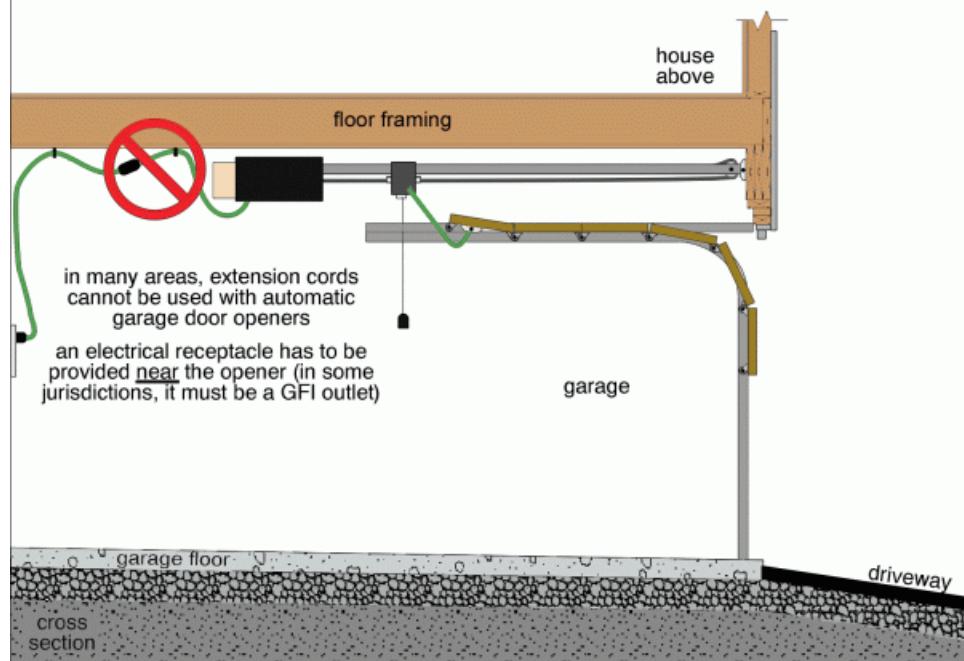
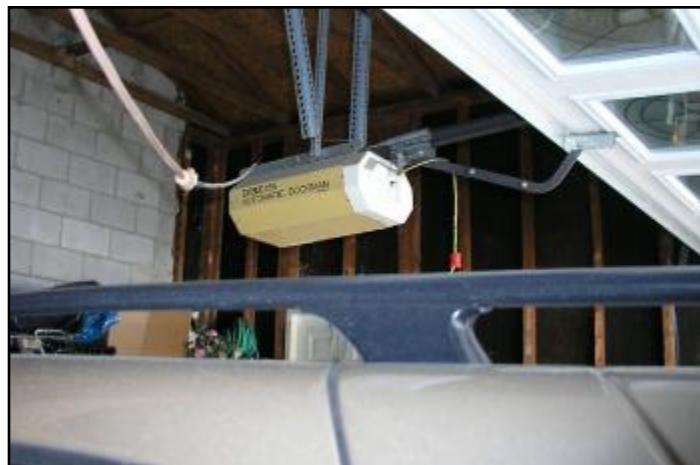
21. Condition: • [Extension cord for opener](#)

Implication(s): Electric shock

Location: Garage

17. Extension cord for west garage door opener

Task: Replace with permanent wiring

Time: Immediate
