# INSPECTION REPORT

For the Property at:  
**123 Leafy Lane**  
HASTINGS, ON

Prepared for: Mr & Mrs Twig  
Inspection Date: Sunday, March 14, 2021  
Prepared by: David Sharman

RE: Report No. 1366  
123 Leafy Lane  
Hastings, ON

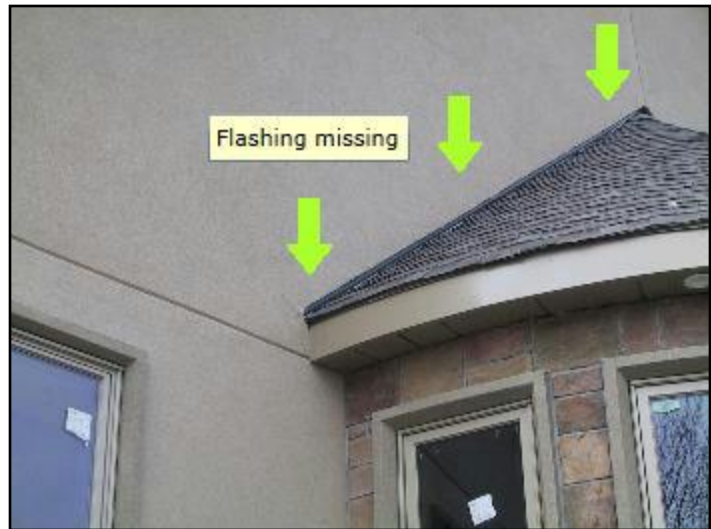
2. **Condition:** • [No kickout flashing](#)

**Implication(s):** Chance of water damage to contents, finishes and/or structure

**Location:** North First floor

1. No kickout flashing at roof/sidewall junction

**Task:** Improve

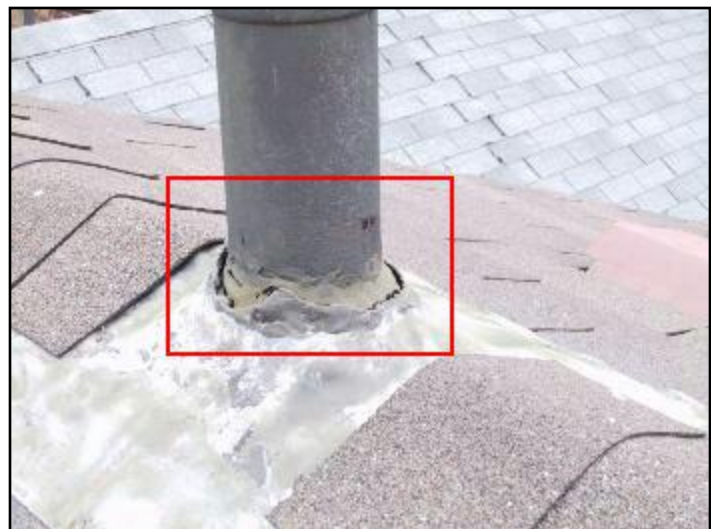
3. Condition: • [Leak](#)

Implication(s): Chance of water damage to contents, finishes and/or structure

Location: North

2. Leak

Task: Repair, immediate

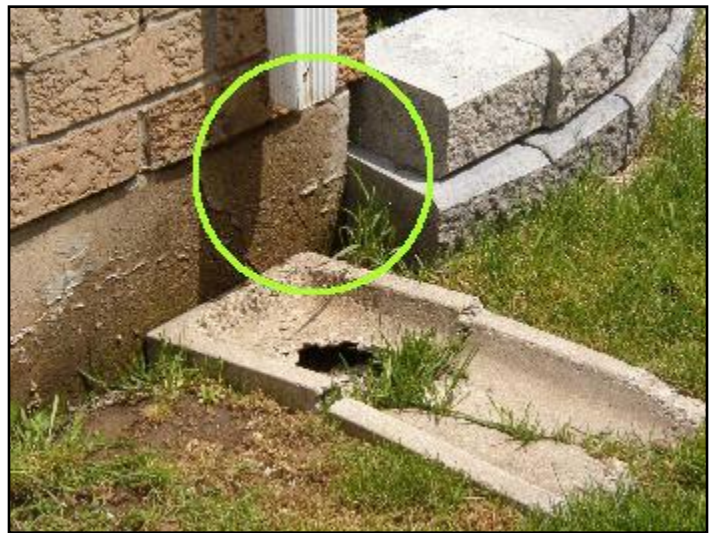
**4. Condition:** • [Downspouts end too close to building](#)

**Implication(s):** Chance of water damage to contents, finishes and/or structure

**Location:** East Exterior wall

3. Downspout ends too close to building

The downspout should be extended to discharge at least 6 feet from the home. The splash block can be discarded.

**Task:** Improve

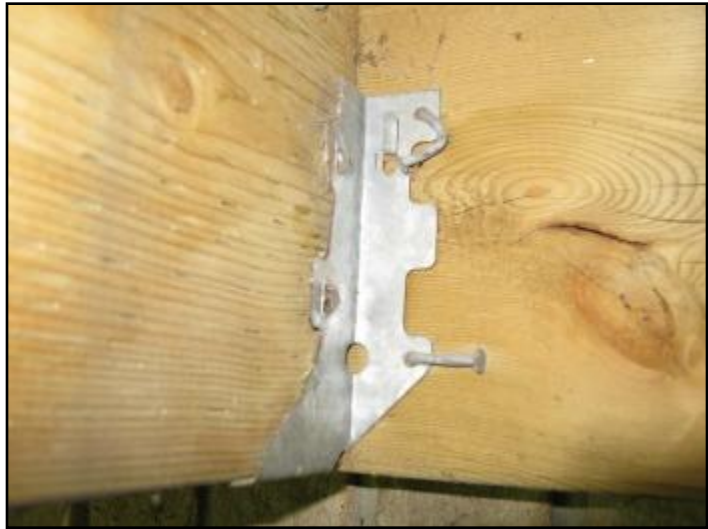
#### **5. Condition:** • [Fastener problems](#)

Joist hangers for wood deck are not properly nailed.

**Implication(s):** Weakened structure | Chance of movement

**Location:** North Exterior Wall

4. Poor end bearing, joist hanger connections

**Task:** Improve

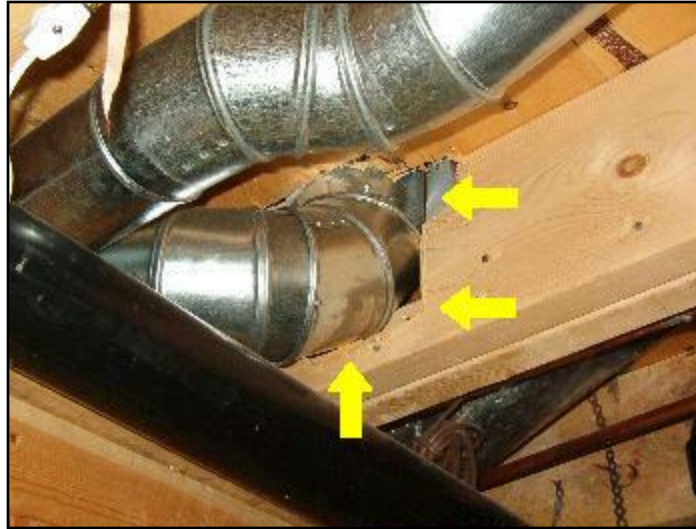
**Condition:** • [Notches or holes](#)

**Implication(s):** Weakened structure

**Location:** West

**6. Condition:** • [Notches or holes](#)

5. Joists are notched and weakened

**Task:** Repair

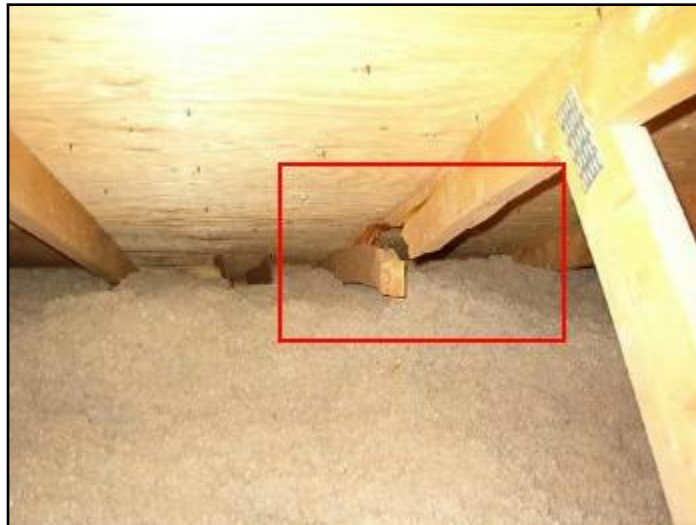
7. **Condition:** • Top chord of truss is broken

**Location:** North Attic

6. Top chord of truss is broken

**Task:** Replace

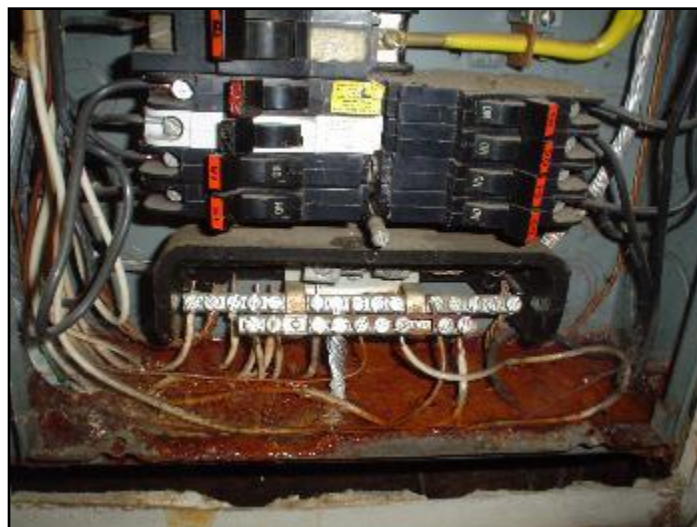
**Condition:** • [Rust or water in panel](#)

**Implication(s):** Electric shock | Fire hazard

**Location:** North Basement

9. Condition: • [Rust or water in panel](#)

Implication(s): Electric shock | Fire hazard

Location: North Basement

7. Water and rust in bottom of panel

Task: Replace

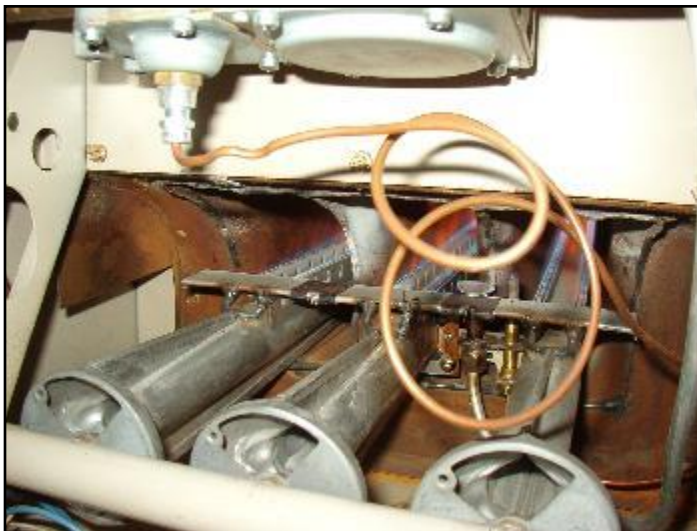
A considerable amount of rust was noted on the front of the furnace.

9. Rust at bottom of heat exchanger

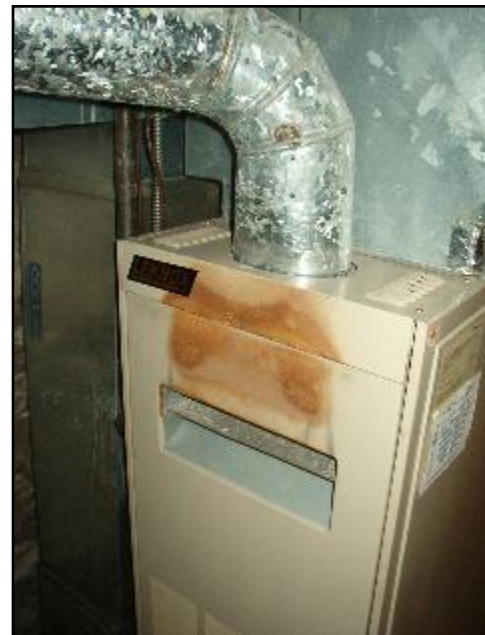
14. **Condition:** • [Draft hood spillage or backdraft](#)

This suggests a back-drafting problem, with combustion products entering the home.

This is a safety issue that should be addressed without delay.

**Implication(s):** Equipment not operating properly | Hazardous combustion products entering home

**Location:** Basement Furnace room

10. Evidence of furnace backdrafting

**Task:** Correct

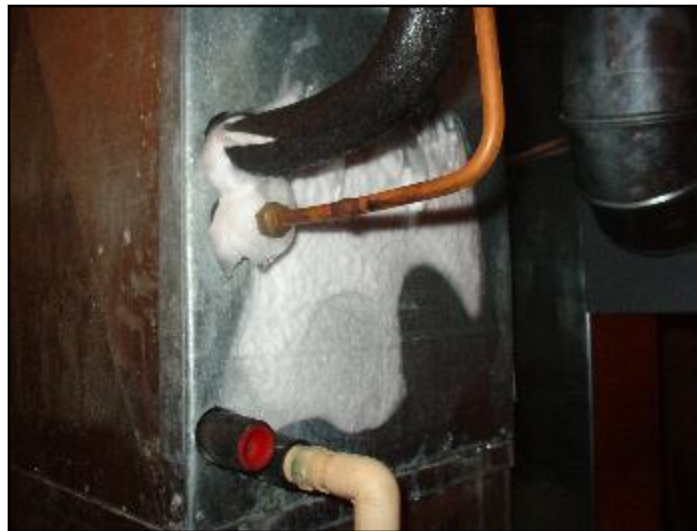
**15. Condition:** • [Frost](#)

**Implication(s):** Increased cooling costs | Reduced comfort

**Location:** West Basement

11. Frost visible on ductwork at AC coil

**Task:** Repair

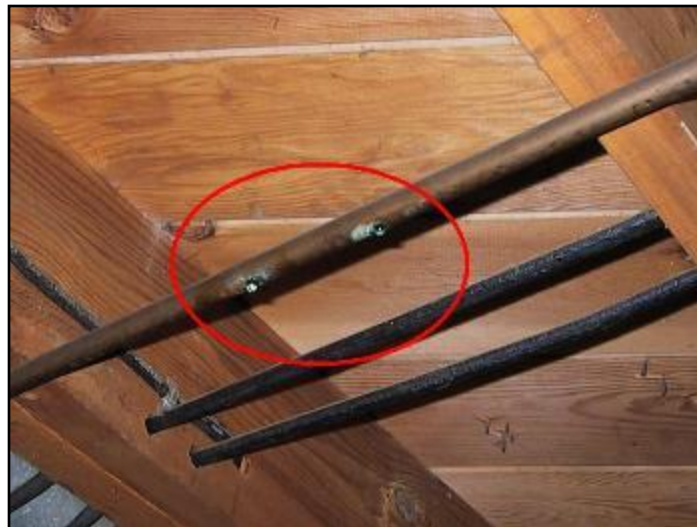
**17. Condition:** • [Leak](#)

**Implication(s):** Chance of water damage to contents, finishes and/or structure | System inoperative

**Location:** Northeast Basement

**13.** *Leaking copper supply pipe*

**Task:** Replace

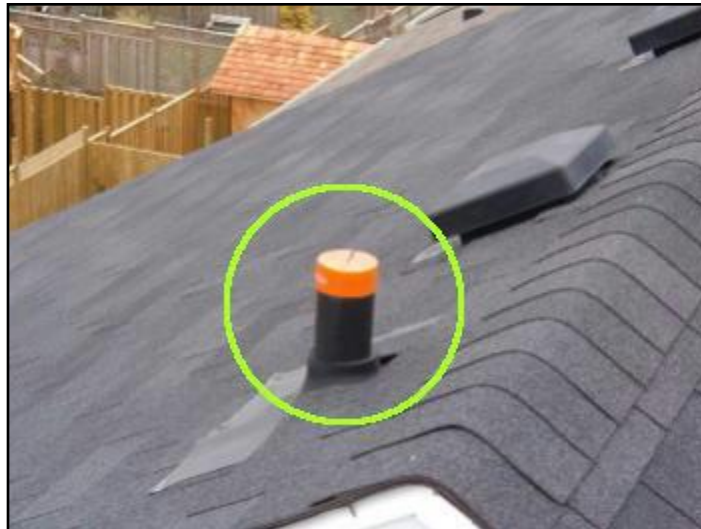
**19. Condition:** • [Vent termination problems](#)

**Implication(s):** Reduced operability | Sewer gases entering the building

**Location:** West central part of roof

15. Plumbing stack is capped

**Task:** Remove cap

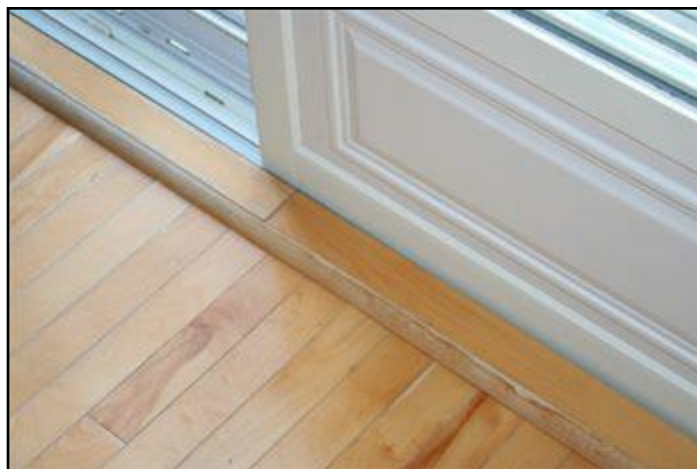
**20. Condition:** • [Stained](#)

**Implication(s):** Cosmetic defects

**Location:** North First Floor Family Room

16. Stained

**Task:** Repair

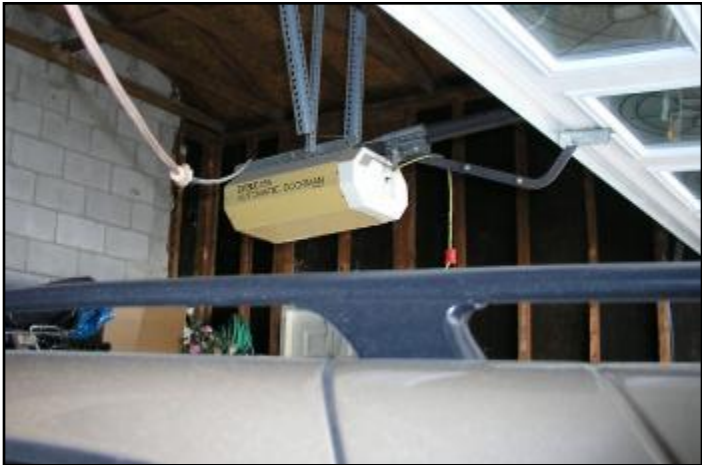
**21. Condition:** • [Extension cord for opener](#)

**Implication(s):** Electric shock

**Location:** Garage

17. Extension cord for west garage door opener

**Task:** Replace with permanent wiring
