# LEVEL 1 REPLACEMENT RESERVE REPORT FY 2024 SUNRISE BAY PROPERTY OWNERS ASSOCIATION, INC.

## SUNRISE BAY PROPERTY OWNERS ASSOCIATION, INC.

MINERAL, VIRGINIA

February 18, 2023

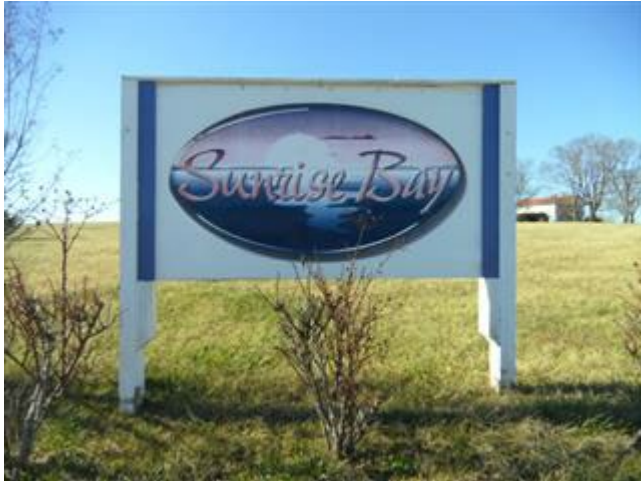
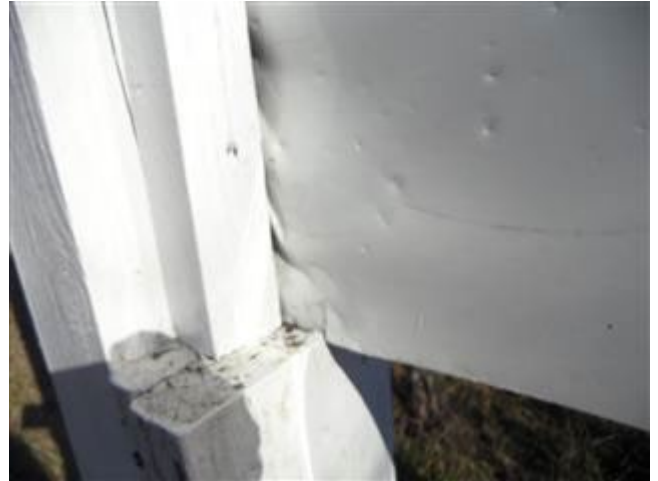
The largest entrance sign is located at the intersection of Belmont and Cedar Hill Drive. The wood frame is in good condition, with flaking paint. The foam board sign is damaged in a couple of areas but remains serviceable.

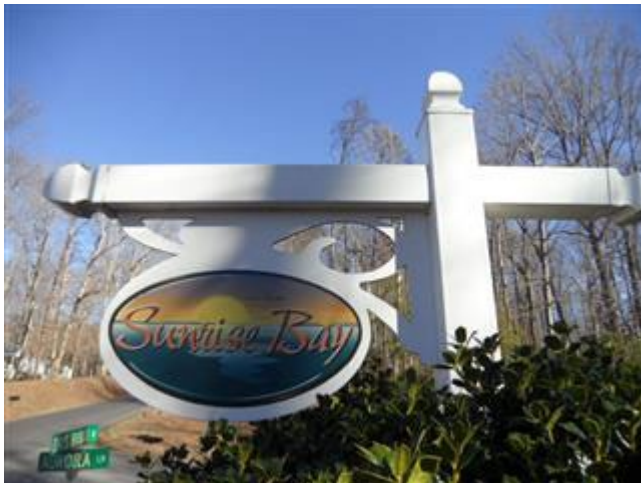
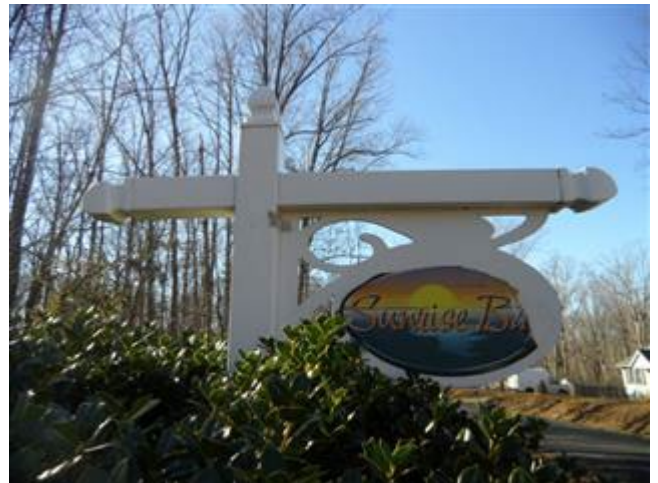
The small sign at the intersection of Days Bridge Rd and Aurora Ln is in good condition. This sign has vinyl posts and the sticker appears to have been placed on composite material. The stickers are on both sides of the sign, and one is peeling.

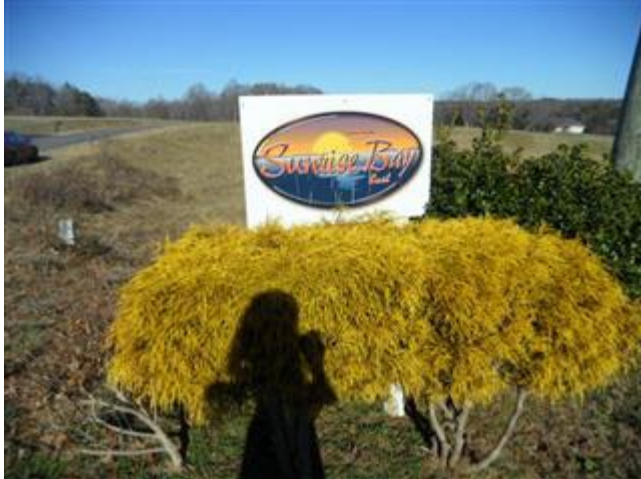
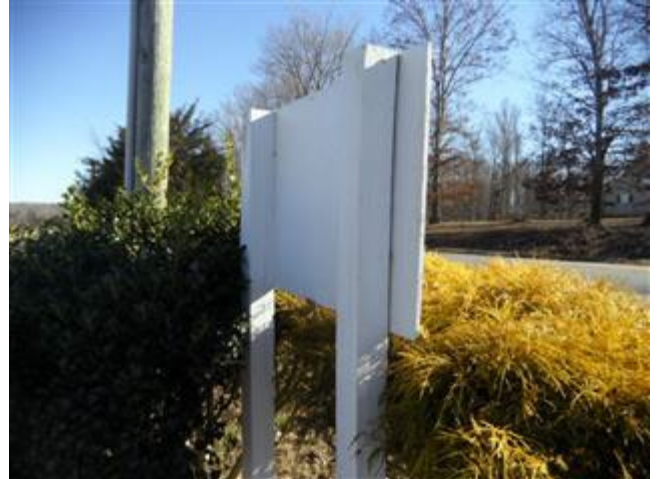
The small sign at the intersection of Day Break and Belmont is in fair condition. The sign is completely wood, except for the sticker. The sticker is cracked and the wood needs to be painted.

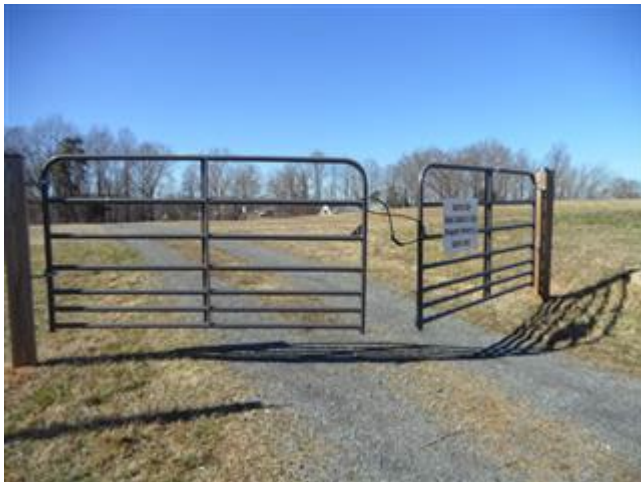
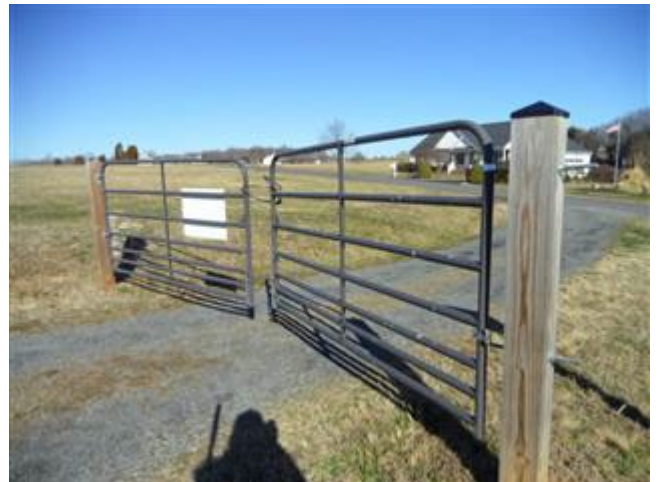
**Metal Gates, A-Dock.** A metal gate system with wood posts was installed to control access to the A-docks. The gates are locked with a chain lock that opens with a combination provided to unit owners. The gates were installed in 2019 and are in good condition, with minor rust.

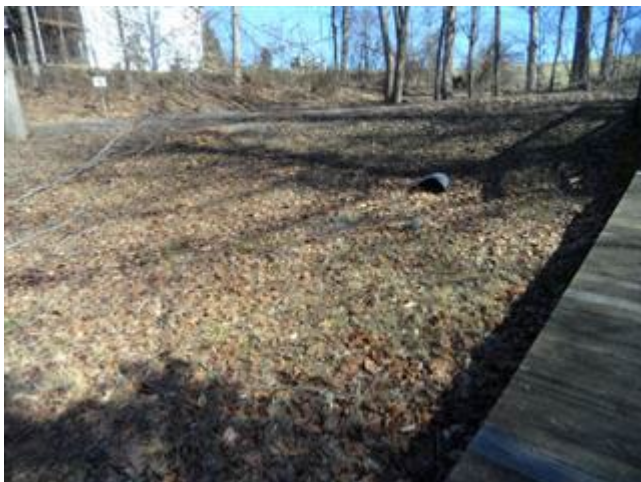
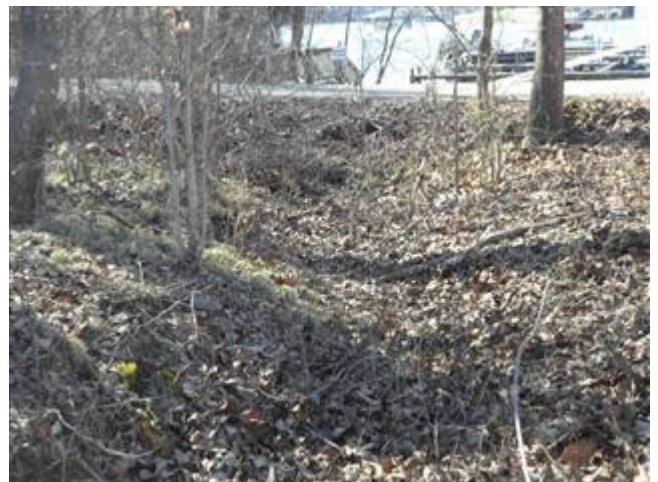
**Stormwater Management Allowance, A-Dock.** There is a culvert beneath the concrete boat ramp that channels water from a nearby stream into the lake. The Association should monitor erosion of the swale upstream, and ensure that the culvert remains clear of debris. At some point, major swale restoration or culvert lining/replacement may be required. We have included an allowance to address either or both conditions every 30 years.

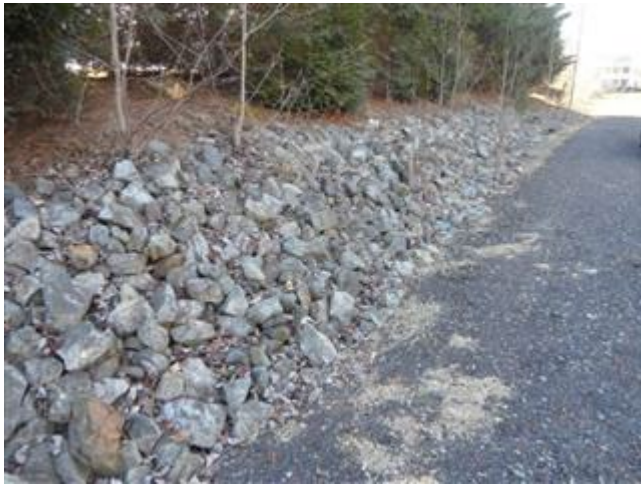
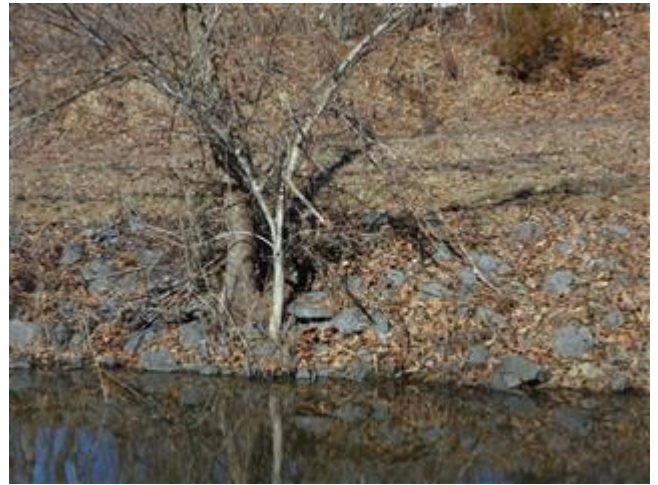
The D-dock is accessed via a gravel roadway through an easement. Rip rap has been installed along this path near the lake. Rip-rap has also been installed along portions of the A-dock banks. Rip-rap should have a long life, and replenishment of the gravel pathways is being funded from the operating budget.

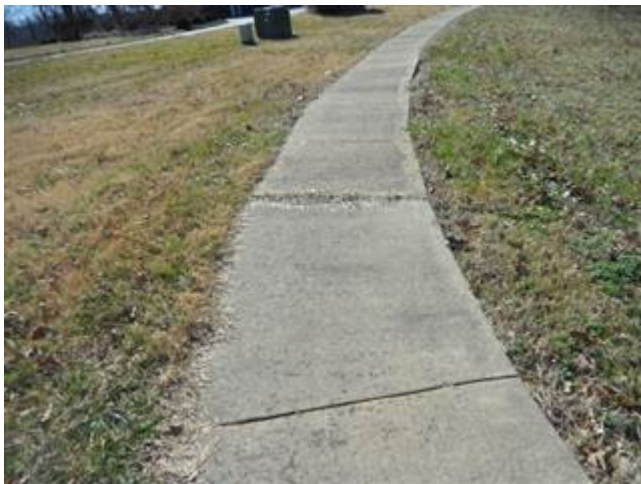
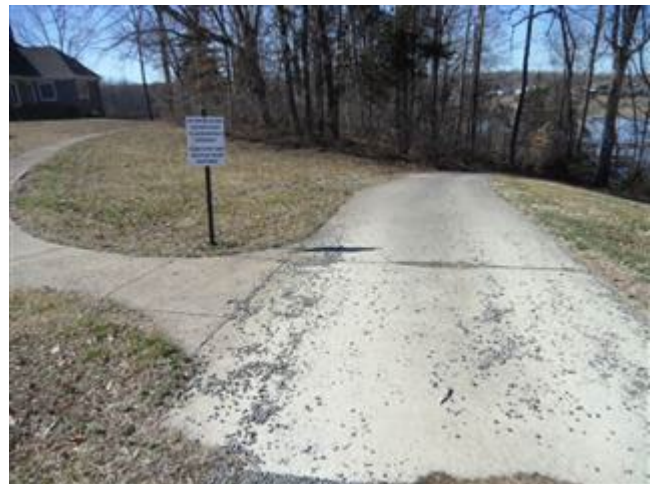
**Concrete Work.** The concrete work includes the community sidewalks and boat ramp at A-dock. The overall condition of the concrete work is excellent, with only one cracked corner in the boat ramp and no obvious defects in the sidewalk.

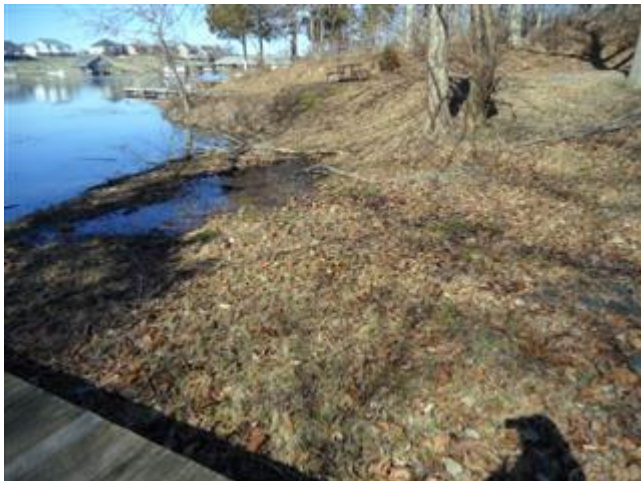
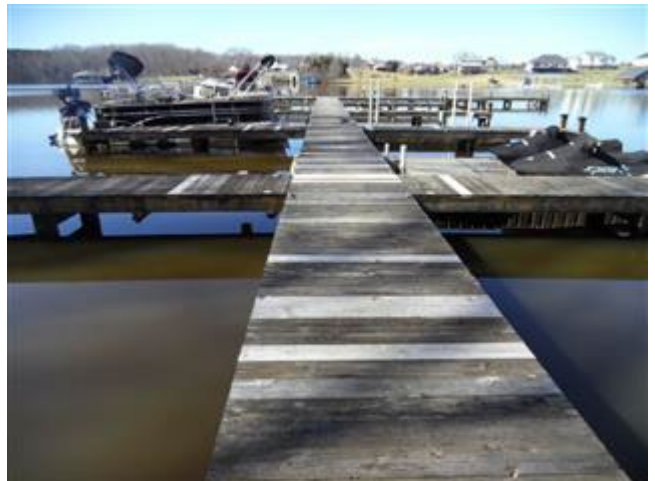
There are three piers at Common Area A, referred to as "A-Docks". The largest dock ("Main") is built near wetlands, which complicates the design and use of the docks since vegetation control is not allowed. The Board President reported that the layout concerns have improved since "No Wake" buoys were installed in this area.

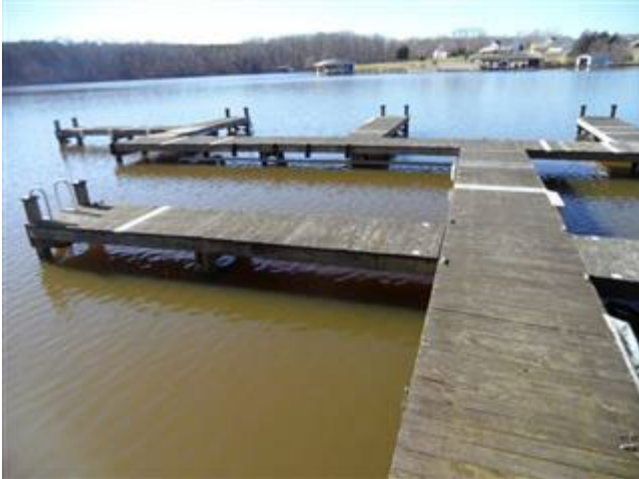
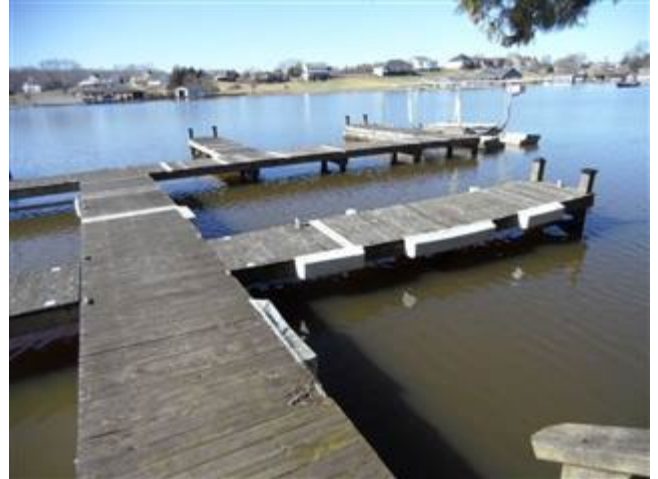
The medium-size dock ("Pathway") has a couple of pilings that are leaning. The pier for slips 30/32 is noticeably tilted, and we sensed movement of at least one other pier during our site visit. These pilings are scheduled to be addressed in 2023, although the contractor is unsure whether they will be able to successfully secure these piles.

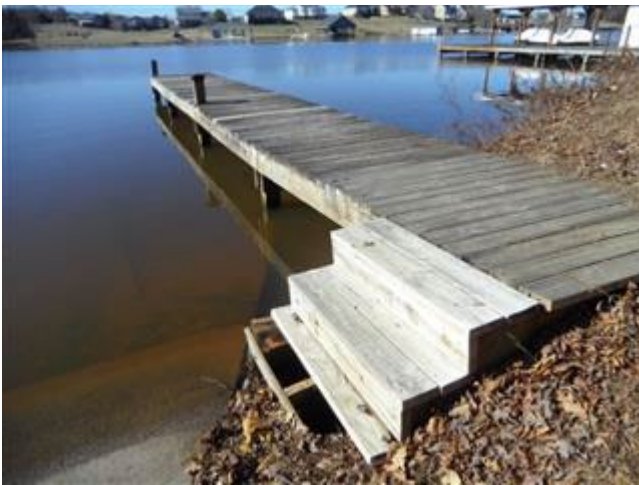
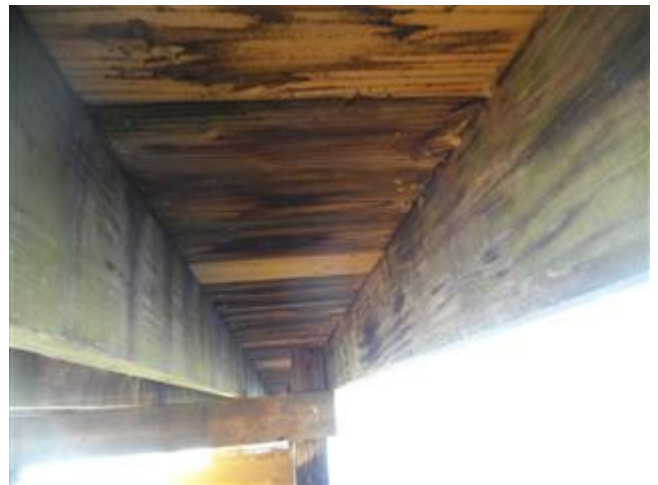
The smallest pier at Dock-A ("Launch") is shown below. The bottom step will be addressed during the 2023 repair project.

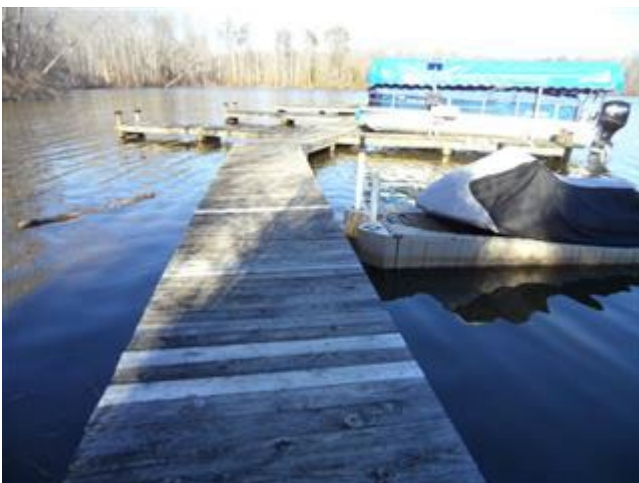
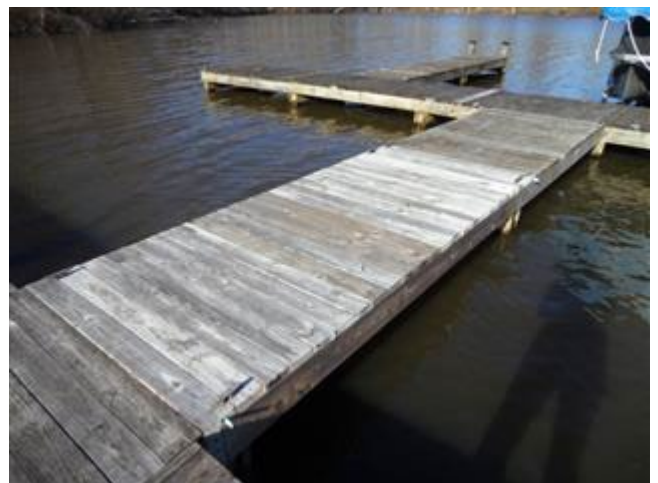
There is one pier in Common Area D, referred to as "D-Dock". This pier is reported to be structurally stable.

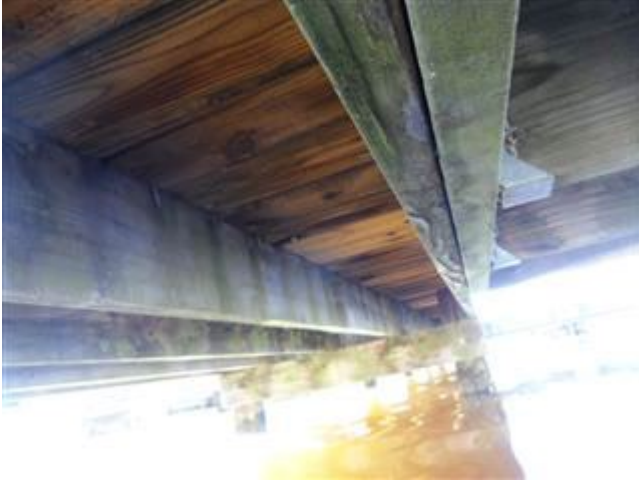
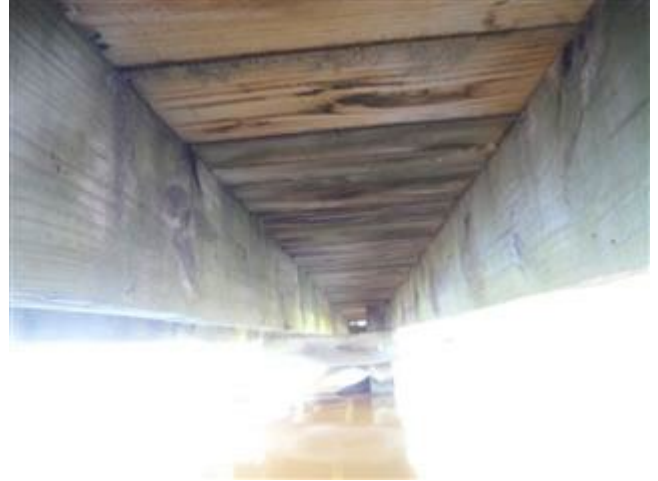
The Main dock structure is reported to be stable. It is possible that when the deck boards are replaced, the original structure can remain.

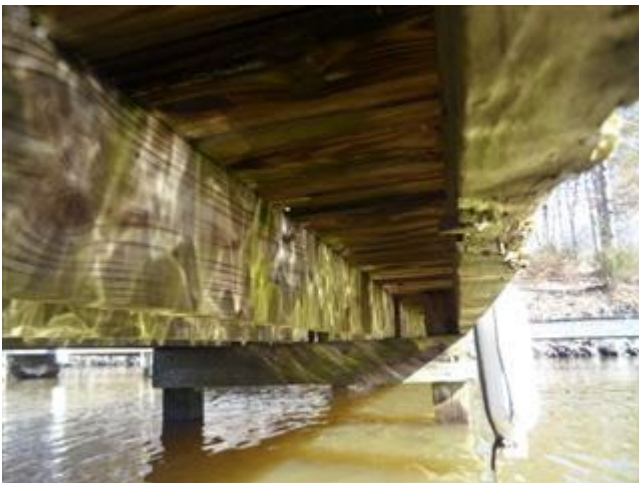
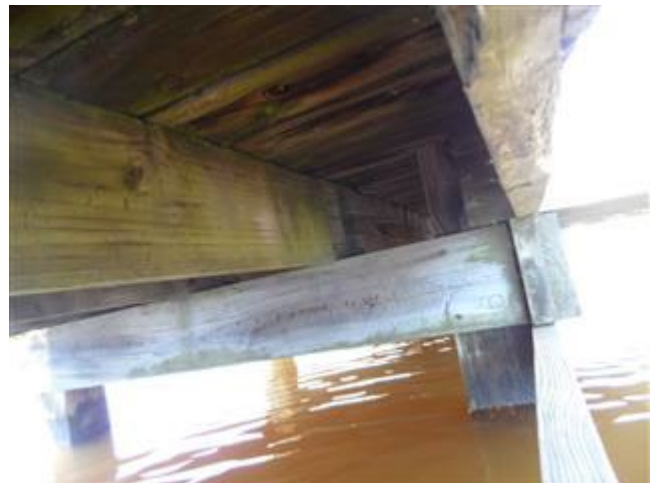
The Pathway dock structure needs attention, as noted above. The 2023 work includes lowering two pilings and installing support beams to minimize future lifting.

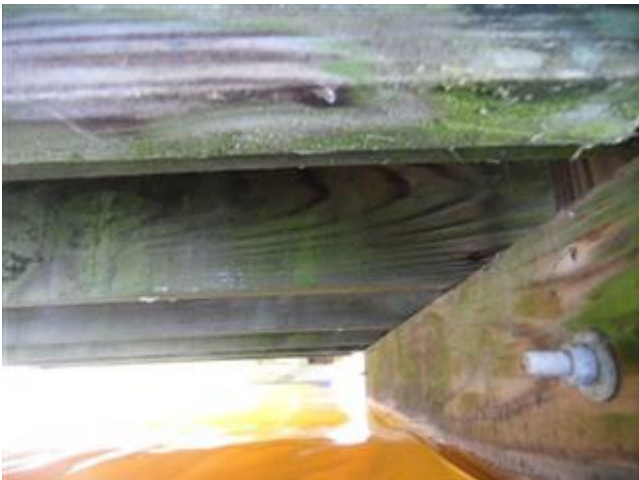
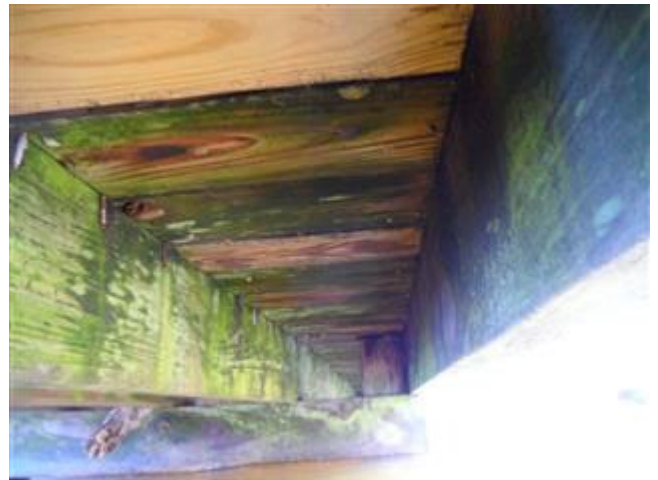
The D-dock structure is reported to be stable.

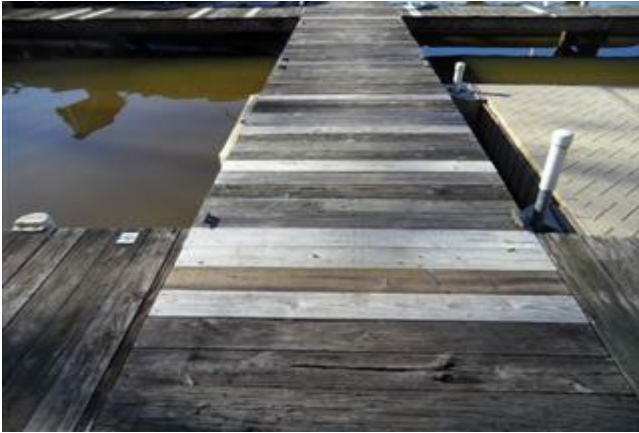
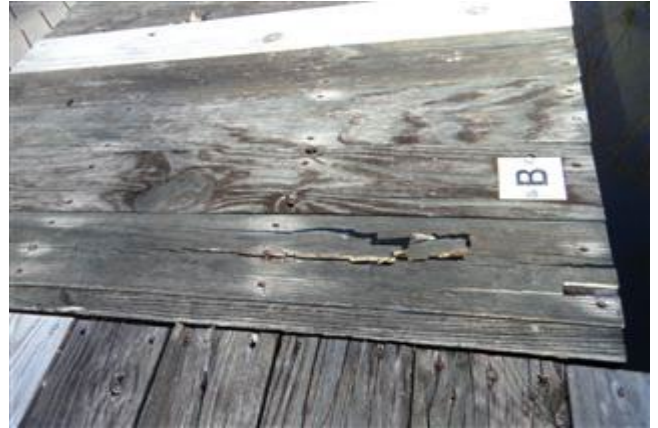
Deck boards have been replaced as needed, which has extended the overall life of the deck boards. We noted several boards that have failed and may need to be replaced. The 2023 work includes the replacement of 26 deteriorated floorboards with pressure treated 2x6 floorboards.

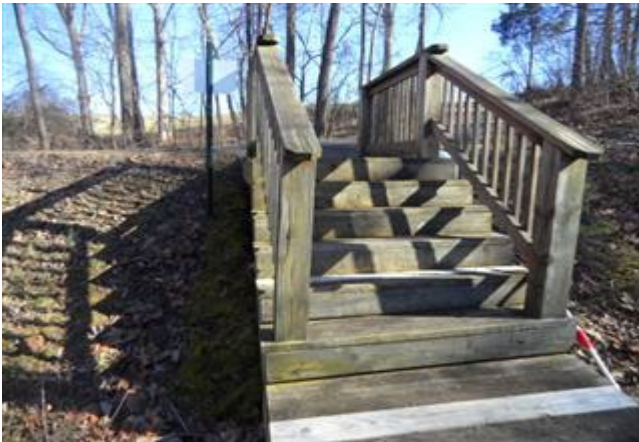
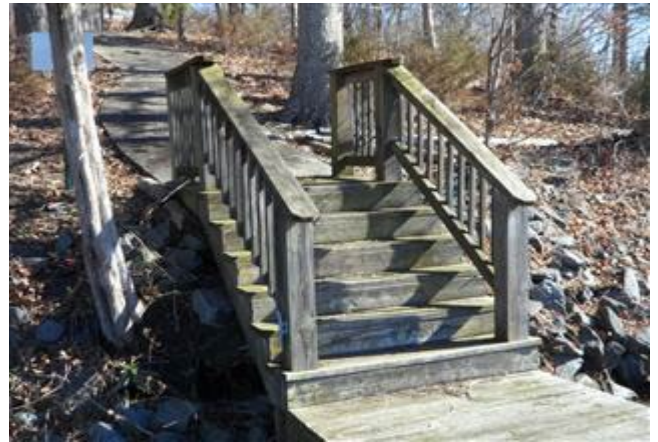
The two A-dock stair structures are shown below.

**Pressure Treated Wood Steps.** The three larger docks are accessed by steps that are constructed from pressure-treated wood. The general condition of the steps is fair to good. The railings were sturdy and wood boards were intact.

The community may wish to consider using engineered lumber instead of pressure-treated wood when rebuilding these steps. While engineered lumber is one-third more expensive than pressure-treated wood, it offers the advantages of not splitting, cracking, creating splinters, or rotting. As a result, its rated service life is approximately 50% longer than the service life of pressure-treated wood.
