ANDERSON  
PROPERTY  
GROUP,  
INC.

## RESIDENTIAL REPORT

Inspector  
**Arden Anderson**  
InterNACHI# NACHI23050109  
+19862265355  
[arden@theandersonpropertygroup.com](mailto:arden@theandersonpropertygroup.com)

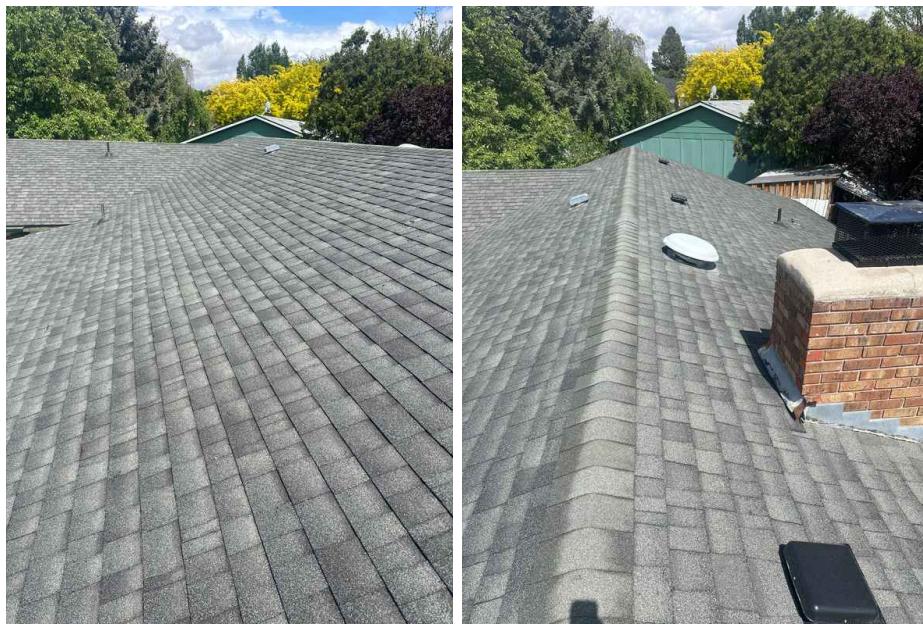
**The roofing material has lost quite a bit of granules and appears to be aging quickly. Recommend a roofing inspection from a qualified roofer to determine the life expectancy of the roof.**

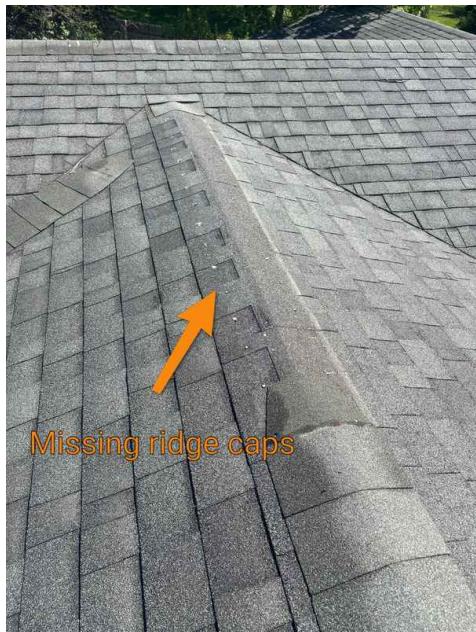
Roof coverings showed moderate damage. Recommend a qualified roofing professional evaluate and repair.

Missing ridge caps

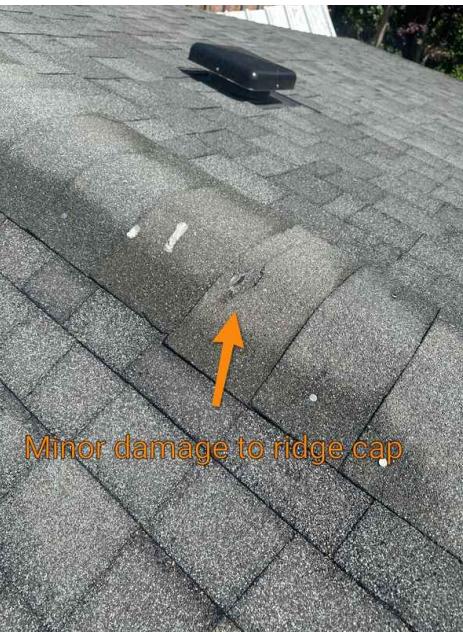
Minor damage to ridge cap

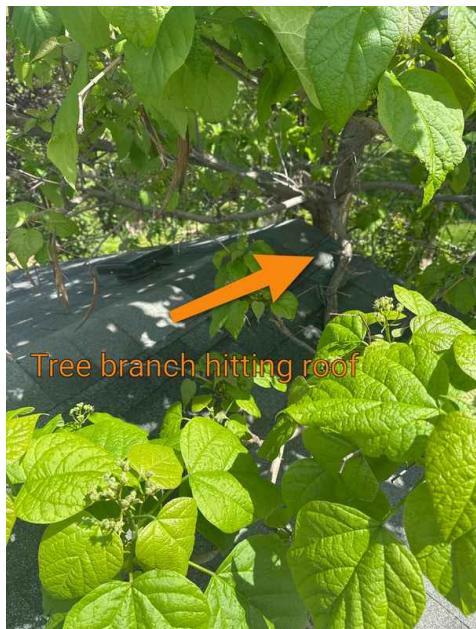
Trees observed to be touching the roof. This can cause damage to the roof. Recommend trimming trees to clear roofing surface..

Tree branch hitting roof

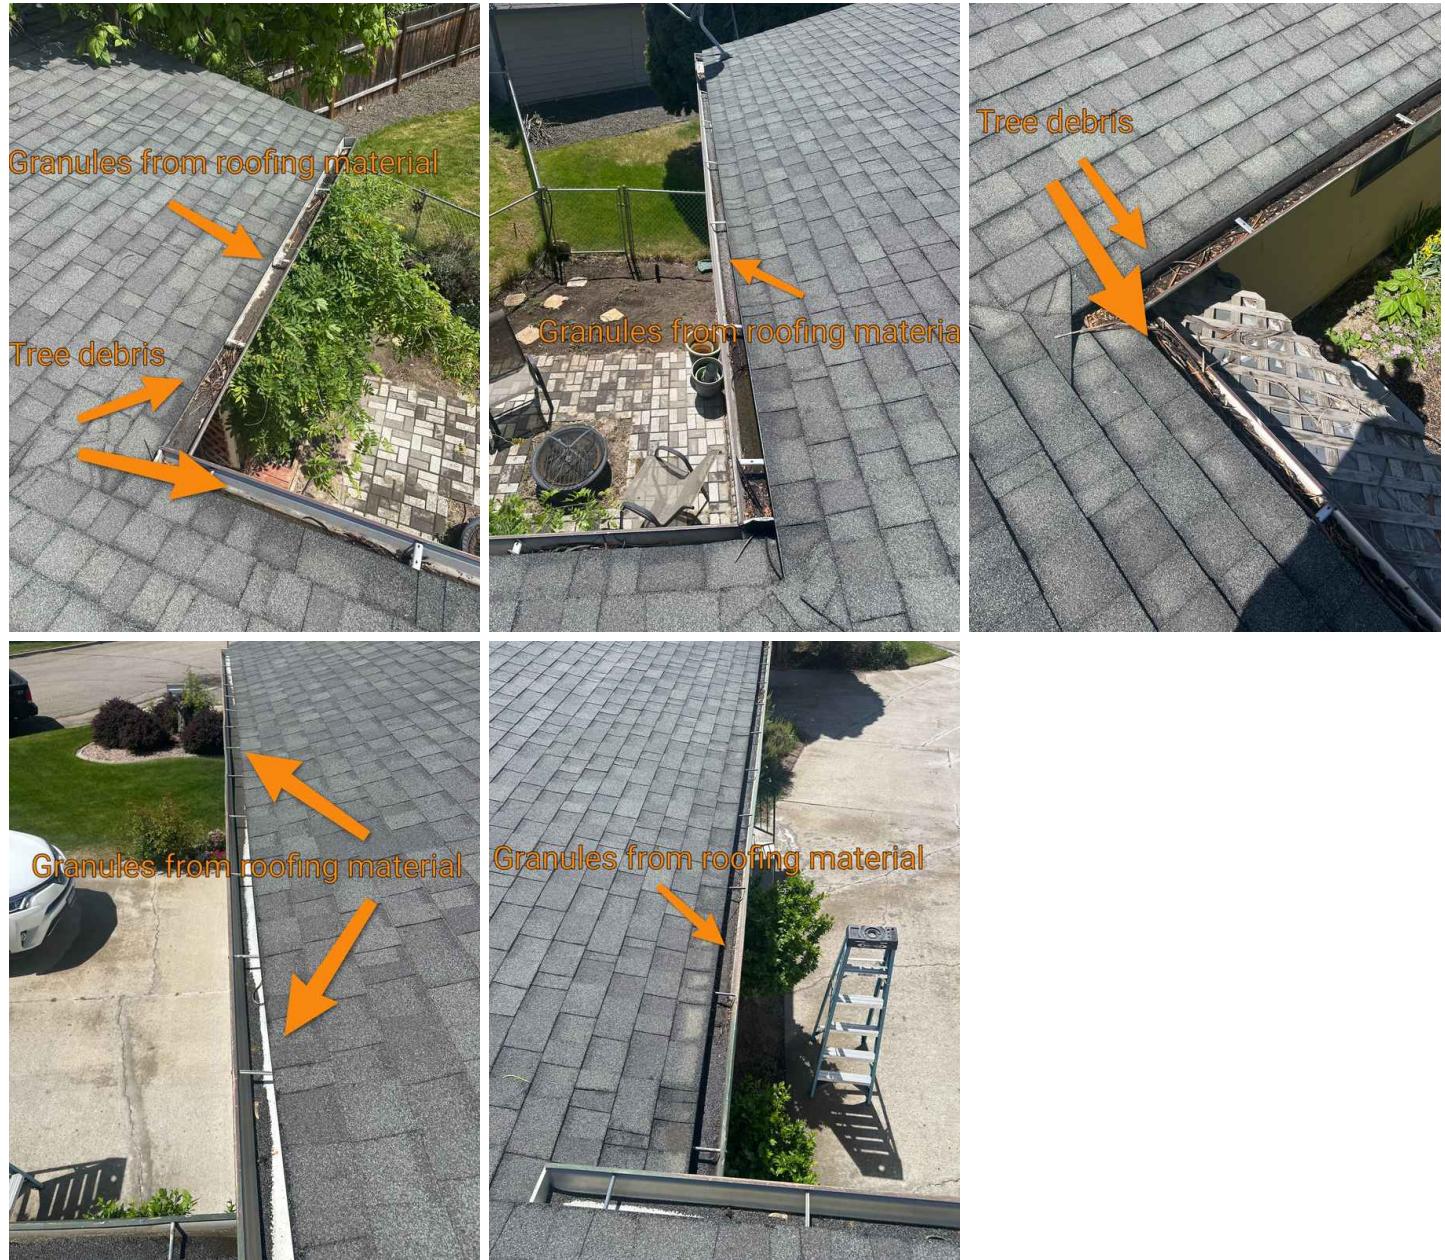
Debris has accumulated in the gutters. Recommend cleaning to facilitate water flow.

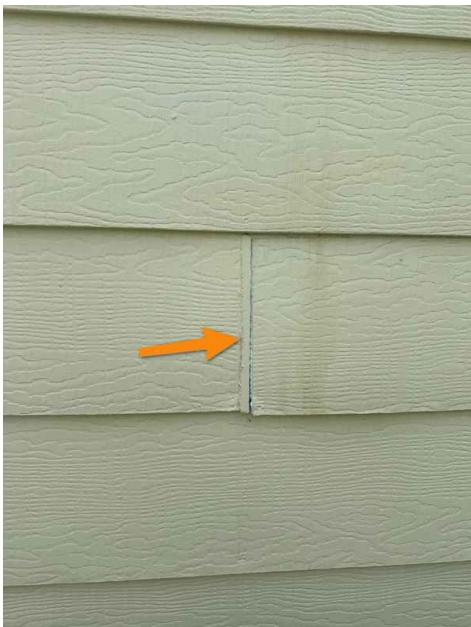
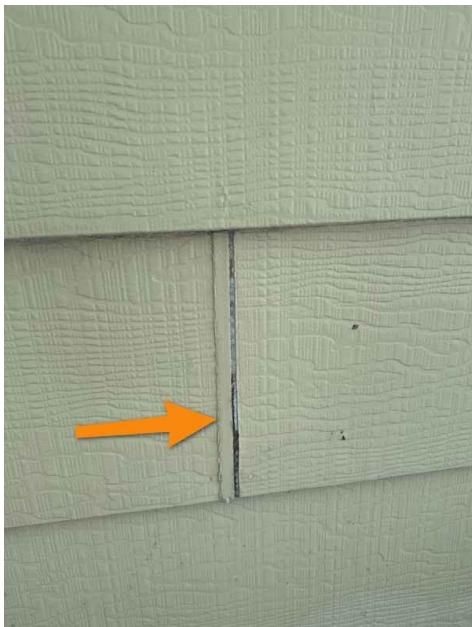
Flashing & trim pieces were improperly installed, which could result in moisture intrusion and damaging leaks. Recommend caulking and/or larger gap flashing being installed.

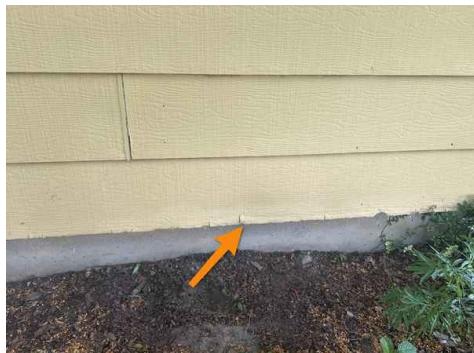
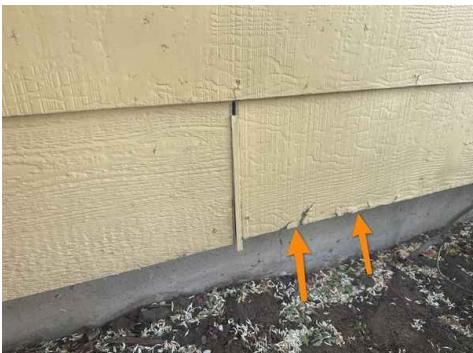
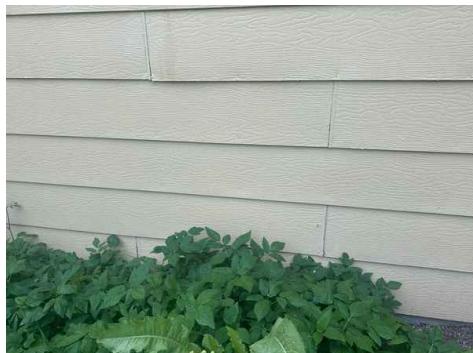
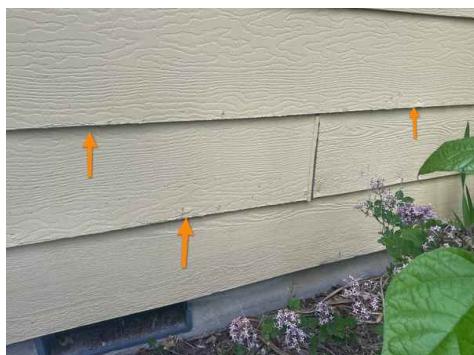
Some deterioration to lower courses of siding at various locations around the building.

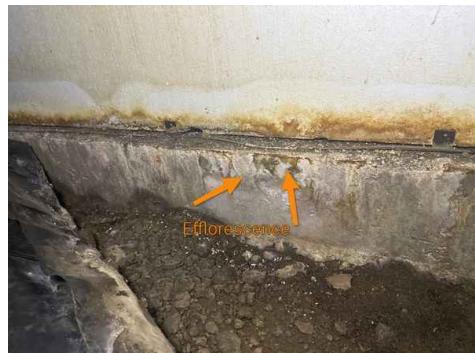
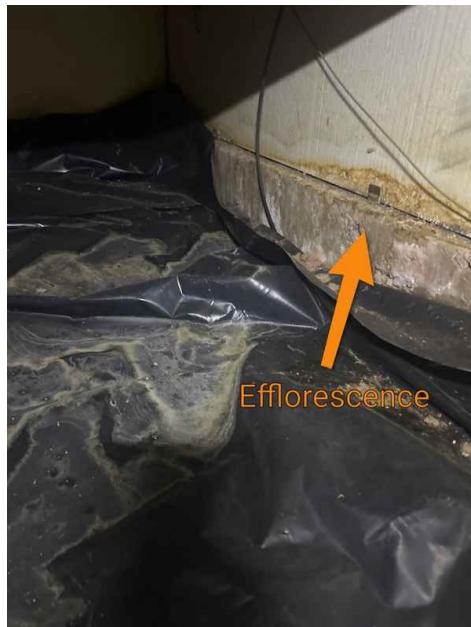
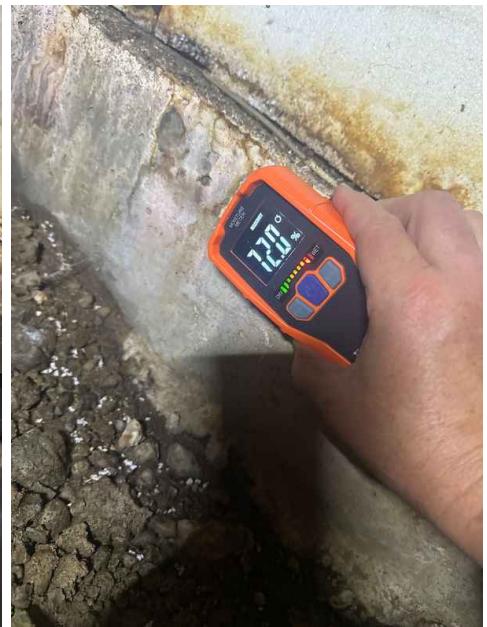
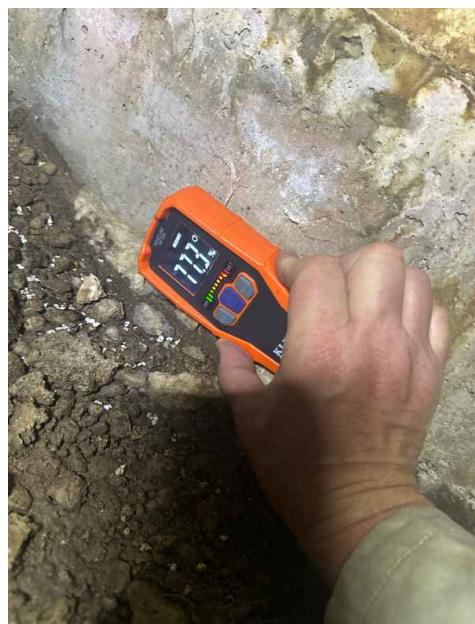
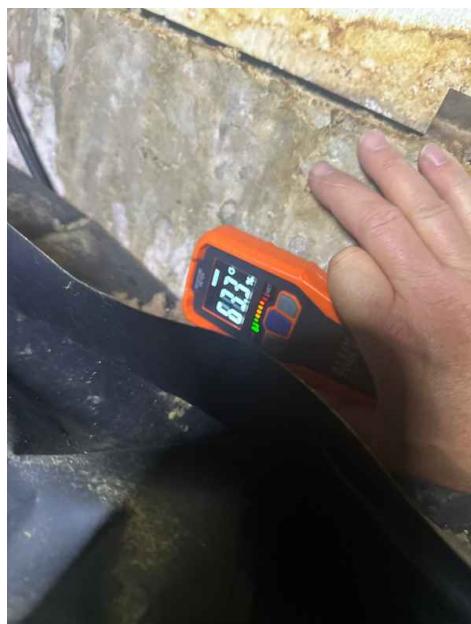
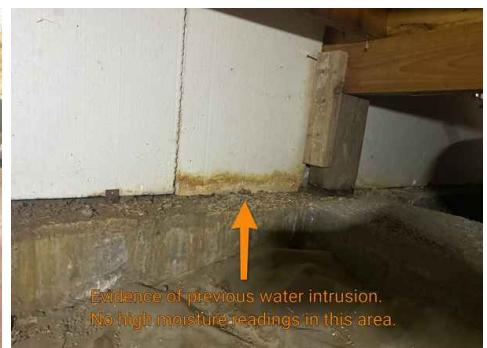
Efflorescence noted on the crawlspace surface. This a white, powdery deposit that is consistent with moisture intrusion. This can compromise the soil's ability to support the home structure and/or lead to mold growth. Recommend a qualified contractor identify source or moisture and correct.

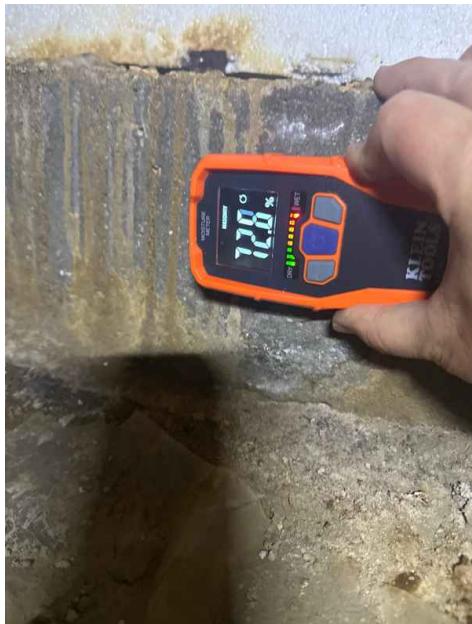
High moisture reading

High levels of moisture were noted in areas of the basement. Recommend monitoring and finding source of moisture intrusion to prevent damage to structure.

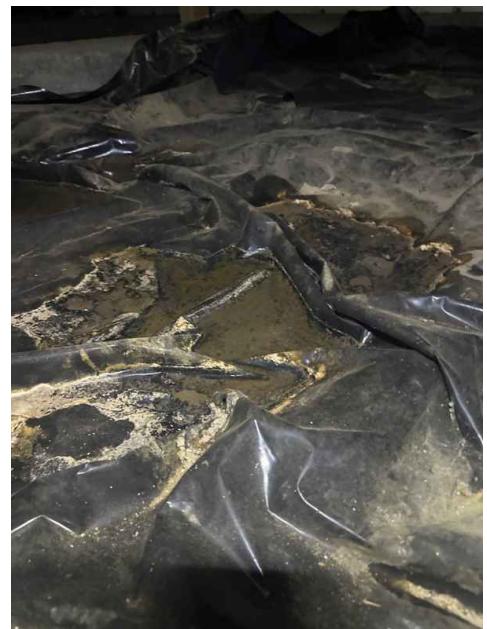
Observed signs on basement floor that standing water may have been present. Recommend a qualified contractor evaluate and find potential moisture source.

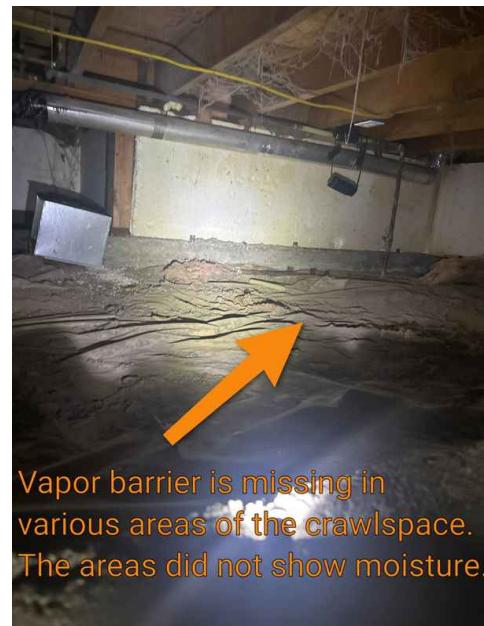
There is no vapor barrier beneath the flooring. This can result in unwanted moisture.

Vapor barrier is missing in various areas of the crawlspace. The areas did not show moisture.

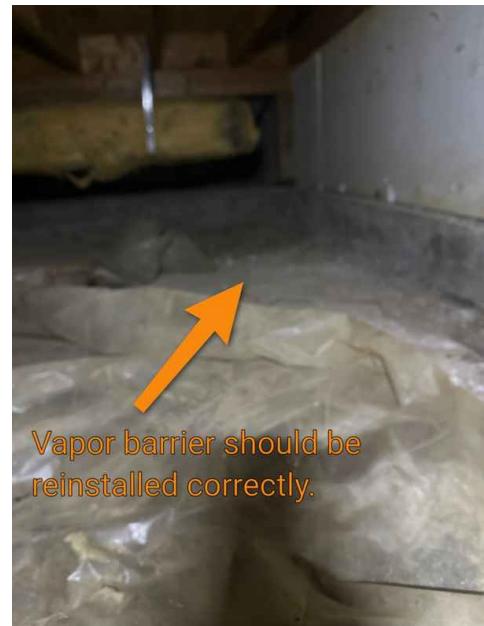
Vapor barrier is damaged in one or more areas. Recommend insulation contractor repair or replace.

Vapor barrier should be reinstalled correctly.

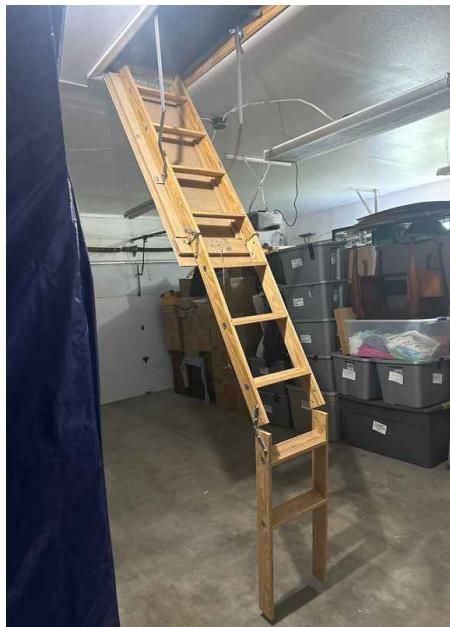
Attic access ladder does not extend all the way to the ground and should be replaced for safe access to the attic.

This attic access ladder was not properly installed and should be replaced so that the ladder extends all the way to the floor.

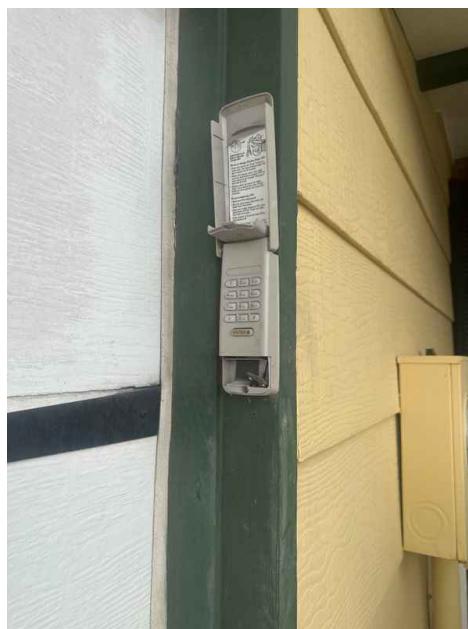
No battery in exterior keypad

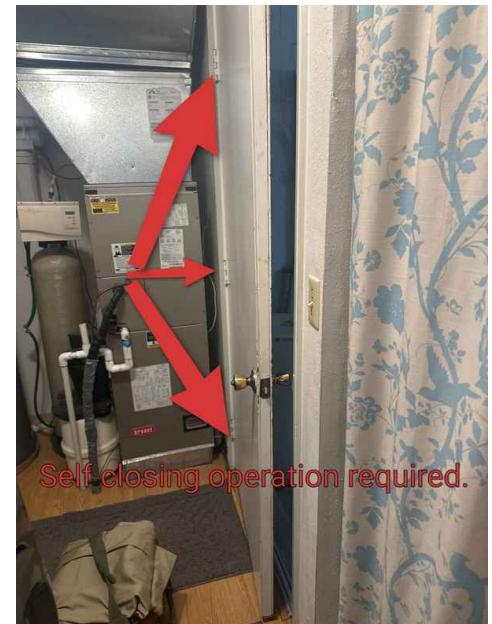
Door from garage to home should have self-closing hinges to help prevent spread of a fire to living space. Recommend installation of self-closing hinges.

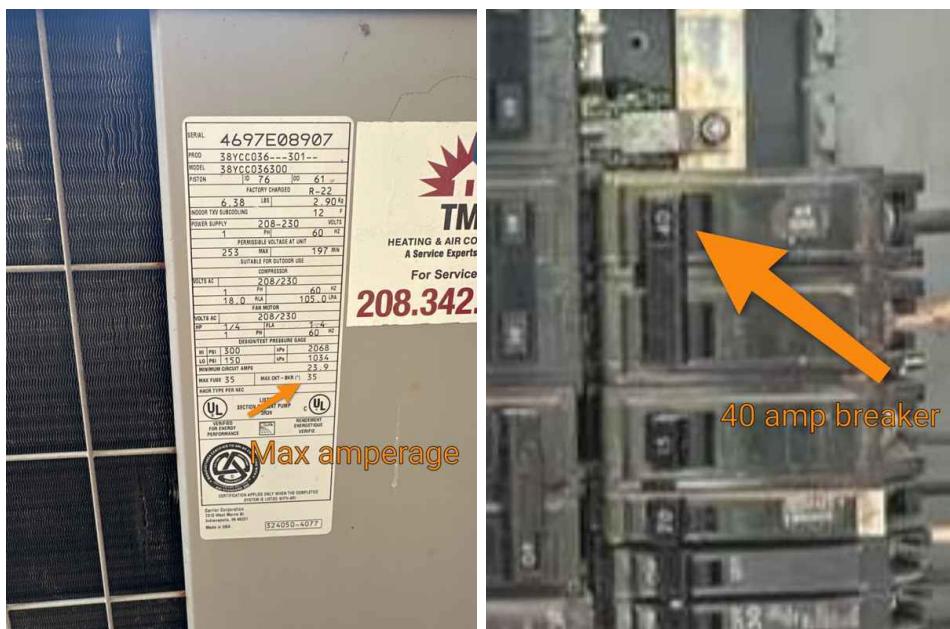
The proper size breaker needs to be installed for this equipment.

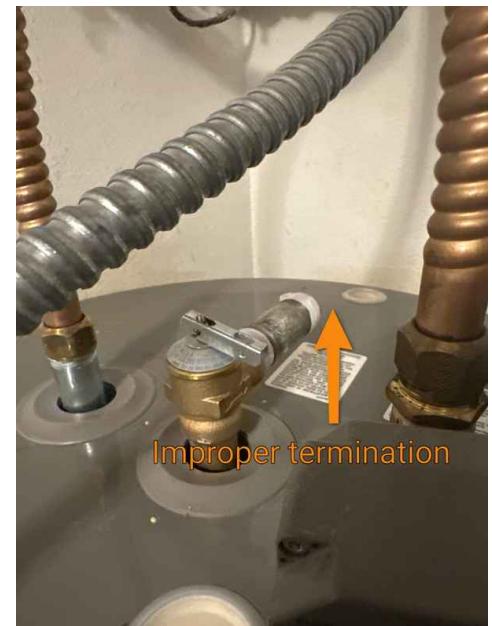
Discharge pipe is improper as it does not extend to the floor and is not straight.

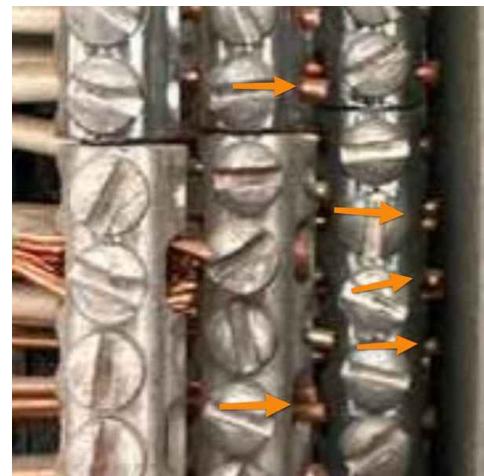
Connecting multiple conductors to single lugs is not proper. A licensed electrician should evaluate and repair as necessary.

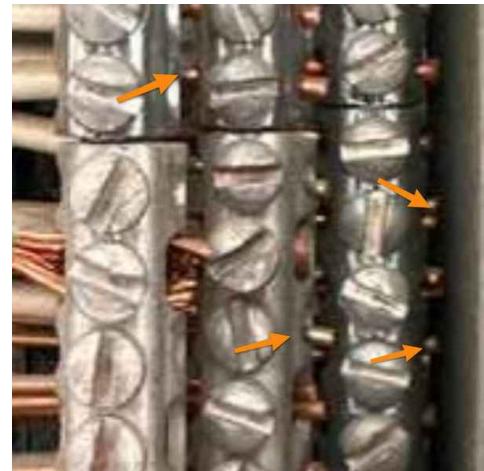
Aluminum wire appears to be installed on some branch electrical circuits in the subject premises. These single strand, branch circuit aluminum wires were used widely in houses during the mid 1960s and 1970s. According to the U.S. Consumer Product Safety Commission, problems due to expansion can cause overheating at connections between the wire and devices (switches and outlets) or at splices, which has resulted in fires. For further information on aluminum wiring contact the U.S. Consumer Product Safety Commission via the Internet at <http://www.cpsc.gov/>. It is recommended that the electrical system be evaluated by a licensed electrician.
