Solar PV String Inverter System Inspection Report

Project Name:	D. Jacobson & Sons Ltd	Contractors Name and Address
Installation Address:	Bacup Road, Rawtenstall, BB4 7PA	MBC Renewables Ltd 14 Fairview Drive Medomsley Edge Consett Co. Durham DH8 6QX
Tested by:	Michael Middlemast	Signature:
Project Reference:	JACOBSON001	
Commissioning Date:	2022	
Test Start Time:	29/05/2023 10:10 AM	
Test End Time:	30/05/2023 10:45 AM	
Rate kWp of plant:	100kWp

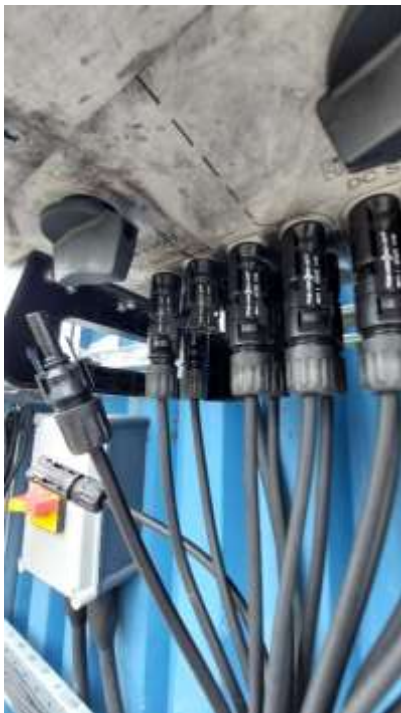
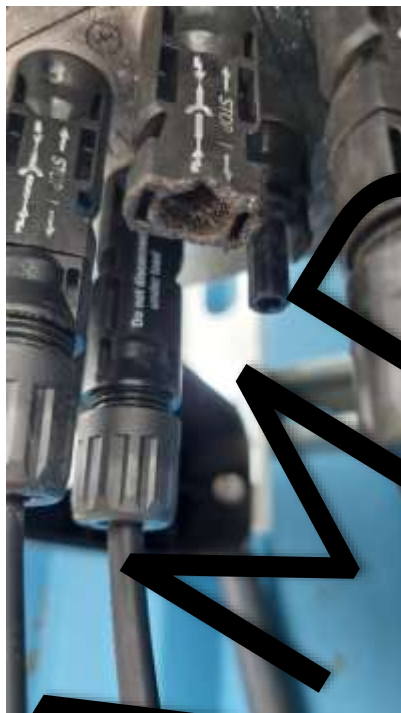
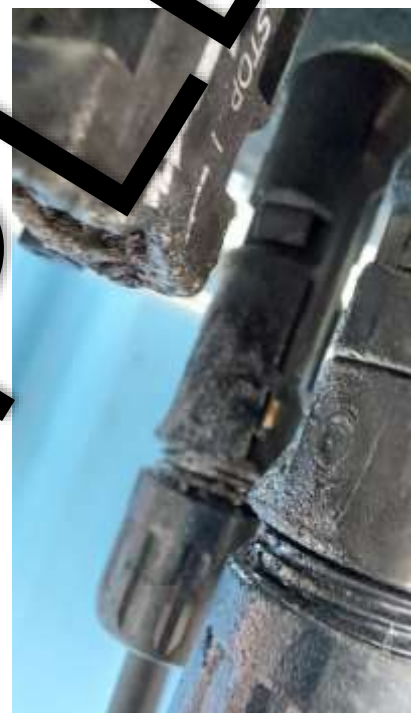
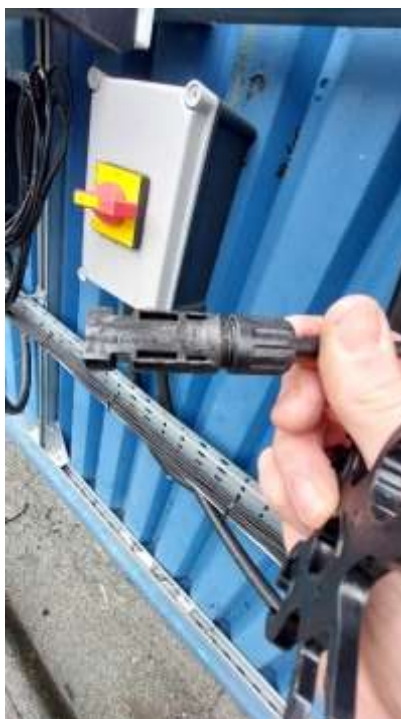
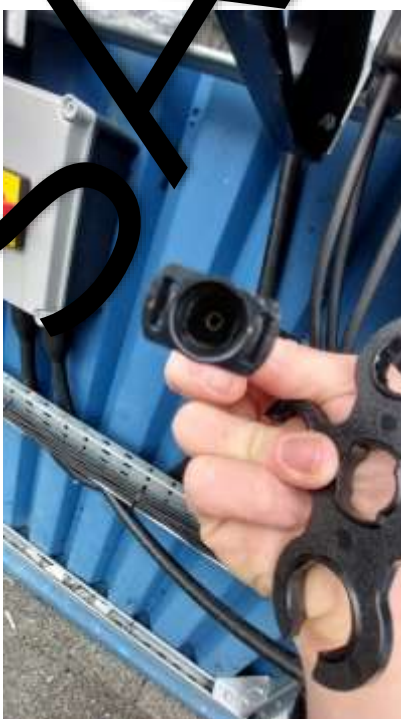
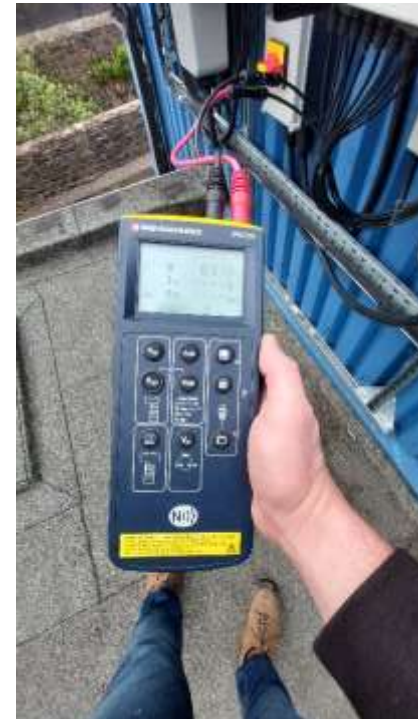
There are several **INSULATION FAULTS** within the cabling, this is stopping the system from working correctly and has also caused a **FIRE EVENT**:

Loose cables can be seen from the top side of the array.

These loose cables are then subject to the elements and movement over time. This loosens connections causing the insulation faults on the array.

The full width of cable trays has not been utilised and TAPE has been used to hold cables together (*see images*) this is not in line with code.

Inverters are exposed to the elements and harsh environment. This is not in line with the manufacturer's suggested installation instructions and **will void any warranty**. Suggest installation of housing and protective cover.

System is not properly grounded (*see images*)

Around the installation is litter from the installation crew and old installation manuals (*see images*). This poses further fire risk and suggests "bad practice" culture amongst installers.

Suggest original installer properly isolate and disconnect system from grid until remedial works are complete"
