**Revised**  
**FULL RESERVE STUDY**  
**Sunset Lakes**  
**Homeowners' Association, Inc.**

**Merritt Island, Florida**  
**Inspected - February 23, 2021**  
**Revised - October 15, 2021**

Sunset Lakes Homeowners' Association, Inc.  
Merritt Island, Florida

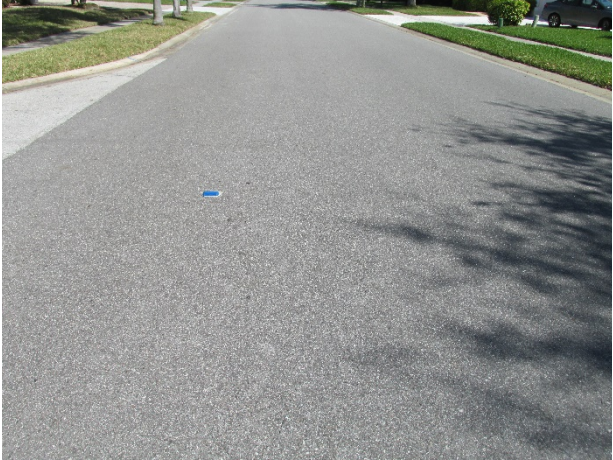
**Condition:** The section of pavement that was repaved in 2019 is in good condition. The remaining original pavement is in fair condition overall with settlement, longitudinal cracks, surface cracks, centerline cracks, slippage cracks, deterioration, potholes and raveling evident.

**Asphalt pavement repaved in 2019 on Sunset Lakes Drive**

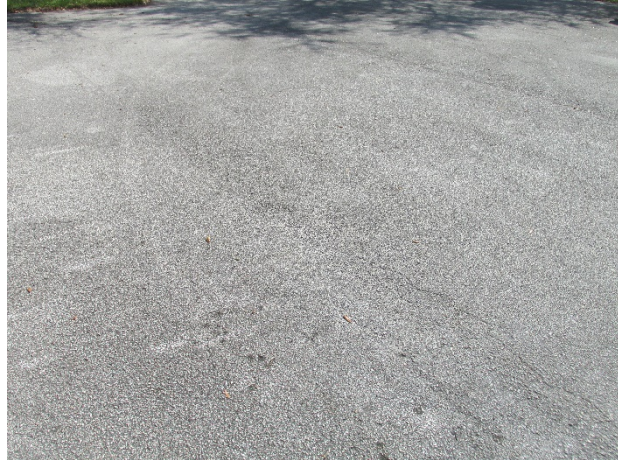
**Asphalt pavement at amenity parking area**

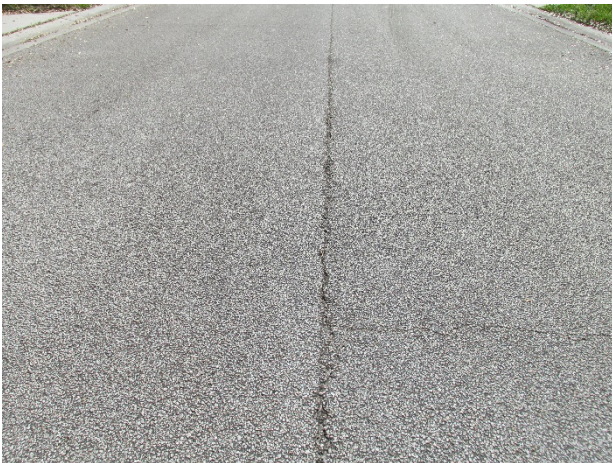
**Asphalt pavement on Sunward Drive – Note centerline cracks evident**

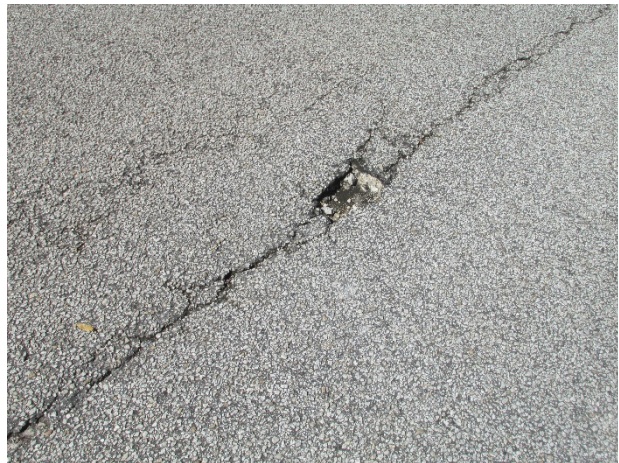
**Asphalt pavement on Sunward Drive – Note centerline cracks with pothole evident**

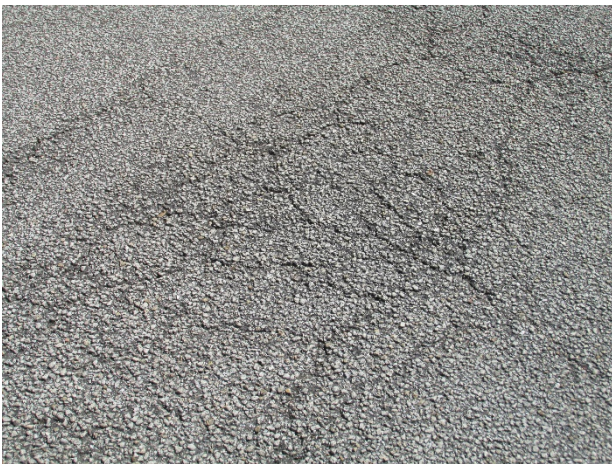
**Asphalt pavement on Sunward Drive – Note surface cracks evident**

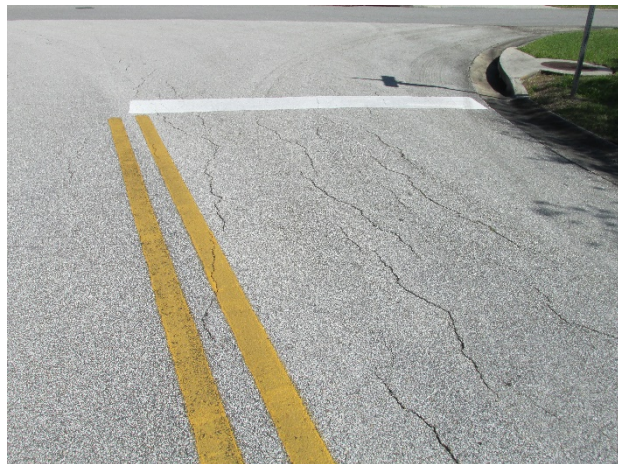
**Asphalt pavement on Sierra Drive – Note longitudinal cracks evident**

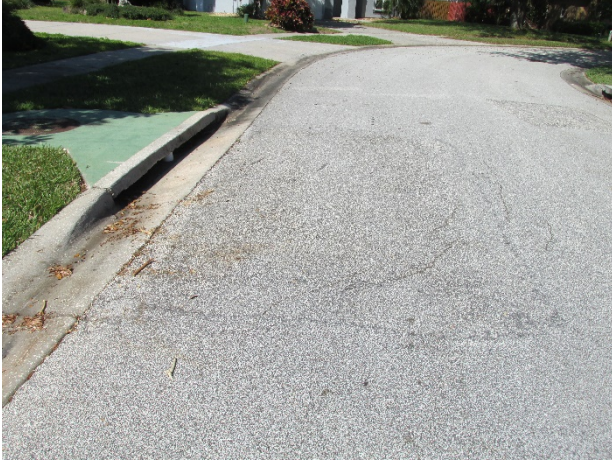
**Asphalt pavement on Sierra Drive – Note slippage cracks at catch basin evident**

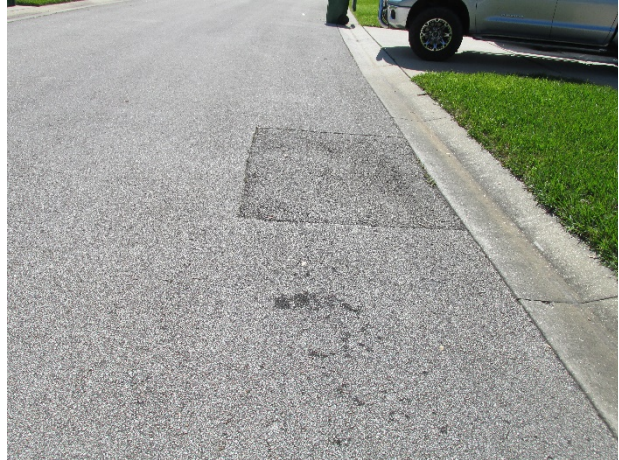
**Asphalt pavement on Sierra Drive – Note settlement at patch evident**

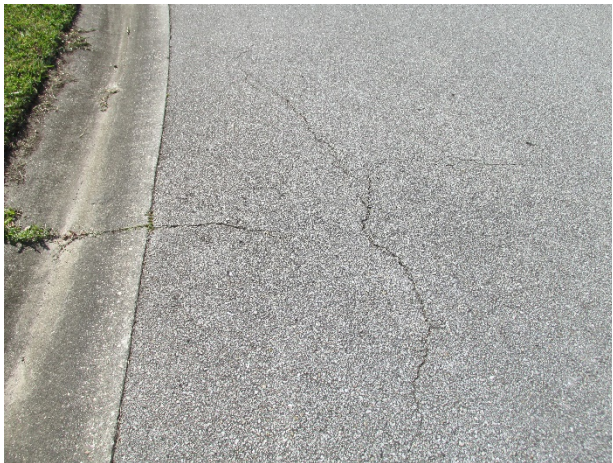
**Asphalt pavement on Killarney Court – Note surface cracks evident**

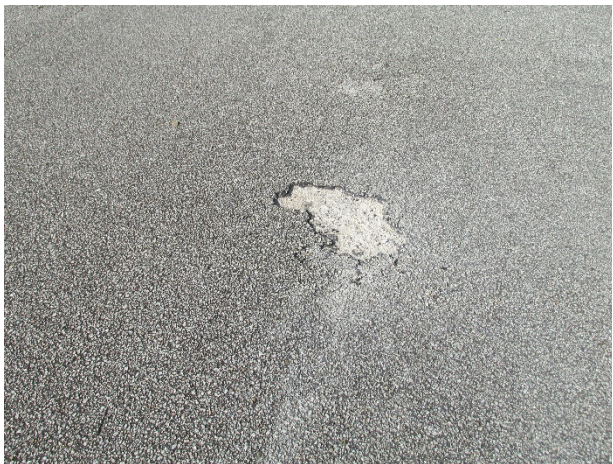
**Asphalt pavement on Tradewinds Trail – Note deterioration evident**

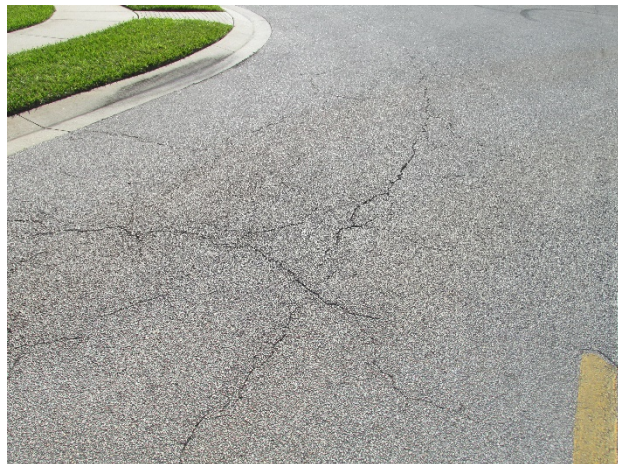
**Asphalt pavement on Windchime Place – Note surface cracks evident**

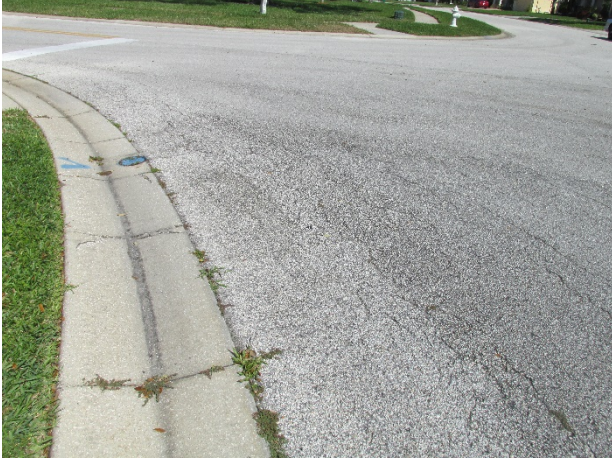
**Asphalt pavement on Sierra Drive – Note longitudinal cracks evident**

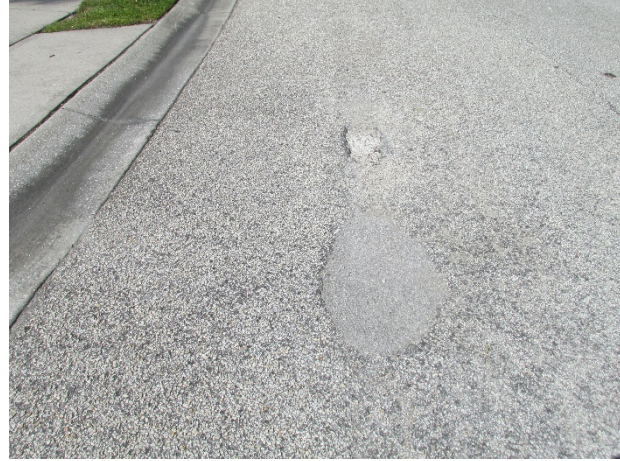
**Asphalt pavement on Sunbeam Court – Note raveling and deterioration evident**

The manner of repaving is either a mill and overlay or total replacement. A mill and overlay is a method of repaving where cracked, worn and failed pavement is mechanically removed or milled until sound pavement is found. A new layer of asphalt is overlaid atop the remaining base course of pavement. Total replacement includes the removal of all existing asphalt down to the base course of aggregate and native soil followed by the application of two or more new lifts of asphalt. We recommend mill and overlayment on asphalt pavement that exhibits normal deterioration and wear. We recommend total replacement of asphalt pavement that exhibits severe deterioration, inadequate drainage, pavement that has been overlaid multiple times in the past or where the configuration makes overlayment not possible. Based on the apparent visual condition and configuration of the asphalt pavement, we recommend the mill and overlay method of repaving at Sunset Lakes.

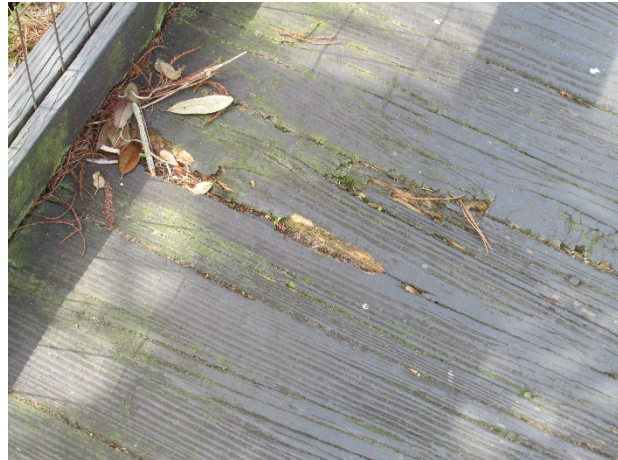
**Condition:** Fair to poor overall condition with deterioration of railing components and wood deterioration evident.

**Bridge with wood deterioration evident**

**Expenditure Detail Notes:** Expenditure timing and costs are depicted in the **Reserve Expenditures** table in Section 3. Our estimate of cost includes replacement of the wood decking, framing and railings, and up to twenty-five percent (25%) of the wood pilings. We suggest the Association fund interim repairs and paint finish applications through the operating budget as necessary.

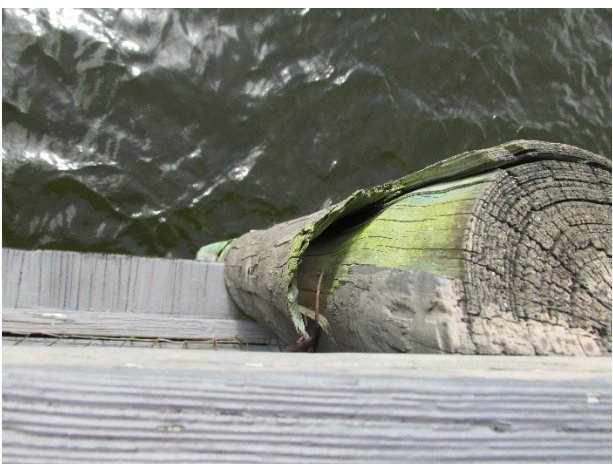
**Bridge with wood deterioration at piling evident**

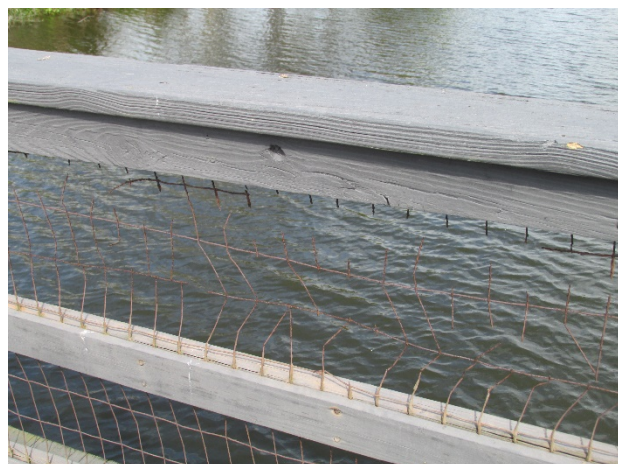
**Bridge with rust and deterioration evident at railing wire mesh**

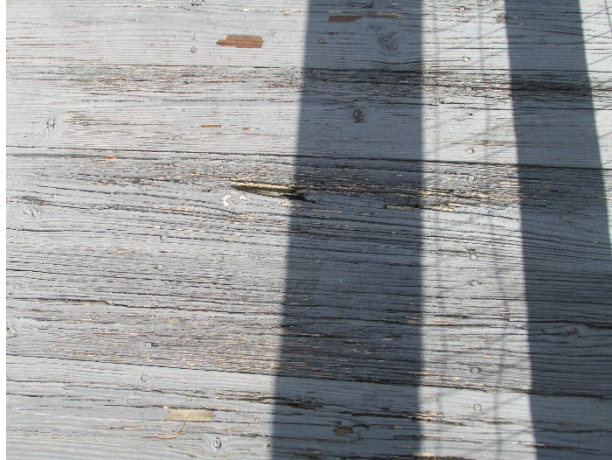
**Bridge with wood deterioration evident**

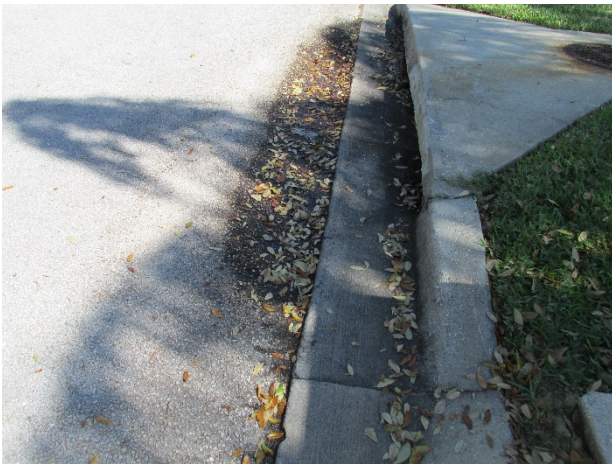
**Condition:** Fair overall with widespread settlement visually apparent

Catch basin with settlement evident on Sunward Drive

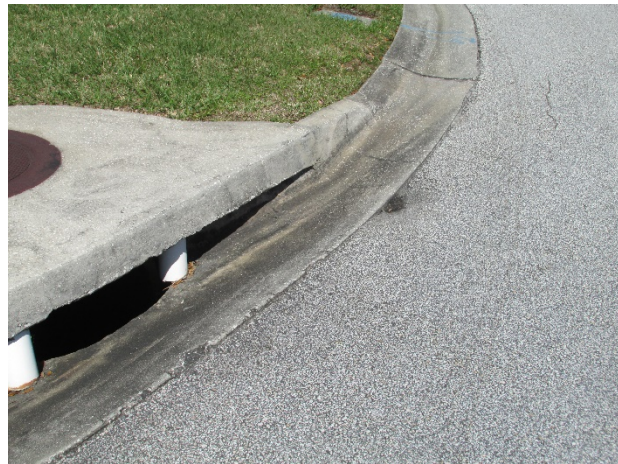
Catch basin with settlement evident on Sierra Drive

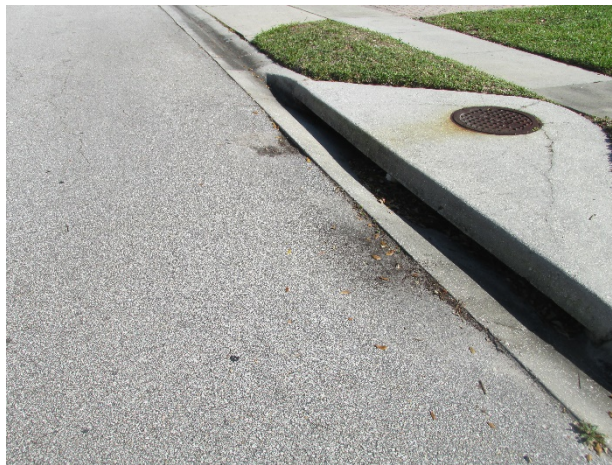
**Catch basin with settlement evident on Sunset Lakes Drive**

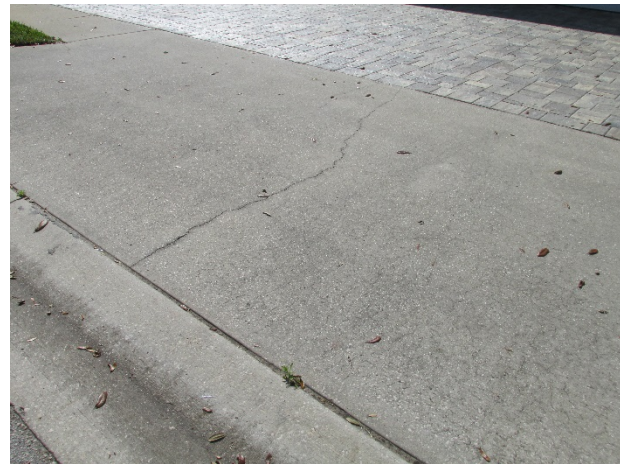
**Concrete apron with minor cracks**

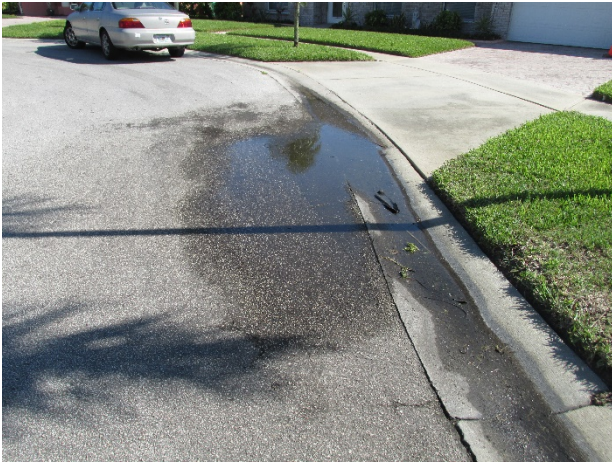
**Condition:** Good to fair overall with cracks and areas of settlement causing ponding water at driveways

**Concrete gutters with ponding water evident on Killarney Court**

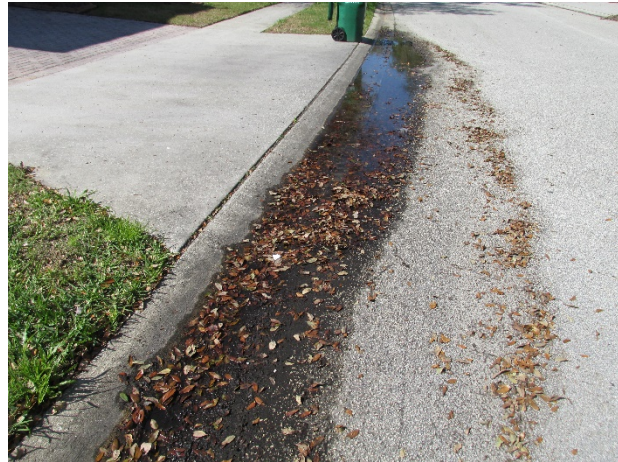
**Concrete gutters with ponding water evident on Tipperary Drive**

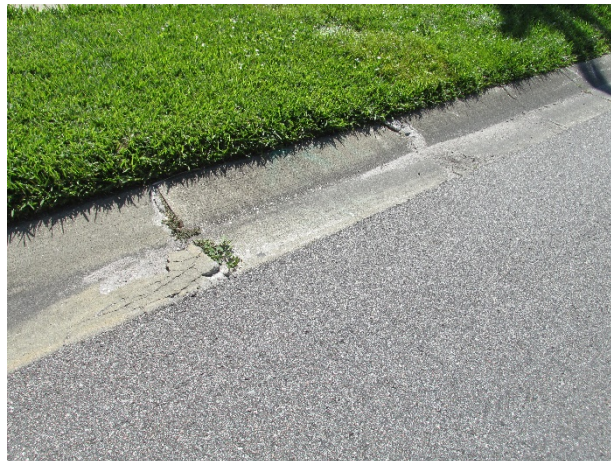
**Concrete gutters with cracks evident**

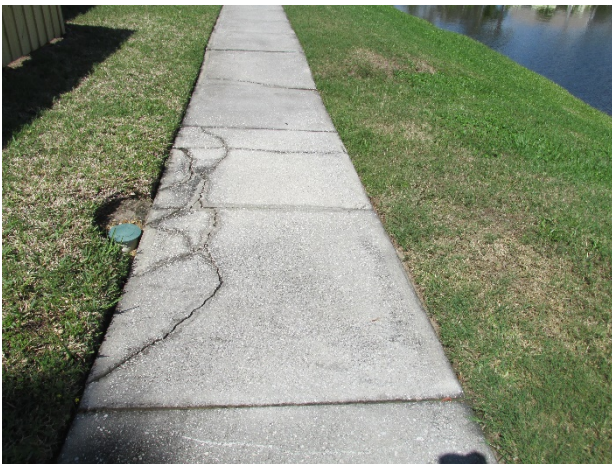
**Condition:** Good to fair overall with settlement (causing horizontal sloping conditions), trip hazards and cracks evident

**Concrete sidewalks with cracks and settlement evident**

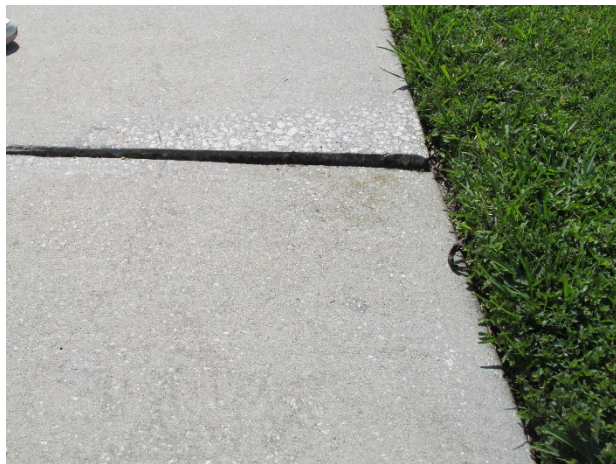
**Concrete sidewalk with trip hazard evident**

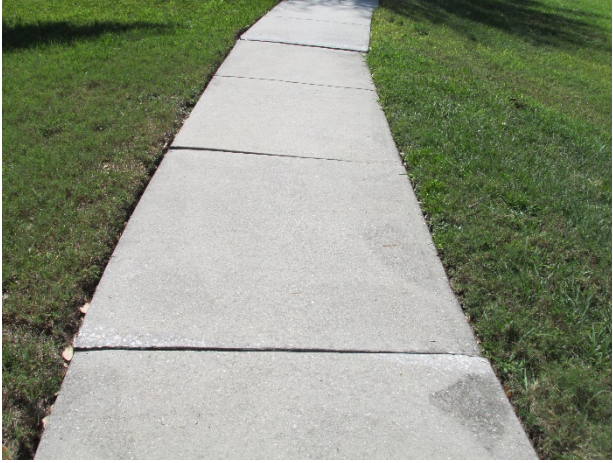
**Concrete sidewalks with settlement evident**

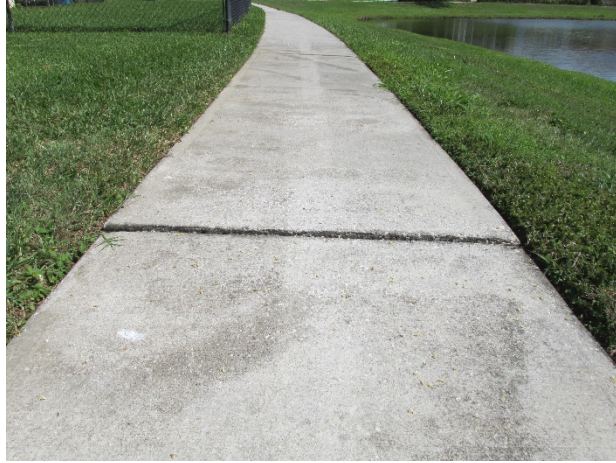
**Concrete sidewalk with trip hazard evident**

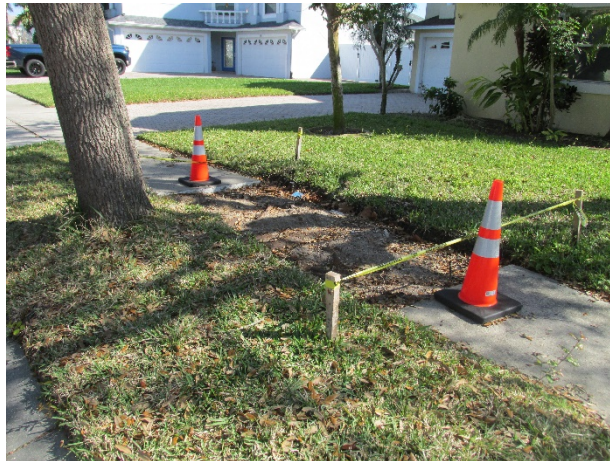
**Concrete sidewalks with replacements underway**

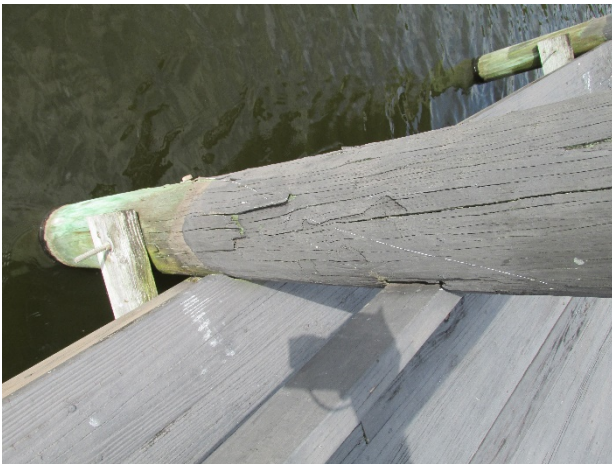
**Condition:** Fair overall with wood deterioration evident

**Wood piling deterioration evident**

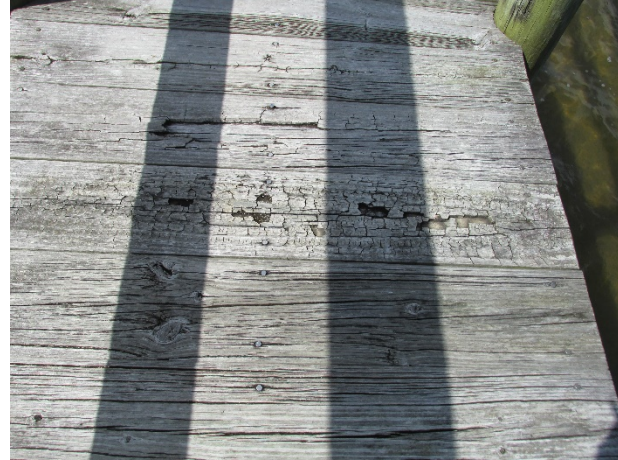
**Wood deterioration evident**

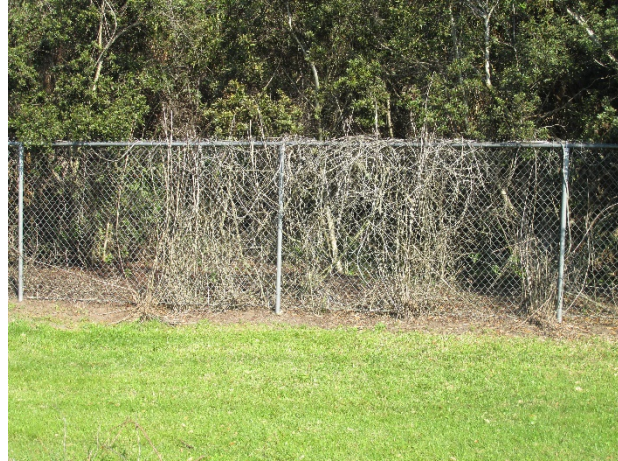
**Condition:** Fair overall with vegetation cover evident

Chain link fence with vegetation cover

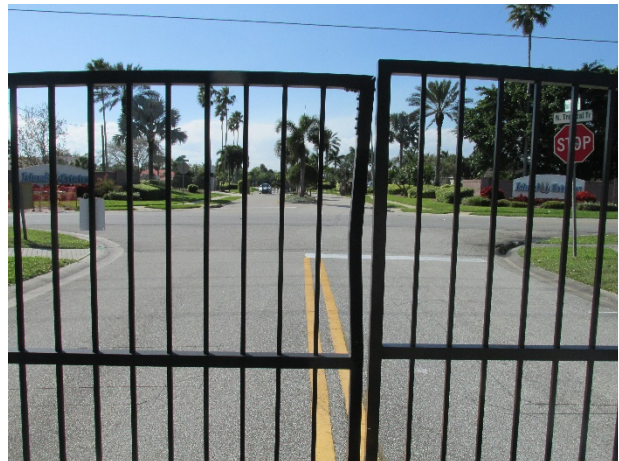
**Condition:** The gates are in satisfactory condition overall with some finish deterioration and damage evident. The gate operators are reported in unsatisfactory condition with a history of ongoing repairs.

**Gates with damage evident**

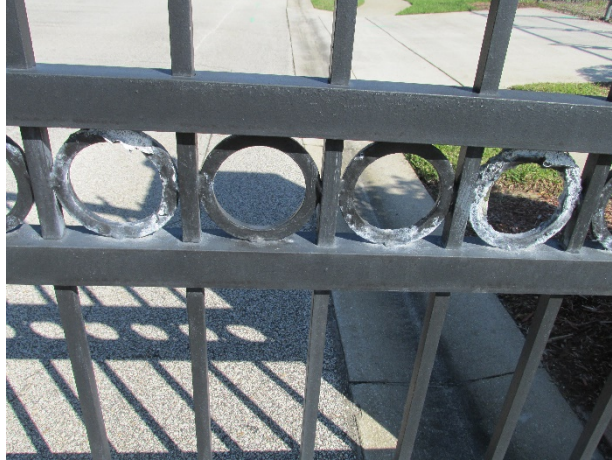
**Gate with finish deterioration evident**

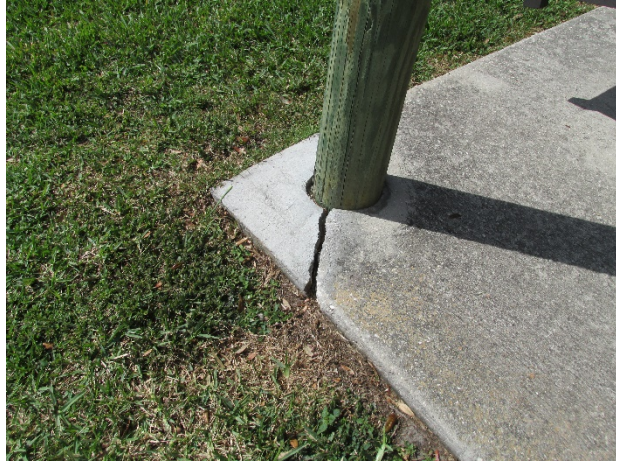
**Condition:** Fair overall with cracks evident at bases of posts

**Cracks at bases of posts evident**

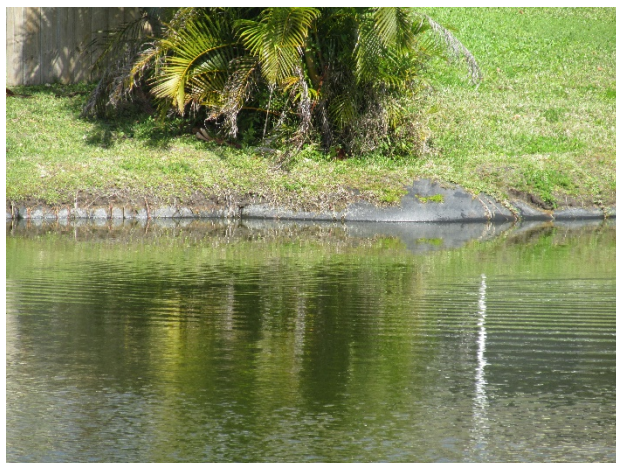
**Pond shorelines with geotubes exposed**

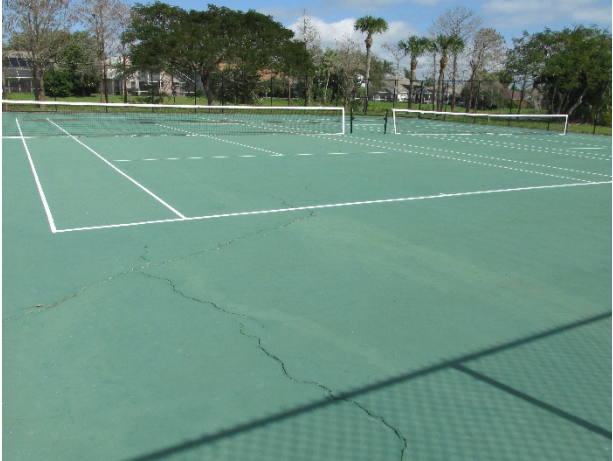
**Condition:** The tennis court is in poor overall condition and the basketball court is in good to fair overall condition.

Tennis courts overview

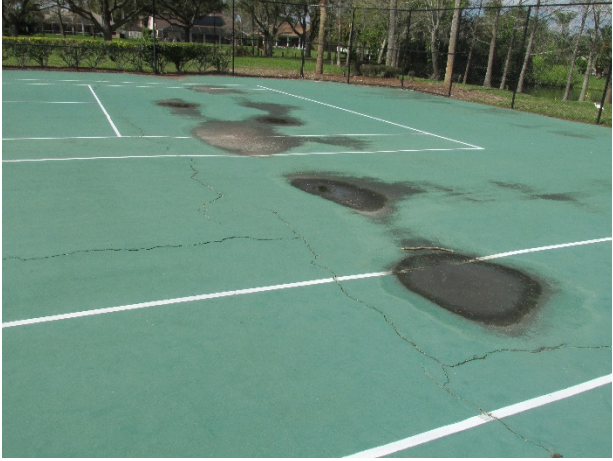
**Condition:** The tennis court is in poor overall condition with cracks and major settlement throughout, and the basketball court is in good to fair overall condition with cracks evident.

**Tennis court surface settlement evident**

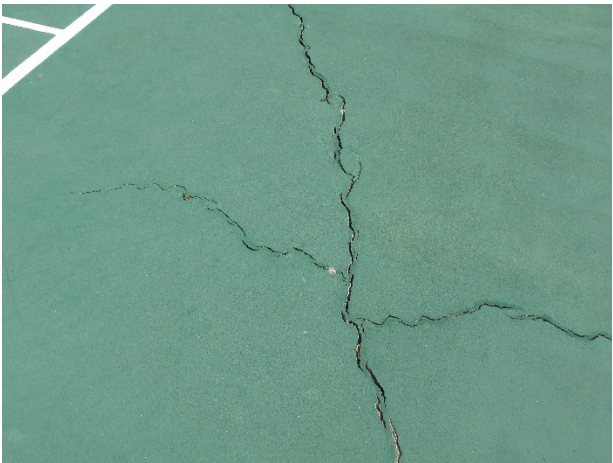
**Tennis court cracks evident**

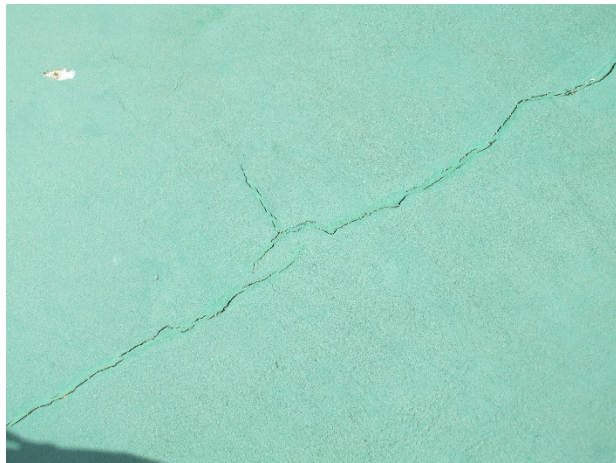
**Basketball court cracks evident**
