Case Study 4: Drone Roof Survey on an Industrial Unit with Trapezoidal Insulated Roofing Sheets.

30th September 2024

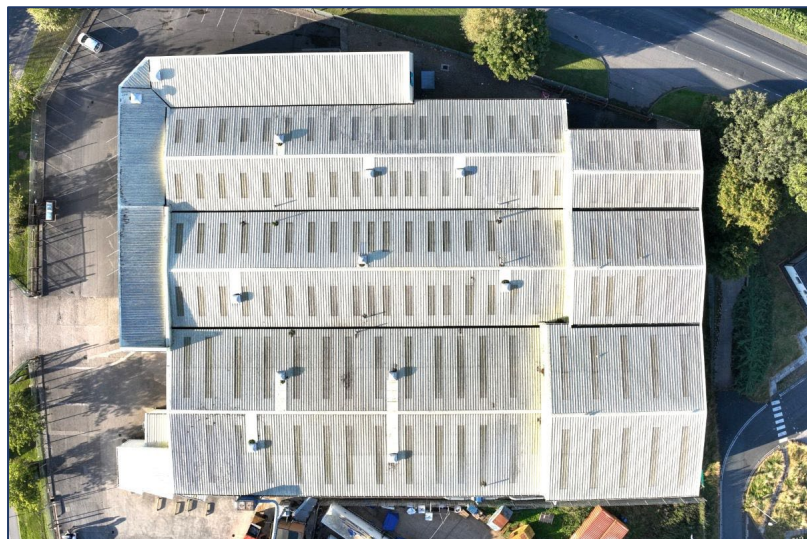
Figure 1. Nadir image of industrial unit with trapezoidal roof on portal framed building with 6 valley gutters. Yorkshire, UK.

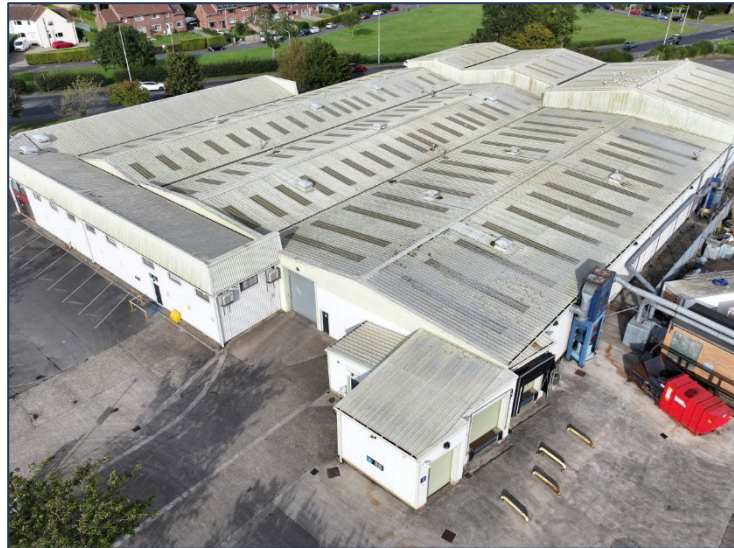
Figure 2. Low oblique image of a factory industrial unit from a drone roof survey and roof inspection in Yorkshire, UK.

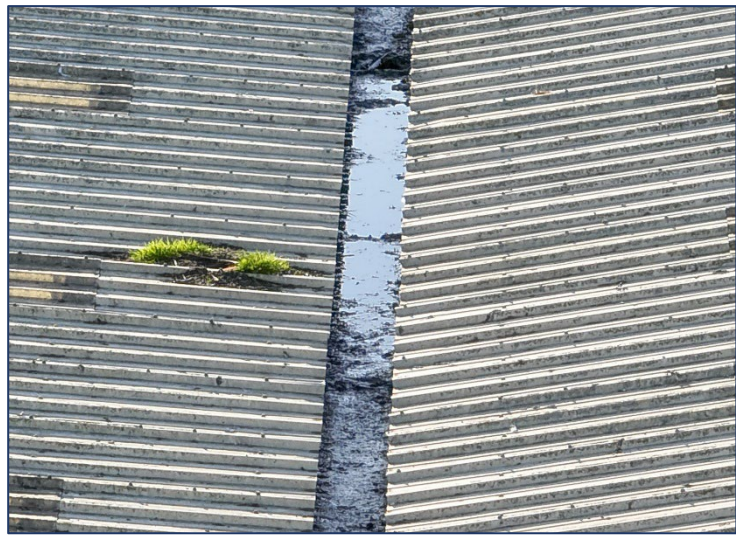
Figure 3. Valley gutter inspection, showing standing water, seagull guano buildup and vegetation on trapezoidal factory roof, from a roof survey in Yorkshire, UK.

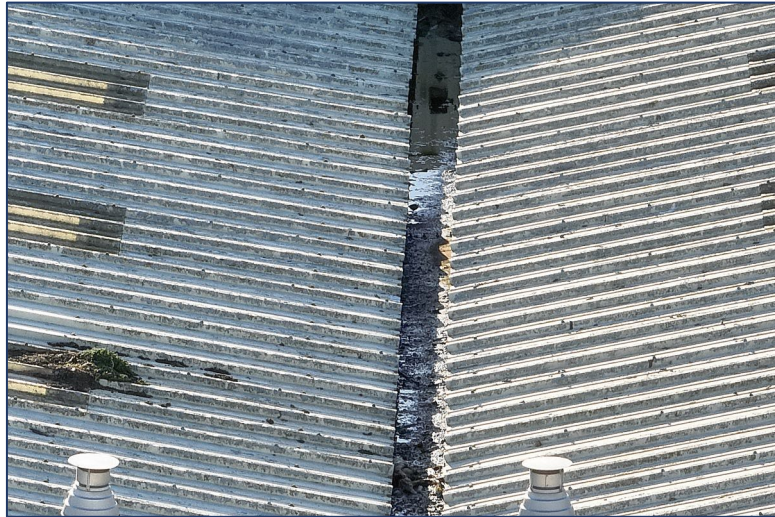
Figure 4. A close up of the a valley gutter showing signs of corrosion and seagull guano, requiring maintenance.

- **Moss, Lichen, and Vegetation Growth:** Large portions of the roof were covered in moss and lichen, which were trapping moisture against the roofing sheets. This was contributing to the corrosion of the galvanized gutters and increasing the risk of leaks.
- **Seagull Guano:** The seagull guano present on the roof posed a health hazard and had accelerated the degradation of certain roof sections. The drone captured clear images of the areas most affected by the guano, allowing for targeted cleaning and repair.
- **Corroded Valley Gutters:** The survey identified significant corrosion in the valley gutters, particularly in areas where water had been pooling. Rust was visible in several

maintenance locations, and the thermal imaging data confirmed that these areas were likely the source of water leaks into the building.

- **Roof Cleaning:** The roof required thorough cleaning to remove moss, lichen, vegetation, and seagull guano. This would prevent further damage and restore the roof's ability to shed water effectively.
- **Gutter Repair or Replacement:** The corroded valley gutters needed immediate attention. In some areas, repairs could be made, but in others, the gutters would need to be replaced entirely to prevent future leaks.
- **Waterproofing and Sealing:** Sections of the roof where water ingress was detected should be resealed or treated with a waterproofing solution to prevent further leaks.
- **Regular Maintenance:** Ongoing maintenance, including periodic cleaning and inspections, was recommended to prevent the buildup of contaminants and ensure the longevity of the roof.

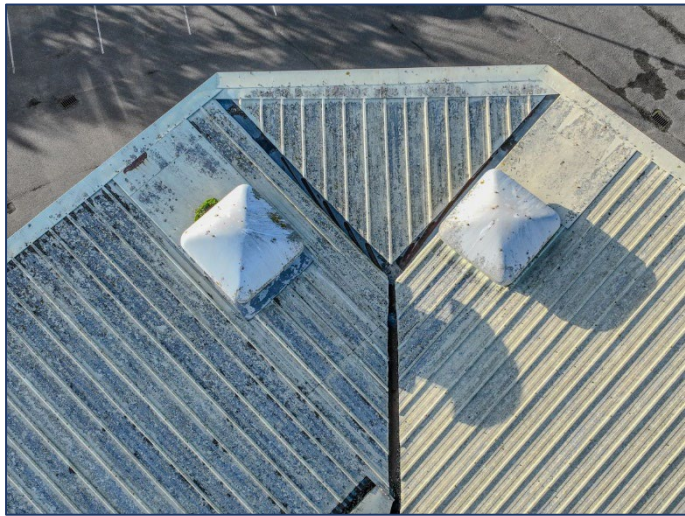
Figure 5. Corner detail of industrial roof with valley gutters showing slight sign of corrosion from a roof survey and inspection, in Yorkshire, UK.

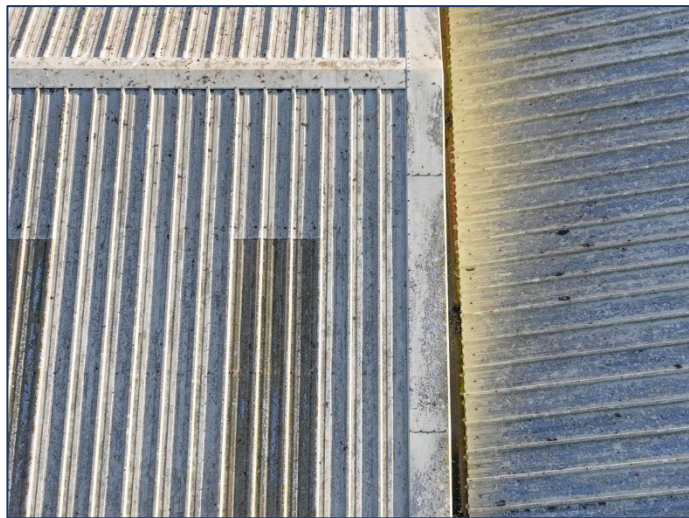
Figure 6. Image showing valley gutter on industrial roof with signs of corrosion.
