Case Study 2: Drone Roof Survey of a Block of Flats in Scarborough, North Yorkshire, UK.

2nd March 2024

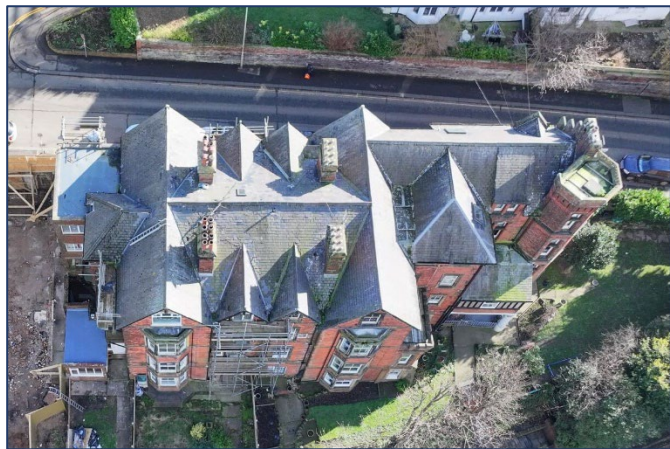
Figure 1. Aerial view of the block of flats.

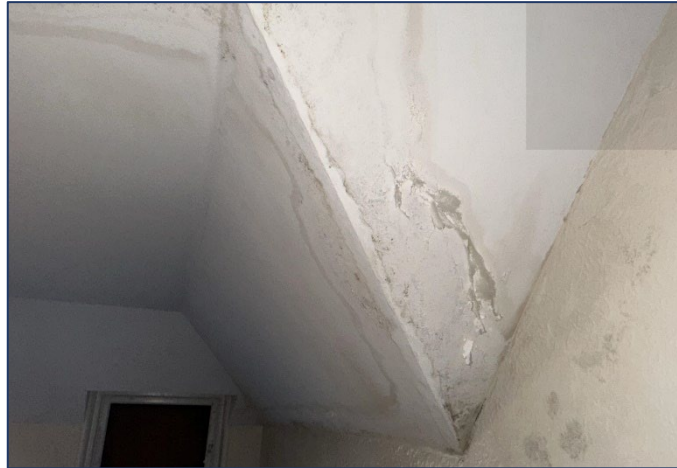
3. **Water Ingress and Dampness:** The most pressing issue was the water ingress that had caused extensive dampness in the top-floor flats. The dampness had led to the growth of small amounts of black mold, creating an unhealthy living environment.

Figure 2. Areas of damp in top stairwell.

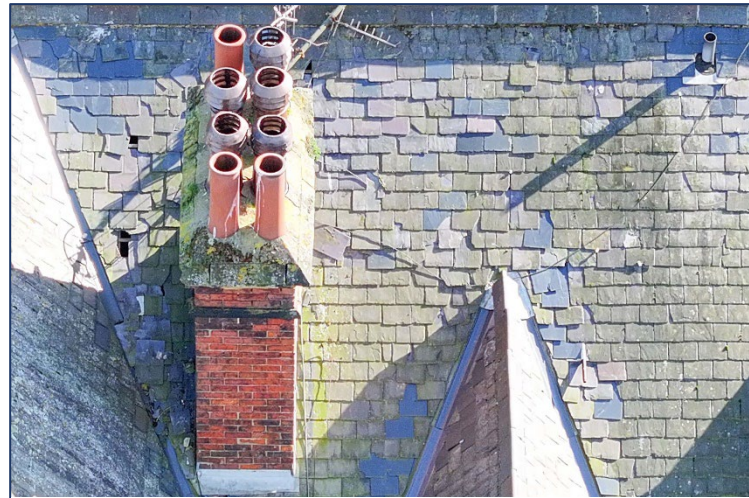
1. **Broken and Missing Slates:** The drone identified several areas where slates were either broken or missing entirely. These gaps were the primary entry points for water, leading to the issues experienced by the residents.
2. **Clogged Gutters:** The gutters were indeed filled with vegetation and debris, confirming the suspicions of the managing agent. The blockage was severe enough to prevent water from draining properly, exacerbating the dampness issue.
3. **Damage to Flashing and Chimney Stack:** The survey also revealed that the flashing around the chimney stack was damaged, further contributing to water ingress. The chimney stack itself showed signs of deterioration that needed attention.

Figure 3. Holes in the slate roof and many slates that were broken or displaced.

Next, the damaged and missing slates were replaced. The contractor sourced matching slates to maintain the aesthetic integrity of the roof, ensuring that the repairs blended seamlessly with the existing structure.

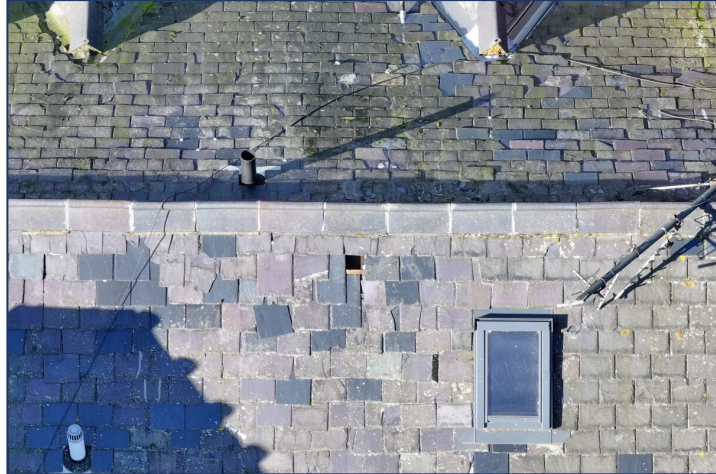
Figure 4. This image was taken 35 metres above the property, showing a hole in the roof caused by a missing slate.

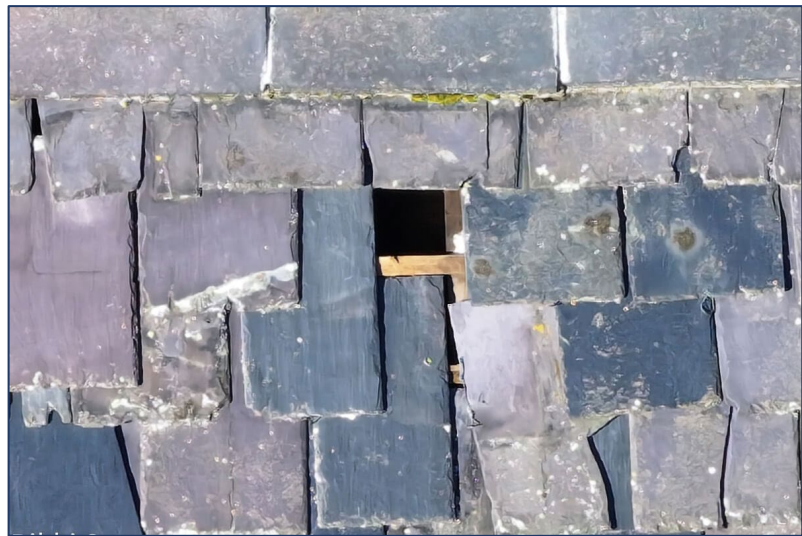
Figure 5. Zoom x 10 image of hole in roof, showing roofing lath underneath and part of a roofing truss.
