# RYZE Development Construction

## Property Damage Assessment Report

Room: Bathroom, Kitchen, Laundry, Living Room Bedroom (1,2,3) Other: **Hallway**

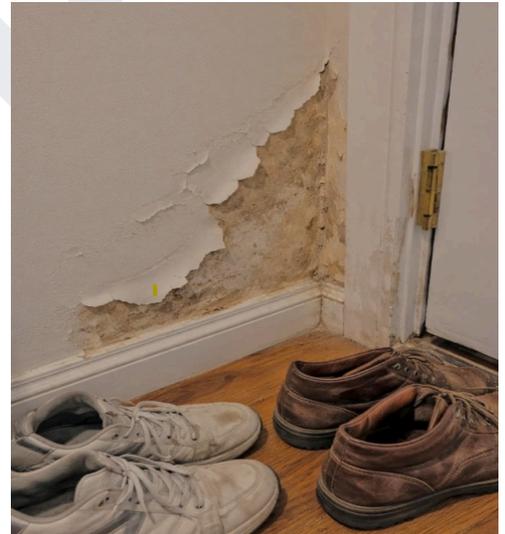
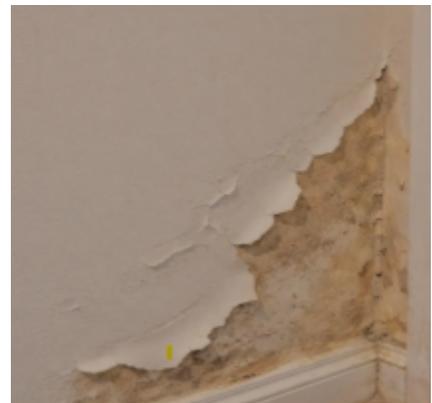
Localized deterioration to lower internal wall adjacent to door frame. Paint delamination and plaster breakdown evident at skirting level, with staining and material loss consistent with prolonged moisture exposure. Damage is concentrated near floor level and corner junction, with no visible impact damage or mechanical marks.

The pattern and location strongly indicate moisture ingress rather than impact or misuse. Likely contributors include:

- Rising damp or capillary moisture migration
- Minor water ingress from external wall or door threshold
- Long-term exposure to humidity without adequate ventilation

The damage progression suggests gradual degradation over time, not a sudden event.

- **Further degrade plaster and finishes**
- **Encourage mould growth**
- **Potentially affect timber elements and door framing**

The damage is assessed as **natural deterioration resulting from prolonged moisture exposure**, likely occurring over an extended period. There is no evidence to suggest accidental or deliberate human action contributed to the condition.

Moisture-related deterioration of this nature is progressive. If left unresolved, it can extend beyond the visible area, affecting adjacent wall sections, internal framing, finishes, and potentially floor or door components. Over time, this can lead to increased repair scope, higher costs, and potential compliance or habitability concerns. Early intervention is strongly recommended to limit further degradation and reduce long-term expense

Ryze Development Construction is equipped to manage this issue in full, including moisture source identification, rectification, and reinstatement works. Our team provides end-to-end remediation to restore affected areas and prevent recurrence, ensuring the asset is protected and compliant.
