**INNERARITY ISLAND UTILITIES SYSTEM
EVALUATION REPORT**

**INNERARITY ISLAND UTILITIES SYSTEM
EVALUATION REPORT
DECEMBER, 2013**

**Prepared by:
Kenneth Horne & Associates, Inc.**

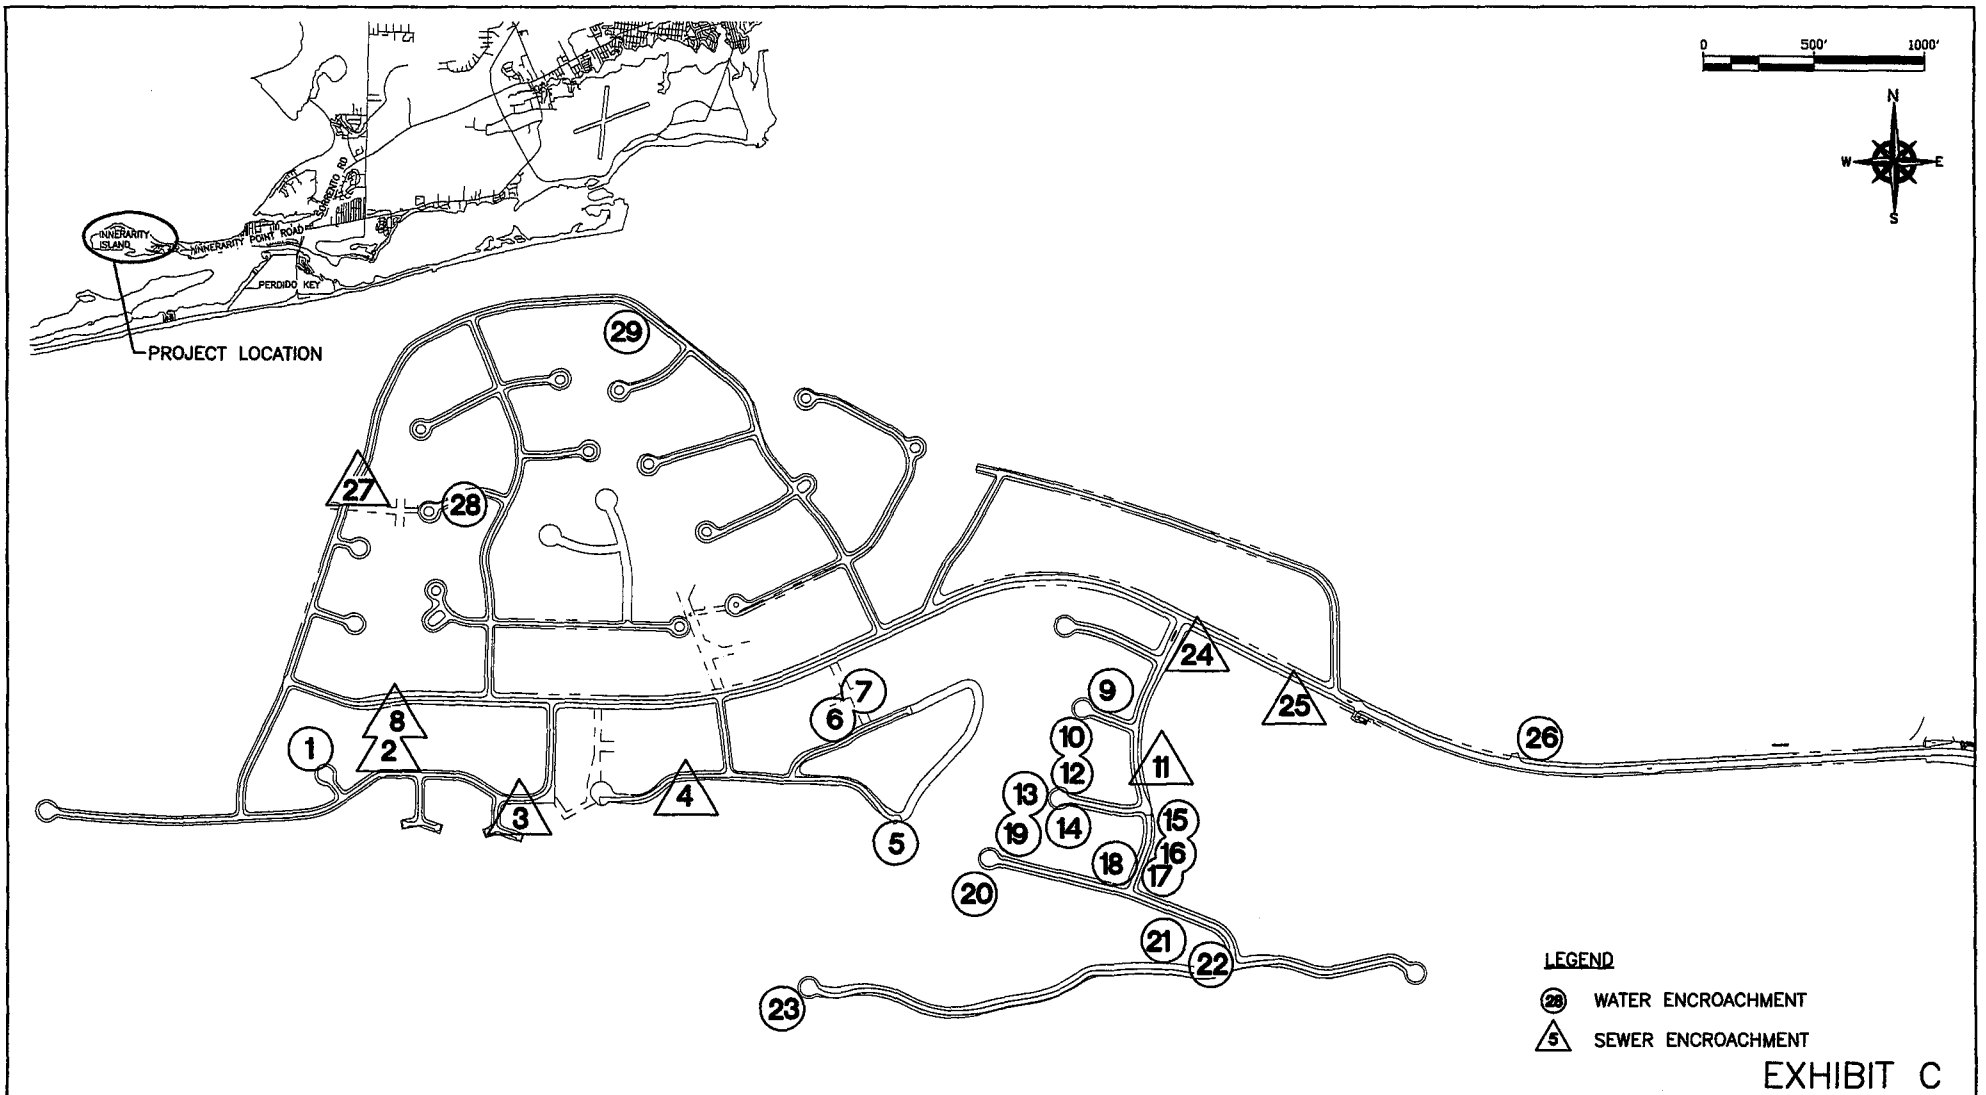
NO.	REVISIONS	APPROVED BY	DATE	PROJECT NAME: II UTILITY TRANSFER
1				UTILITY ENCROACHMENT-KEY SHEET
2				PROJECT NO.: 2013-11
3				BY: DIC DATE: DECEMBER 2013
4				SHEET 1 OF 26
5

Utility Encroachments Beyond Right-of-Way and/or Easement Lines. Exhibit C provides graphic representation of the locations where water distribution and sewer collection lines are installed outside the right-way per the survey. Table 5 below provides a quantitative summary of these encroachments.

The encroachments should be eliminated by removal and replacement of the encroaching utilities to a location within the existing right-of-way. The estimated cost of these relocations is depicted below in line items #1 and #2 of Table 6. A limited number of these encroachments may be mitigated by securing additional easements or right-of-way.

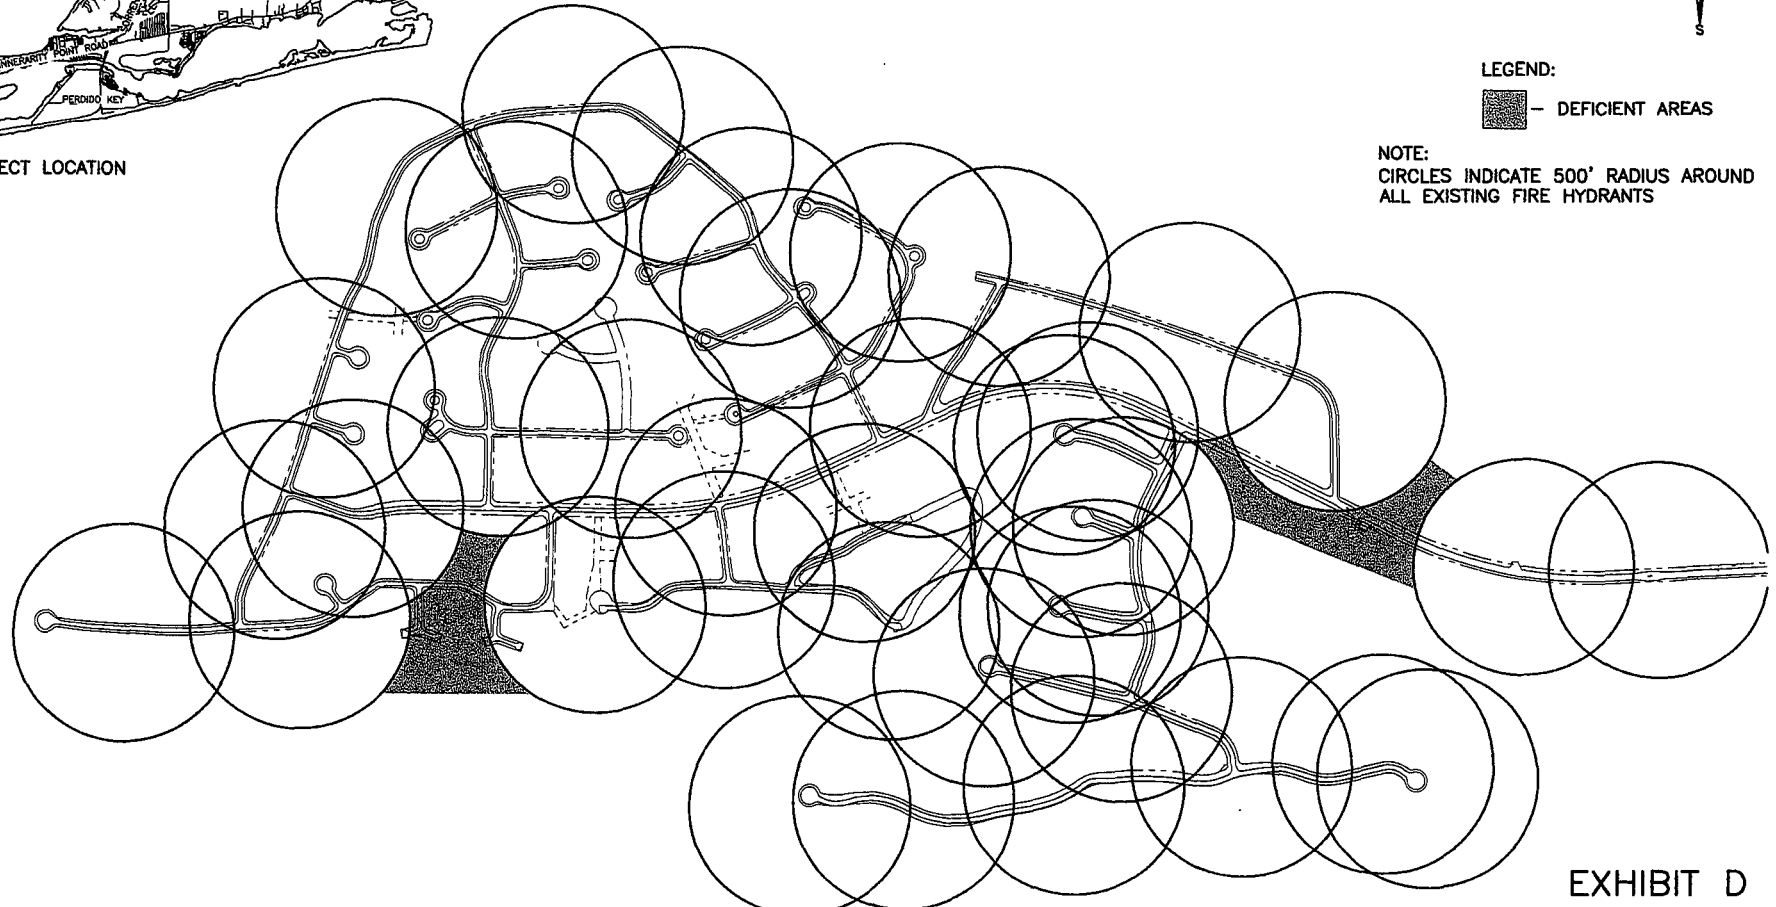
NO.	REVISIONS	APPROVED BY	DATE	PROJECT NAME: II UTILITY TRANSFER
1				FIRE HYDRANT LOCATIONS
2				PROJECT NO.: 2013-11
3				BY: DIC DATE: DEC 2013
4				SHEET 1 OF 1
5

Fire Flow Capacity. The Florida Fire Code (2010) requires a minimum of 1,000 gpm fire protection water flow to one and two family dwellings (Section 18.4.5.1.1). This value can be reduced by 50% if dwellings are provided with sprinkler protection and by 25% if the residences are spaced 30 feet apart. Sprinkler protection is not provided to the dwellings, however the residences are generally 30' apart. The desired fire flow at each hydrant is therefore 750gpm. The Ten States Standards for water distribution systems states that the minimum acceptable pressure in the water distribution is 20 psig (Part 8, paragraph 2.1). The Escambia County "Land Development Code" requires a 500 feet maximum distance from a residence to a fire hydrant (Part II, Article 4, Section 4.04.12).

As documented in Table 4 above, there are no locations where fire flow capacity and associated residual pressure met or exceeded the accepted standards to support new residential development at the time the tests were conducted. Exhibit D provides a graphic representation of the areas of the development currently within the required 500 feet of a fire hydrant. Note that there are two areas of current residential development outside the 500 foot radius.

Potential measures to improve fire flow capacity include: a) increasing distribution main size around main "loop" and along the entire length of Innerarity Point Road (see Exhibit E), b) adding finished water storage at the west end of the island, and c) adding three new fire hydrants to close gaps in fire hydrant coverage. Below, Table 6 details the estimated costs for these improvements.

We have assumed replacement of the existing 6" main along Innerarity Point Road and North Shore Road with an 8" water main (approximately 8,800 LF) and adding 250,000 gallons of finished water storage on the west side of the island. For estimating purposes, elevated storage has been assumed. It is possible that ECUA may prefer ground storage with high service pumps.
