INNERARITY ISLAND UTILITIES SYSTEM EVALUATION REPORT

Kenneth Horne & Associates, Inc.
CIVIL ENGINEERS

Prepared for:
Escambia County

OCTOBER 28, 2015

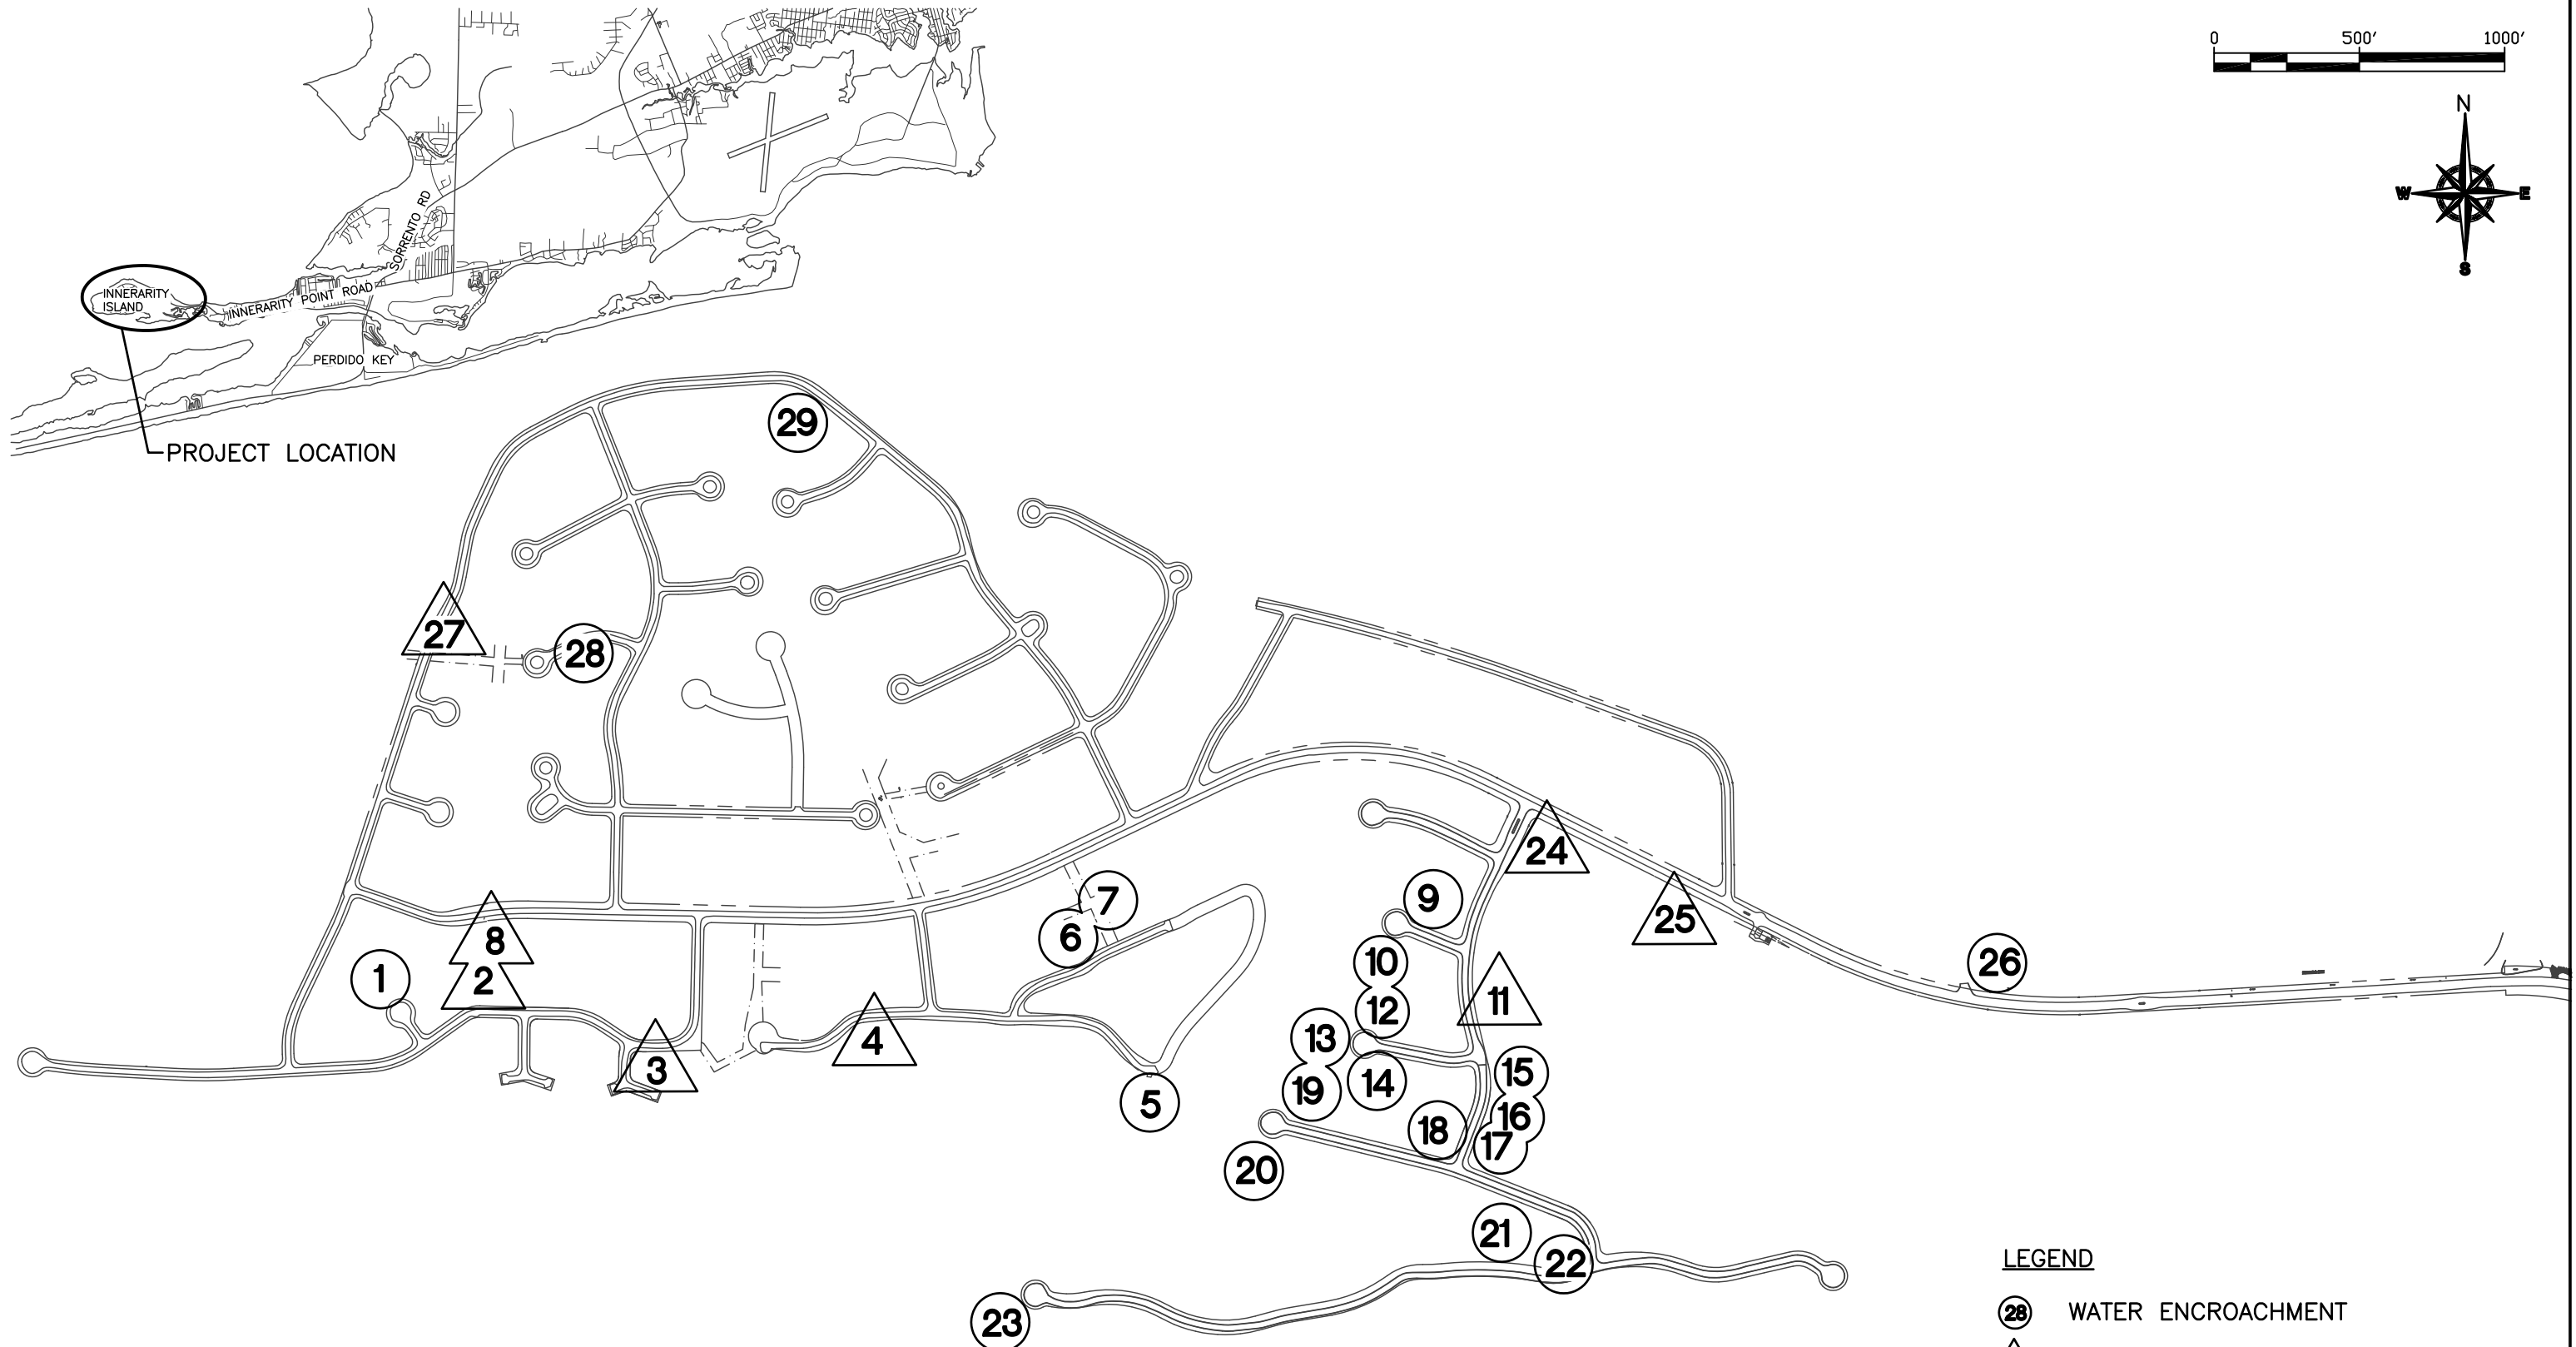
- 28 WATER ENCROACHMENT
- 5 SEWER ENCROACHMENT

The encroachments could be eliminated by removal and replacement of the encroaching utilities to a location within the existing right-of-way. As an alternative to relocation, these encroachments may be mitigated by securing easements allowing the mains to remain in place. This item has been zeroed out of the estimated cost on the assumption the II HOA will assist in securing the necessary easements.

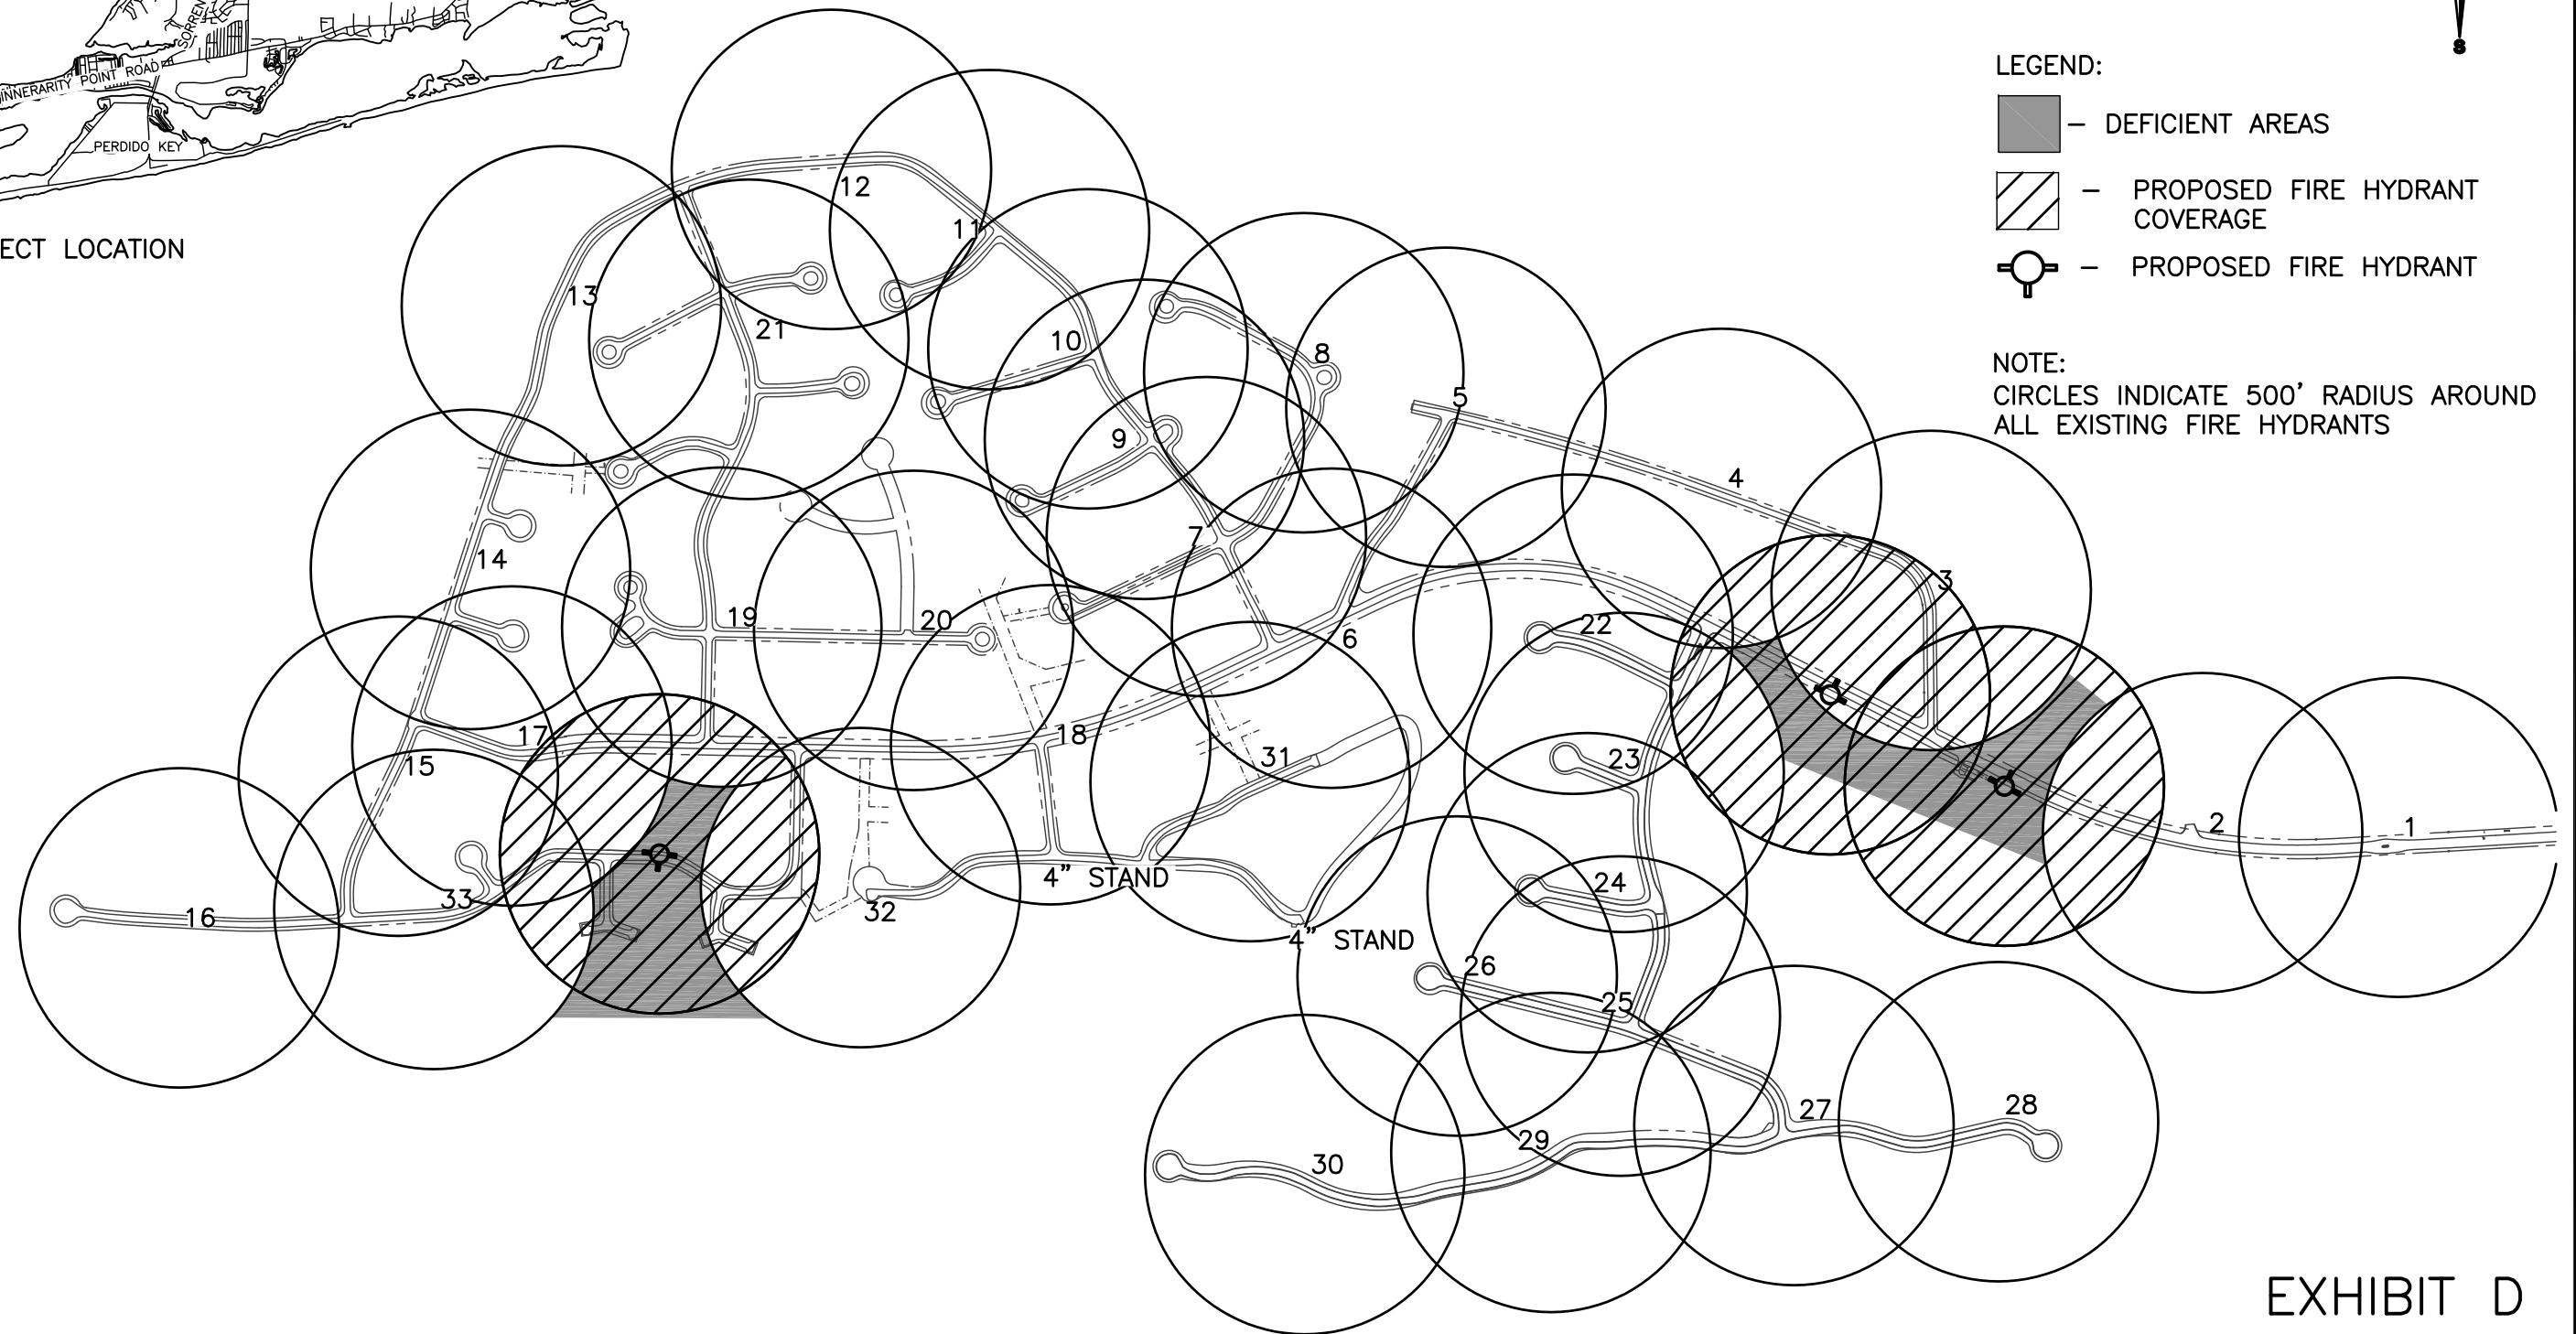
EXHIBIT D

- DEFICIENT AREAS
-

CIRCLES INDICATE 500' RADIUS AROUND ALL EXISTING FIRE HYDRANTS

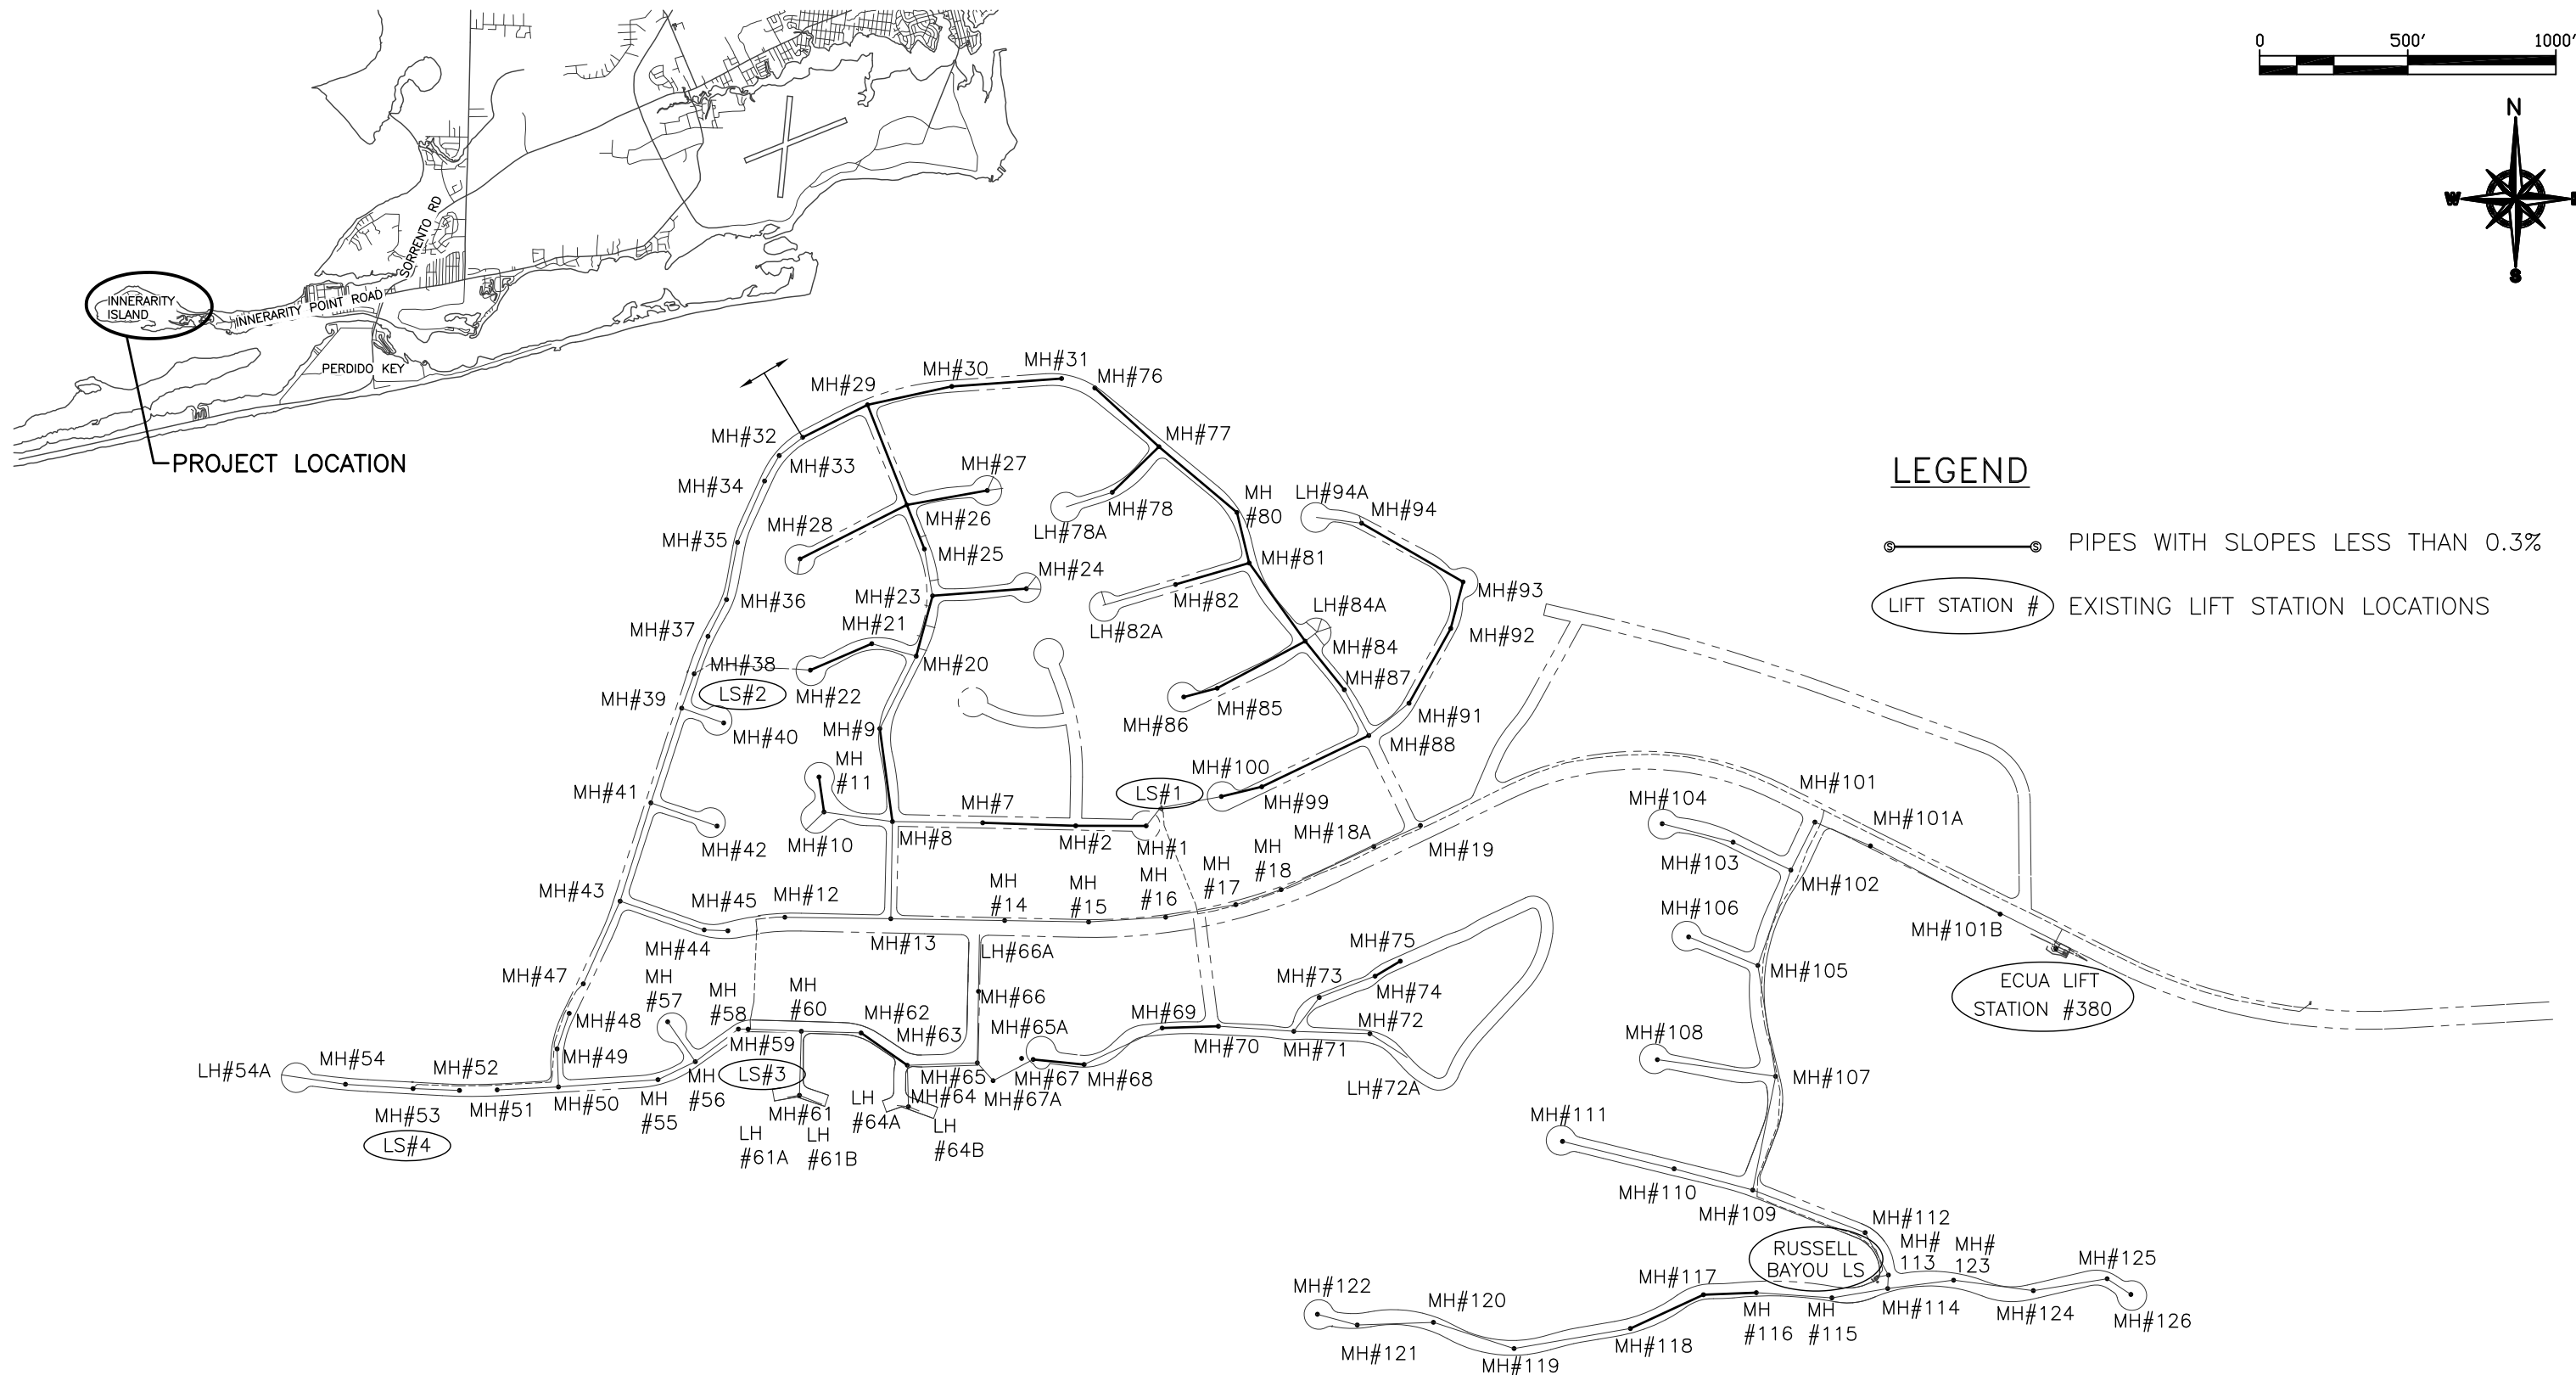
— PIPES WITH SLOPES LESS THAN 0.3%

The repair of the sewer system by replacement of lift stations and low slope lines has been determined to be cost prohibitive. Replacement of the bulk of the collection system on the
