Home Inspection Prepared for
John Doe
Jane Doe

123 Main Street
Frisco 75035

Inspection Date : 07/08/2024

PROPERTY INSPECTION REPORT FORM

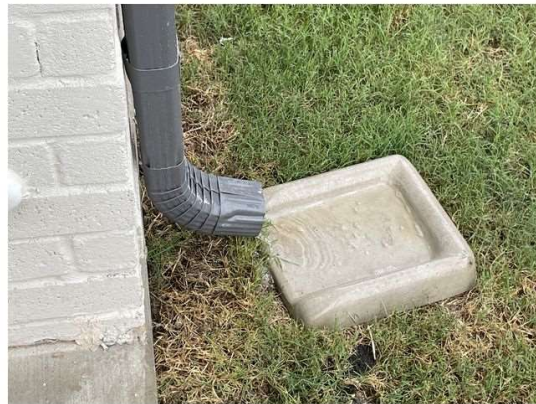
—» Gutters draining too close to the structure

- IRC (International Residential Codes) Guidelines recommend gutter down spouts discharge 5 feet from the edge of the foundation, however this is NOT a requirement

- what is pictured above appears to be the norm for builders in the NTX area

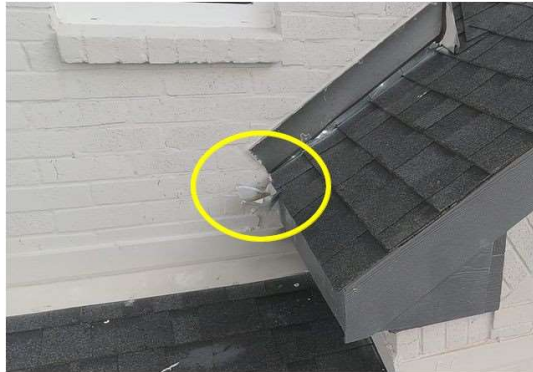
→» Flashing is lifting, ill configured, or missing

- kick flashing is torn or not attached at step flashing
- allows excessive water from roof to run down brick
- recommend repair by builder's contractor

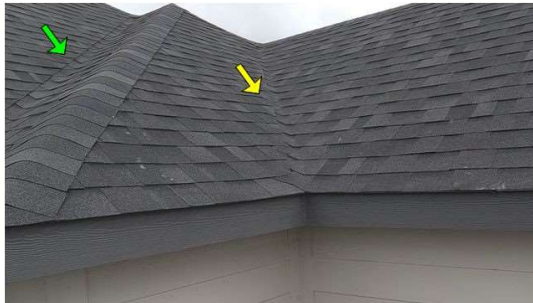
→» Improper valley cut at back of house

- green arrow indicates correct placement of cut edge - 2" above valley center line towards larger section of roof
- yellow arrow indicates incorrect placement of cut edge - 2" inches above valley center line on smaller section of roof

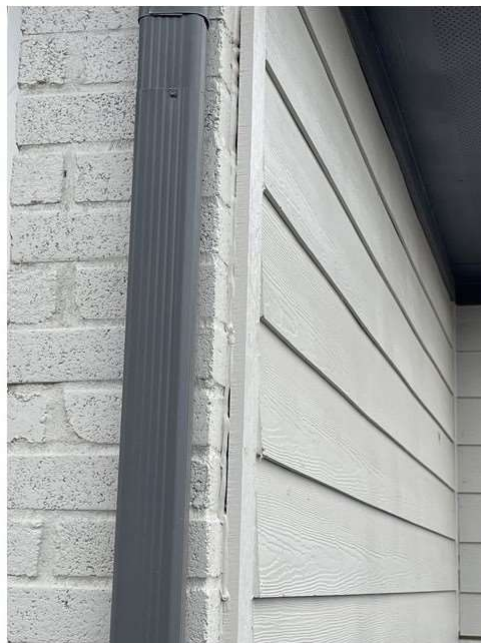
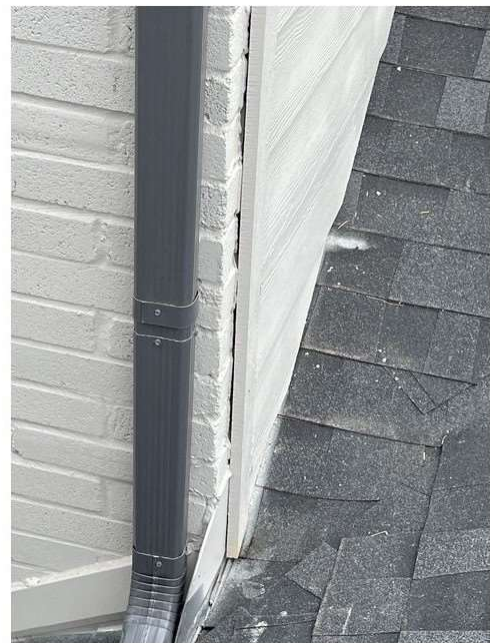
→ **Caulking / sealant is separated or missing in some areas**

- edge of siding above garage (towards narrow breeze way) needs re-caulking at junction with brick
- moisture from rain can enter and potentially cause rot and/or mold on wood framing

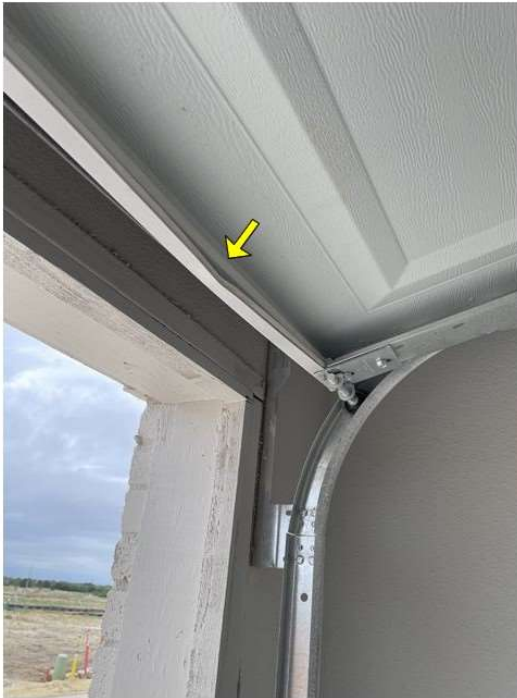
→ Doors / panels are damaged

- Small bend in bottom right (looking from inside) panel

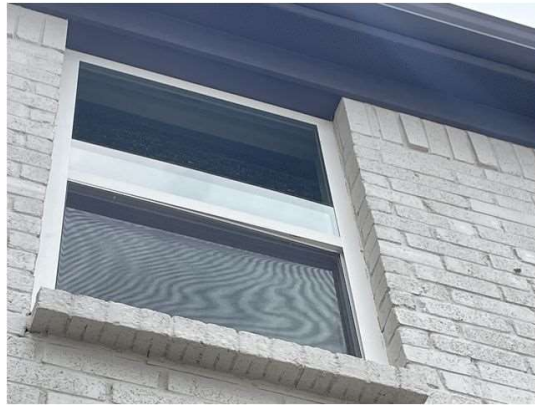
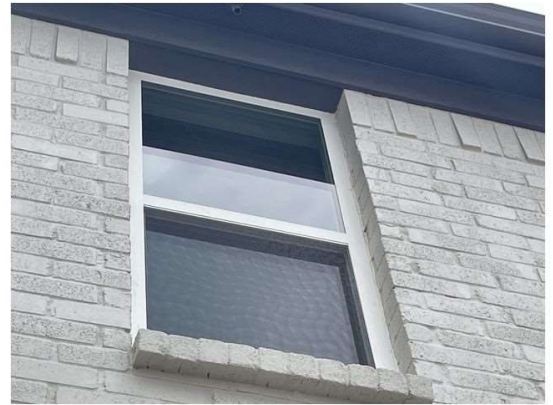
- left - bedroom 4, right - game room next to entrance to bedroom 5

→ Caulking damaged and/or missing on exterior

- Back 3 windows of upstairs on left side of house need re-caulking on exterior

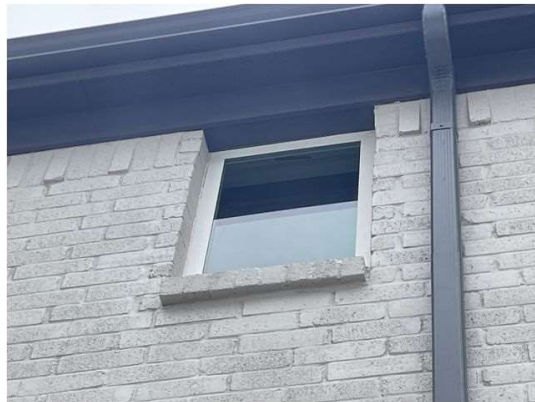
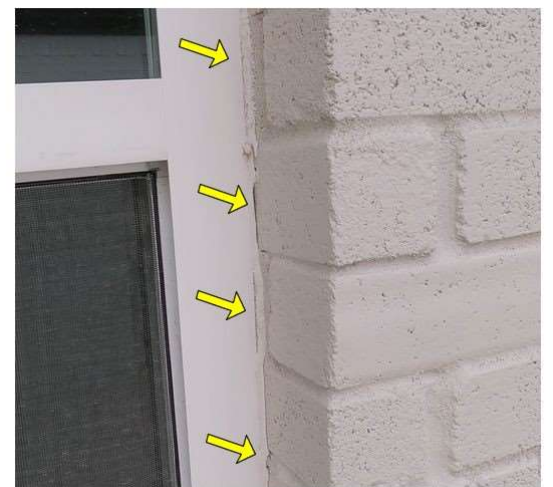
- left - window above top of stairs, right - close-up of caulk job
- recommend repair by builder's contractor

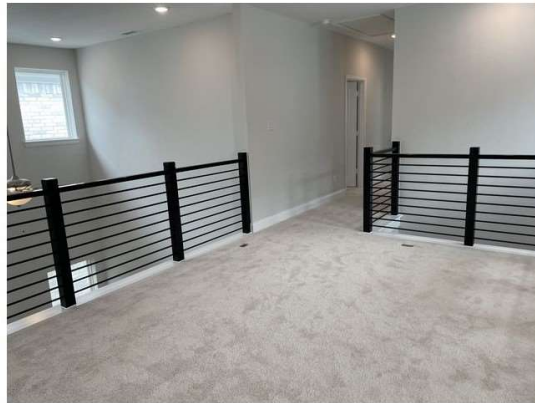
→ Balusters in hand railings of game room not vertical

- IRC guidelines recommend balusters should be vertical and that space between balusters be a maximum of 4" - this prevents children from climbing over or slipping between balusters
- this is considered a safety hazard as the handrails are now ladders for young children
- unfortunately, local regulations permit this configuration
- the builder is not obligated to remedy the issue

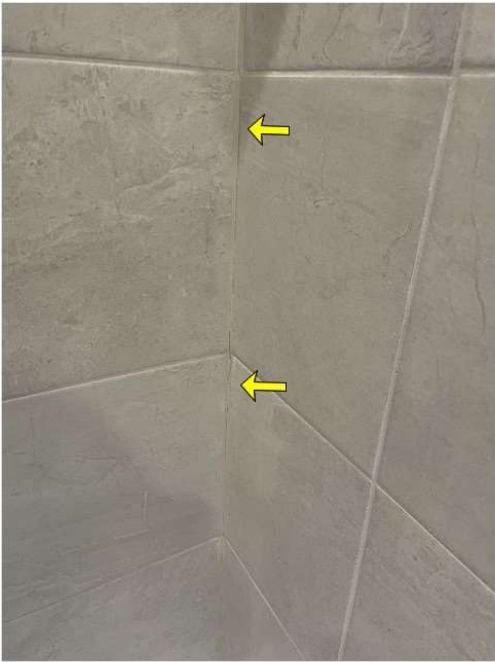
→ Leakage around tub/shower

- shower in bathroom 3 needs re-caulking in both corners and along bottom of tile above the tub

- example of cracks observed

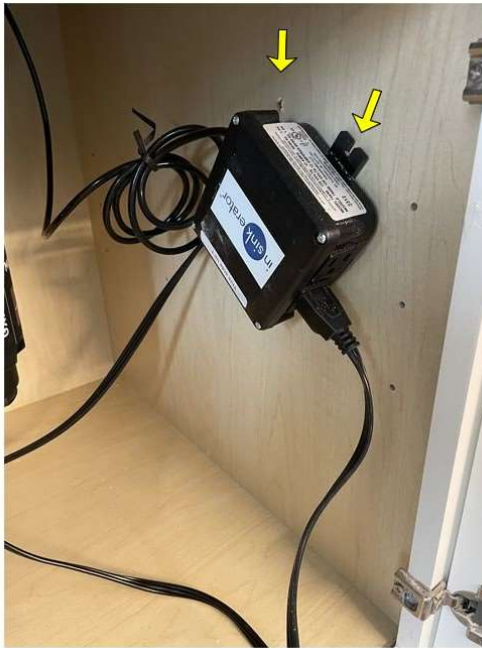
→ Loose mounting of pneumatic switch under sink

- missing screw that secures unit
