Subject: Simulated Wind Load on the IR-G Series Systems.

INSPECTION AND TEST REPORT

PNL REF. # 26-240383 S.O. # 001 INDEX 02

IR-G Series Rack Frame: Simulated Wind Load

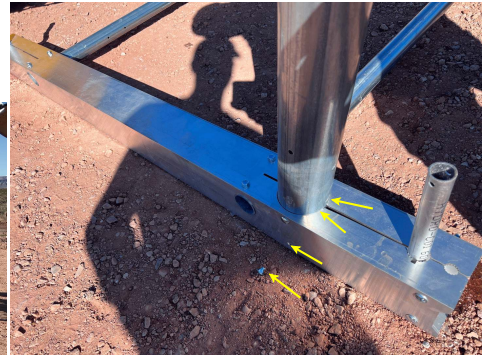
SIMULATED WIND LOAD (TENSILE UPLIFT FORCE) INSPECTION DETAILS					
NO.	MAX FORCE REACHED (lbf)	OBSERVATIONS			
1	1,545	Load reached the limit of the skidsteer capacity to pull.			
2	1,040	Test force applied horizontally. A lower mounting bolt for the main pole to the square base tube failed and sheared (Photo 3). The main pole rotated in the direction of loading and the lower lip was able to rotate up and into the tube since there was minimal stickout, about 0.050 in., of the vertical tube through the base tube. The rotation caused stress to the mounting point bolt which eventually sheared the bolt. The sheared failed bolt was ungraded.			
3	2,085	For the third test a grade 2 bolt was used in place of the ungraded bolt. The test was performed again and a total of 2085 lbf was reached with no failure. There was minimal deformation noted between the connection of the base tube and upright connection.

PHOTO 3: Sheared bolt and minor aluminum tube deformation

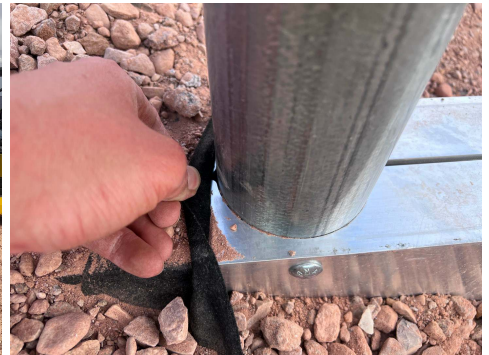
SIMULATED WIND LOAD (TENSILE UPLIFT FORCE) TEST PROCEDURE/DESCRIPTION					
<p>The IR-G Series Ground Mount Solar Array was installed with the IR EarthBallast Mounting System. Soil was loaded onto the frame as ballast. A total of 10 skid steer buckets were used. The total amount of soil was estimated as 5000 lbf. Simulated wind loads, tensile loads, were applied via a lifting strap wrapped around each of the upright poles and then attached to a forklift. The load was applied at an approximate 90 degree angle from the mounted orientation of the solar panel. The solar panel was mounted at a 45 degree angle.</p>					
SIMULATED WIND LOAD (TENSILE UPLIFT FORCE) INSPECTION DETAILS					
NO.	MAX FORCE REACHED (lbf)	OBSERVATIONS			
1	3,755	Frame deflected under load. When load was removed the frame moved back into original position. No permanent deformation noted (Photo 3) and no movement of frame or earth ballast.

PHOTO 3: No signs of deformation observed after testing

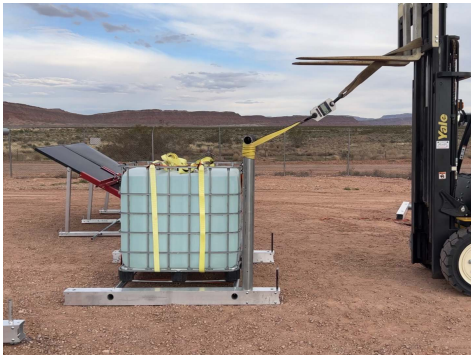
PHOTO 1: Test setup

<p>The IR-G Series Ground Mount Solar Array was installed with the IR EarthBallast Mounting System and one 275 gallon water tote as ballast. The total weight was estimated as 2400 lbf. Simulated wind loads, tensile loads, were applied via a lifting strap wrapped around each of the upright poles and then attached to a forklift. The load was applied at an approximate 90 degree angle from the mounted orientation of the solar panel. The solar panel was mounted at a 45 degree angle. For the first two tests, only 2 ground spikes were installed at the front of the frame (Photo 1-3). For the third test, an additional 2 ground spikes were installed into the back of the frame (Photo 4).</p>					
SIMULATED WIND LOAD (TENSILE UPLIFT FORCE) INSPECTION DETAILS					
NO.	MAX FORCE REACHED (lbf)	OBSERVATIONS			
1	1,460	Load was applied at an approximate 45 degree upward angle. The frame began to roll forward and lift off the ground at the back end at ~ 1460 lbf (Photo 1-2). No permanent damage was noted.

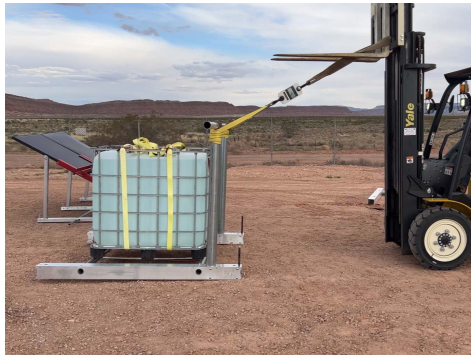
PHOTO 2: Load applied at ~ 45 degree angle

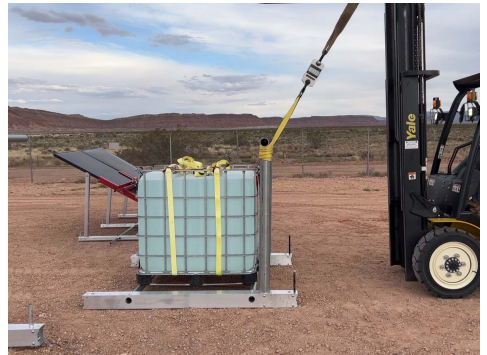
2	2,400	The load angle was adjusted to 60 degrees. The frame began to roll forward and lift off the ground at the back end at 2400 lbf (Photo 3). No permanent damage was noted.			
3	2,550	Two additional ground spikes were installed into the frame prior to the test. The load angle was ~ 60 degrees. The rear ground spikes started to pull out of the ground at ~ 2100 lbf. The rear ground spikes came out of the ground at 2550 lbf and the frame began to lift off the ground. The front spikes were still in the ground and resisting the load (Photo 4).

PHOTO 3: Load applied at ~ 60 degree angle.

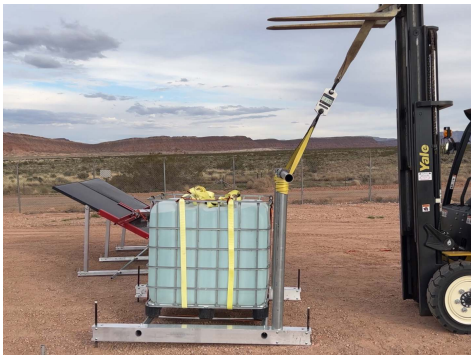
PHOTO 4: 3rd test with additional ground spikes installed at the back end of the frame.

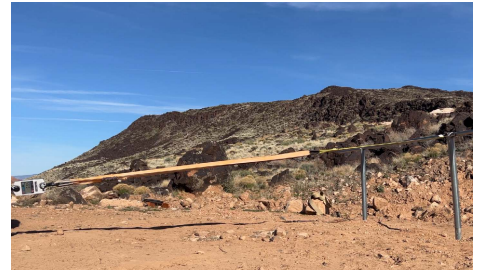
PHOTO 3: Dual post under load

HORIZONTAL TENSILE TEST INSPECTION DETAILS					
NO.	TEST SETUP	POST ANGLE, BEFORE TEST	POST ANGLE, AFTER TEST	MAXIMUM LOAD (lbf)	OBSERVATIONS
1	2 posts	0.1°	0.4°	2,490	The concrete cap cracked at one post (Photo 3) and the frame shifted forward. Posts deflected under load. Upon load removal they returned to their starting position but had experienced some permanent deformation due to bending in the load direction. The bolts that were used to tighten the post sleeve were deformed and started to deform the metal around it (Photo 7).

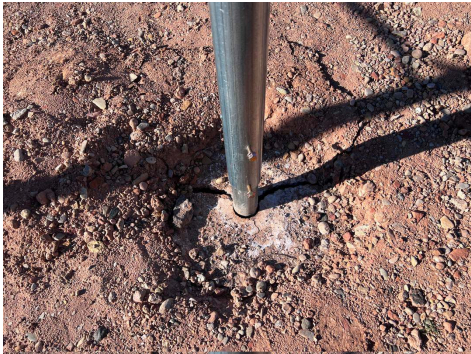
PHOTO 4: Cracked concrete in base of post after dual post test

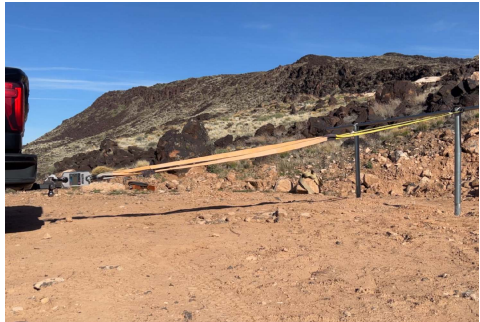
PHOTO 6: Single post test under load

0.2°	2.5°		
2	1 post	0.6°	2.4°	1,695	The concrete cap shifted and the soil around the post had a visible crack where the concrete shifted.

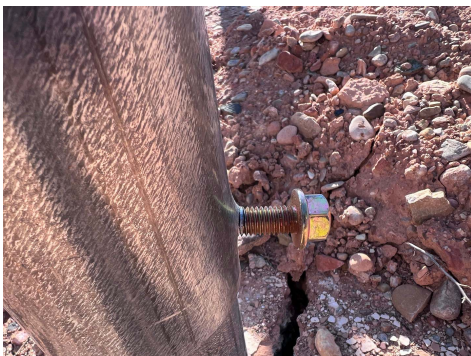
PHOTO 7: Typical post deformation around bolts
